**MANOR FARM  
CARLTON ROAD  
BARTON IN THE BEANS  
CV13 0DD**

**UPDATED - 2  
PRELIMINARY ECOLOGICAL APPRAISAL  
Incl. POTENTIAL ROOST ASSESSMENT**

Ref: WCL/ML/PEA/281124U2

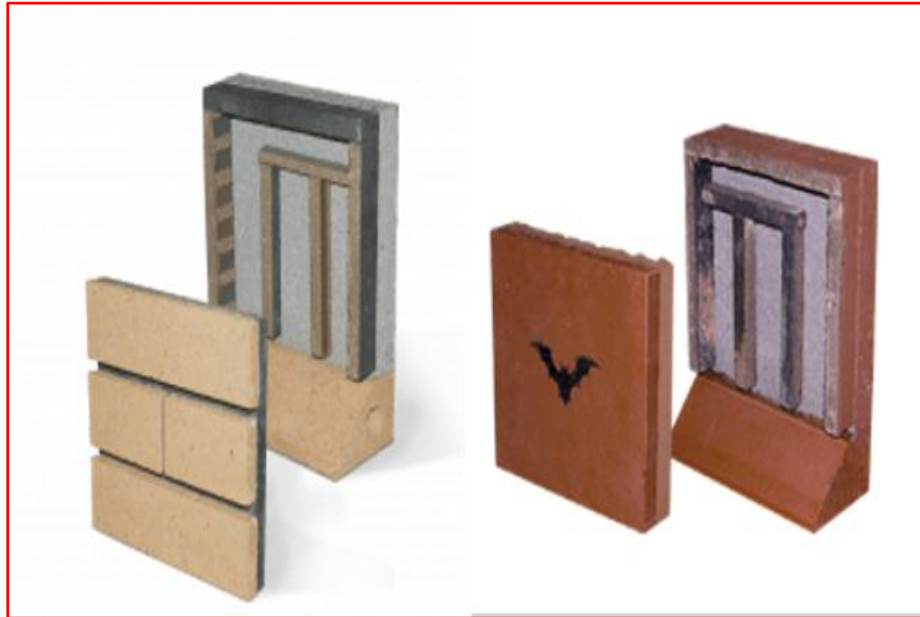
i) Ibstock Enclosed Bat Box 'B' or Ibstock Enclosed Bat Box 'C'

A) Incorporation of 2 / 3 bat bricks into any new development either i) or ii)  
– Gable ends

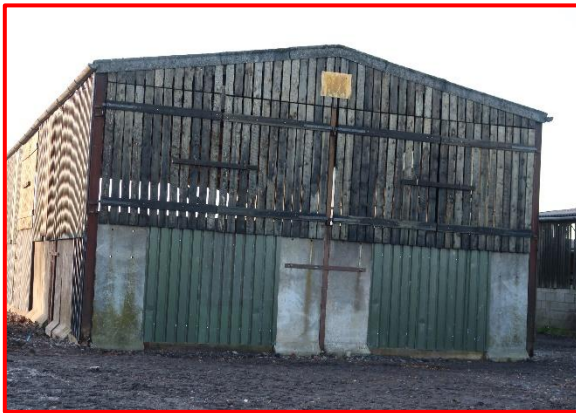
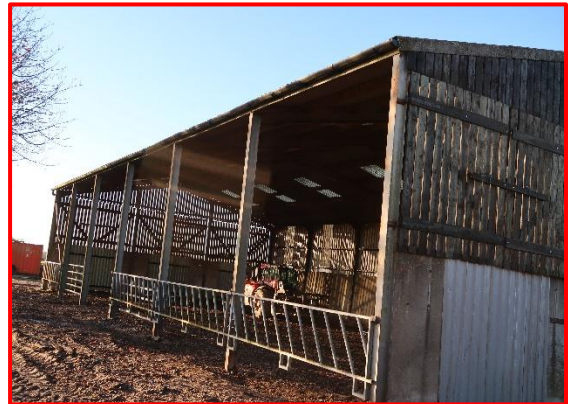
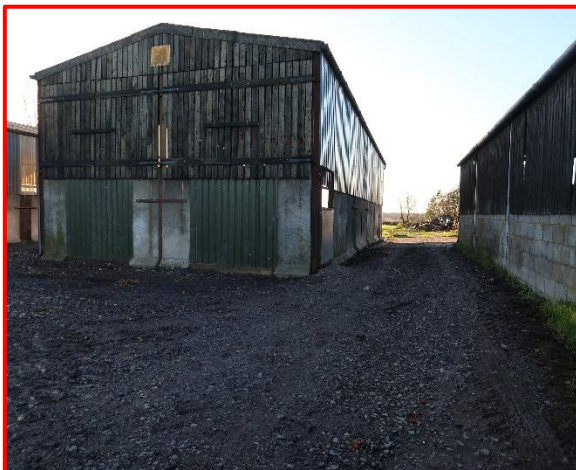
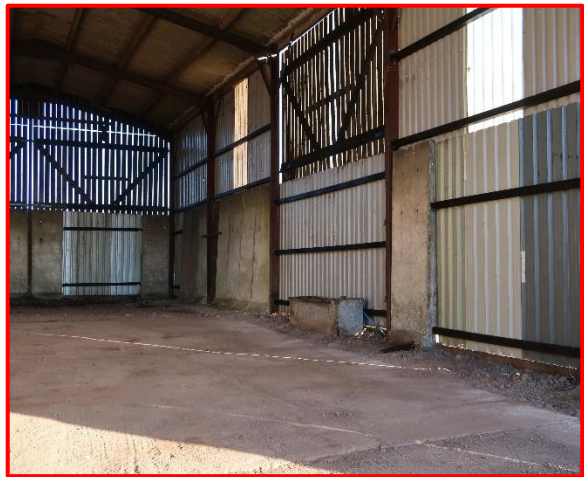
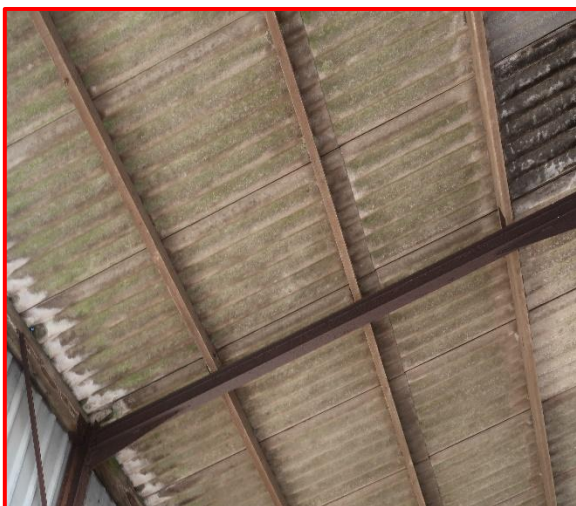
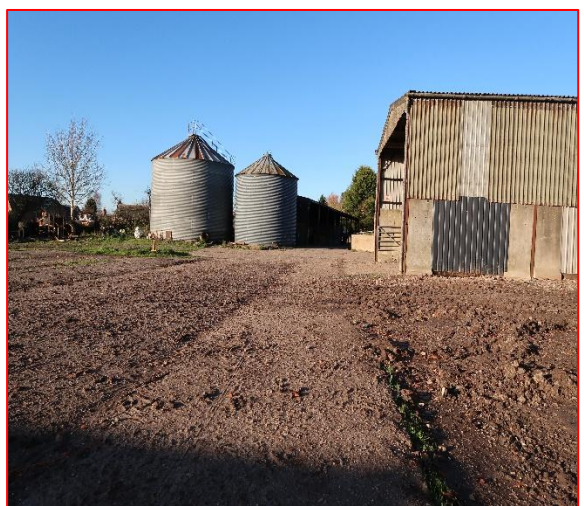
The two buildings, on site, are Agricultural Portal Framed with concrete panel sides, Yorkshire Boarding, corrugated sheeting with corrugated roof sheeting with some sides and ends being open, concrete and hard standing floors and aprons.

They were used for housing livestock for the former dairy business at the farm but are now redundant.

View of buildings.

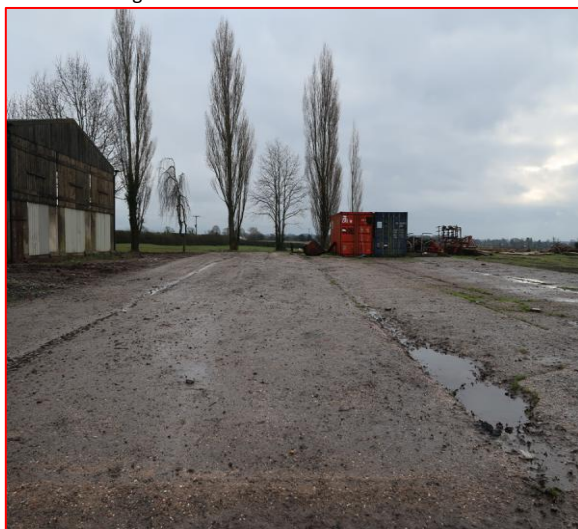
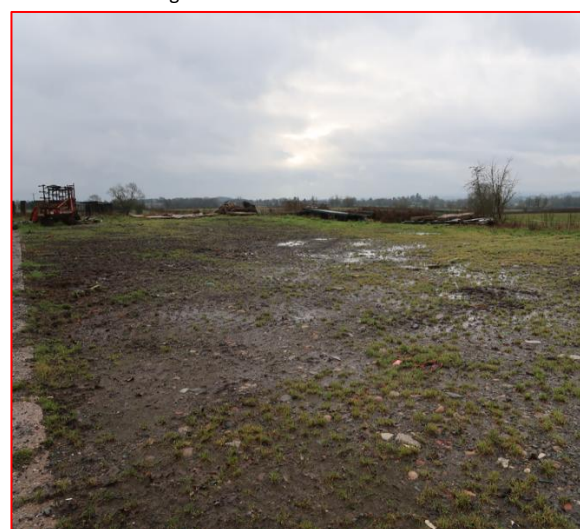
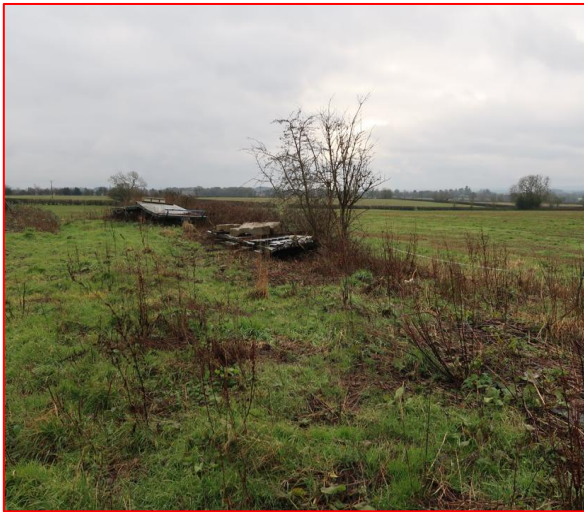
View of existing hard standing – proposed gardens

The proposal is to convert two agricultural outbuildings to form two dwellinghouses and the hard standings to be removed and established as gardens to the properties.

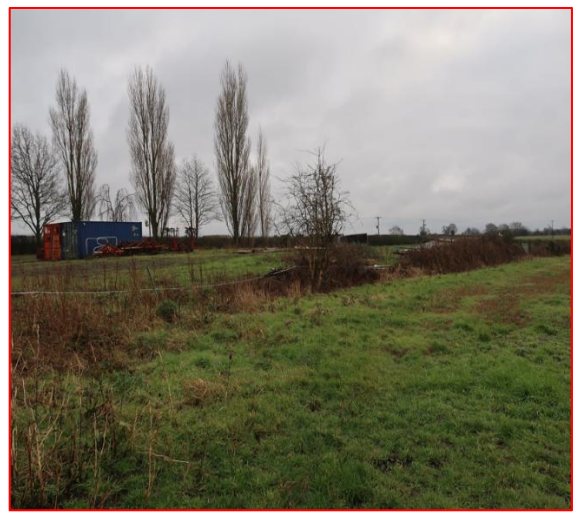
View of existing hedge – site & adjacent agricultural field

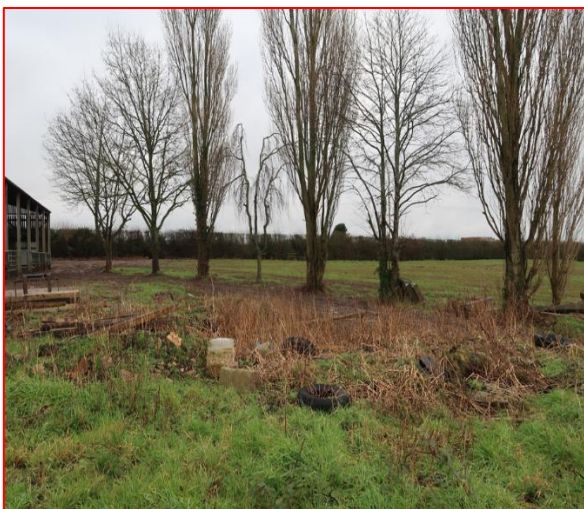
View of existing tree & proposed new hedge line

- i) New post & rail fencing and hedgerows to be planted to the field side boundaries
- ii) Post & rail fence to include new hedgerow between the gardens.

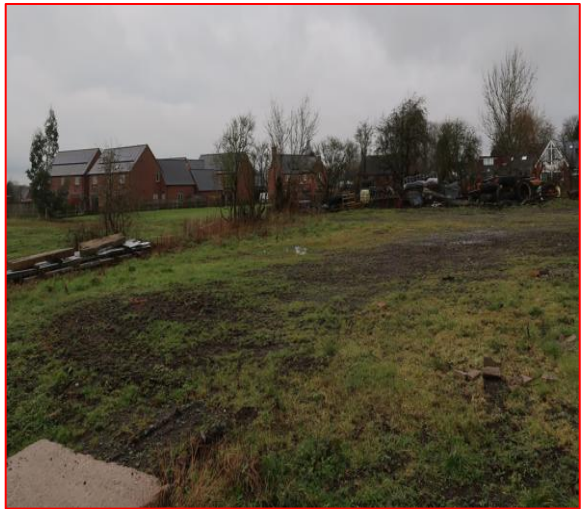
View of existing boundary & proposed new hedge line
