Preliminary Bat Roost Assessment & Ground Level Tree Assessment

Land adjacent to
3 Peckleton Lane

November 2025

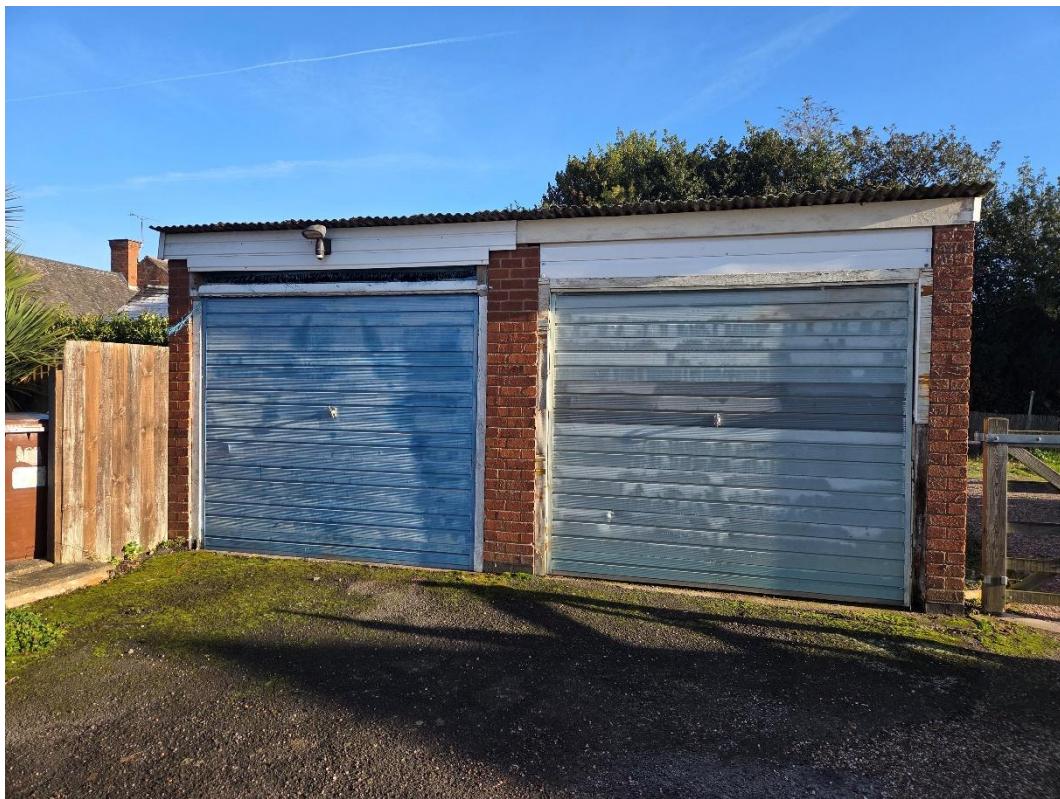
Red brick built double garage, covered in asbestos corrugated panels, mixture wood and plastic barge boards, and wooden windows and doors throughout.

Photograph 1: The western elevation of the Building.

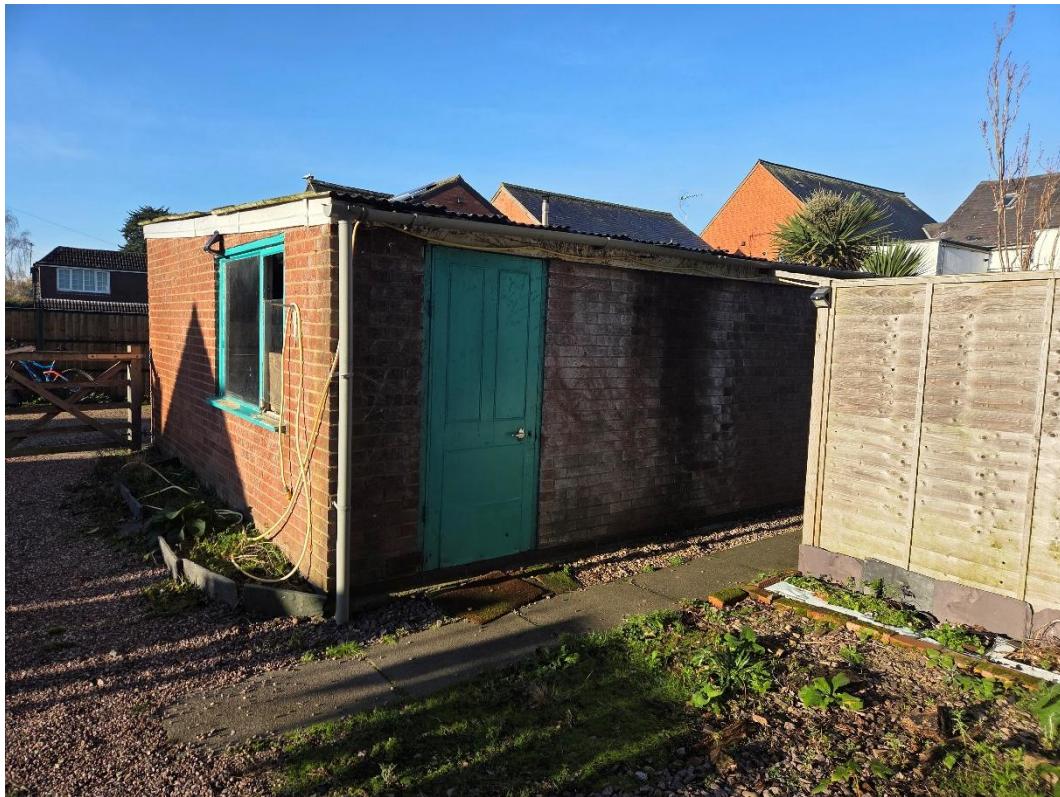
Photograph 2: The south and eastern elevations of the garage.

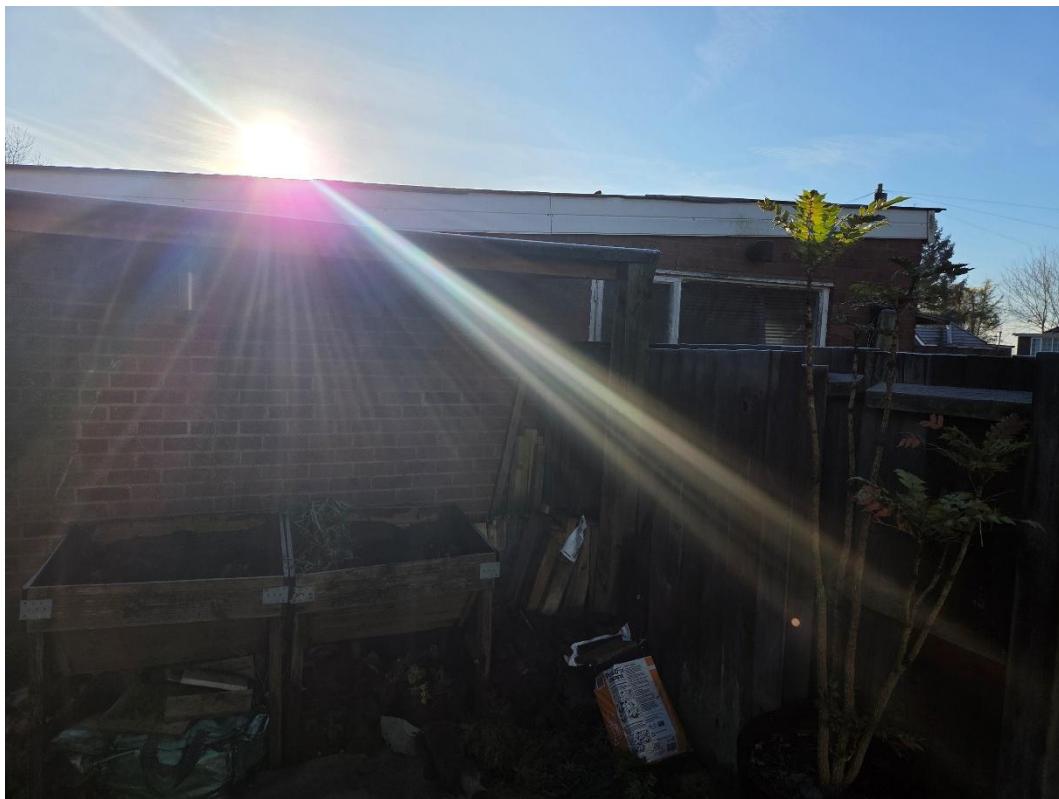
Photograph 3: The western elevation of the garage.

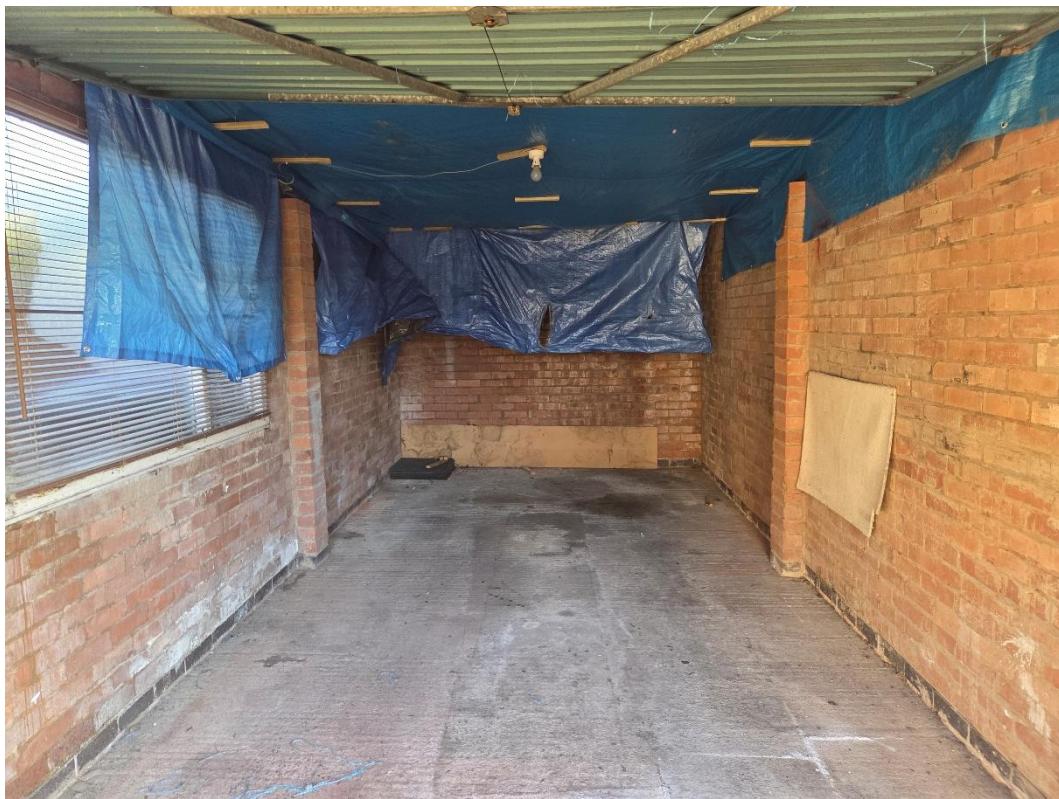
Photograph 4: The internal view of the building.

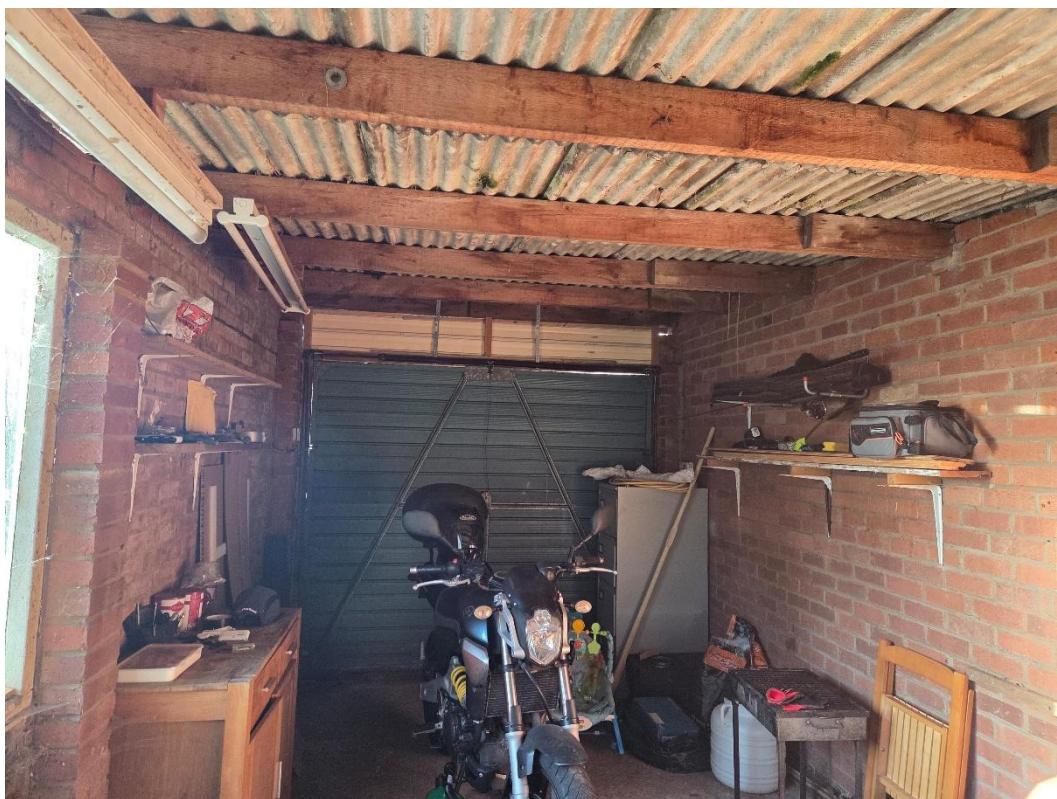
Photograph 5: The internal view of the building.

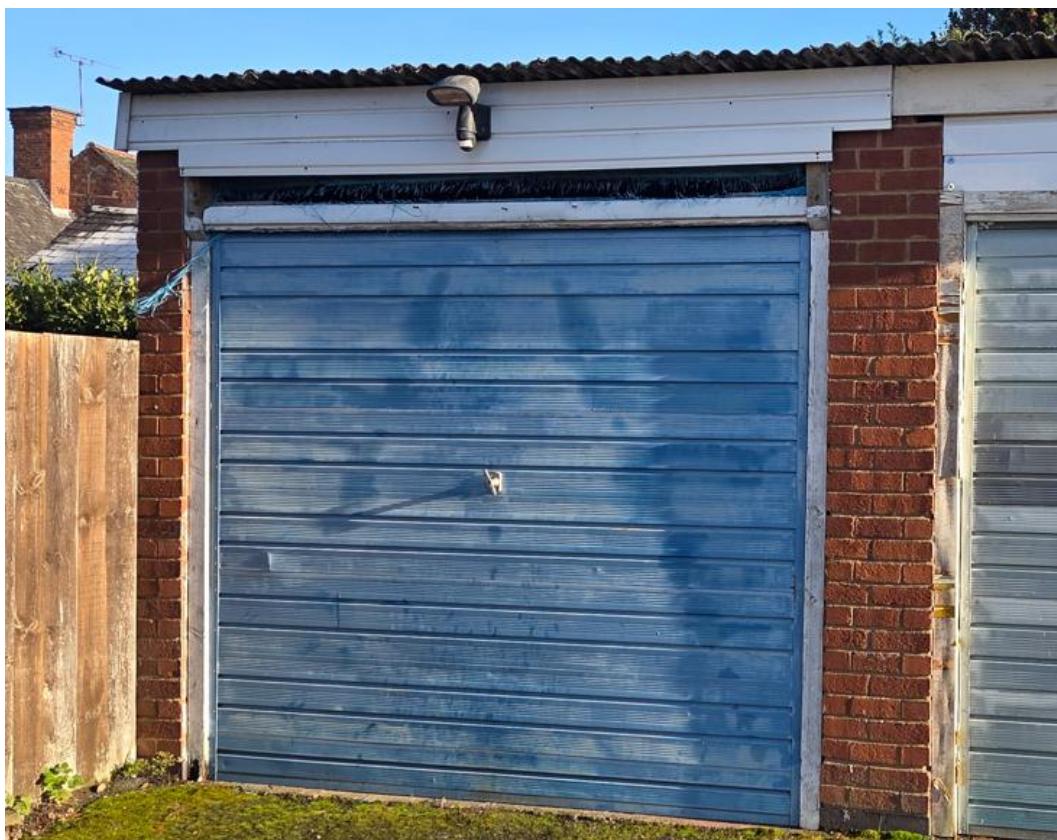
Potential access points for bats were noted, including a significant gap above the garage door (see photograph 6 below). However, internal features suitable for roosting were minimal, and no indications of historic use, such as droppings or urine staining, were observed. The building appeared draughty and cold.

Photograph 6: Gap above the garage door.

There are no additional requirements for bats, but it's essential to follow the guidance in Appendix 1 when demolishing the garage.

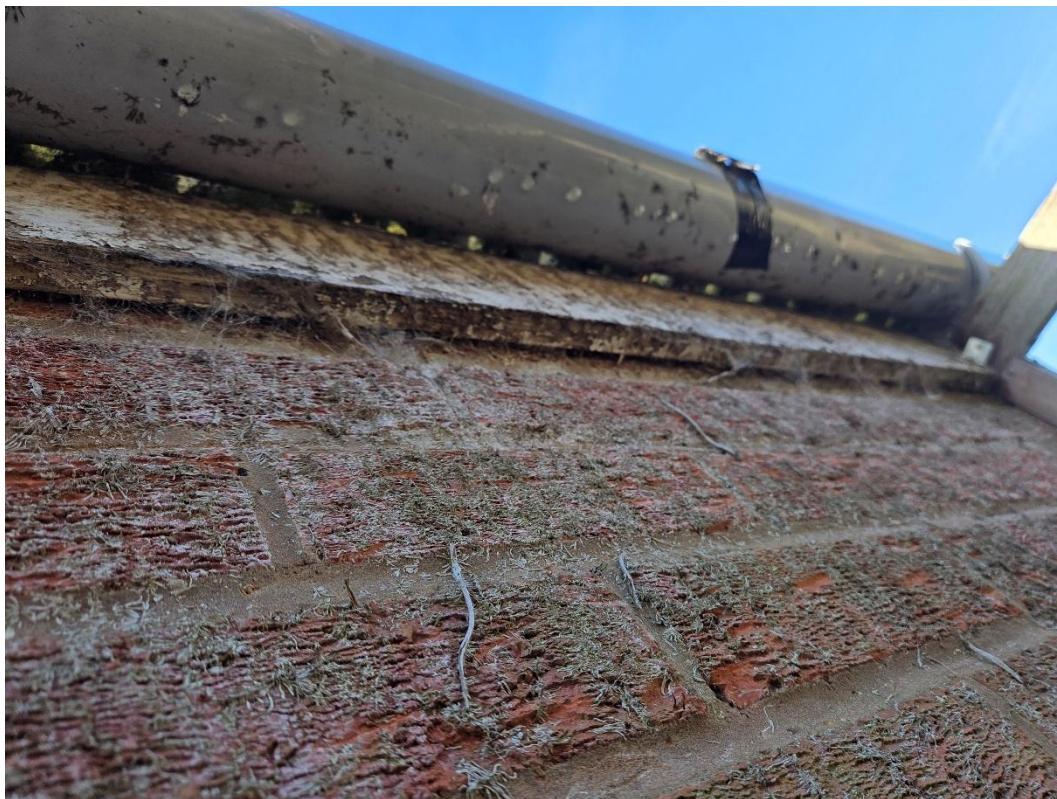
The fascia boards around the building's exterior, typically considered potential roosting sites for bats, were covered with webs and displayed no signs of previous occupancy (see photograph 7 below).

Photograph 7: An example of the fascia boards with dense webbing.

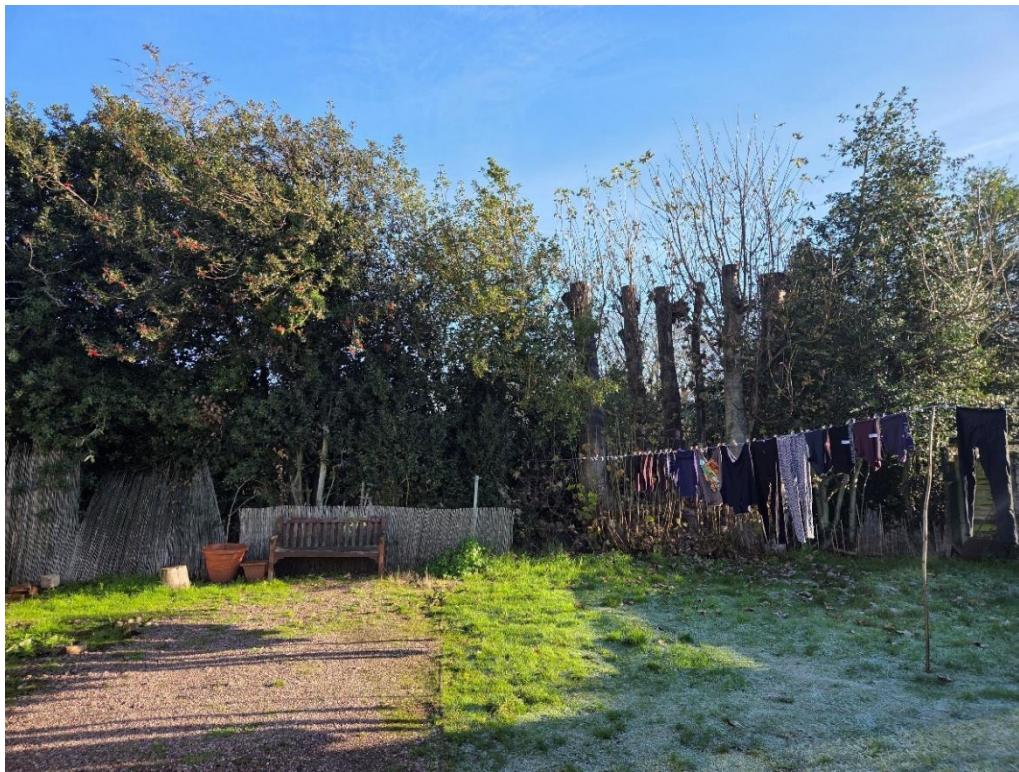
The holly was identified as unsuitable for roosting bats, but may provide suitable nesting areas for birds.

The six Sycamore trunks originated from a single root system at their base and were recently pruned by a neighbouring property owner. These trees exhibited symptoms of

Photographs 8: The holly along the boundary which may be impacted, and the six Sycamore stems.

The five trees with potential bat roosting features, are all to be cleared. In line with Collins (2023) Table 6.3 “no further surveys” are required for PRF – I only. A Roost Resource Approach alongside a Precautionary Working Method Statement will offset the losses and safeguard the bats. This is detailed within the Environmental Construction Method in section 6.2.

Trees must be felled using the "soft fell" technique, overseen by a licensed ecologist, to avoid harming any bats.

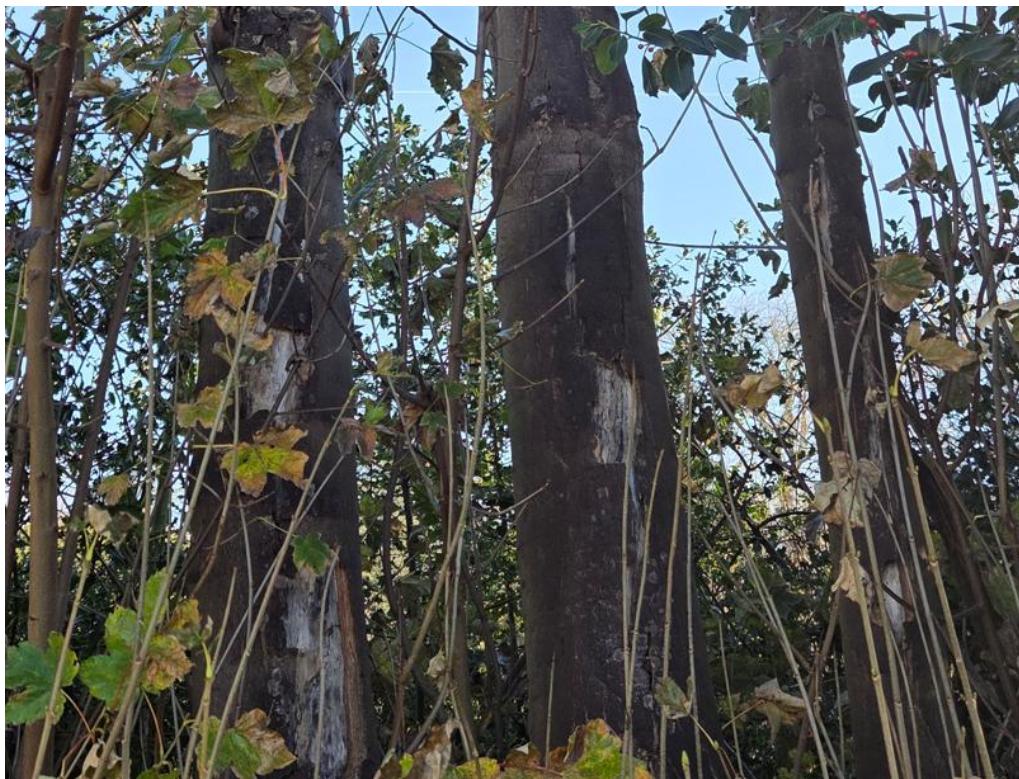
disease, with most displaying lifted bark. This condition may offer potential roosting habitats for individual bats, although no bats were observed during the survey. The extent of bark lifting could increase over time. The trees have been classified as PRF-I, indicating suitability for individual bats or small populations.

Photographs 10: Lifted bark shown on the trees.

- Sectional Cutting: Dismantle trees in sections whenever possible.
- Buffer Zones: When cutting near a PRF (like a rot hole), make cuts at least 50cm above and below it to avoid damaging the cavity.
- Controlled Lowering: PRF sections should be rigged and slowly lowered using ropes, not dropped.
- Ground Inspection: Once on the ground, the ECoW will inspect these sections immediately.
- Soft Release: If a section contains a deep, un-inspectable cavity, leave it gently on the ground (with the hole facing up and clear) for 24 hours so undiscovered bats can exit overnight.

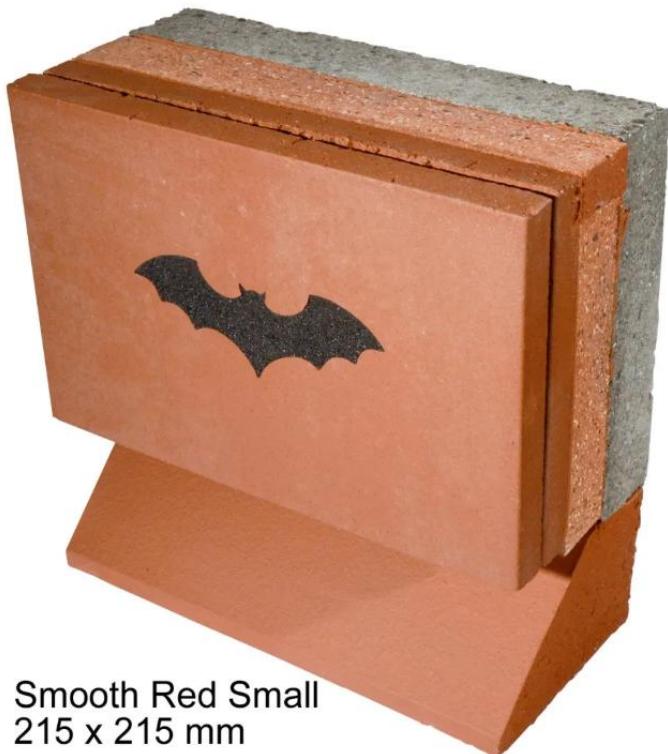
Smooth Red Small
215 x 215 mm

Screenshot 1: An example of a Ibstock Enclosed Bat Box 'C' courtesy of NHBS.com.

As the Roost Resource Approach, two bat boxes will be integrated into the fabric of the new building. They will be Ibstock Enclosed Bat Box 'C' or similar and will be situated under the direct guidance of a licenced bat worker. An example of these type of bat boxes is shown below.

Two integrated bat boxes will be added to the new construction to boost local roosting options, focusing on crevice-dwelling species like pipistrelles. These must be Ibstock Enclosed Bat Box 'C' or equivalent and installed under the supervision of a licensed bat worker.
