**Concordia Theatre – Preliminary Roost Assessment and Baseline Biodiversity Net Gain Assessment**

I write to you regarding the Preliminary Roost Assessment (PRA) and baseline Biodiversity Net Gain (BNG) survey conducted of Concordia Theatre, Hinckley, in June 2026.

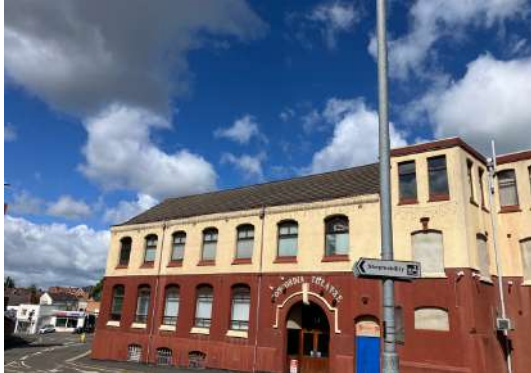
Building B1 is a two-storey brick-built theatre with a pitched roof clad in concrete tiles. There is an extension north that is brick to first storey and corrugated metal to second storey. The concrete tiles and ridge tiles are in good condition with no gaps/lifting to allow internal access for bats. On the west elevation of the building there are some areas of missing mortar between brickwork that could provide suitable crevices for bats, however there is artificial night lighting along this elevation that is likely to make these features less suitable for bats. There is a single-storey brick-built flat roof extension to the north with fascia boarding that has some lifting between the board and the wall, however no gaps identified were large enough to support roosting bats. No other external features are present with the potential to support roosting bats.

**Photograph 1:** exterior of B1

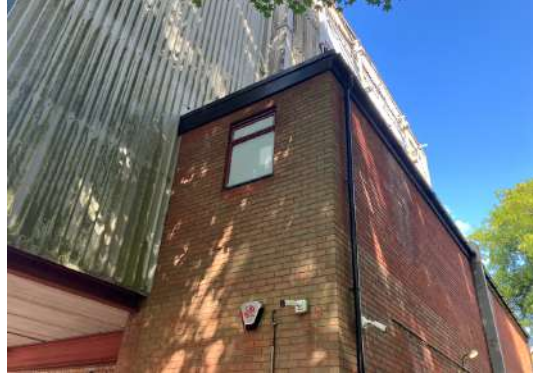
**Photograph 2:** fascia boarding of single-storey extension of B1

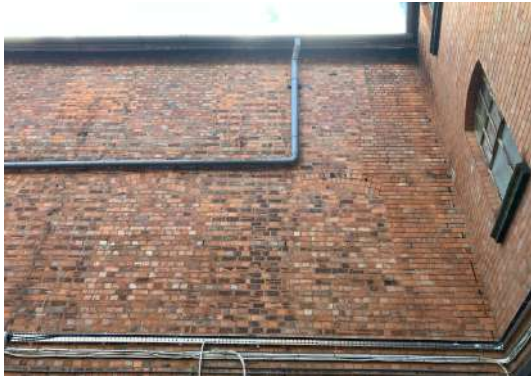
Overall, building B1 is assessed as being of negligible suitability for roosting bats, as even with the presence of low suitability Potential Roosting Features on the western elevation, these are reduced in suitability by the presence of artificial night lighting and poor connectivity to foraging/commuting habitats in the wider landscape.

**Photograph 3:** missing mortar on west elevation of B1

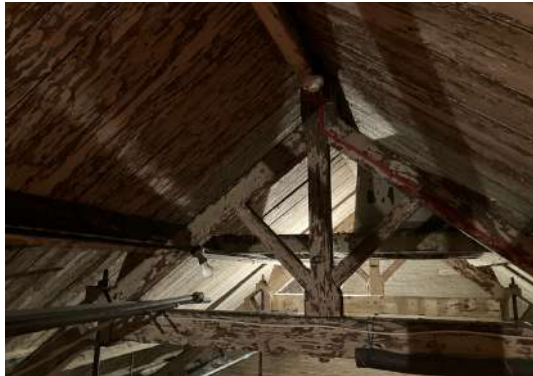
Building B1 has one internal loft void at the south of the building. The loft void is approximately 3m tall with a wooden platform approximately 1m off the floor. The roof is underlined in wooden boarding. The gable ends are brick with missing bricks at the south gable end potentially providing crevices for roosting bats. No access points are present that would permit access to bats from the

exterior of the building. No bats were observed *in situ*, and no evidence of roosting bats, such as droppings or urine staining, was found.

**Photograph 4:** internal loft void of B1

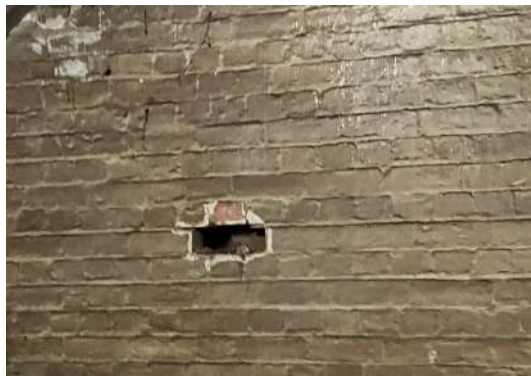
**Photograph 5:** missing bricks at south gable of internal void of B1

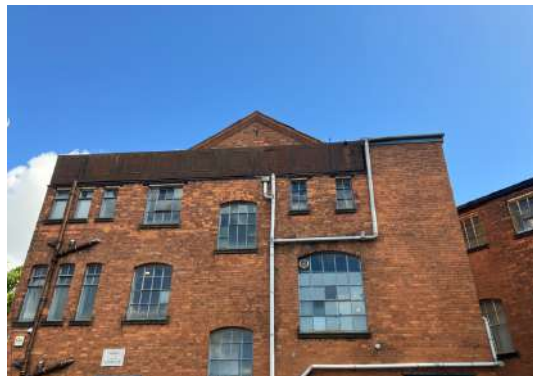
Building B2 is a two-storey brick-built building with a pitched roof clad in concrete tiles, connected to B1 by a brick second-storey link. The tiles are in good condition with no lifting/gaps suitable for roosting bats. The brickwork is in good condition with no areas of missing mortar or gaps. No external features were identified with the potential to support roosting bats.

Building B2 is assessed as being of low suitability for roosting bats on a precautionary basis, as no roosting features or access points were identified externally, however it could not be confirmed that there are not suitable internal voids that are accessible to bats.

**Photograph 6:** exterior of B2

Building B2 is considered to offer low suitability for roosting bats, however no works are proposed in relation to B2, therefore no impacts on bats are anticipated and no further survey effort is required.

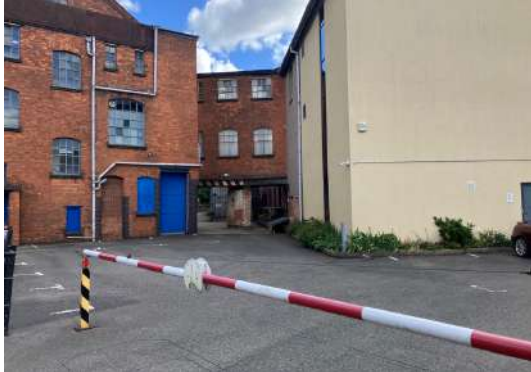
| Habitat type | Parcel Ref (if relevant) | Description |
|---|---|---|
| Developed land; sealed surface (u1b) | PR1 & PR2 | Sealed surface tarmac car parking around two main buildings. |

**Photograph 7:** tarmac car park (PR1 and PR2)

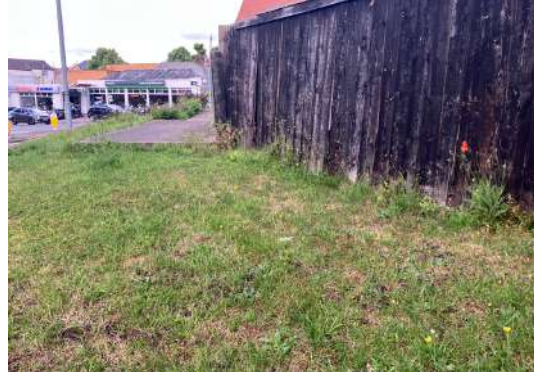
| Habitat type | Parcel Ref (if relevant) | Description |
|---|---|---|
| Modified grassland (g4) | PR3 | Short sward modified grassland at the south of the site with <6 species per m <sup>2</sup> . Dominated by perennial rye grass ( <i>Lolium perenne</i> ) with other species present including chickweed ( <i>Stellaria media</i> ), cats ear ( <i>Hypochaeris radicata</i> ), poppy ( <i>Papaver rhoeas</i> ), daisy ( <i>Bellis perennis</i> ), Yorkshire fog ( <i>Holcus lannatus</i> ), yarrow ( <i>Achillea millefolium</i> ), cock's-foot ( <i>Dactylis glomerata</i> ), false-oat grass ( <i>Arrhenatherum</i> |

**Photograph 8:** modified grassland (PR3)

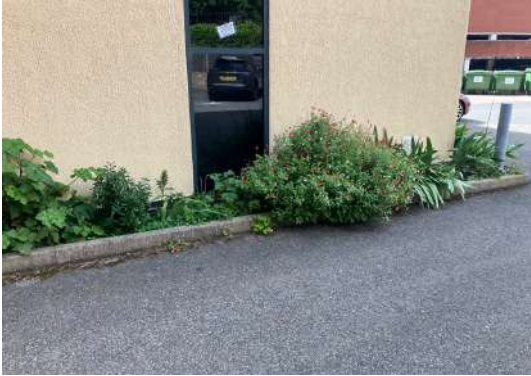
| Introduced shrub [847] | PR4 | Ornamental planting around the northwest corner of B1. Species include iris ( <i>Iris</i> sp.), spindle ( <i>Euonymus</i> sp.), salvia ( <i>Salvia</i> sp.), and herb Robert ( <i>Geranium robertianum</i> ). |

**Photograph 9:** introduced shrub (PR4)

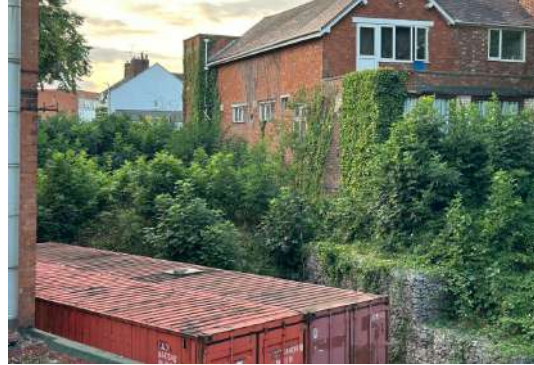
Broadleaved woodland within PR5 was subject to tree removal prior to the site visit. It's original habitat type and condition have been estimated on a precautionary basis and included within the metric calculation as degradation.

| Other broadleaved woodland (w1g) | PR5 | PR5 is in the north of the site and comprises ash ( <i>Fraxinus excelsior</i> ) and sycamore ( <i>Acer pseudoplatanus</i> ) saplings and young trees ranging from 3m to 7m in height. Prior to the site visit semi-mature to mature ash trees were removed as seen in Google satellite imagery and Streetview. |

**Photograph 10:** other broadleaved woodland

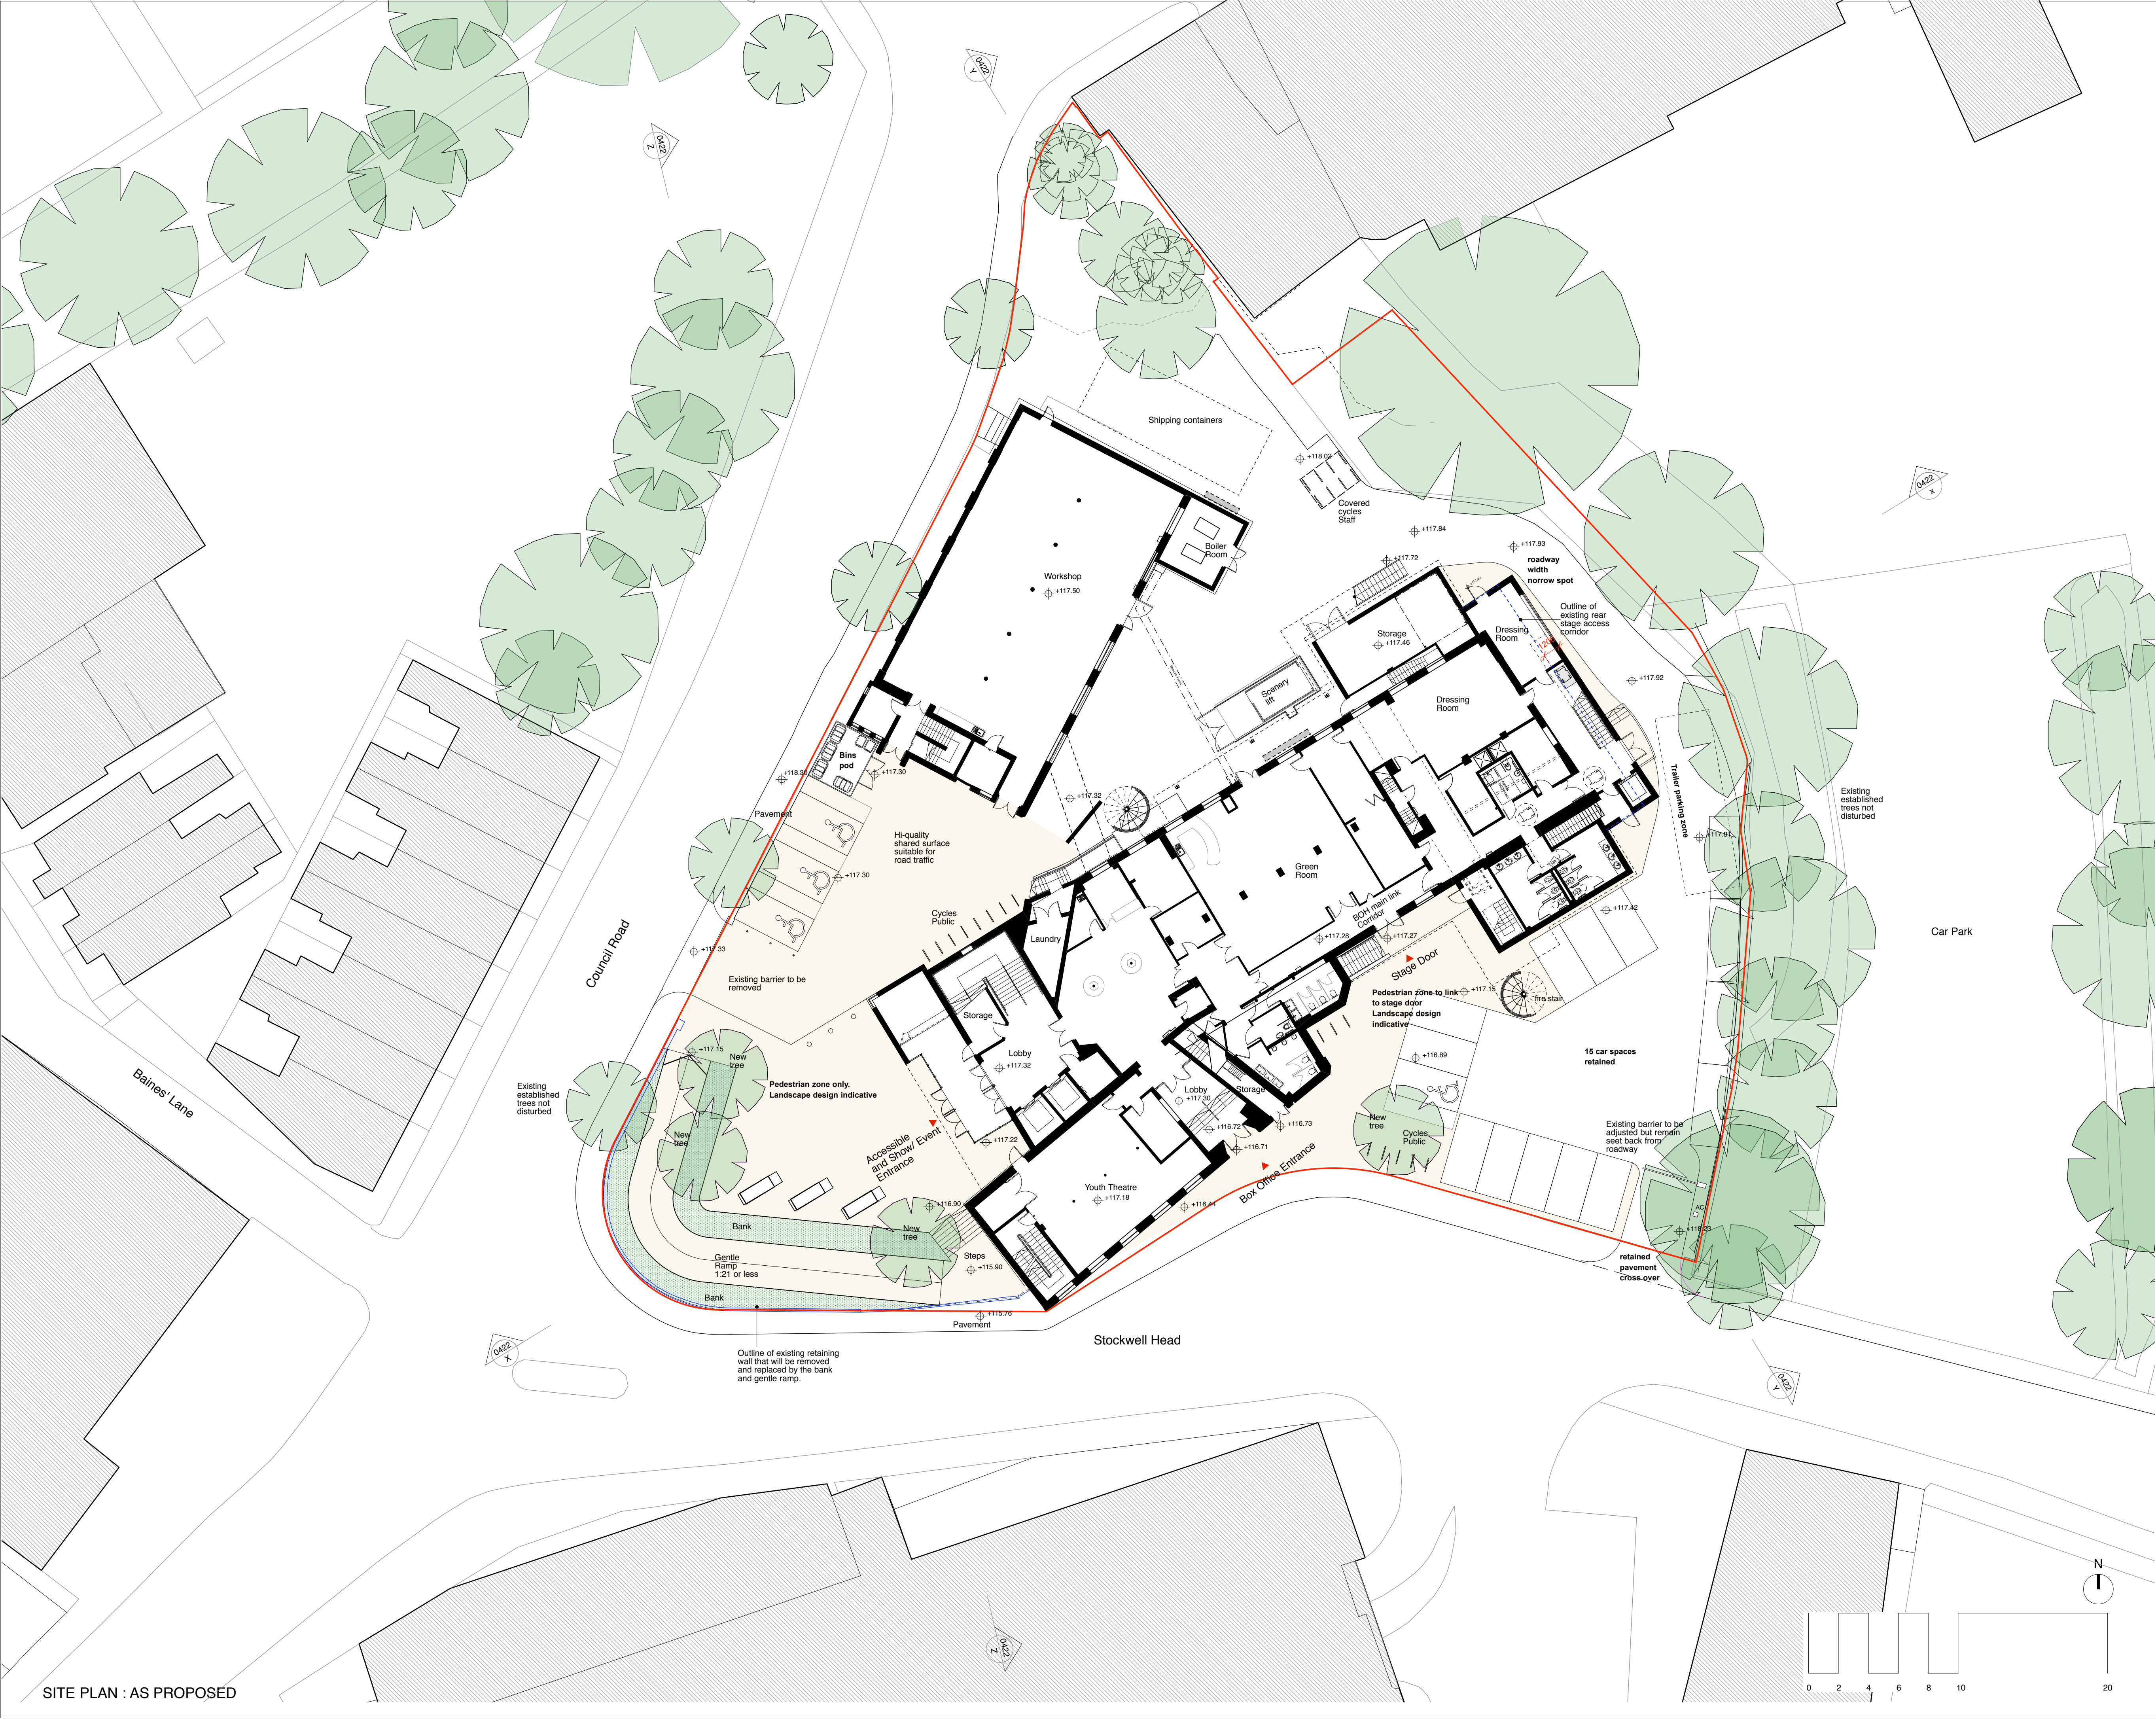
Drawing ref. [HCA-KWA-X-00-DR-a-0401]

Proposed habitats include extensions of the existing buildings and car parking, modified grassland bank, and four individual urban trees. The proposed woodland is a lower condition reflection of the baseline woodland to account for the degradation of the habitat prior to the initial site visit.

SITE PLAN : AS PROPOSED

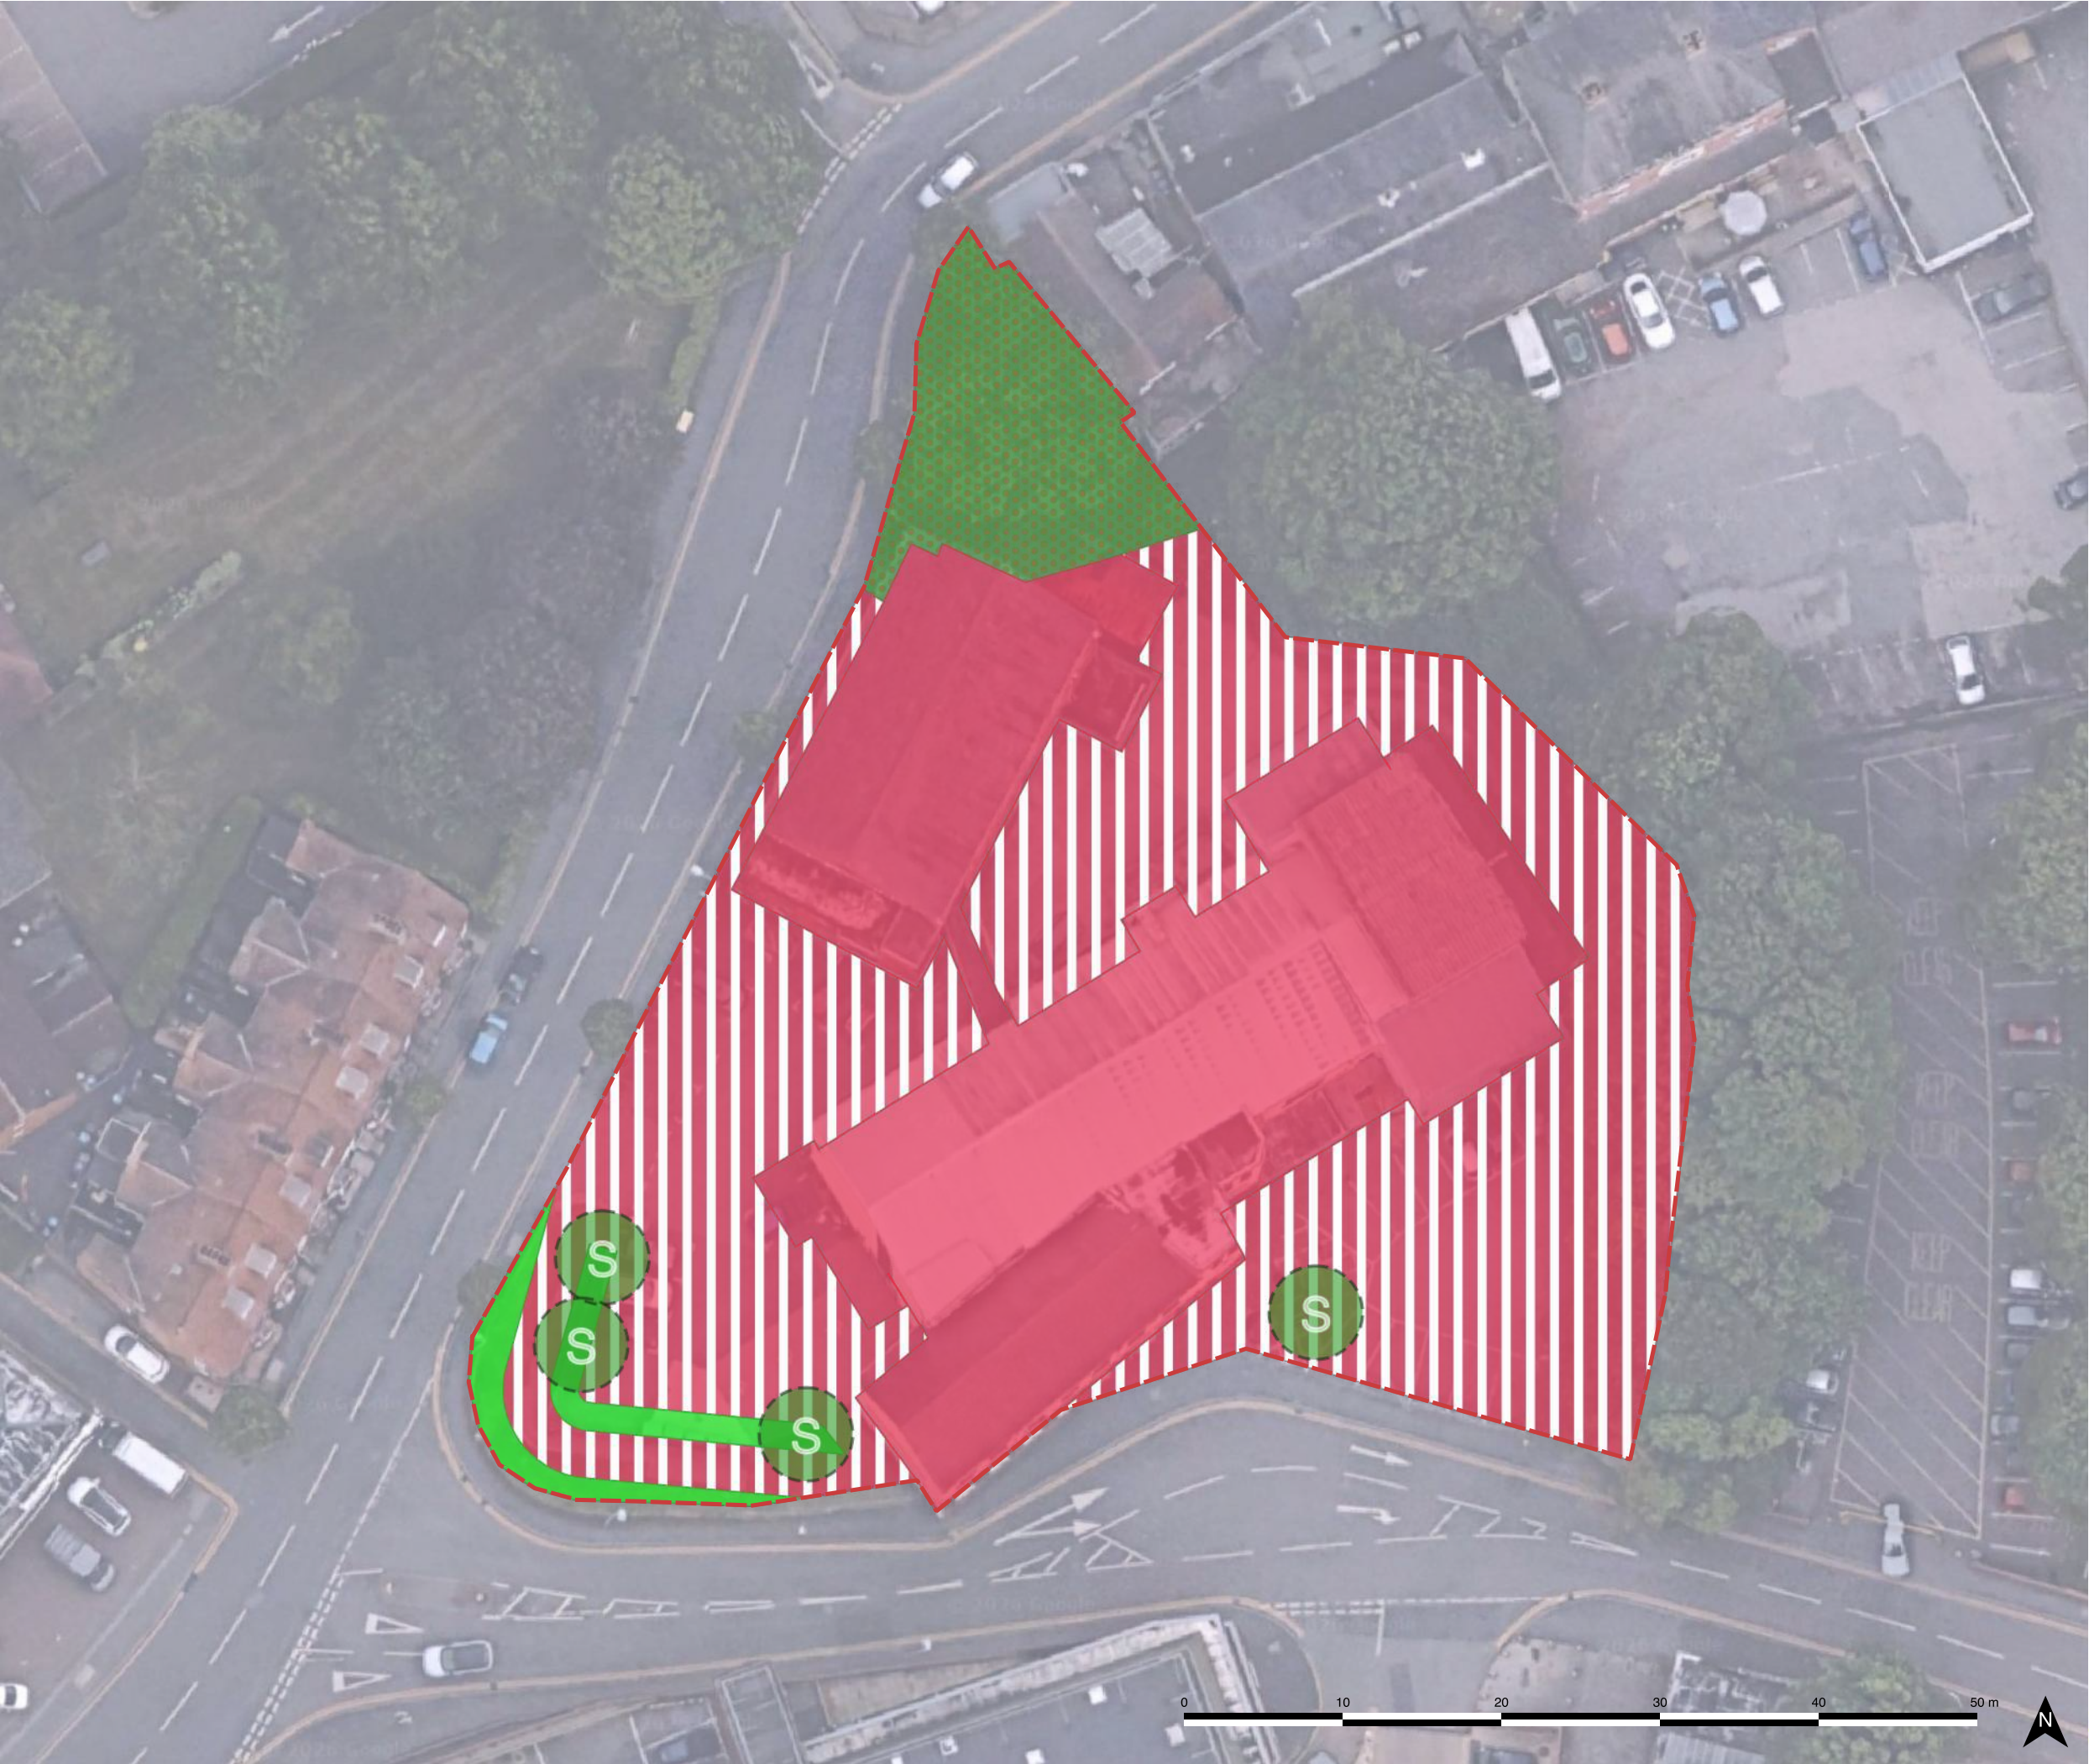
Site layout proposals used to inform the proposals are provided at Appendix 2; our interpretation of these habitats for input into the metric is illustrated on drawing EBD\_4685\_DR003 at Appendix 3. Detailed condition assessments for the proposed habitats are provided at Appendix 5 alongside justification.
