# *Former Moore's Arms*

6 Orton Lane, Norton Juxta Twycross, Warwickshire, CV9 3PU.

Archaeological Strip, Map & Sample Excavation.

*3rd July 2024*

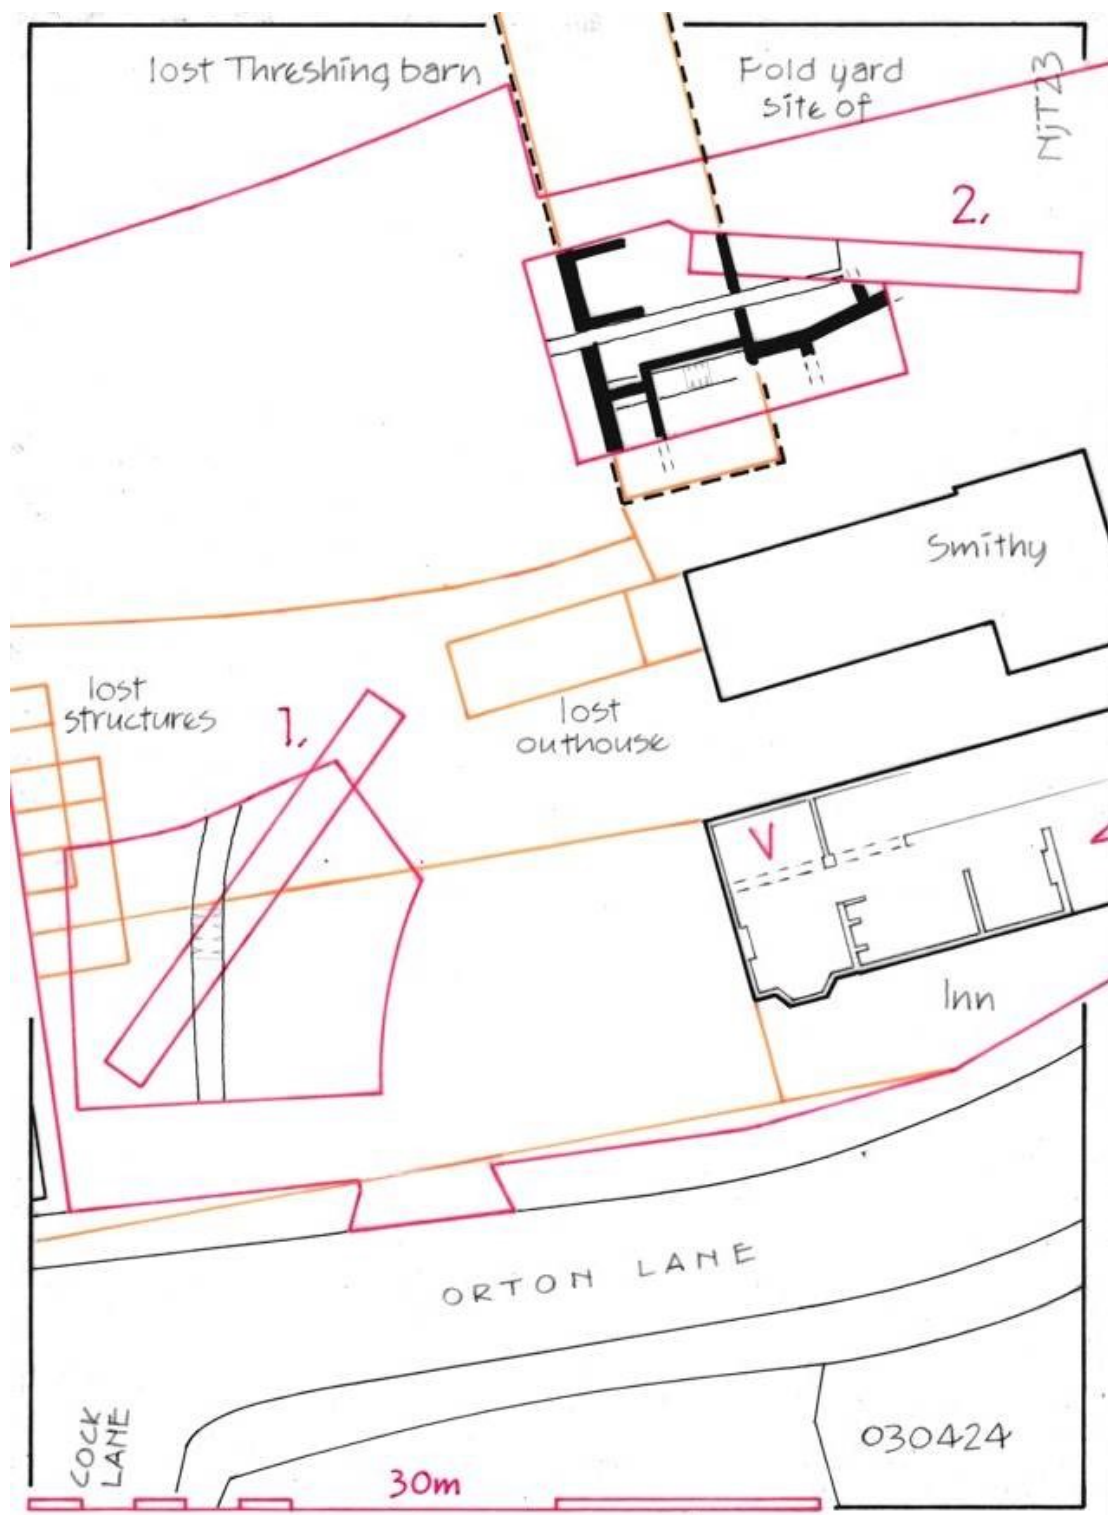
Fig. 4: Site plan showing location of the ASMSE Areas 1 & 2 and the main archaeological features, lost features from 1st Edition OS shown in orange. Building recording locations (see plates 17 & 18) shown with red arrows.

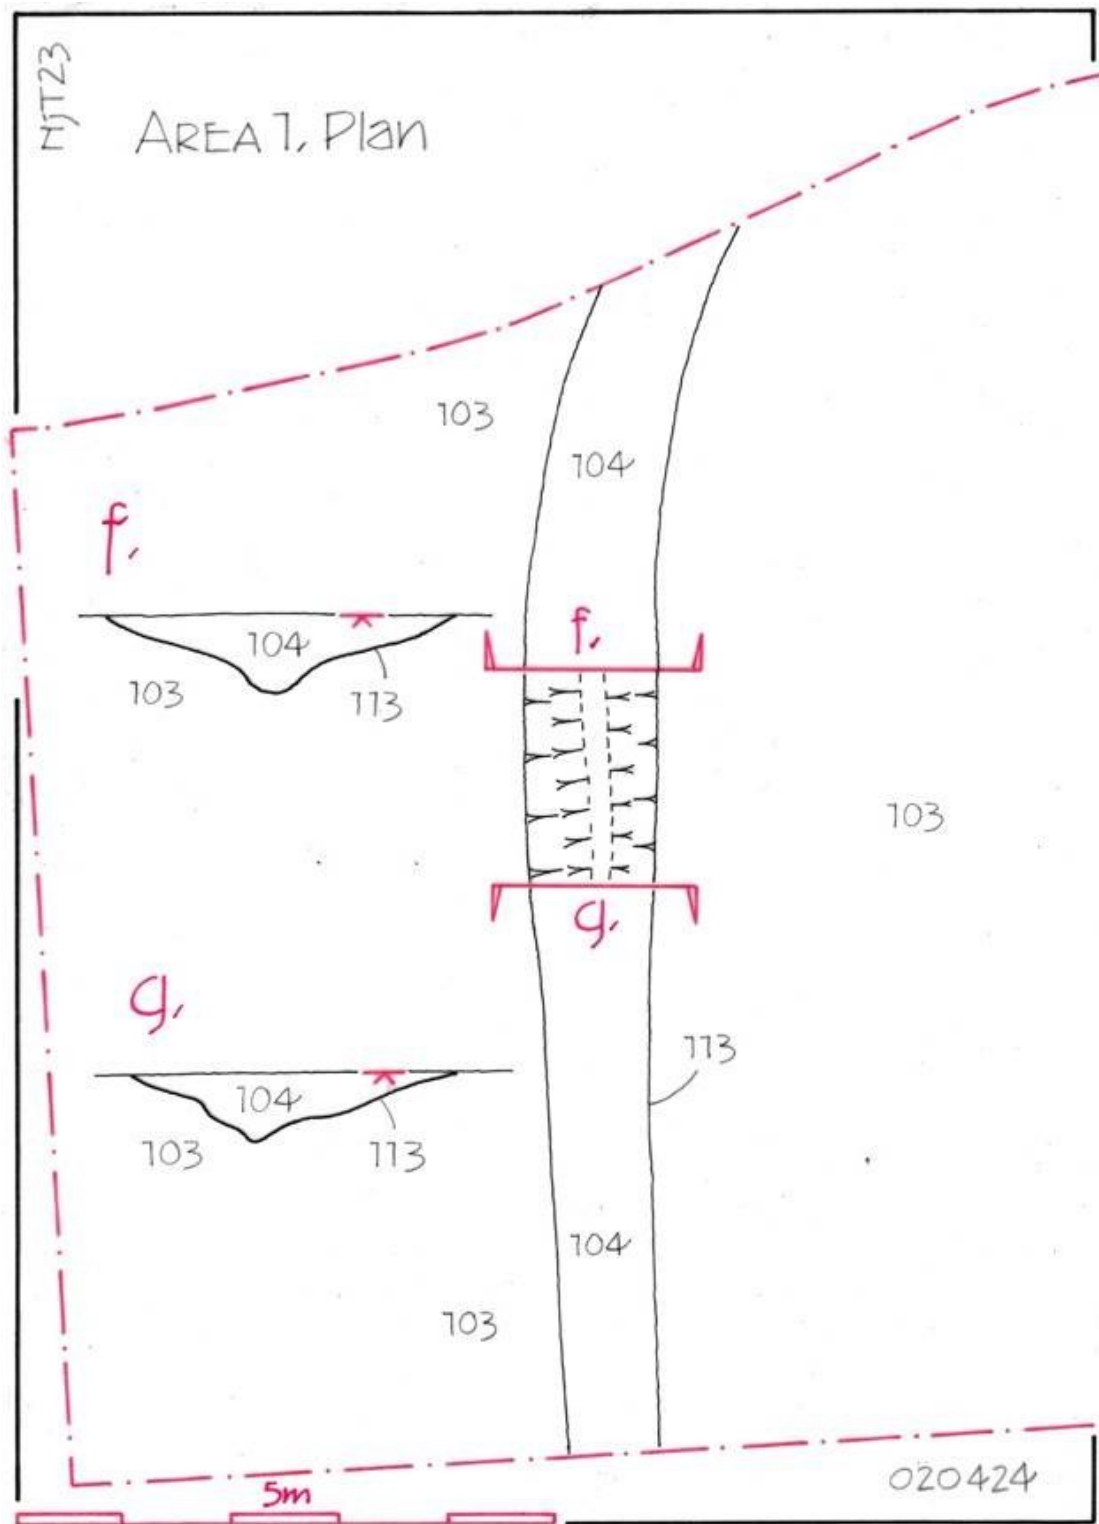
Fig. 5: Area 1, plan of ditch [113] and sections.

The surface of the natural substrate (103), consisting of a stiff light grey/brown clay (103) with the occasional component of small stones, was recorded at a roughly level height of about 107.80m AOD throughout the excavated area. There were the occasional small lenses of reddish-brown gravel intermittent throughout the deposit. Truncating the substrate and crossing the excavation from north-south was the remains of ditch [113], previously recorded during the evaluation. Sample excavation showed this to be similarly sized, measuring up to 1.30m wide and 0.30m deep and similarly filled by the deposit (104) although in this instance no finds were recovered during the process. Interestingly, at the northern end of its alignment the feature begins to curve northeast. It is noted that originally the ditch feature is likely to have larger, the current truncated form of the ditch can

be attributed to later cultivation associated with the overlying relict subsoil layer (102). The thickness of this deposit ranged from between 0.30-40m across the area, equivalent to that recorded during the earlier evaluation and a single abraded sherd of medieval pottery was recovered from the deposit during the

excavation. The evidence would suggest that prior to its truncation the ditch would have probably originally measured in the region of about 2.1-20m wide and 0.70-80m deep.

Area 1, placed to the west of the development site, recorded a single linear ditch [113], the same C14 feature recorded during the evaluation. It was similarly observed within the surface of the natural clay substrate (103) although it is likely that the construction of the ditch was at the surface level of the earlier relict subsoil layer (102) representing the earliest occupation horizon, later truncation to the upper part of the feature is probably linked to subsequent cultivation associated with the subsoil when the ditch was abandoned. A single sherd of residual medieval pottery was recovered from this soil layer, but no further finds were recovered from the C14 ditch during sample excavation.

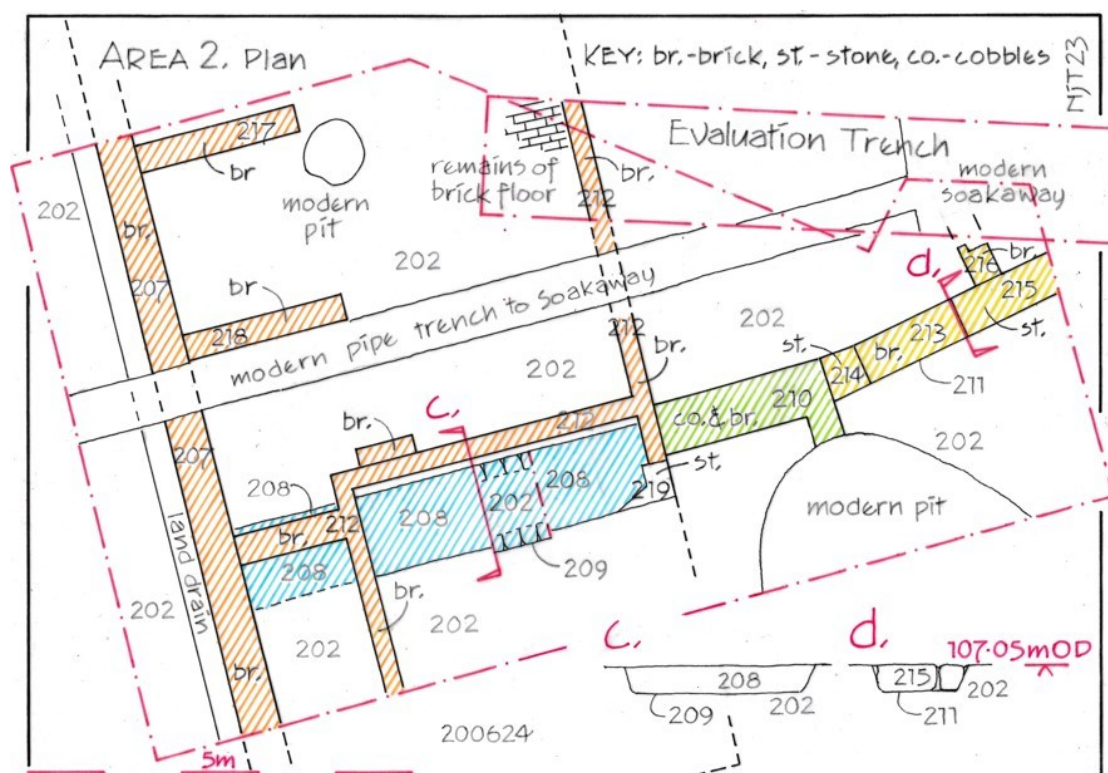
Fig. 6: Area 2, plan showing remains of earlier buildings and features uncovered in Evaluation Trench. Blue: Phase 1, green: Phase 2. Yellow: Phase 3, orange: Phase 4.

The surface of the natural substrate (202), consisting of a stiff red clay mottled throughout with light grey clay and containing a component of occasional small stones, was recorded at a roughly level height of about 107.25m AOD throughout the area. The earliest remains recorded within the surface of this clay comprised a series foundation deposits connected with a former structure aligned east-west.

The form of these deposits and their relationships with one another, suggests the structure developed though at least three phases of construction, the earliest of these consisted of the deposit (208) and its associated trench (219), surviving for a length about 5.50m, albeit truncated at various points and to varying degrees along its length. Sample excavation through an undisturbed area of this deposit revealed a shallow flat-bottomed trench [209], 1.15m wide and about 0.15m deep filled mostly along its length by compacted pebbles and fragments of brick of various sizes within a silty-clay matrix. A deposit of masonry and half bricks (219) was recorded in the southeast corner of this feature.

Seemingly abutting the east end of (208) and slightly offset to the north, was the deposit (210) which appears to represent a second phase later phase of construction, although the relationship between the two deposits is lost through the later intrusion caused by the construction of brick wall (207) which is associated with east side of the former C19 barn. The west end of deposit (208) was also truncated by the west wall of the C19 barn, there was no evidence within the section at the west end of Area 1 to indicate that deposit (208) continued westwards beyond the edge of the excavation.

The foundation deposit (210) continues eastwards from (208) for about 2.25m, at the east end there is what appears to be cornered feature, with a slightly narrower foundation deposit continuing southwards, perpendicular to (208) for about 0.45m with a width of about 0.40m. The southern end of this feature was subsequently truncated by a large modern pit. Sample excavation

A third phase of construction consisting seemingly of another extension of the structure eastwards for at least 3.50m, albeit on a slightly more northeasterly direction, is represented by a sequence of intermittent deposits consisting of masonry (214), (215) and brick (213) filling a narrower, shallower and slightly more rounded bottomed trench [211], 0.55m wide and about 0.15m deep. Another short length of brick walling (216) aligned north-south adjoining the north side of (215) suggests perhaps some later accretion or internal subdivision, this feature was also truncated by a modern trench connecting with the large drainage soak-away recorded in the evaluation. The earlier results from the adjacent evaluation trench suggest deposit (215) terminates between Area 2 and the position of the former trench.

A fourth phase of development in Area 2 is represented by the former north-south aligned large barn shown on the OS 1885. This is comprised of a series of brick walls, the thicker wall (207) representing the west side of the former barn, the eastern side and some of the internal partitioning marked by a

slightly narrower brick wall (212). Walls (217) and (218) appear to be associated with some of the former internal bays/stalls.

The excavation in Area 2 revealed four phases of development related to previous occupation within this part of the site. The earliest phases were associated with the foundations remains (208), (219), (210), (213), (214), (215) and (216) of a former structure aligned east-west, perhaps an earlier barn or outbuilding built with a combination of masonry and brick. The form of these deposits and their relationships with one another suggests three phase of development beginning with (208) and (209) continuing eastwards in order of construction, although no dateable finds were recovered from these deposits, the frequent presence of brick fragments within them points to a post-medieval construction date, possibly C18 or early C19.

Truncating these earlier foundation deposits were the walled remains (207), (212), (217) and (218) representing the former barn shown on the OS 1885 map, its north-south alignment appears to show a re-configuration of the site layout during the period of construction.

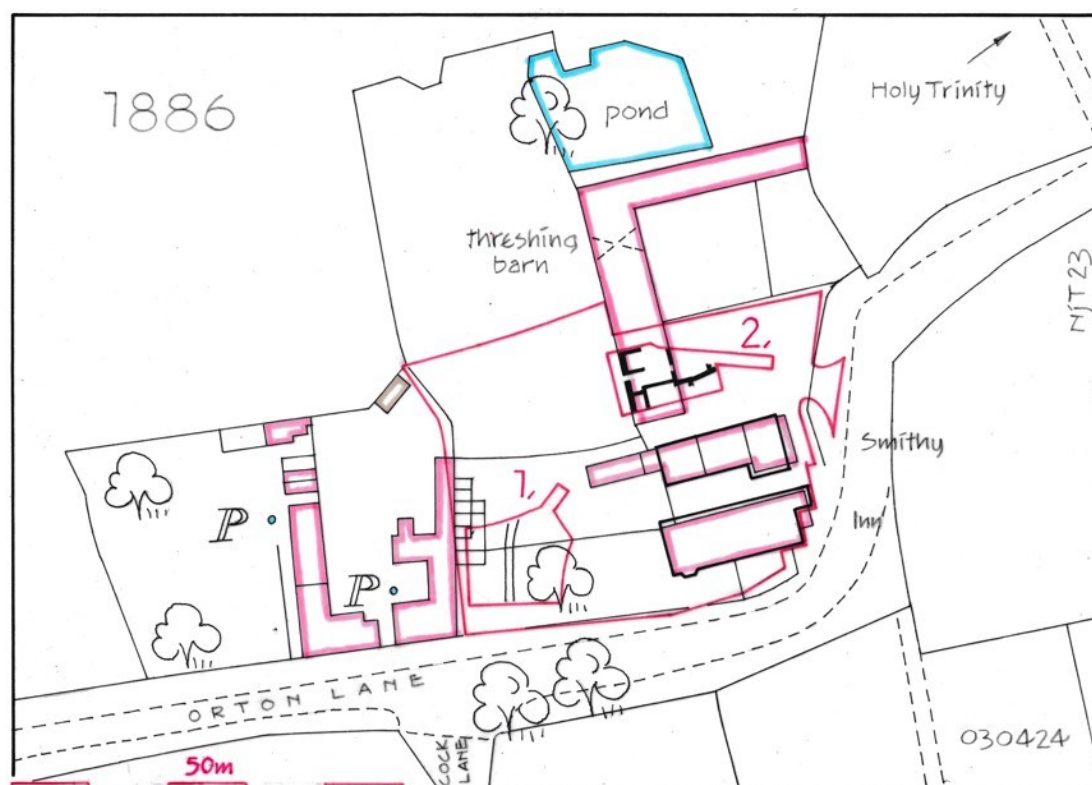
Fig. 7: Site plan with Areas 1 and 2 shown in red and the 1886 setting.

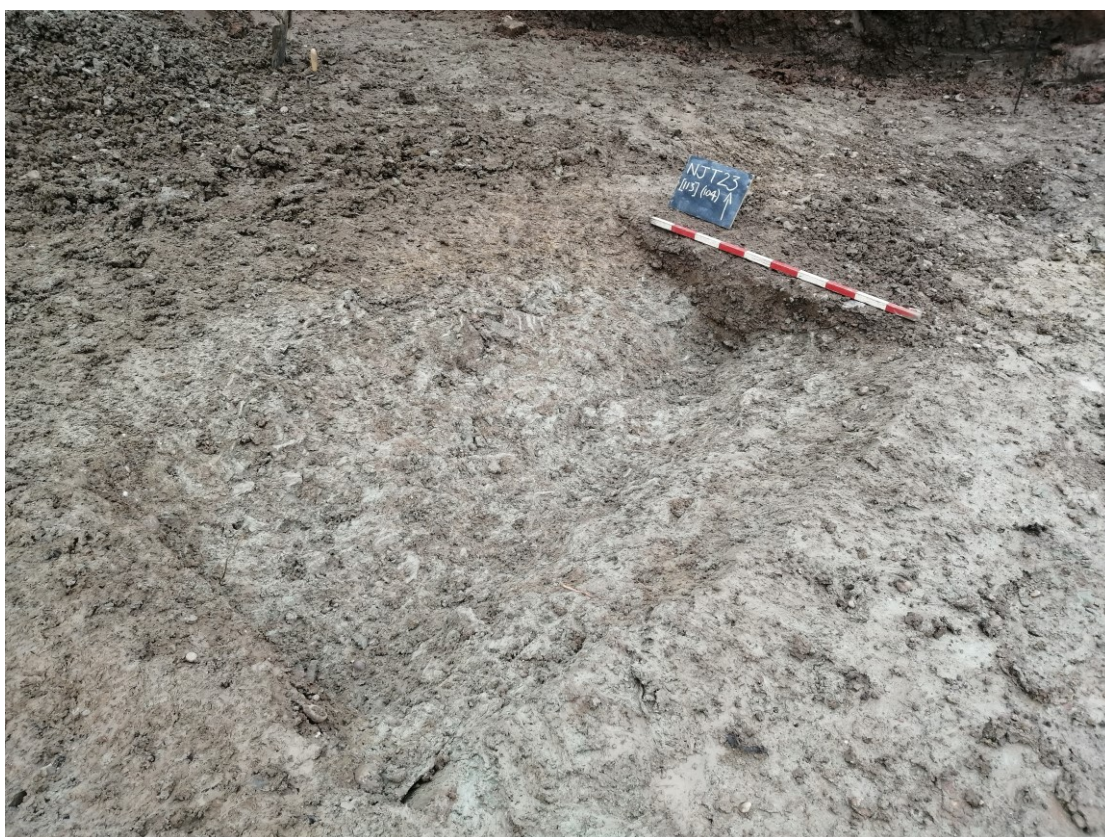
*Plate 4; Ditch 113, view northwest.*

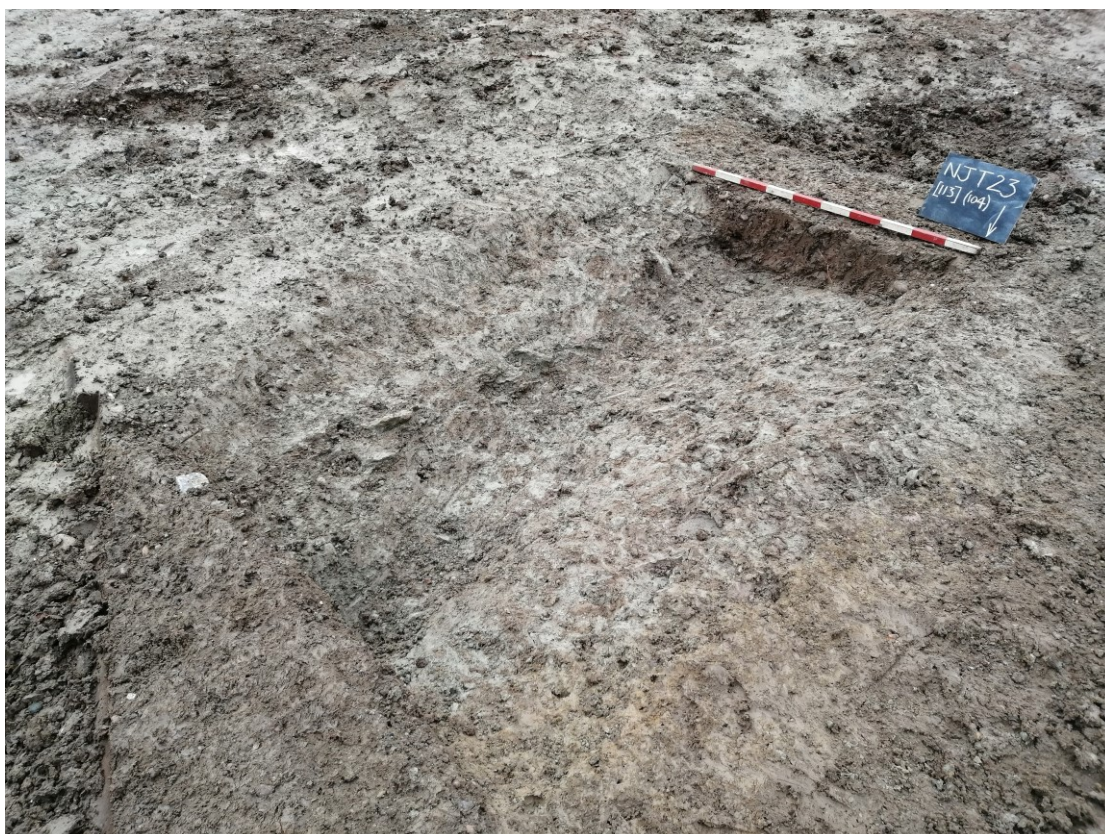
*Plate 5; Ditch 113, view southeast.*

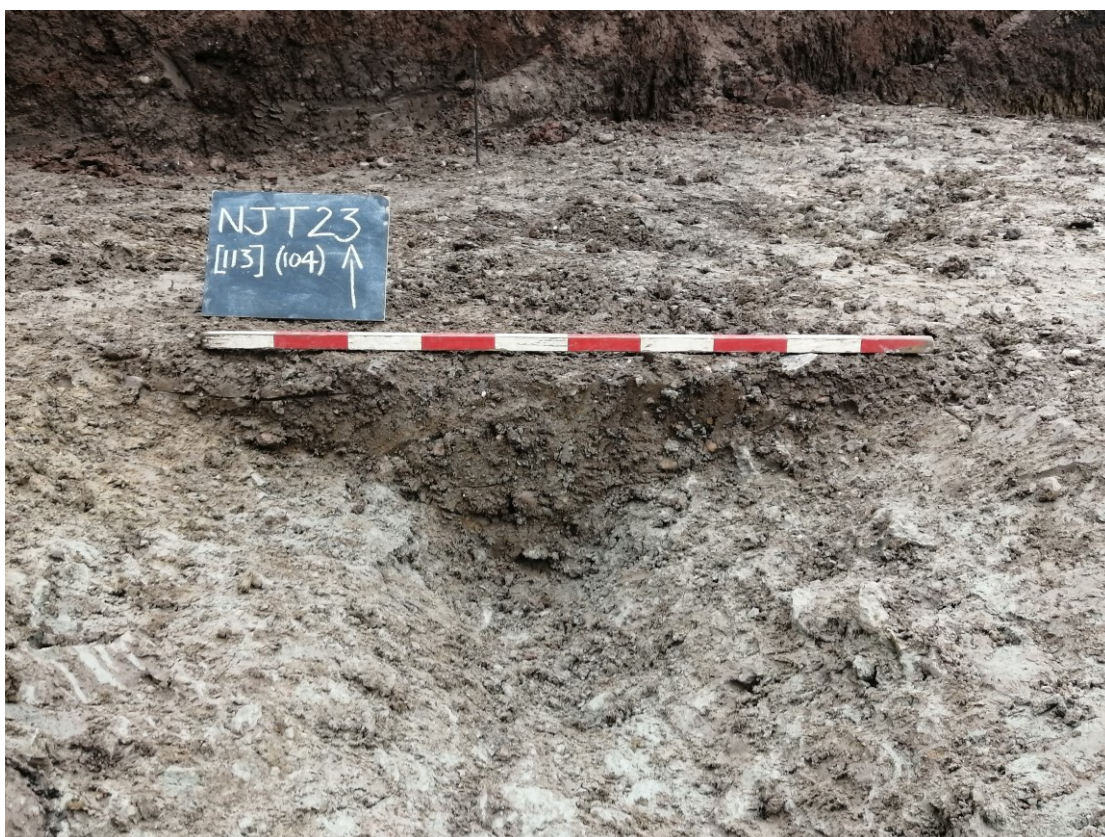
*Plate 6; section 1f.*

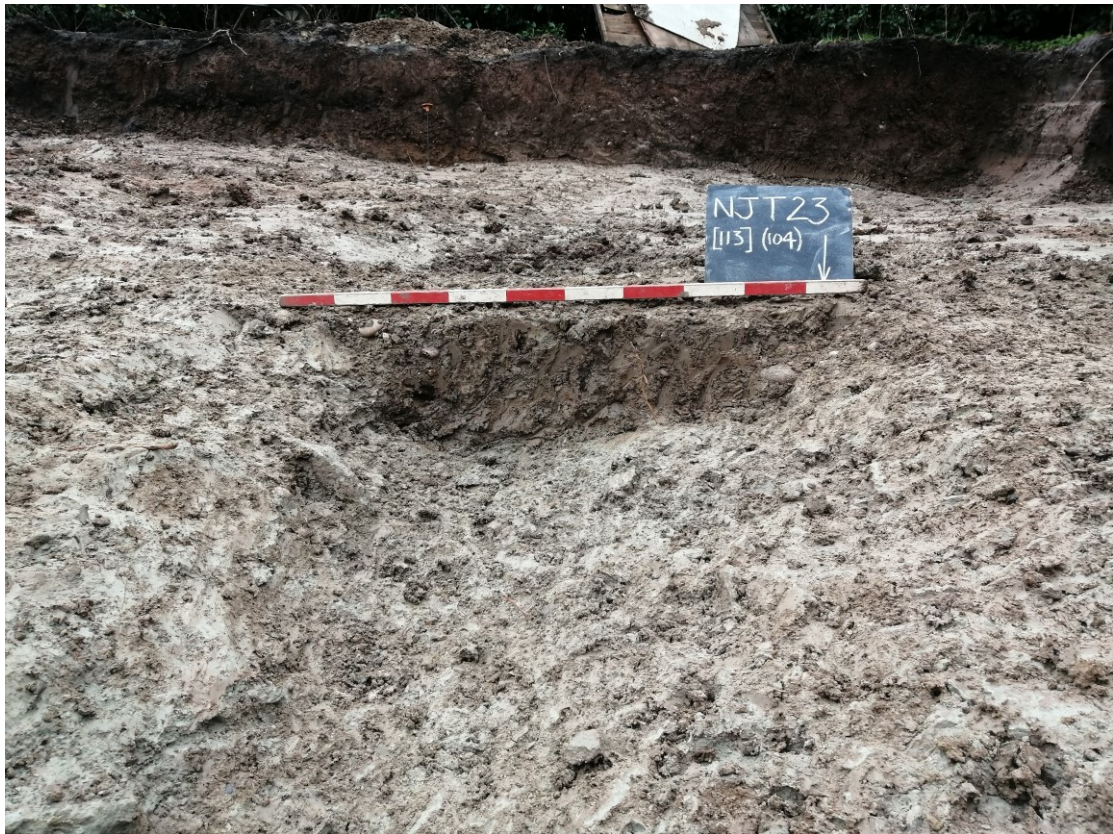
*Plate 7; section 1g.*

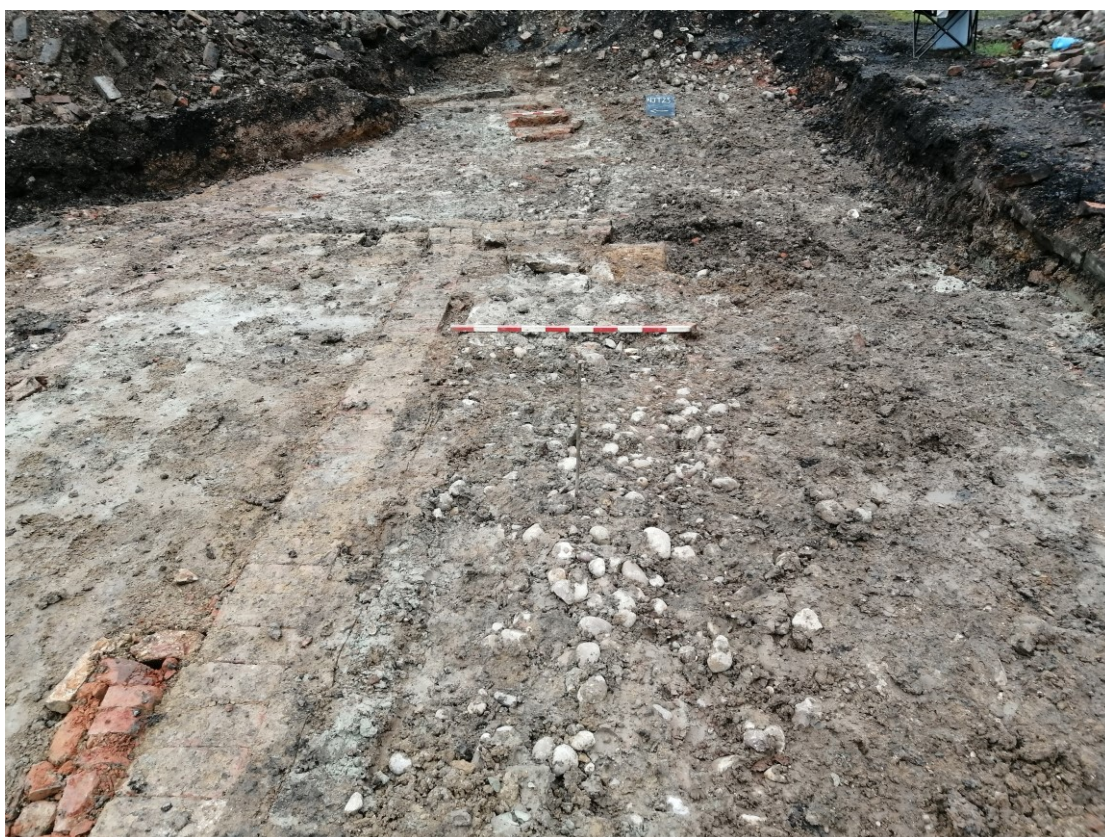
*Plate 12; deposits 208, 210 & 211, view east.*

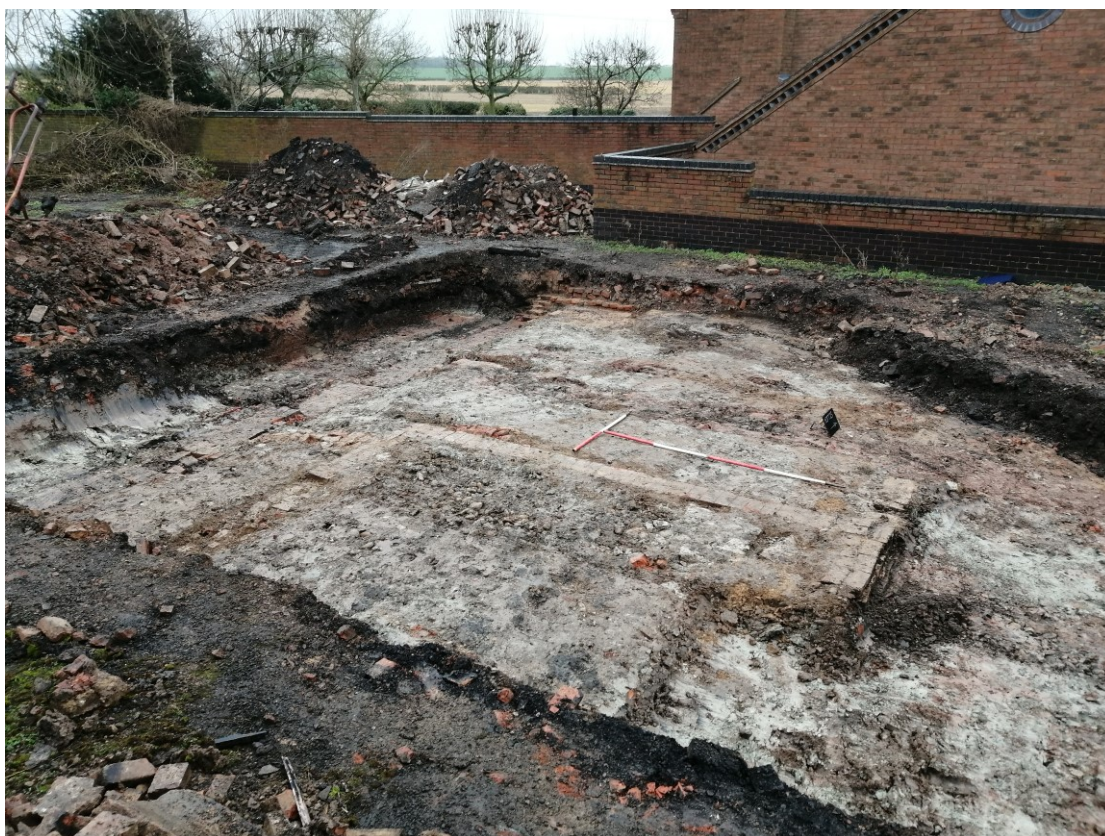
*Plate 13; Deposit 208, view northwest.*

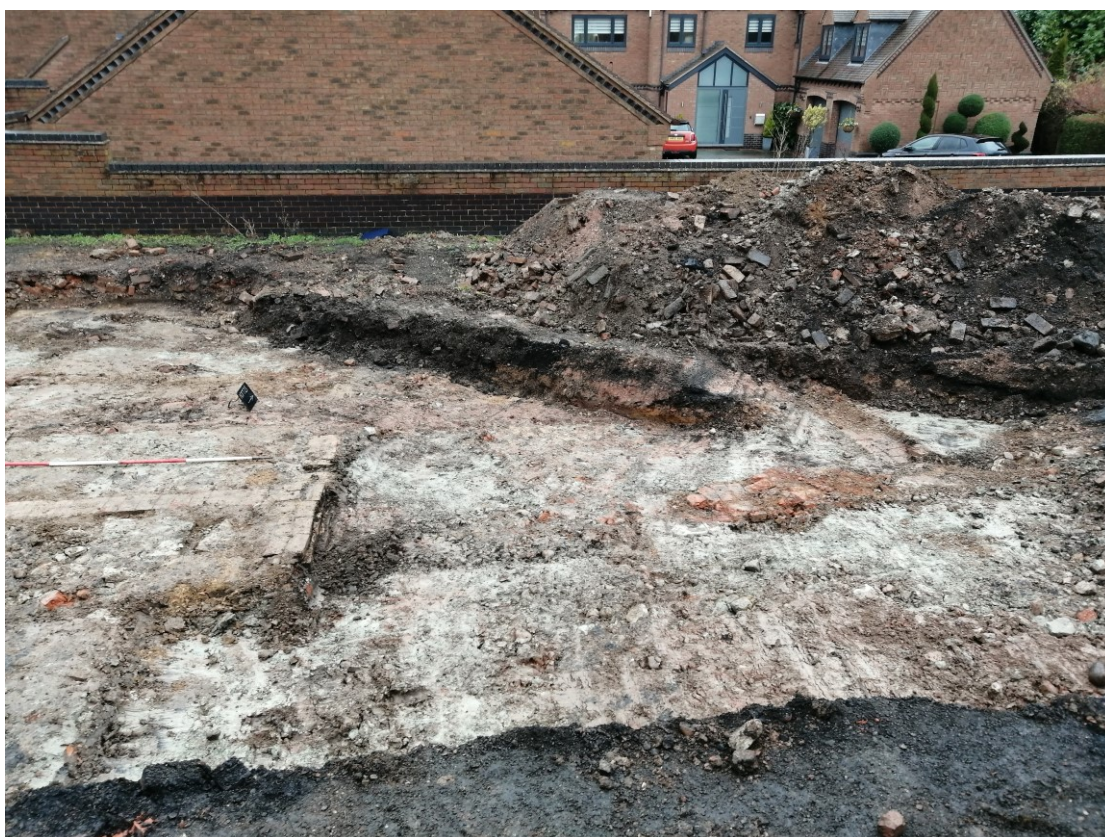
*Plate 14; Deposits 210 & 211, view north.*

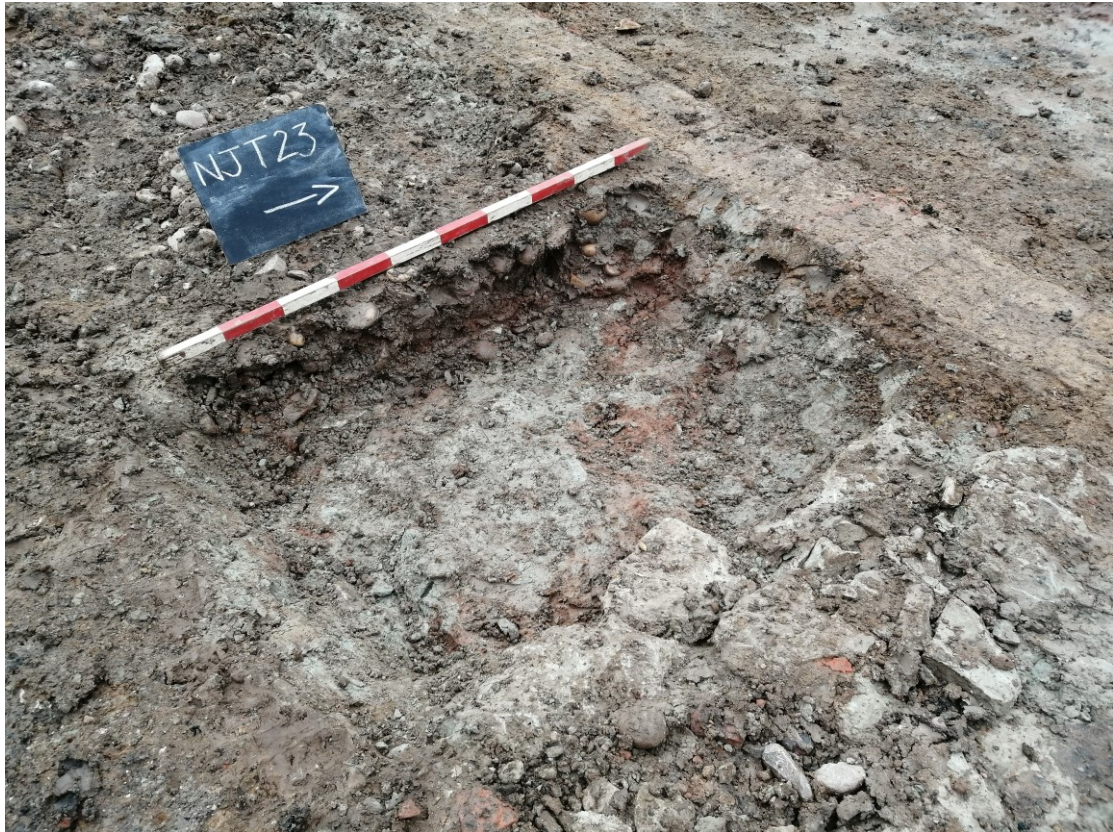
*Plate 15; foundation trench 209 & fill deposit 208, view northwest.*

| <i>Context</i> | <i>classification</i> | <i>Description</i> | <i>Date</i> |
|---|---|---|---|
| 209 | Foundation | 1.10m wide, 0.15m deep. Profile is a flat base, steep sides. | Post- |

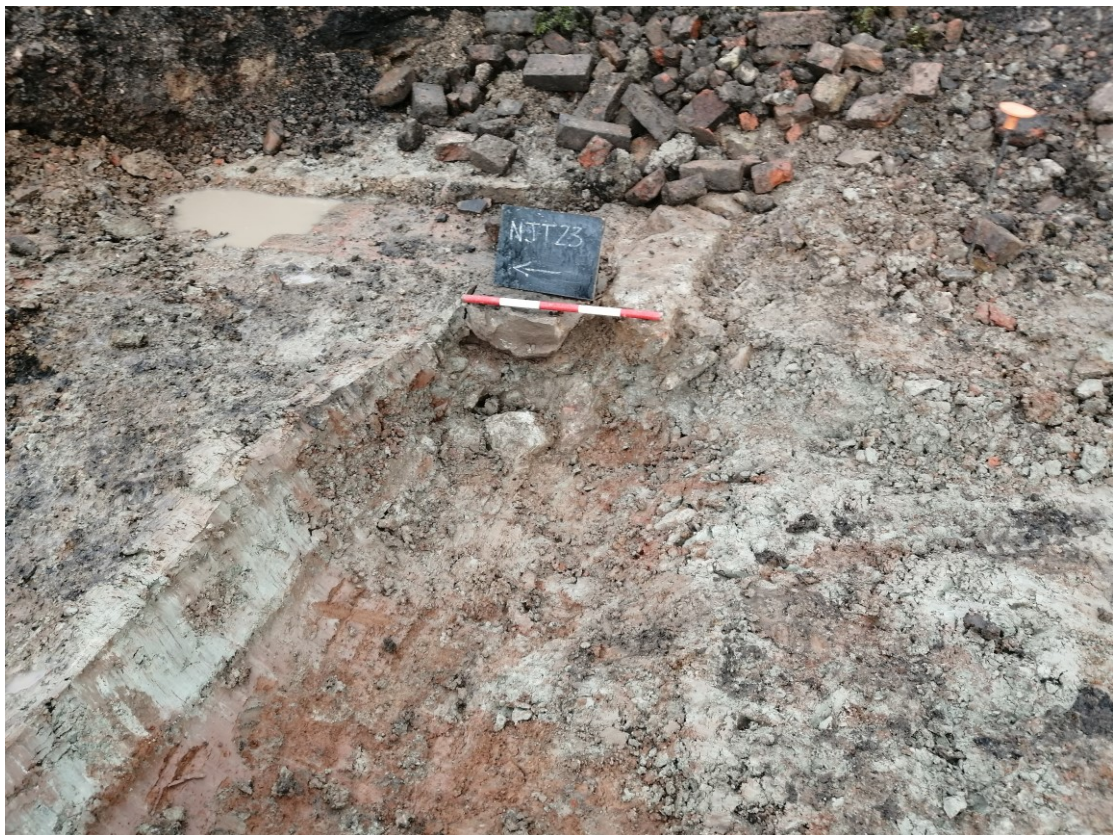
*Plate 16; Deposit 210, section 2d, view northwest.*

| 210 | Foundation deposit | Mostly compacted large and small pebbles within a soil matrix.<br>Some fragments of brick within the deposit | Post-medieval |

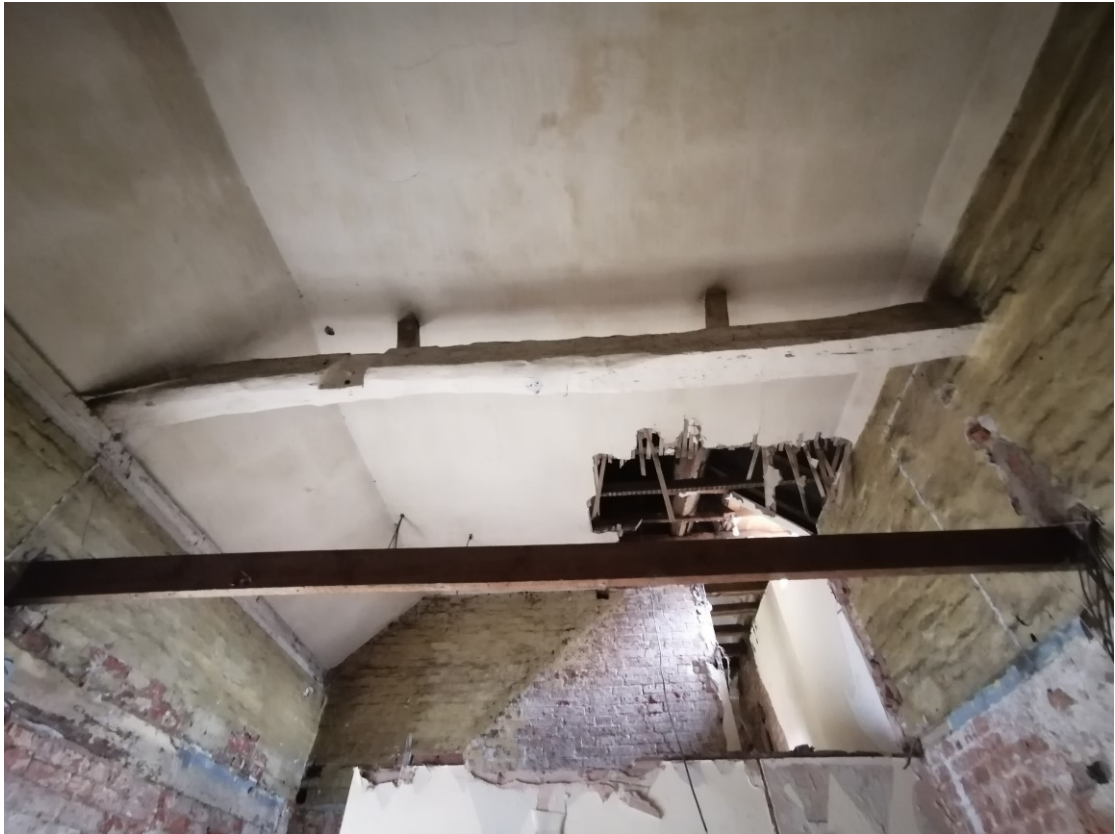
*Plate 17; east wing of the former Moore's Arms showing possible re-used cruck.*

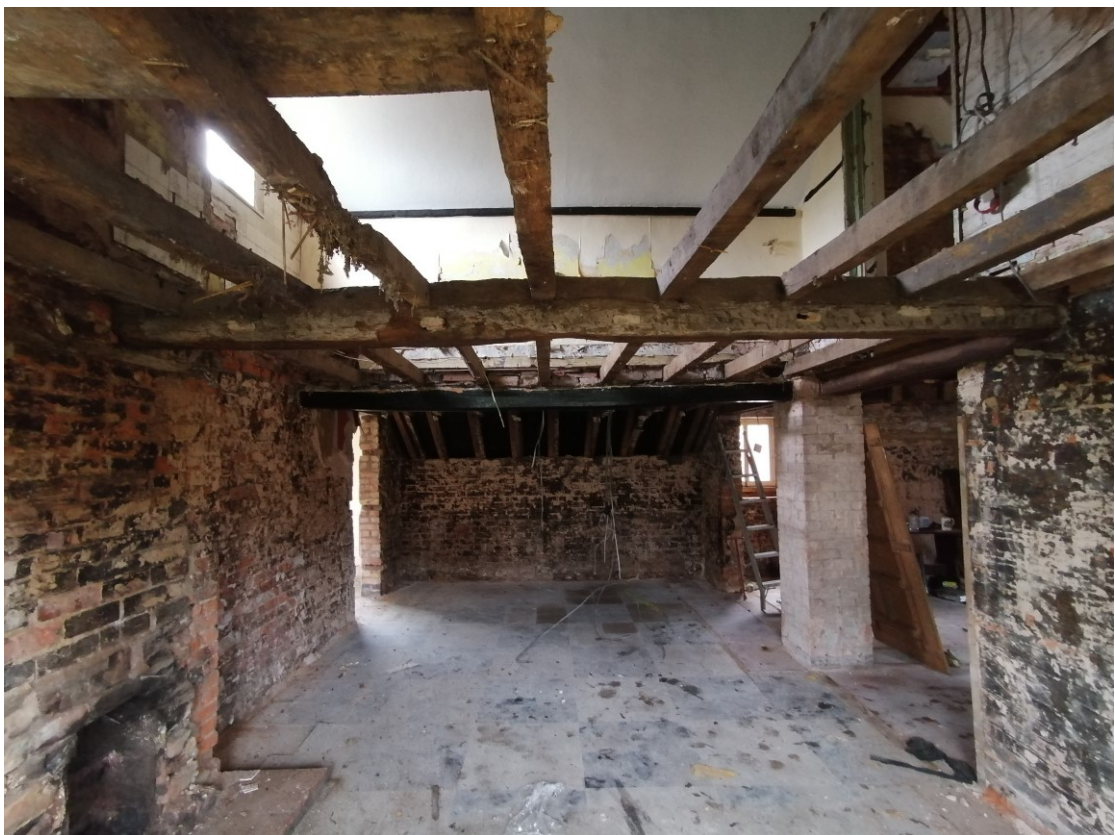
*Plate 18; west-wing of former Moore's Arms showing re-used C17 wall-frame beam with mortices for square-panel framing.*
