## A REMEDIATION VERIFICATION REPORT FOR PHASE 1 PROJECT DESFORD

**TE1270-TE-00-XX-GE-RP-003-V01**

**05 JANUARY 2023**

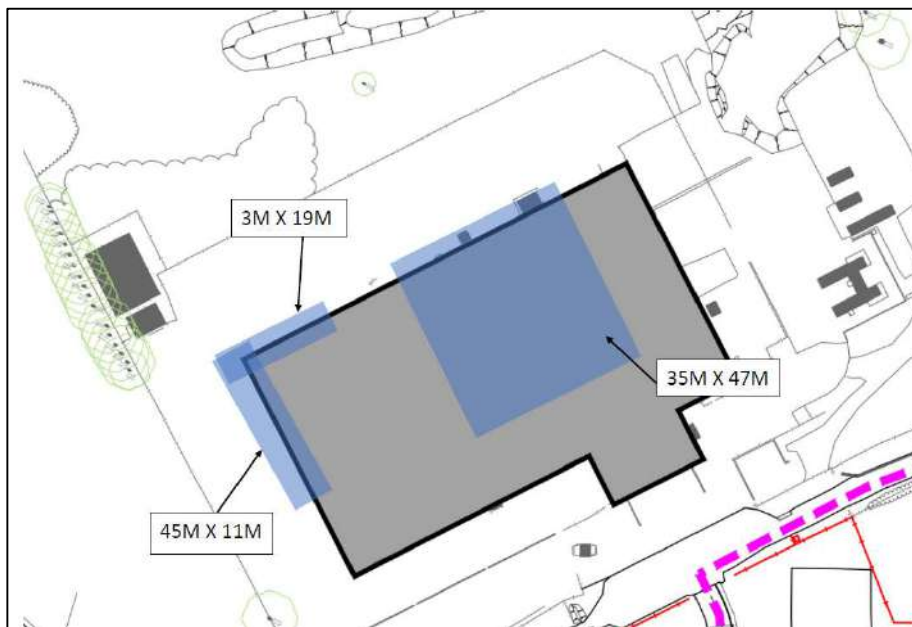
During demolition of Building 1, within the centre of the site, contractors encountered possible asbestos containing materials (ACMs) under the footprint, as shown on the drawing below. Following confirmatory testing by Tier Environmental, a letter was produced dated March 2022 (Ref: TE1270-TE-00-XX-CO-GE-002-V01) in order to notify the Council of the discovery and proposed mitigation for the impacted area (in accordance with Condition 13a of Planning Permission 20/00619/FUL, a resubmission of 20/01009/FUL).

Figure 4-1 Location of ACMs under Building 1 footprint

A second letter was submitted to the Local Authority which demonstrated the successful verification of removed asbestos cement from the area (Ref: TE1270-TE-00-XX-CO-GE-003-V01, dated May 2022). This has been summarised below:

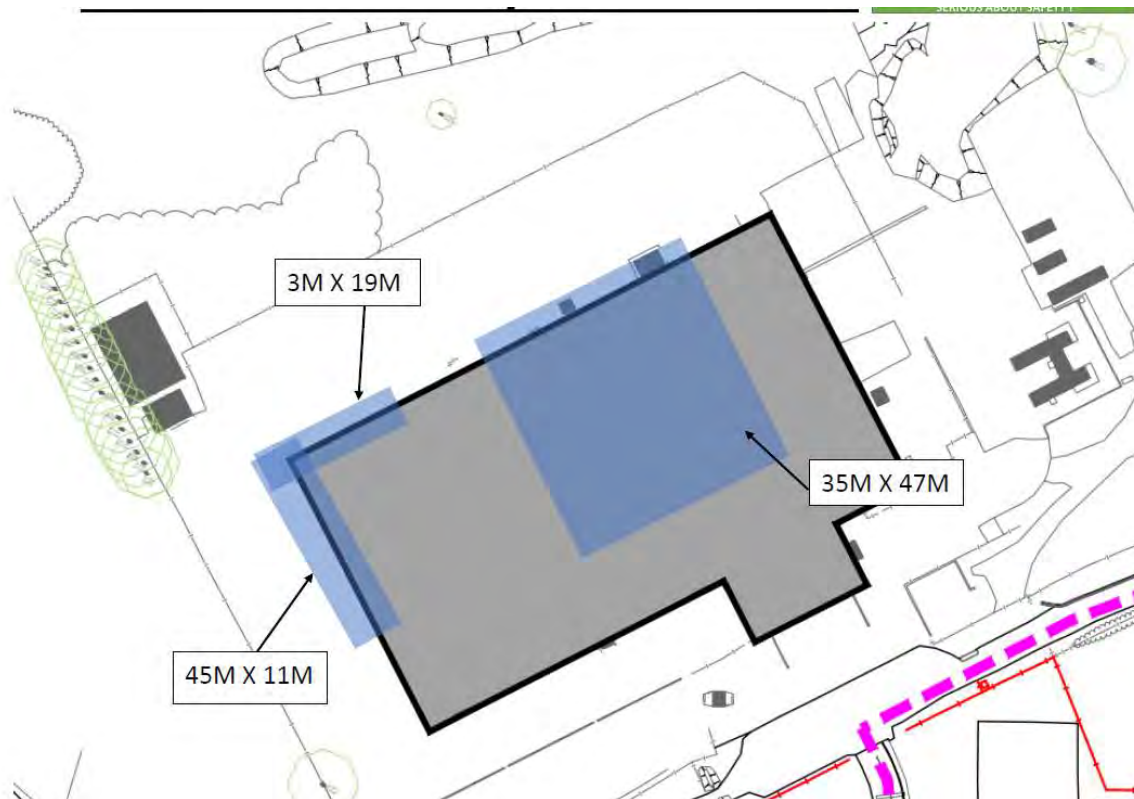
Results confirmed the presence of ACMs in the form of chrysotile asbestos cement. A representative sample of the soils from the impacted area waws returned negative for asbestos, indicating an absence of low level asbestos in the form of loose fibres/fibre bundles. Initial observations have not suggested the presence of either any bonding to the slab or presence within the soil matrix.

**Figure 1 – Approximate Locations of ACMs under building footprint**

It is considered that the identification of ACMs represents a potential source of contamination at the Site.

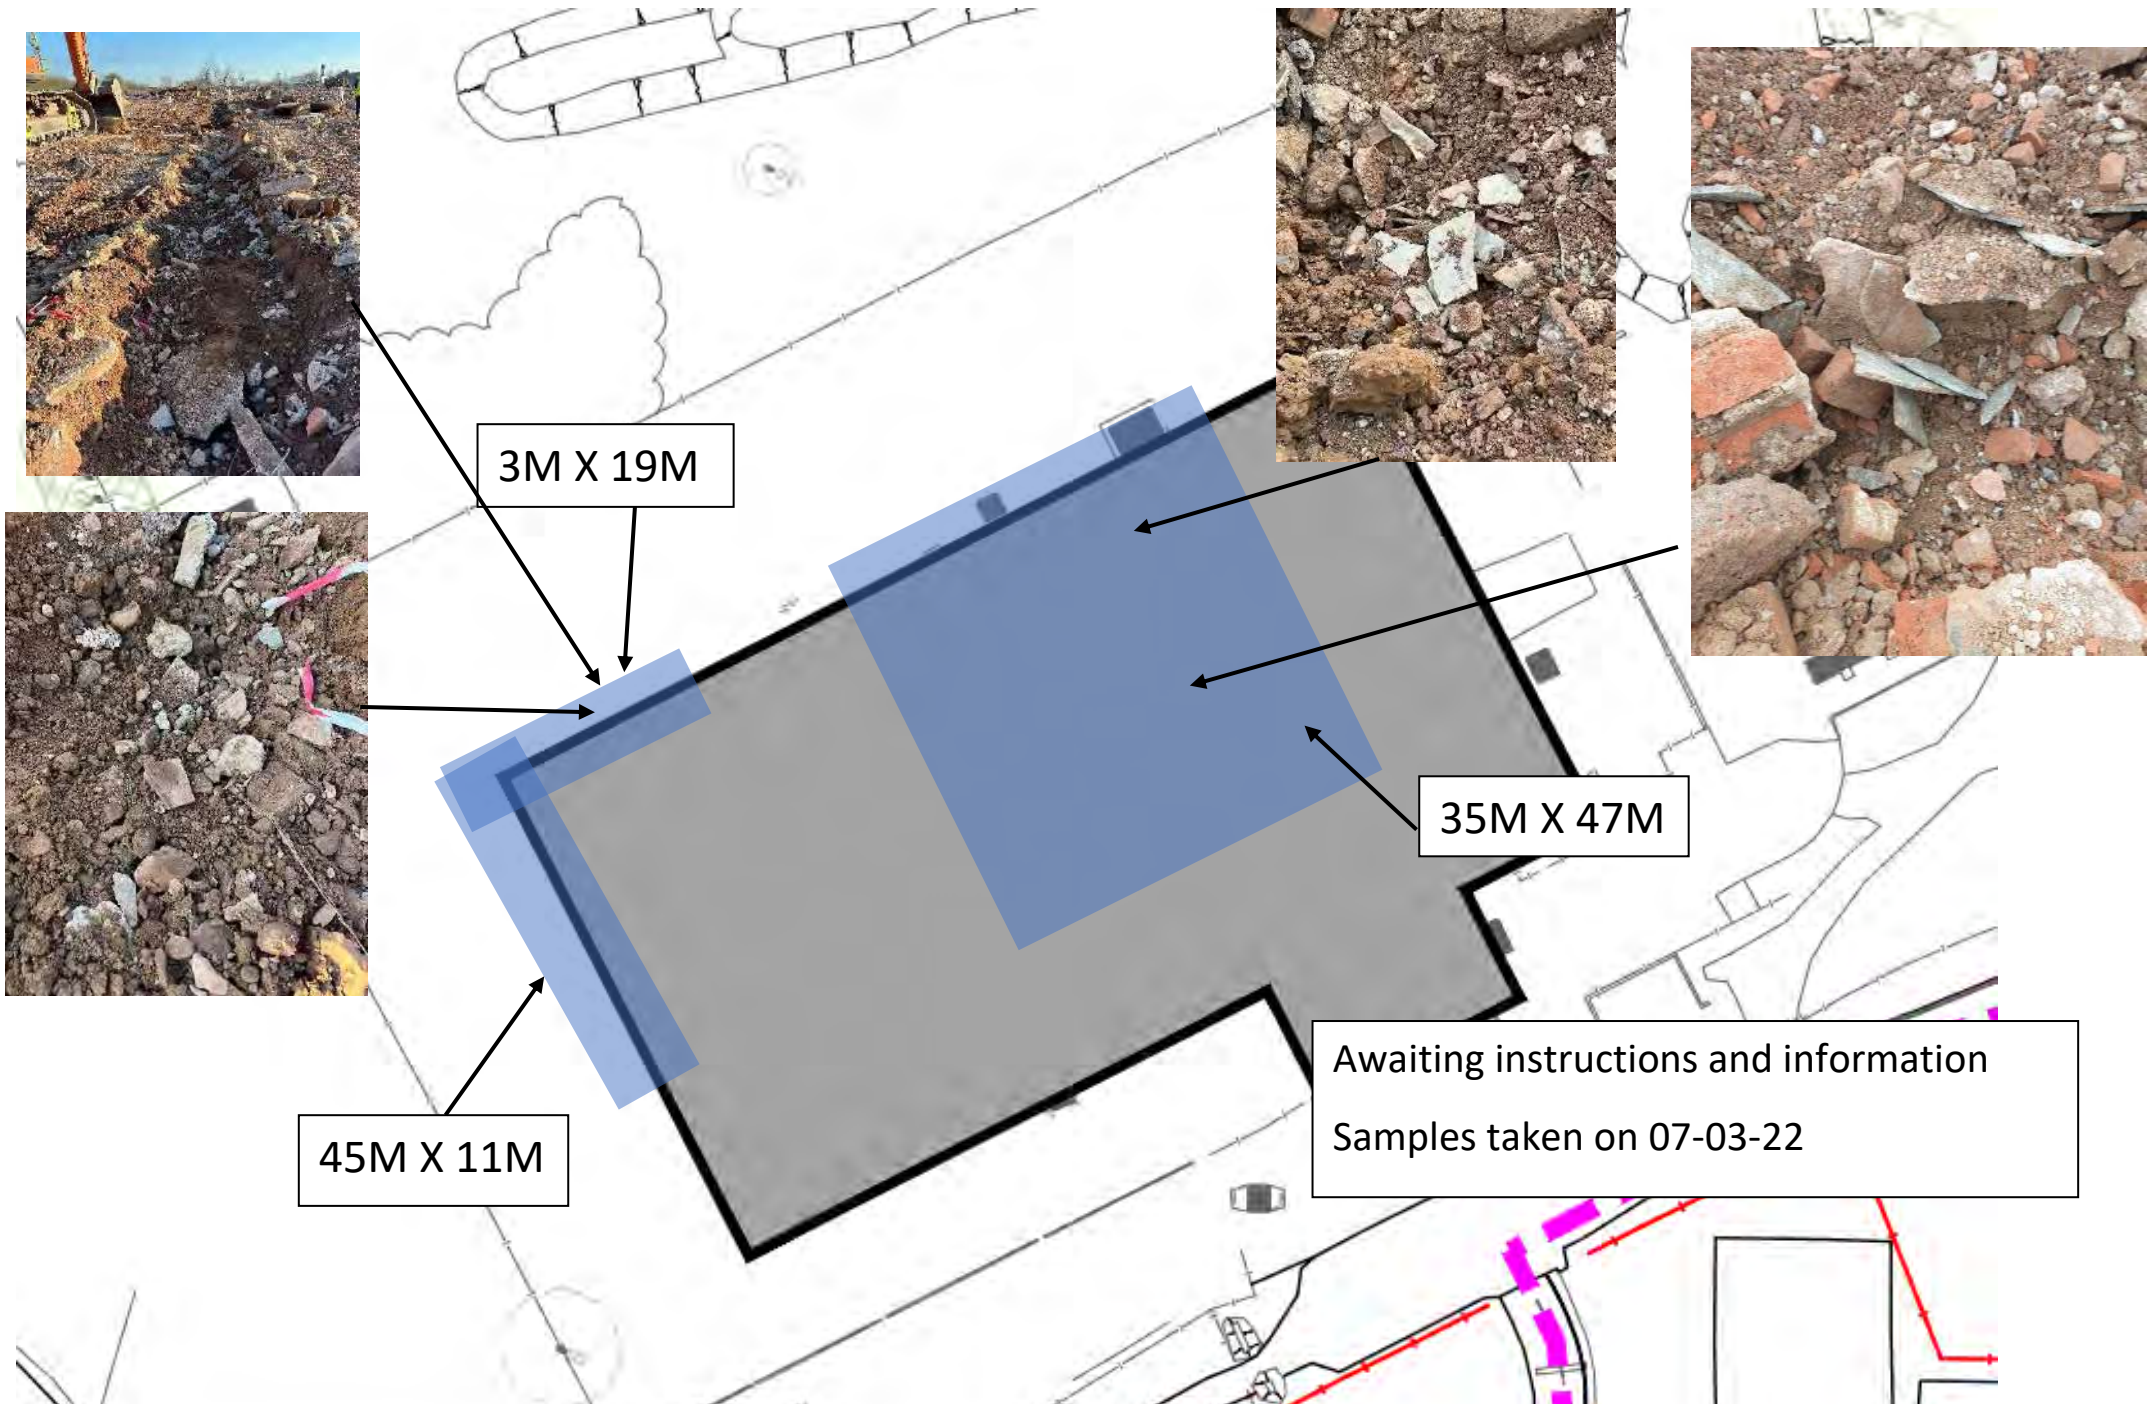
# Asbestos Under slab – Project Desford 14-03-22

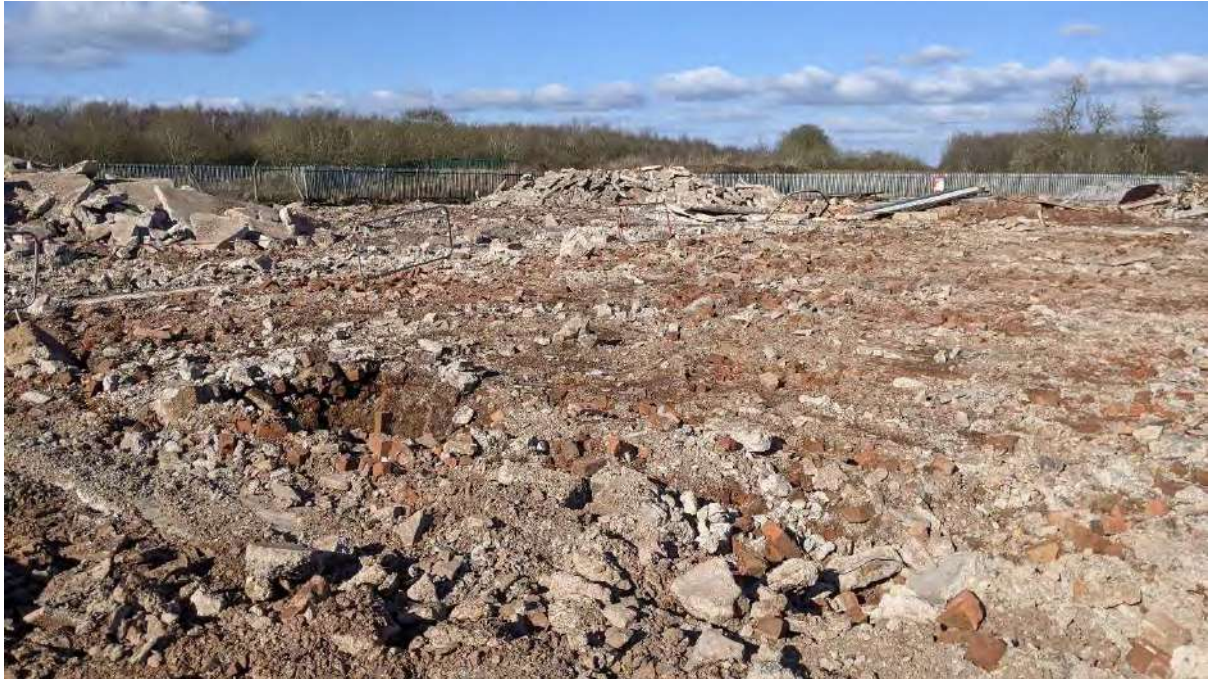
Photo 1 – Impacted Area looking north

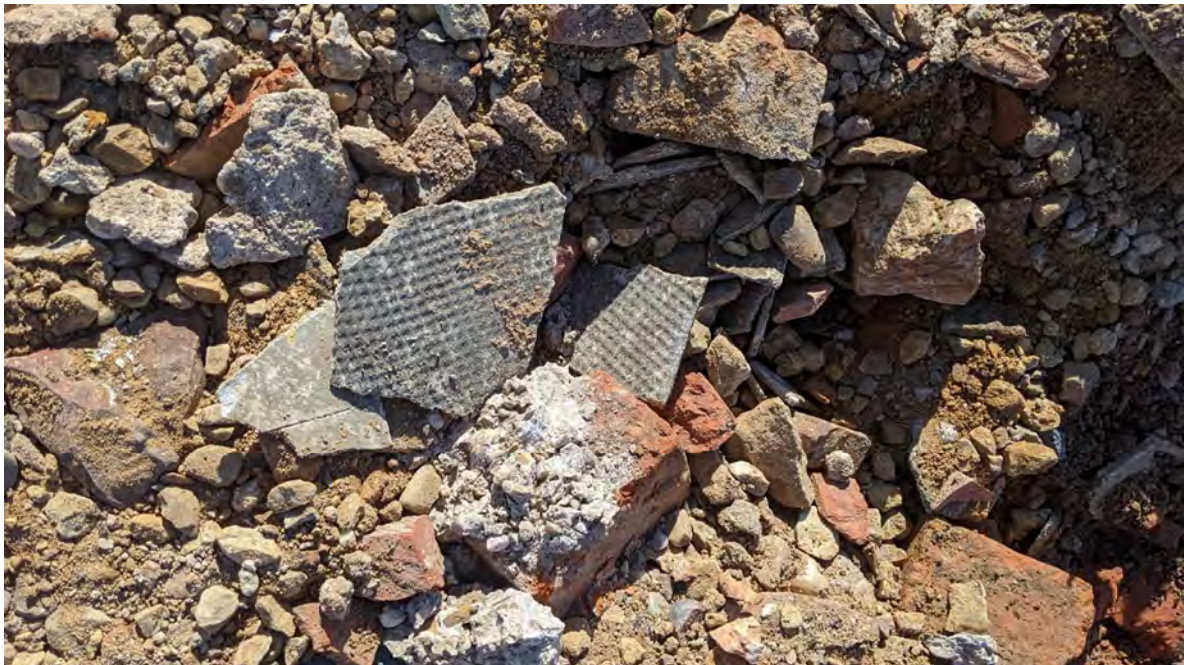
Photo 2 – ACMs

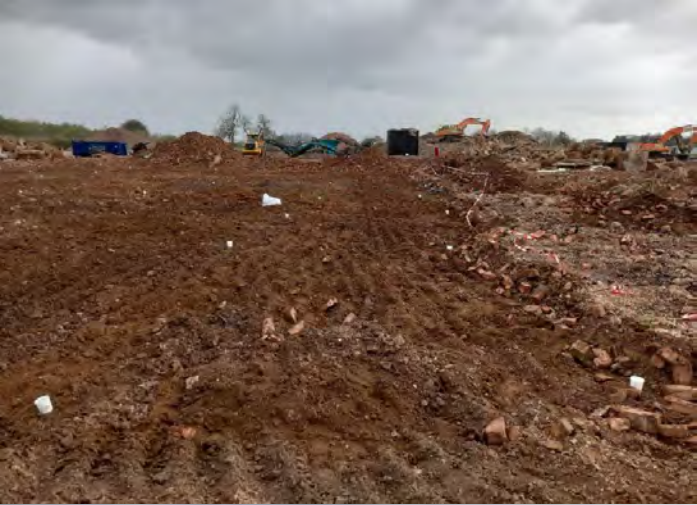
| | | | View looking<br>Northeast |
| | | | Samples<br>VRS1 to VRS6 |

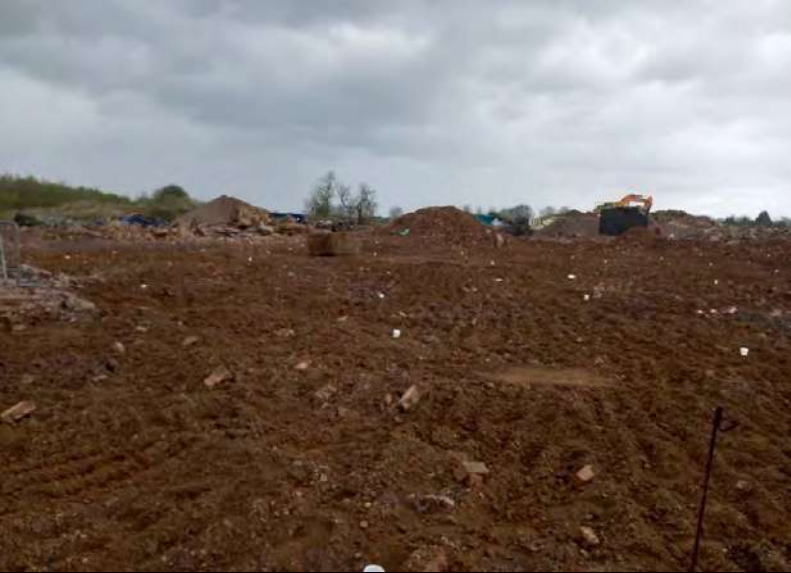
| | | | View looking<br>Northeast |
| | | | Samples<br>VRS12 - VRS17 |

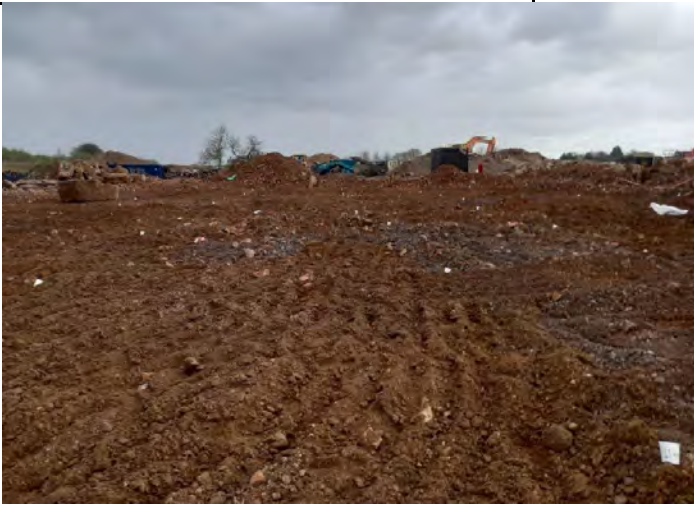
| | View looking<br>Northeast | | |
| | Samples<br>VRS10 - VRS16 | | |

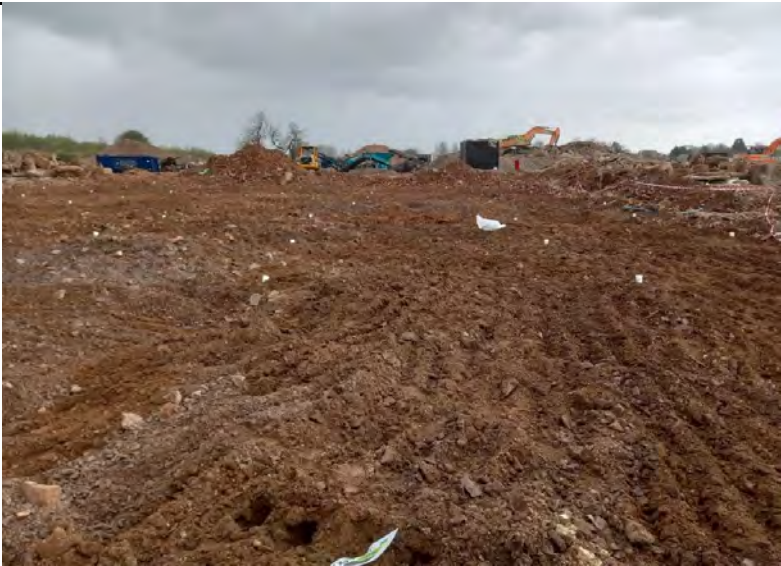
| | View looking<br>Northeast | | |
| | Samples<br>VRS6 - VRS11 | | |

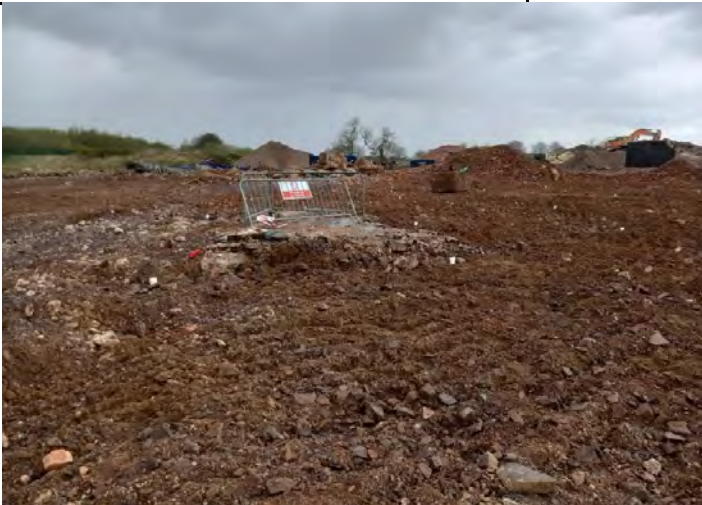
| | | | View looking<br>North<br>Samples<br>VRS18 - VRS20 |

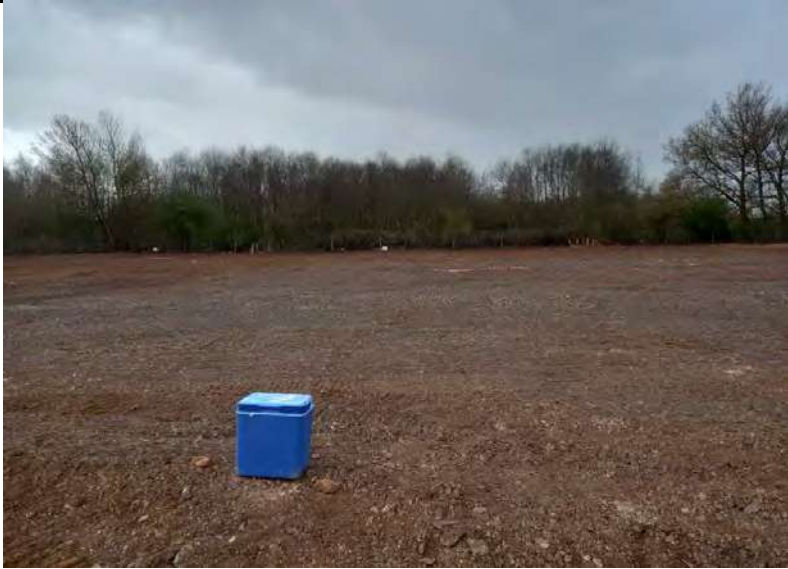
| | | | View looking<br>Soyuthwest<br>Samples<br>VRS21 - VRS28 |

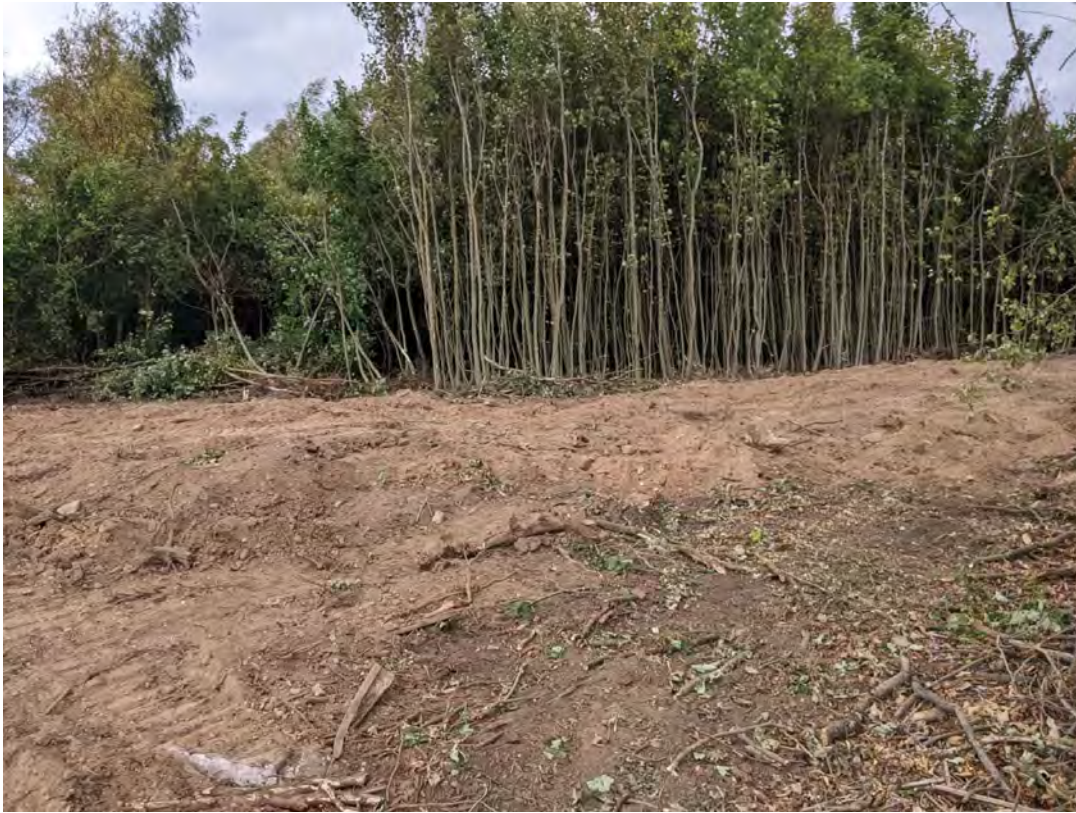
Photo 1: Former Badger Sett area looking north east

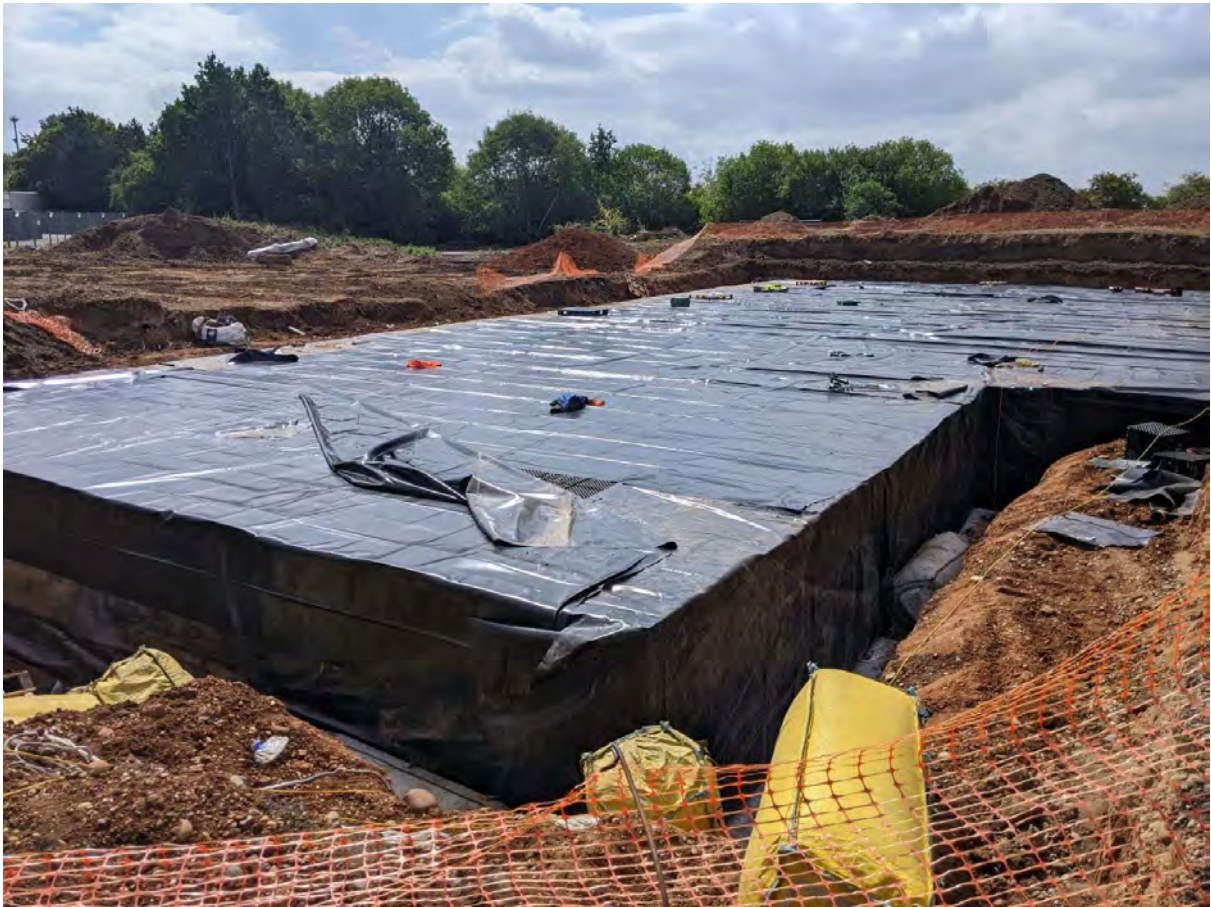
Photo 3: SW Attenuation tank area (south west of former badger sett)

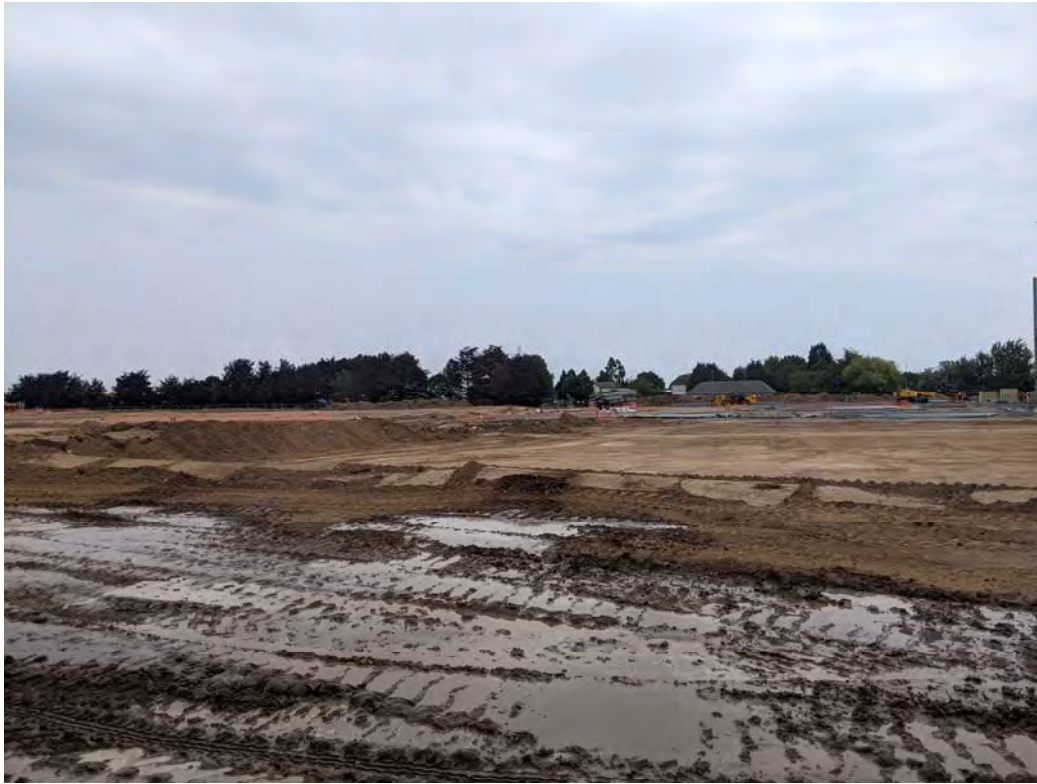
Photo 1: Initial strip of Phase 1 complete

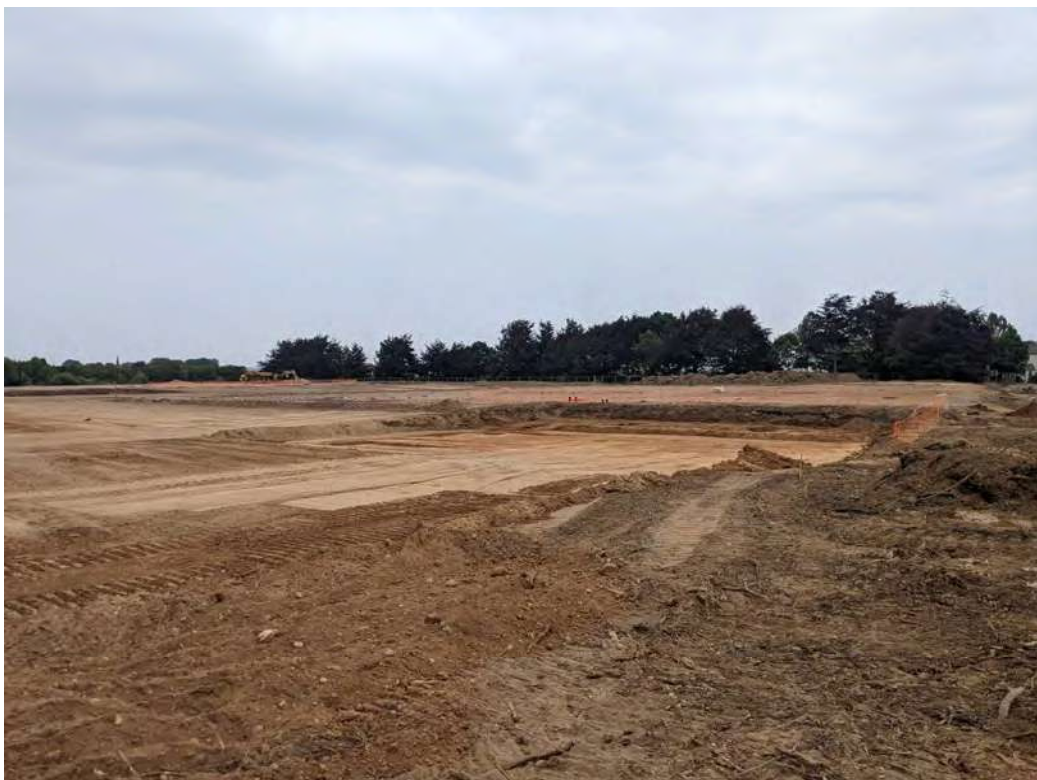
Photo 2: Strip and localised redistribution of materials across Unit 2 of Phase 1

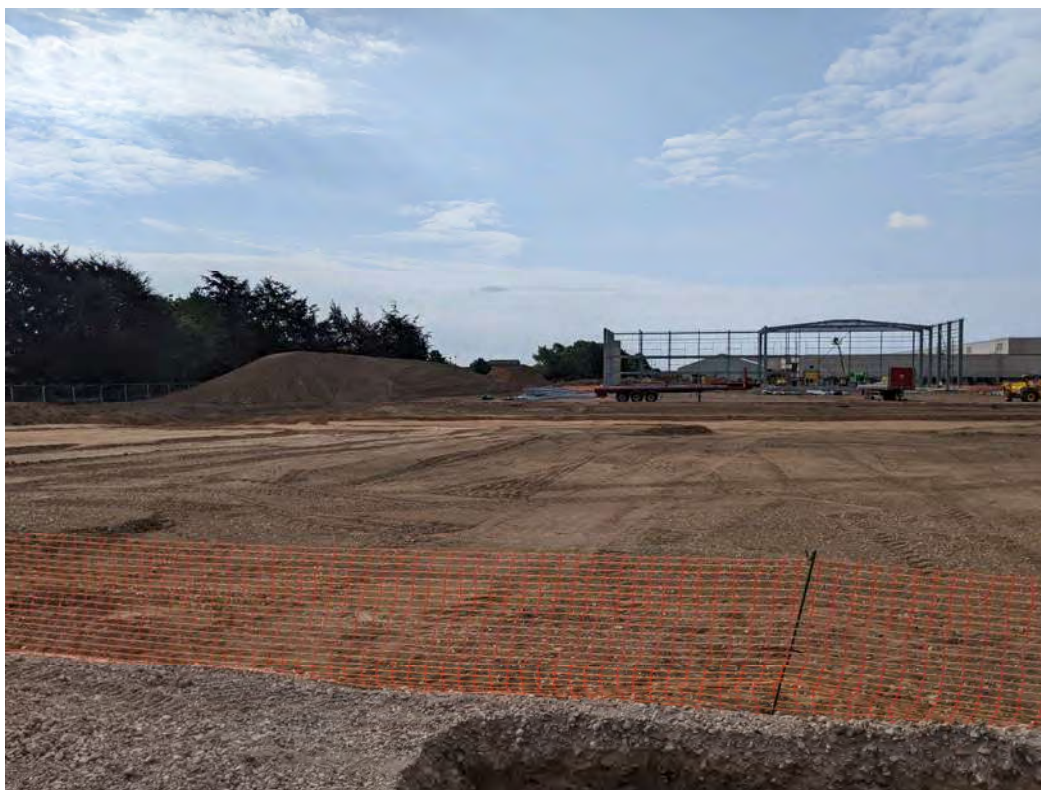
Photo 3: View looking south to Unit 1 showing levels built up for hardstanding of Unit 2

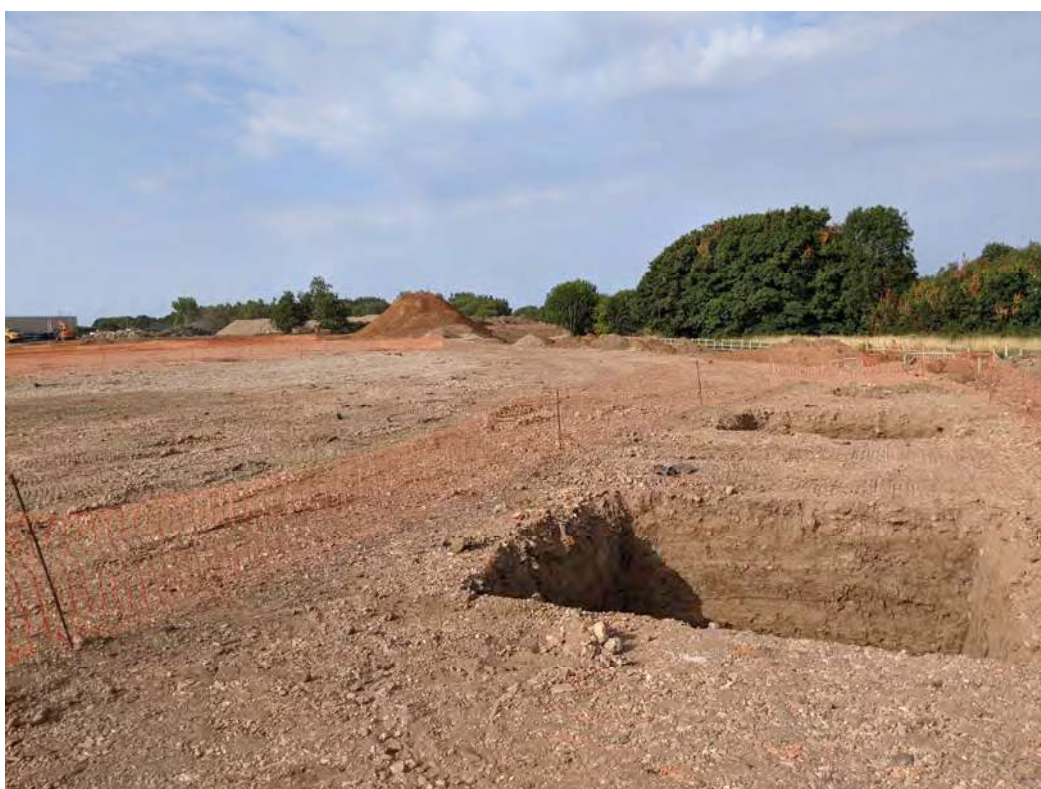
PAH impacted soils were identified in a localised area of the centre and east of the site during the initial ground investigation at TP116 at 0.55m bgl. The remediation strategy took into consideration the possible disturbance of these soils during earthworks and ultimately recommended impacted soils in this area should be retained in-situ beneath the building footprint or hardstanding.

Photo 4: Unit 2 pad foundation excavations to the north of the PAH impacted soils

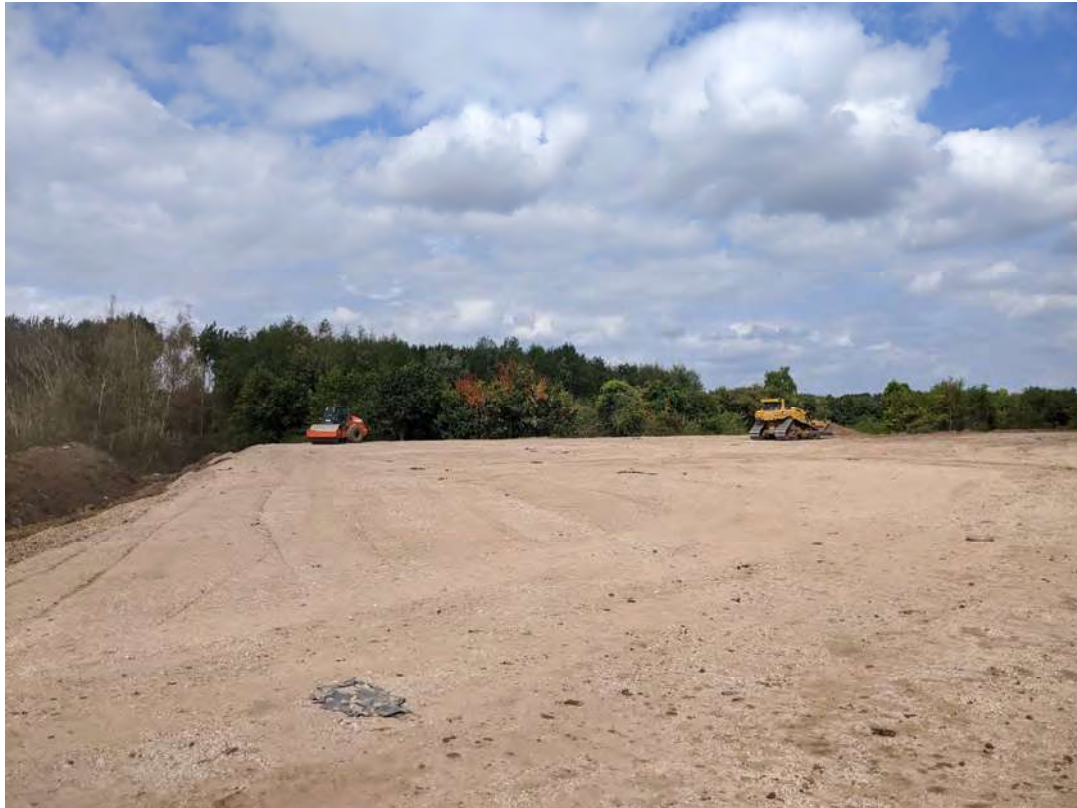
Photo 5: Further build up of Unit 2 levels achieved
