# **Preliminary Risk Assessment**

MIRA, Land South of A5, Nuneaton

February 2022

**Waterman Infrastructure & Environment Ltd**

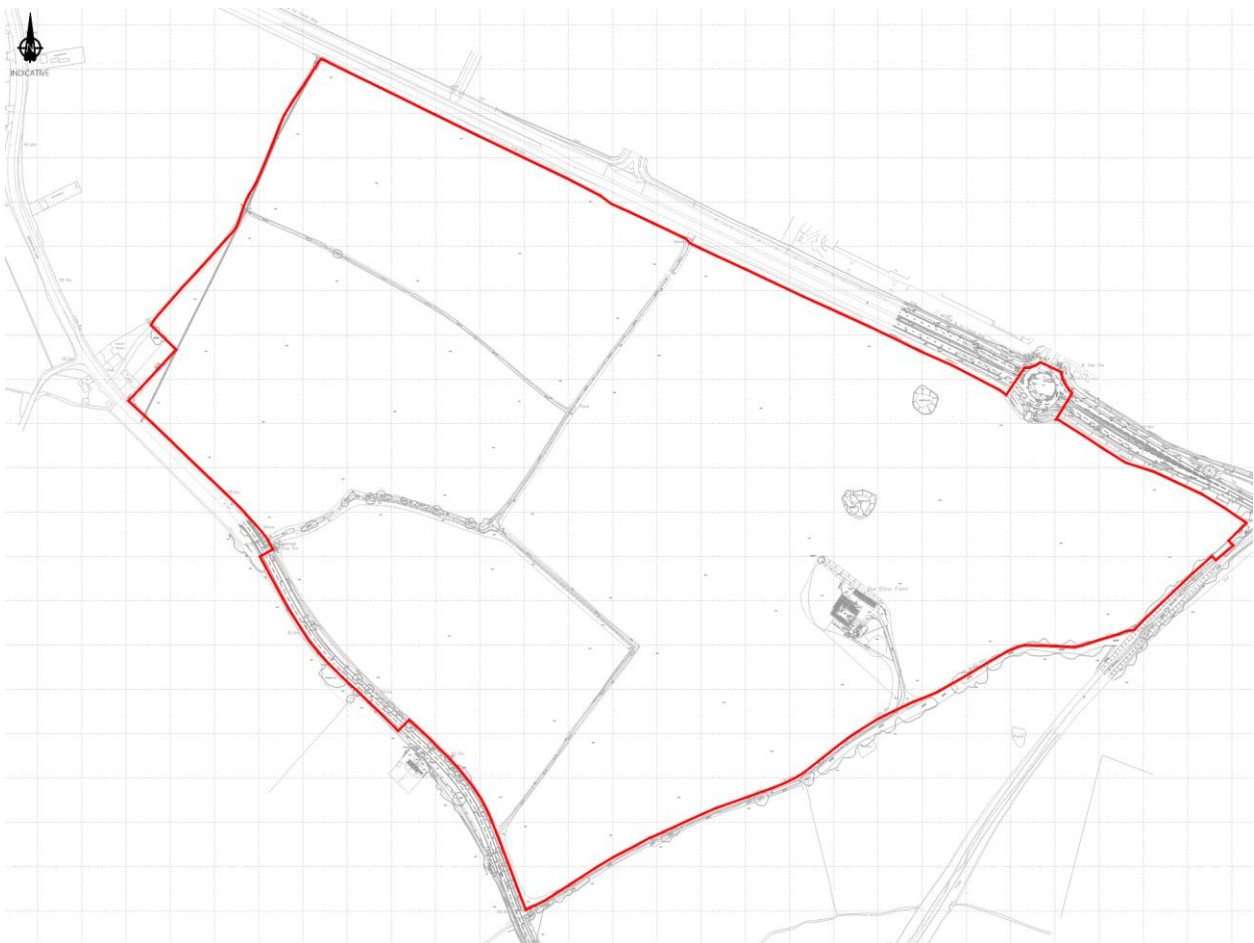
Figure 1: Current Site Plan

The Site comprises four fields, with three smaller fields to the east and larger field to the west. All fields are in agricultural use and separated by hedgerows. A series of farm buildings are in the centre of the eastern field, accessed via a farm track at the eastern Site boundary.

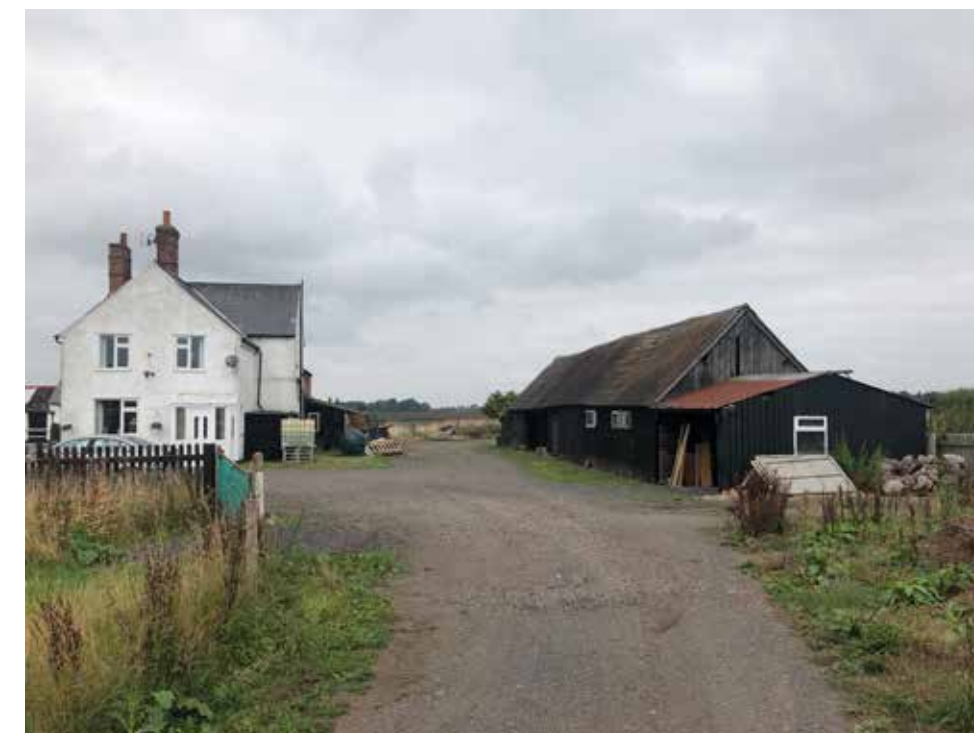
Elm Farm comprises a main farmhouse building and secondary wooden workshop building. These buildings were occupied at the time of the walkover and not accessed internally. The main building is two-storey, brick construction and is connected to a brick barn structure and stables to the west. The roof of this barn structure was noted to potentially be corrugated asbestos sheeting.

The Elms Farm buildings

- Potential asbestos was identified within The Elms Farm buildings structures. A Demolition Asbestos Survey should be prepared for these buildings identifying any potential asbestos risks within the structures;

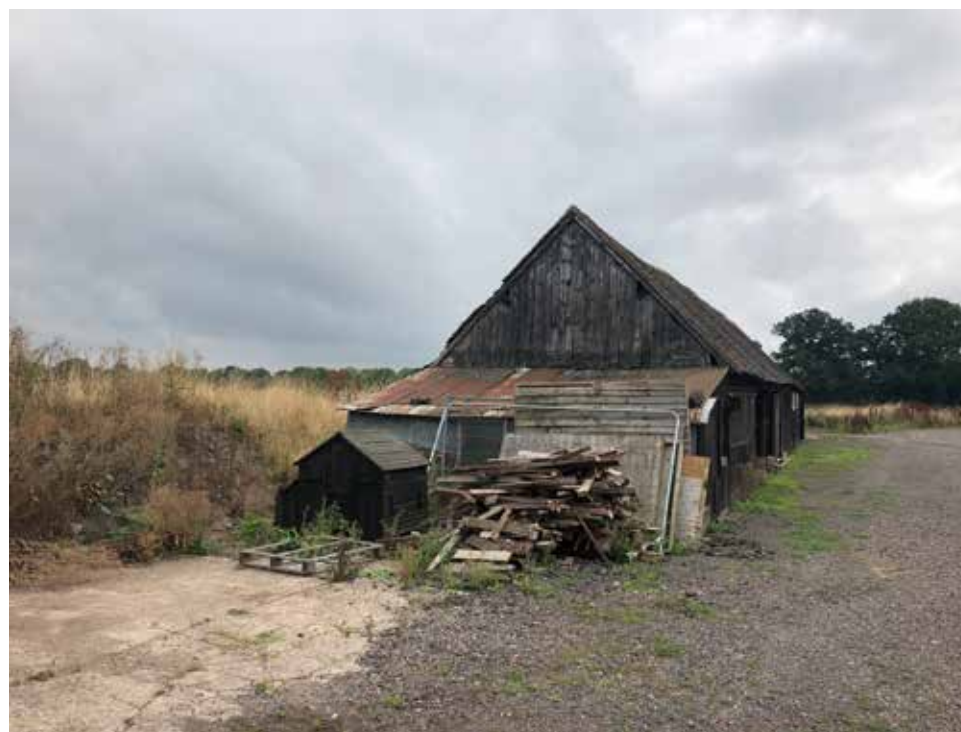
The secondary workshop building is north of the main farm building and is of wood construction. This barn is in use for tools, farm equipment and wood storage. A berm approximately 2m high runs along the northern wall of this workshop, overgrown with shrub plants and grass. The berm consists of Made Ground, with fragments of brick and concrete visible.

Rear of workshop buildings with earth mound

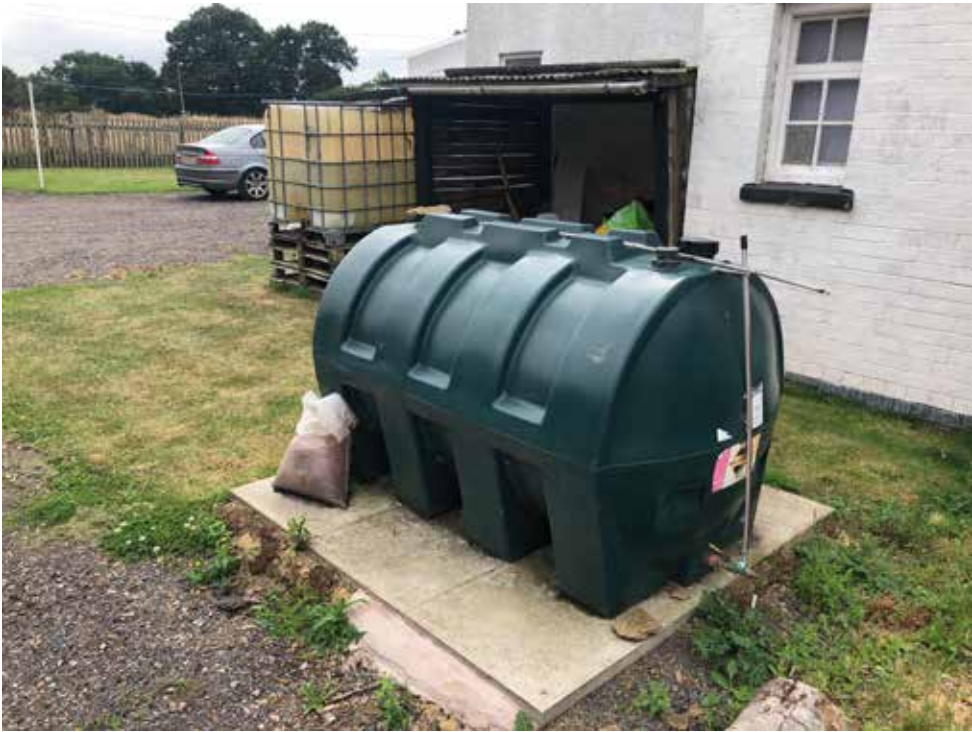
The main building is surrounded by gravel surfacing, with drainage from the roof directed to a 1,000 litre intermediate bulk container located at the north-east corner of the building. A 1,412 litre internally bundled

oil storage tank is also here, sited on paving slabs. Accompanying pipework for this tank runs underground to the main building. At the time of the walkover this tank was observed to be around 80% full. No drips, leaks or spills were observed from this tank.

| Potential Issue | Description | Condition |
|---|---|---|
| Aboveground Storage Tank (and fuel lines) | 1,412 litre household oil storage tank. | In good condition, internally banded and on raised platform with no evidence of leaks or spills noted. |

Oil storage tank at The Elms Farm

| Potential Sources | Linkage | Receptor | Risk | Justification / Mitigation | Residual Risk |
|---|---|---|---|---|---|
| Vapours arising from historical and current oil storage at The Elms Farm | Inhalation, accumulation in confined spaces | | Low | The oil tank identified at The Elms Farm was found to be in good condition, without evidence of leaks or spills. Ground investigation at the Site would identify any contamination arising from this tank or other sources such as the historical railway line and inform any mitigation necessary. | Low |

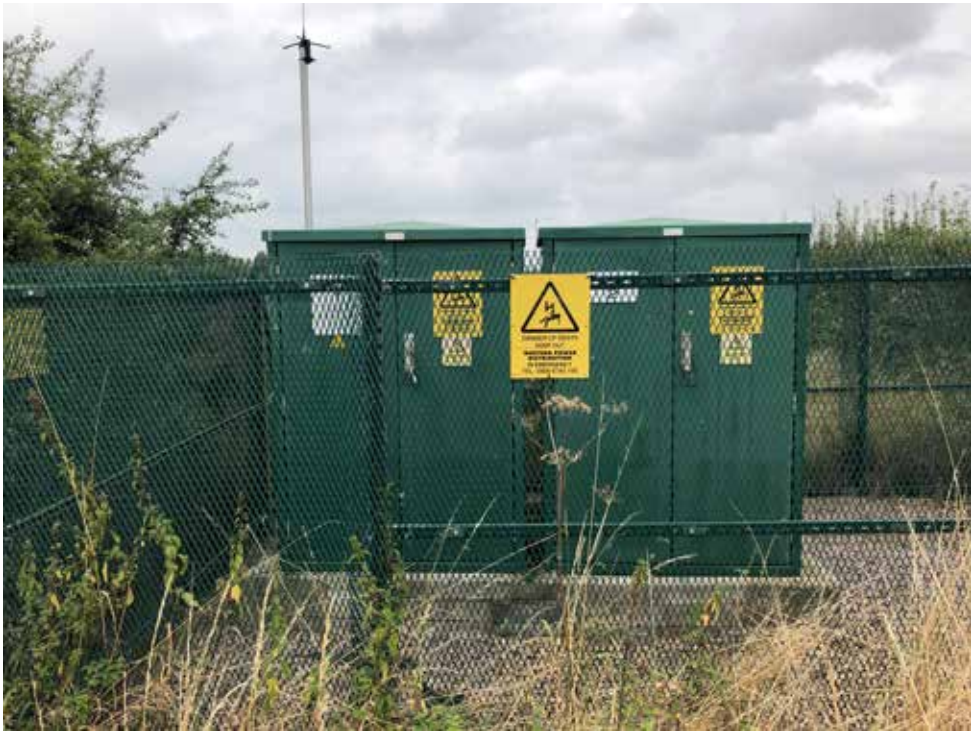
The majority of Elm farmland is in agricultural use. To the north-west of the north-westernmost field an electrical substation is present operated by Western Power Distribution. This substation appeared to be a recent design and was in good condition, however historical mapping details a substation in this location first installed between 1988 and 1994. Drainage ditches bound the Site within hedgerows to the south, east and west boundaries, with a ditch also present in hedgerows running north-south to separate the eastern and western fields. These drainage ditches were all observed to be dry during the walkover.

| Potential Issue | Description | Condition |
|---|---|---|
| Hazardous material storage | Potential for Polychlorinated Biphenyls within electrical substation. | Electrical substation appeared of modern design, however historical mapping indicates a substation has been in this area before 2000 and may have contained PCBs. |

Electrical substation at north-western Site boundary

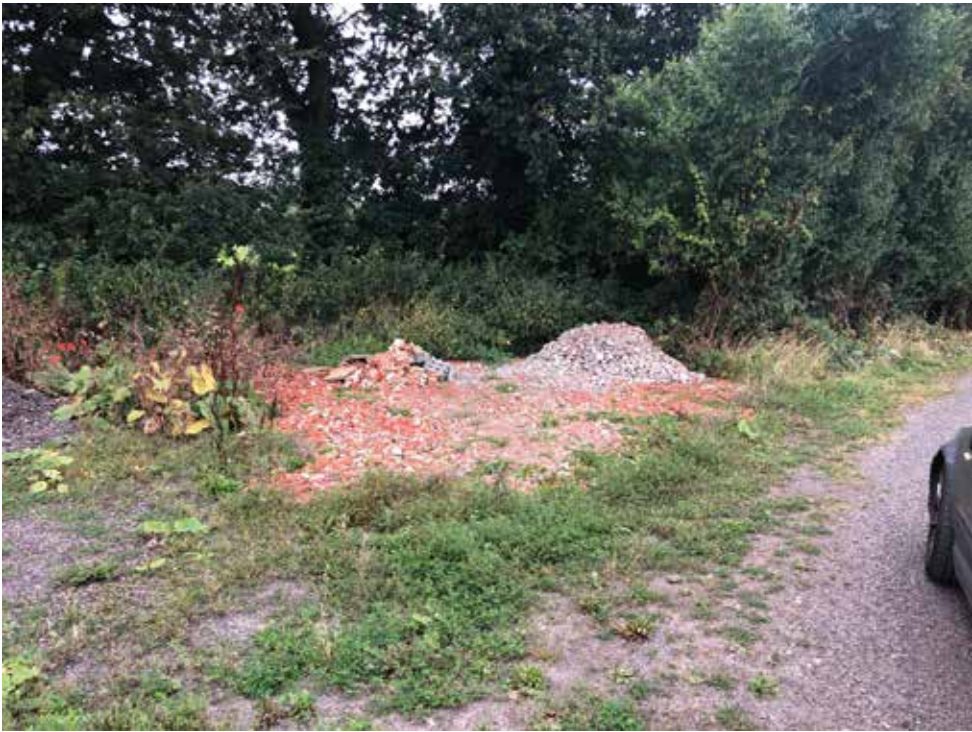
At the eastern Site boundary, a series of small heaps of crushed asphalt, crushed bricks and hardcore are situated. Asbestos containing materials were not observed on the surface of these stockpiles.

| Potential Issue | Description | Condition |
|---|---|---|
| Waste materials | Crushed asphalt, brick and concrete hardcore stockpiles at east of the Site | Asbestos containing materials not observed on surface of stockpiles. |

Heaped crushed asphalt, hardcore and brickwork at eastern Site boundary

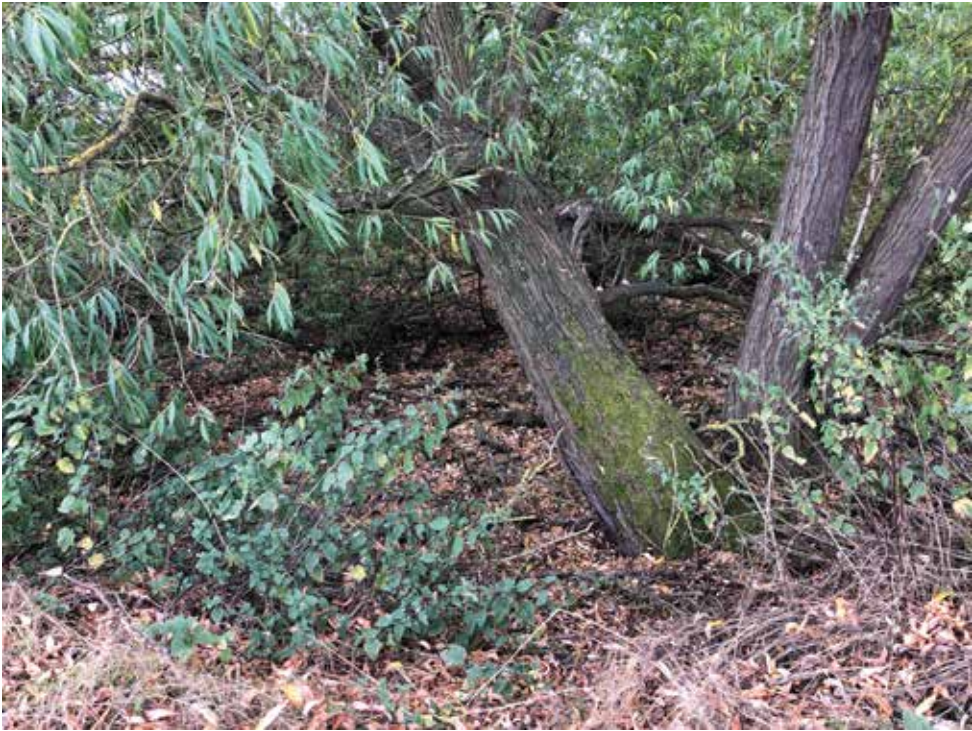
Drainage ditches surround the Site and run north to south adjacent to the hedgerows separating the eastern and western fields. This ditch outflows to the nearby River Anker off-site to the west, and at the time of the walkover was observed to be dry. Two ponds are in the centre-east of the Site. The northern of these was found to be dry at the time of the walkover, with water present in the southern feature.

Northern pond, observed dry at time of walkover

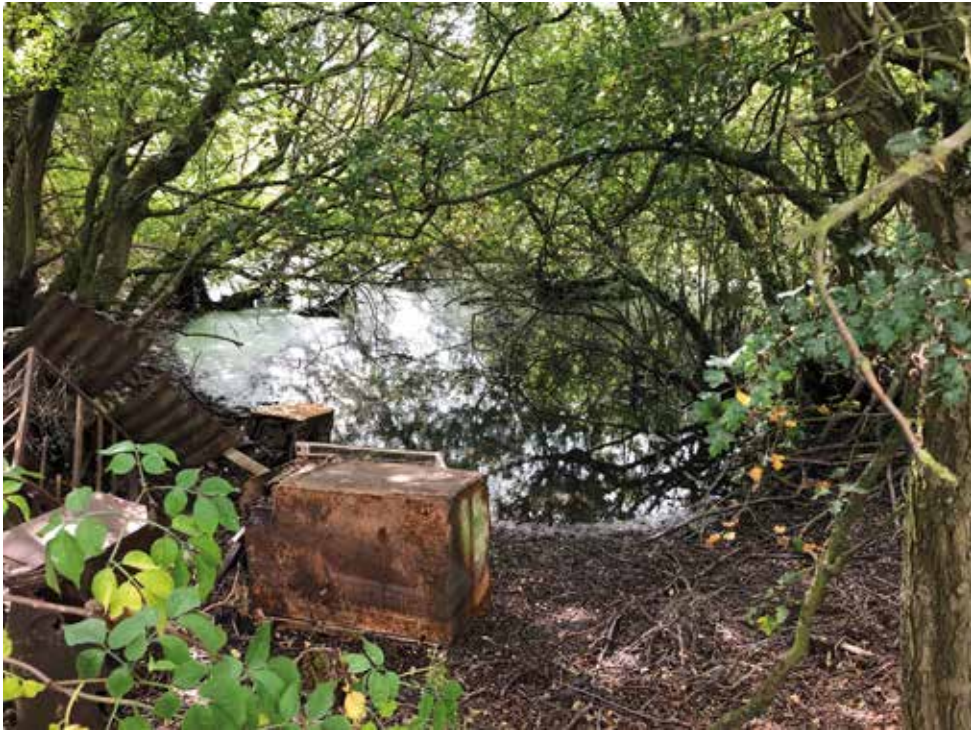
| Potential Issue | Description | Condition |
|---|---|---|
| | Scrap metal abandoned at surface water pond in the south | Scrap metal had corroded and was in poor condition. |

Waste metal at southern pond
