## Preliminary Roost Assessment

143 The Park, Market Bosworth, CV13 0LP

This report is prepared to inform a planning application for: Two storey side extension and single storey rear extension.

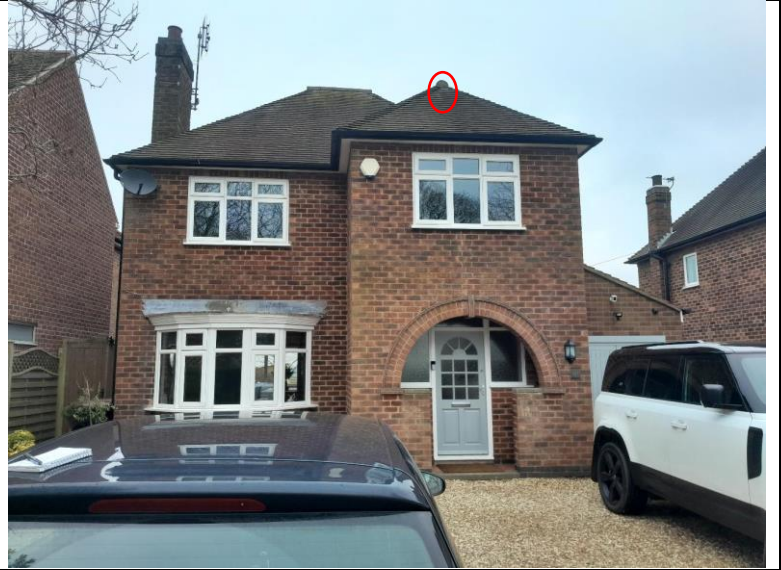
| <i><b>B1 Building description</b></i> | | | <i><b>Photographs</b></i> |
|---|---|---|---|
| <p><i>Summary</i></p> <p>B1 is a two-storey detached residential dwelling with a single storey extension on the eastern elevation that extends into the rear garden.</p> <p>A common pipistrelle maternity roost was identified within the roof structure as a result of previous bat surveys in 2011. 24 individual bats were seen entering the subspace of the roof under the apex of the hipped roof tile on the southern elevation, highlighted opposite.</p> <p>The building is a <b>confirmed roost</b> as evidenced by ~5 droppings found within one of the loft spaces as well as the maternity roost identified through records data. The building has <b>high habitat value</b> for roosting bats due to several raised and missing tiles across the roof and the high value surrounding habitat.</p> | | | |

| <i>Recommendations</i> | | <p><b>Roosting habitat [Buildings]</b></p> <p>Three bat emergence surveys are required during the active bat season (optimal May to August, suboptimal September) to characterise the roosts present. At least two of the surveys should be completed during the optimal survey period mid-May to August inclusive and surveys should be spread at least three weeks apart.</p> <p>Three surveyors are required to provide full coverage of the building (one within the neighbouring property to the east, where possible, to ensure all elevation with features can be viewed). Infra-red cameras should be used as an aid.</p> <p>An EPSL application to Natural England will be required. The EPSL application requires that surveys have been undertaken within the most recent active bat season and planning permission must have been granted and all relevant wildlife-related conditions have been discharged prior to submission.</p> <p>A Material Changes Check will be required within three months of the EPSL submission, if no survey work has been undertaken within that period. Bat droppings found during the PRA will need to be sent off for DNA analysis to confirm the bat species present, to inform the EPSL application.</p> | |

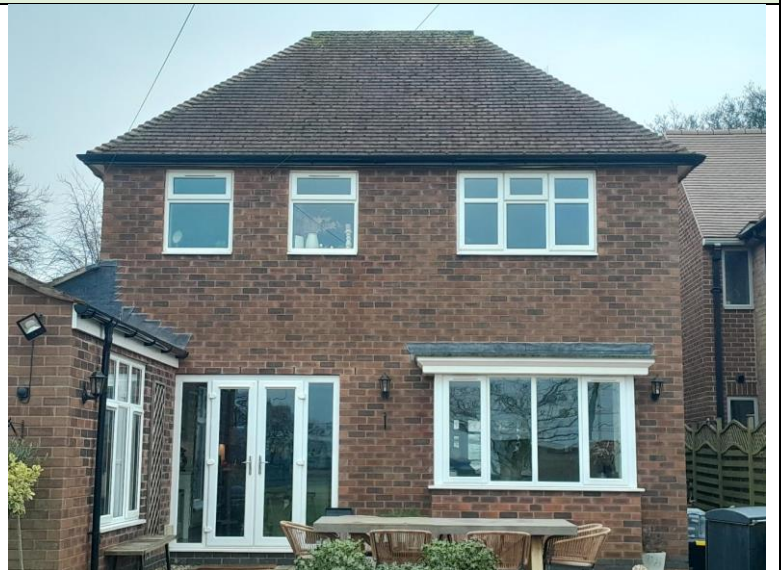
| <i><b>B1 Building description</b></i> | | | <i><b>Photographs</b></i> |
|---|---|---|---|
| Walls | Brick and mortar | <p><b>Condition/description</b></p> <p>The brickwork of the entirety of the building appears to be in good condition with no areas of damage or missing mortar.</p> <p><b>Suitability/access/evidence of bats</b></p> <p>No evidence of bats was found. There are no opportunities for bats to roost in the brickwork or access any cavity walls.</p> | |

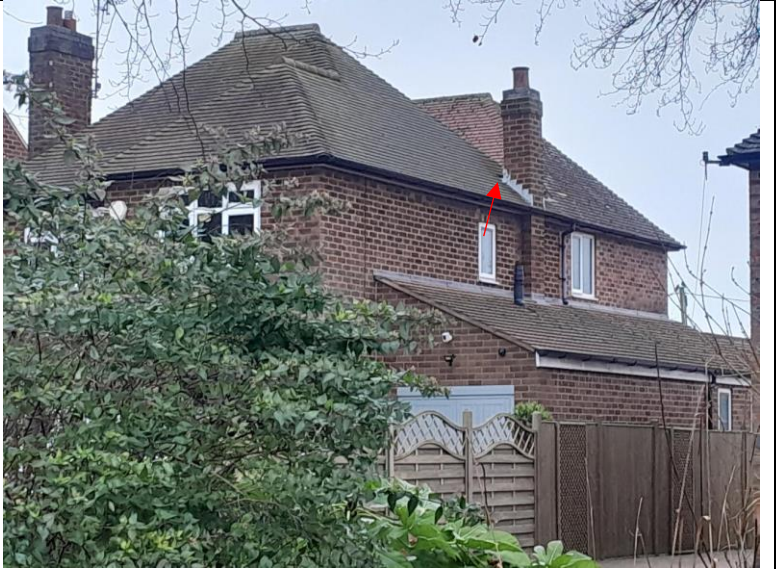
| Roof | Clay | <p><b>Condition/description</b></p> <p>B1 has a double ridged, hipped roof clad in clay tiles. There are several missing tiles across the eastern and southern elevations as well as multiple raised hip tiles on the southern elevation. There appears to be a gap at the apex of the southern hipped extension where a tile has slipped, that bats have known to utilise previously. The chimney appears to be in good condition, with no area of damage. There appears to be a gap under the tiles above the chimney on the eastern elevation, shown opposite.</p> <p><b>Suitability/access/evidence of bats</b></p> <p>Bats could use the gaps under the hip and roof tiles to access the subspace of the roof as well as gain entry into any internal loft spaces. This could support large numbers of bats/maternity roosts.</p> | |

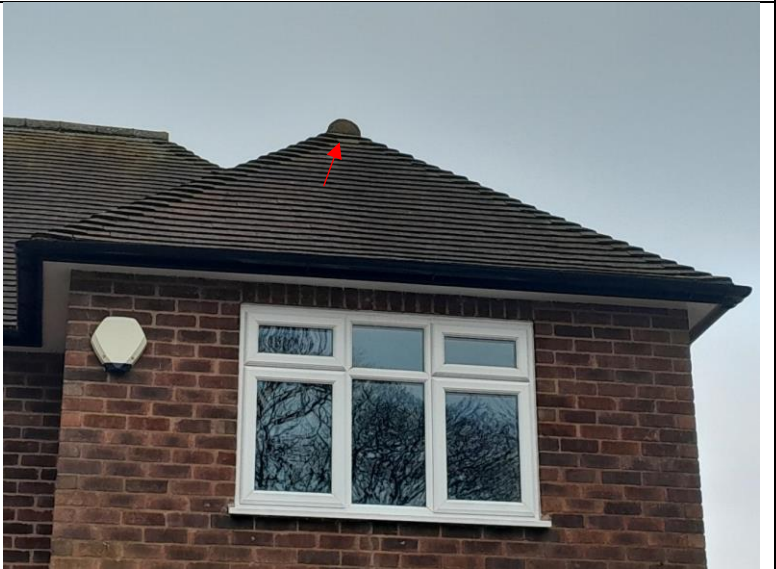
| Eaves | N/A | <p>The eaves across the building are well sealed, with no gaps at the wall tops where the brickwork meets the soffit. There are no gaps suitable for bats to utilise.</p> <p>The sealed eaves and slipped hip tile at the southern apex are shown opposite.</p> | |

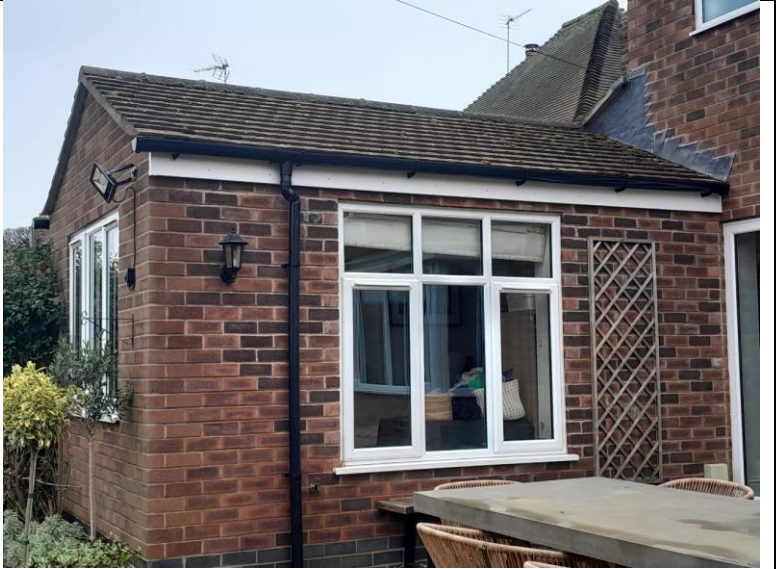
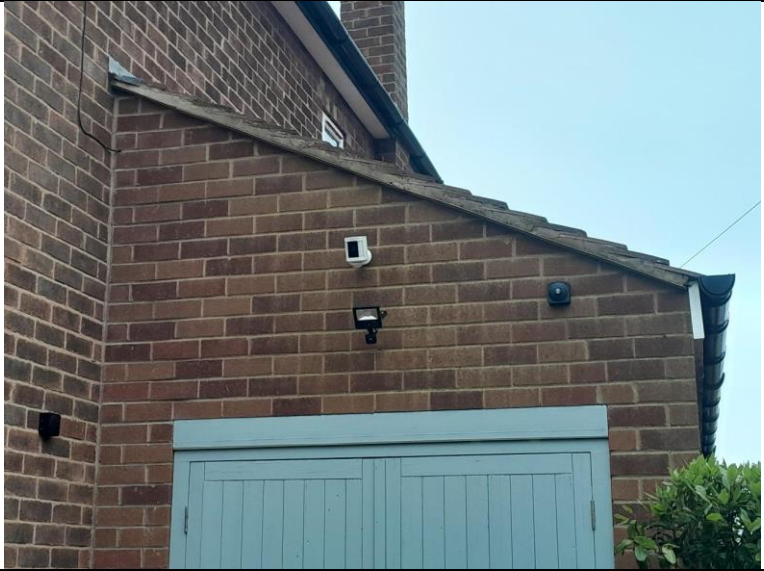
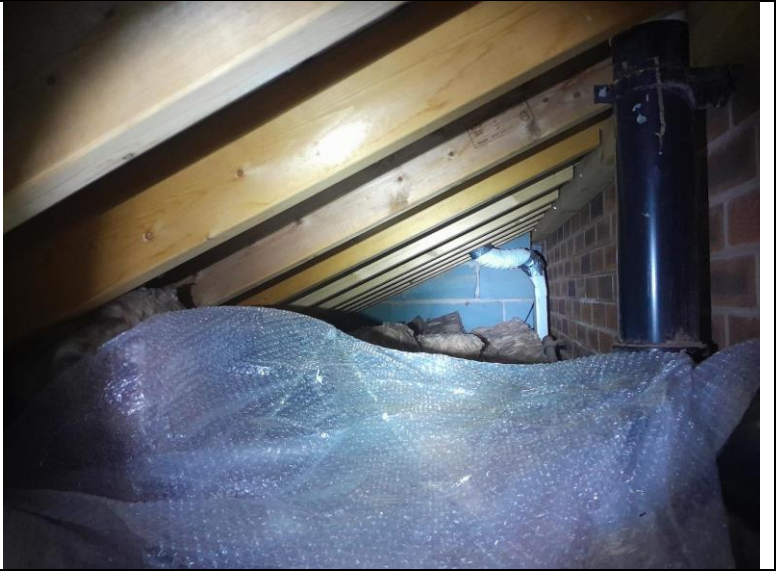
| Rear extension | Brick, pitched roof | <p>There is a single storey extension on the eastern elevation that extends into the rear garden. It has a pitched roof clad in clay tiles and a garage door on the southern elevation. The brickwork across the extension appears to be in good condition, with no gaps in the mortar and no gaps around the doors and windows. The fascia board is also tight to the wall with no opportunities for crevice dwelling bats to roost. The mortar on the roof verge is intact, with no gaps for bats to utilise and there are no missing tiles across the roof. However, there are two raised tiles on the western elevation that could allow crevice dwelling bats to roost underneath. No other roosting features were identified across the roof however a close-up inspection could not be undertaken due to the neighbouring boundaries and therefore the eastern elevation was viewed from a distance with binoculars.</p> <p>There is a small loft space within this extension. No evidence of bats was found within and there is limited space internal flight due to the low height of the roof. No daylight was seen to be coming into the space, suggesting a lack of access from the outside.</p> | |

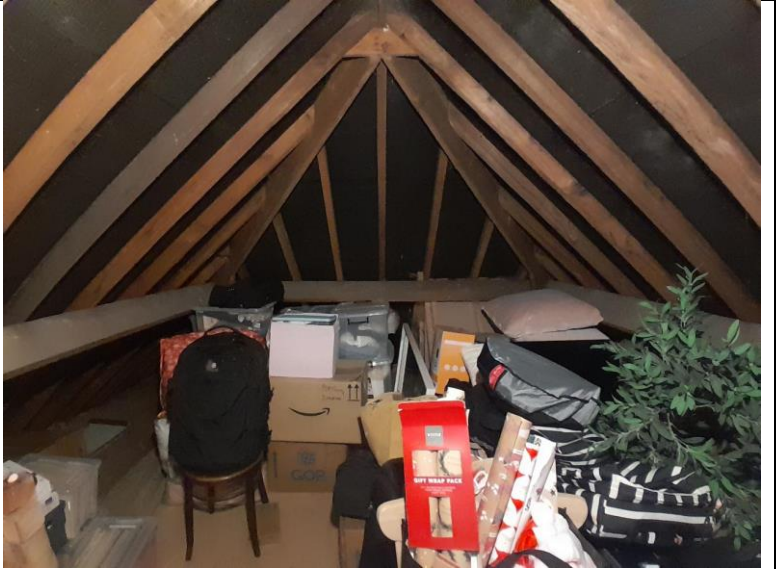
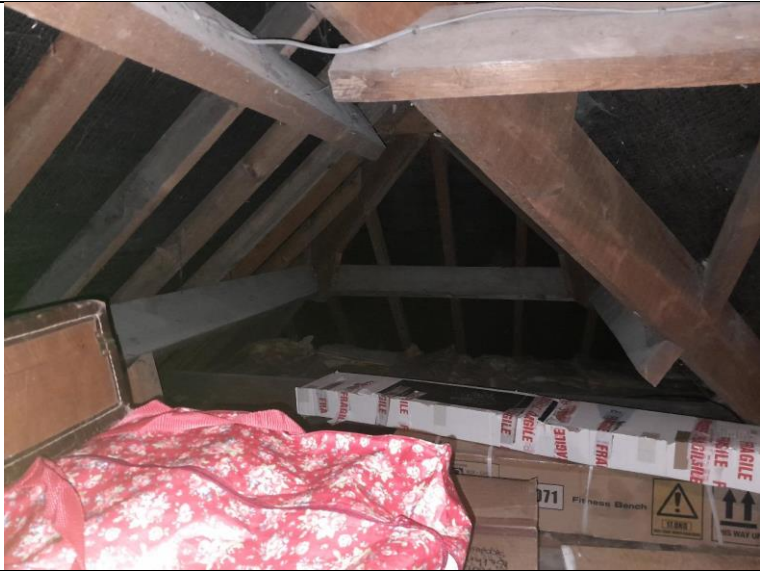
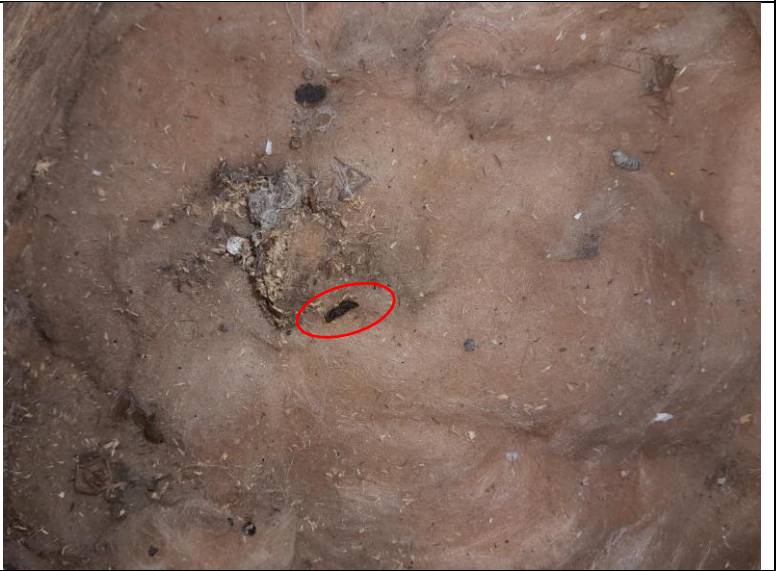
| Internal voids | Loft 1 - south | <p><b>Condition/description</b></p> <p>Loft space 1 is located within the southern hipped roof section and measure approximately 7m (L) x 5m (W) x 2.6m (H) with a temperature of 9° and a relative humidity of 79%.</p> <p>It is lined with a bitumen felt and is partially boarded and used for storage with artificial lighting present. The lining appears to be in good condition, with no tears or areas of sagging. No daylight was seen entering the space and there are dense cobwebs along the western end of the ridgeline.</p> <p><b>Suitability/access/evidence of bats</b></p> <p>Around 5 droppings were found located at the southern end of the loft, within the smaller hipped roof section. A sample of these was collected and will need to be sent off for DNA analysis. These droppings appeared morphologically similar to bat droppings and are characteristic of those of a brown long-eared bat, as shown below. This small number of droppings could suggest an exploratory visit by a small number or individual bat.</p> | |

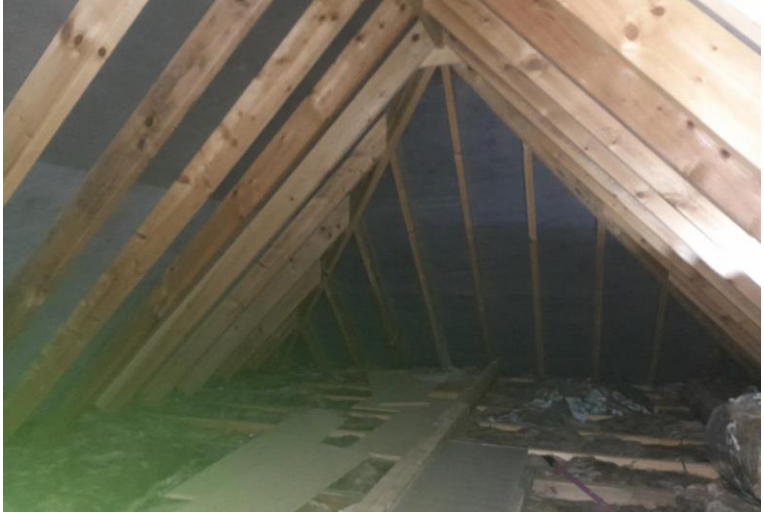
| Internal voids | Loft 2 - north | <p><b>Condition/description</b></p> <p>Loft space 2 is located within the northern hipped roof section and is of a similar construction to loft space 1. It is a newer extension to the roof.</p> <p>It is lined with a breathable roofing membrane is not boarded and not used. The lining appears to be in good condition, with no tears or areas of sagging and no daylight could be seen to enter the space.</p> <p><b>Suitability/access/evidence of bats</b></p> <p>No droppings or evidence of bats was found within this loft space. The loft appears to be well sealed, with no means of access for roosting bats.</p> | |
