## EARL SHILTON WEAVERS SPRINGS

### Weavers Fields Feasibility.Docx

**Agrostis Sports Surface Consulting**

09 April 2024

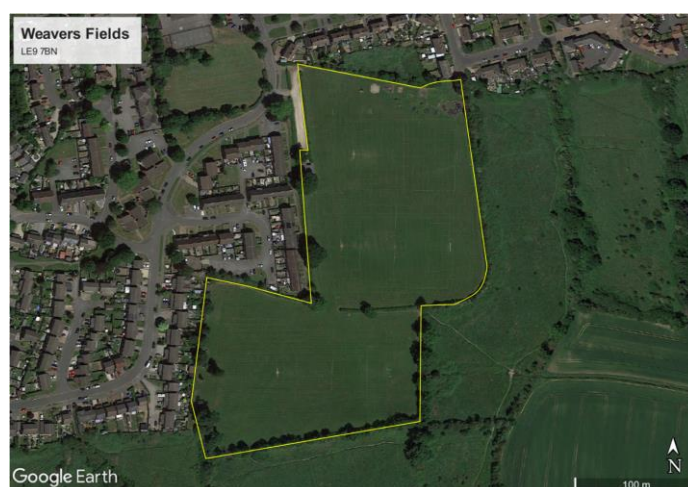
Figure 1-2 Contemporary Google Earth image of the site with outline of development

A Google view of the site, with the area under consideration shown in outline, is provided in Figure 1-2.

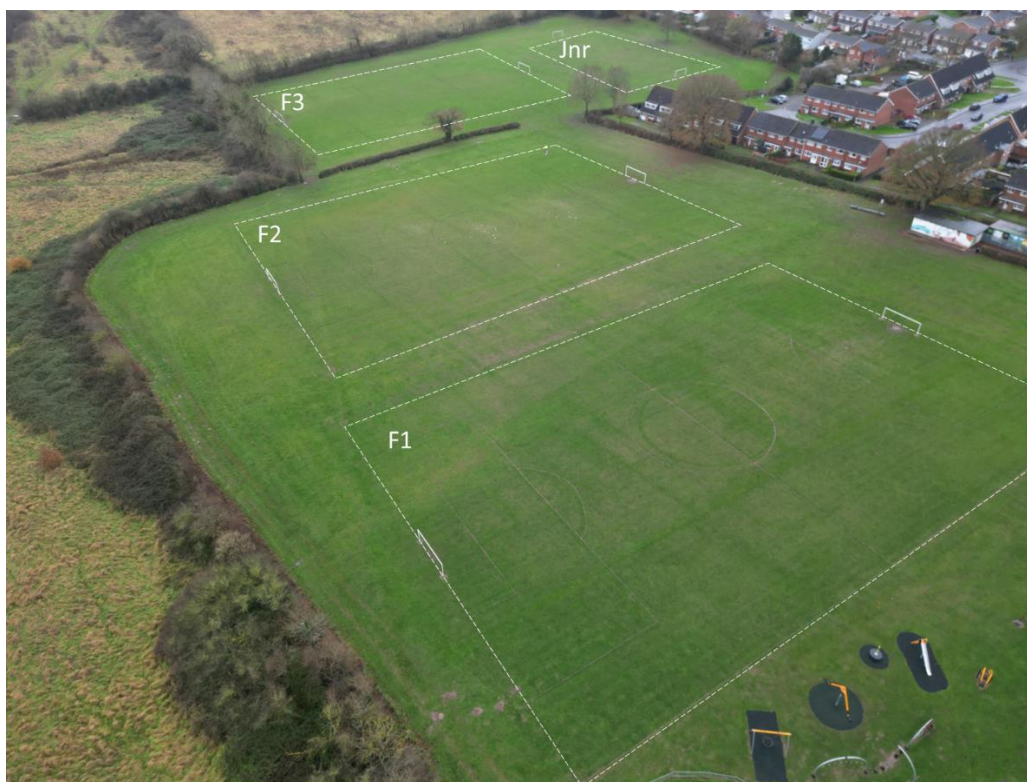
**Figure 1-3 View across the site from the north east with existing pitches marked and labelled**

The existing arrangement of sports pitches, consisting of 3 football pitches, has been described in a drawing<sup>1</sup>, an extract of which is shown in Figure 1-5. The pitches are labelled F1 to F3.

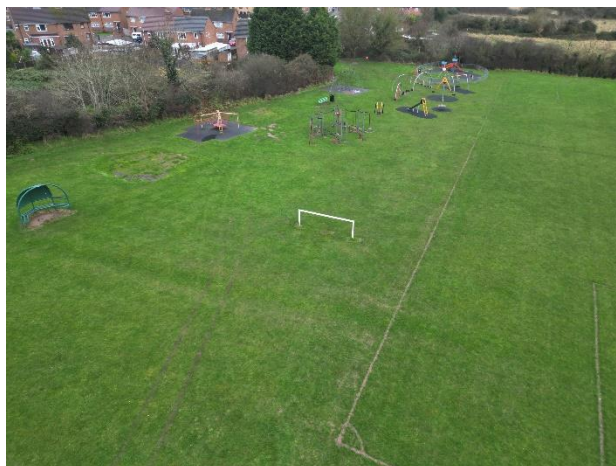
**Figure 1-4 Play equipment and single junior goal to the north of the site**

At the northern end of the site, on the highest ground, an area of play equipment had been established. A single junior goal had also been put in place to the west of the play equipment.

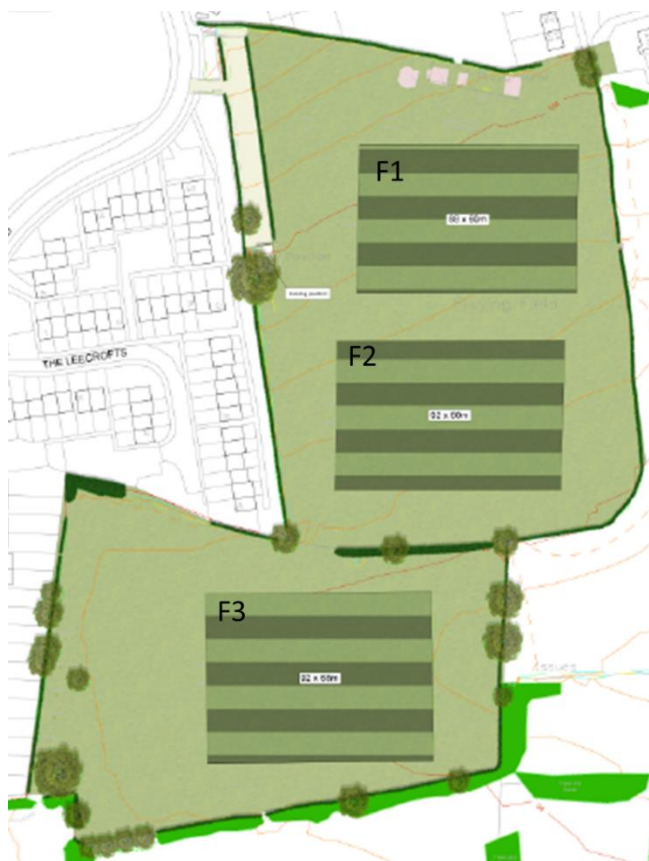
**Figure 1-5 Layout of existing pitches**

The existing football pitches have dimensions and conform to FA recommendations as shown in Table 1-1.

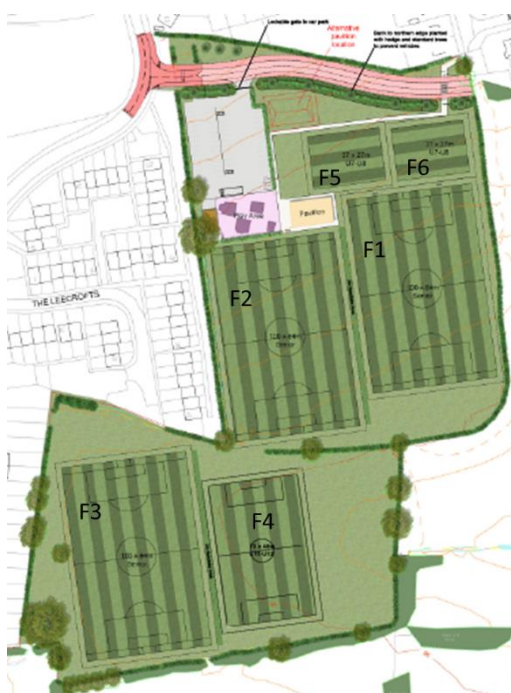
**Figure 1-6 Provisional pitch arrangement proposal**

A revised layout for the site, including the construction of car parking, a pavilion and play area, has been put forward<sup>2</sup> and an extract from this is shown in Figure 1-6. The football pitches are labelled F1 to F6.

These pitches have the dimensions and FA conformity as shown in Table 1-2.

Incorporating the pitch layout suggested in Figure 1-6 would result in a topography something like that shown in Figure 4 1. In this, embankments are shown with slopes of a relatively steep 1 in 3 which should be achievable with the soils noted here.

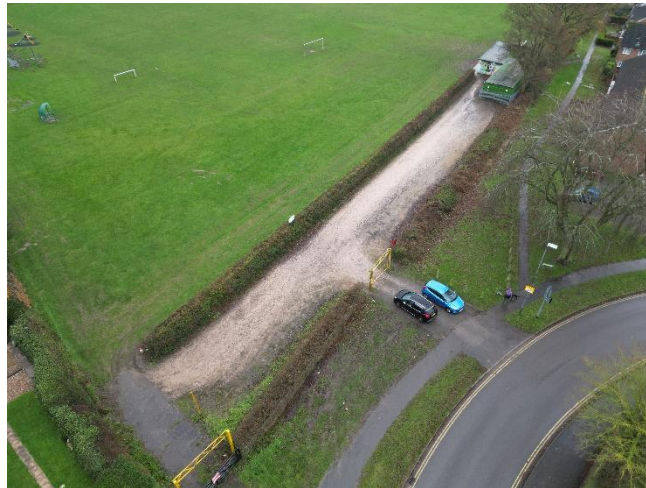
**Figure 3-2 Access area off Astley Road**

The main and only formal access point is in the north west corner of the northern field, off Astley Road, where a gated entrance and small car park is situated.

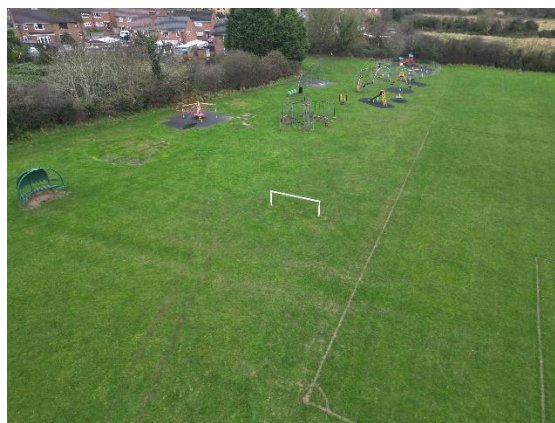
**Figure 3-5 Play equipment to the north**

An area of children's play equipment has been installed at the north of the north field.

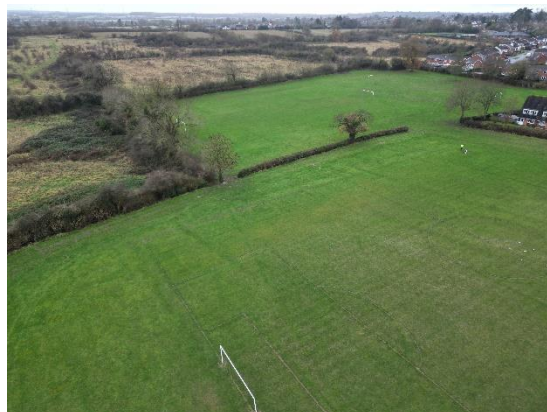
**Figure 3-6 Hedgerow separating the north and south fields**

The perimeter is composed chiefly of largely un-maintained hedgerow and a section of lower hedgerow partially separates the two fields.

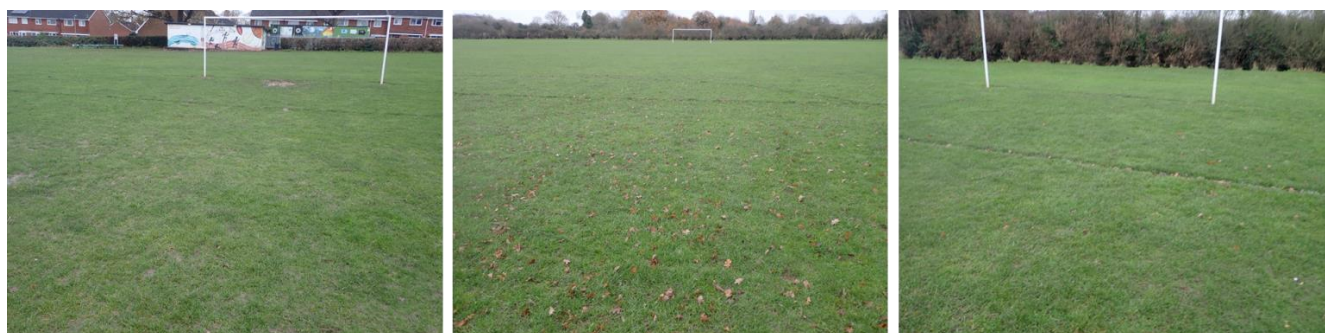
**Figure 3-7 Ground cover in key areas on F1**

Approximately 1 square metre of ground cover had been lost from the western goalmouth of F1 and F2. While all pitches had been used recently, no other significant losses of ground cover were noted within the pitches although wear from linesmen or spectators was noted, in particular to the west of the Junior pitch.

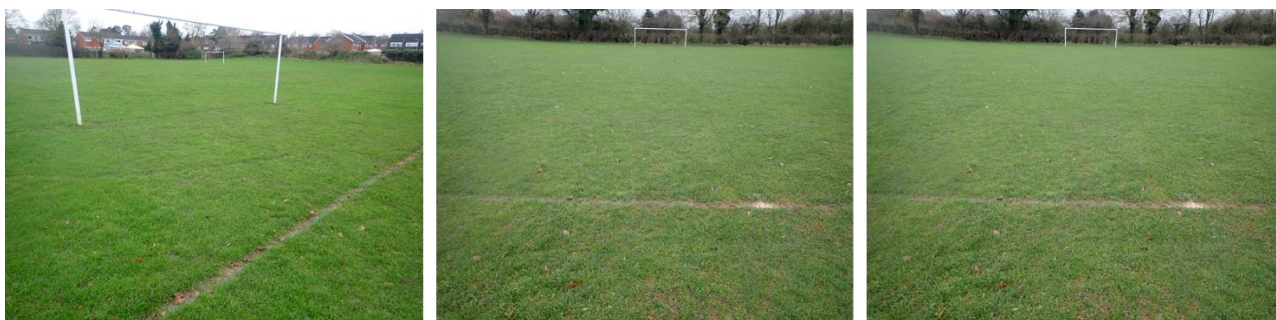
**Figure 3-9 Ground cover in key areas on F3**

Images of the goal mouths and centre circles of the 4 marked pitches are provided in Figure 3-7 to Figure 3-10.

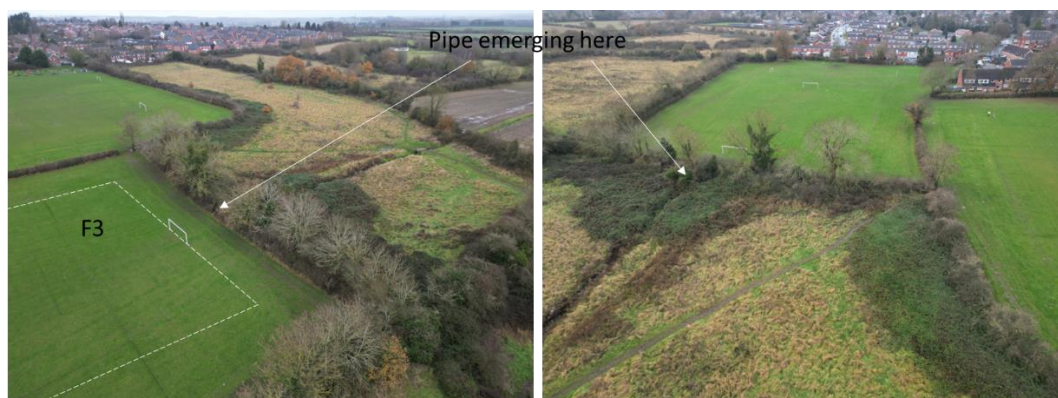
**Figure 3-11 Point of emergence of culverted stream**

A substantial stream ran from a pipe emerging immediately to the east of F3.

The historic map from the 1940's (Figure 1-9) shows the course of this stream crossing the southern end of the southern field and the lowest point within the site. This indicates that the stream was culverted beneath the site some time after the creation of this map.

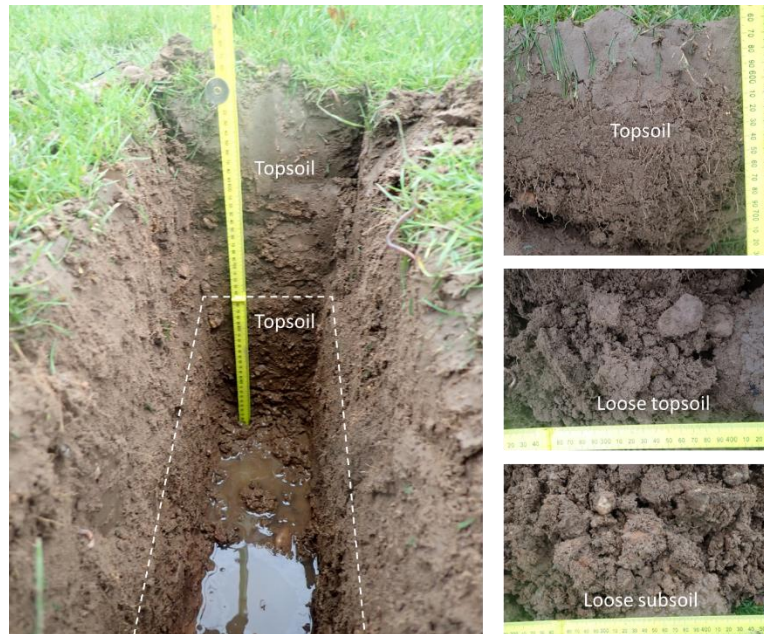
**Figure 3-12 Details of the soil profile**

An excavation in F2 appeared as shown in Figure 3-12. Topsoil extended to 250 mm. This consisted of an organic sandy clay loam with occasional rounded pebbles. Root development was extensive in this well-structured soil in which worm activity was substantial.

The subsoil was an easily worked sandy clay containing few stones.

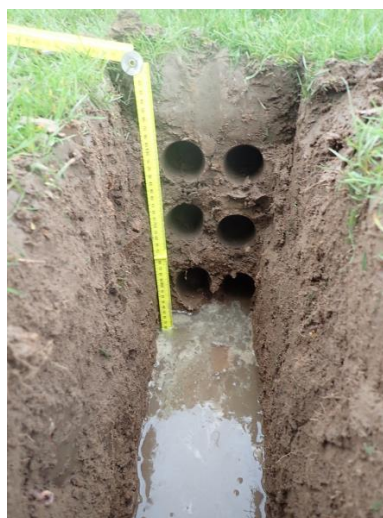
**Figure 3-13 Images of soil profile**

The excavation began accumulating ground water very quickly. This settled at a depth of approximately 450 mm.
