Land off Bosworth Lane
Newbold Verdon

**Phase I Desk Study Report
For
Bloor Homes**

| Project No: D44061 | | Date: 14 th August 2024 | |

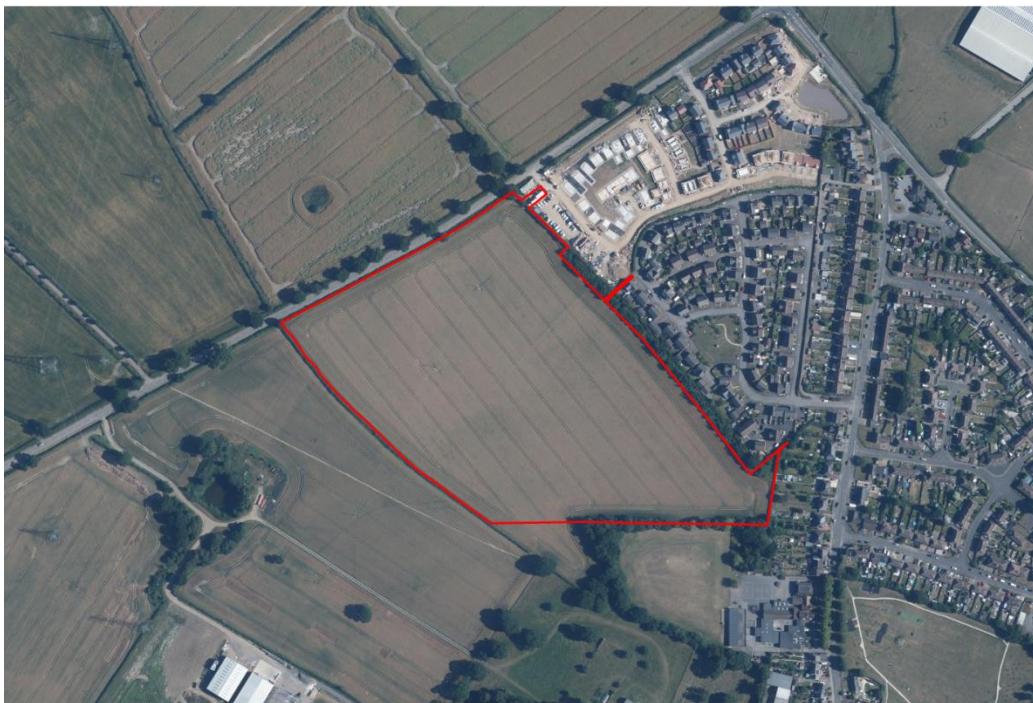
Figure 1: Aerial photograph of the site (2024 image)

An aerial photograph of the site area proposed to be developed, obtained from the Landmark Analysis tool commissioned as part of our works, is presented in Figure 1 on the next page, with the current OS mapping plan for the site and surrounding area presented in Figure 2.

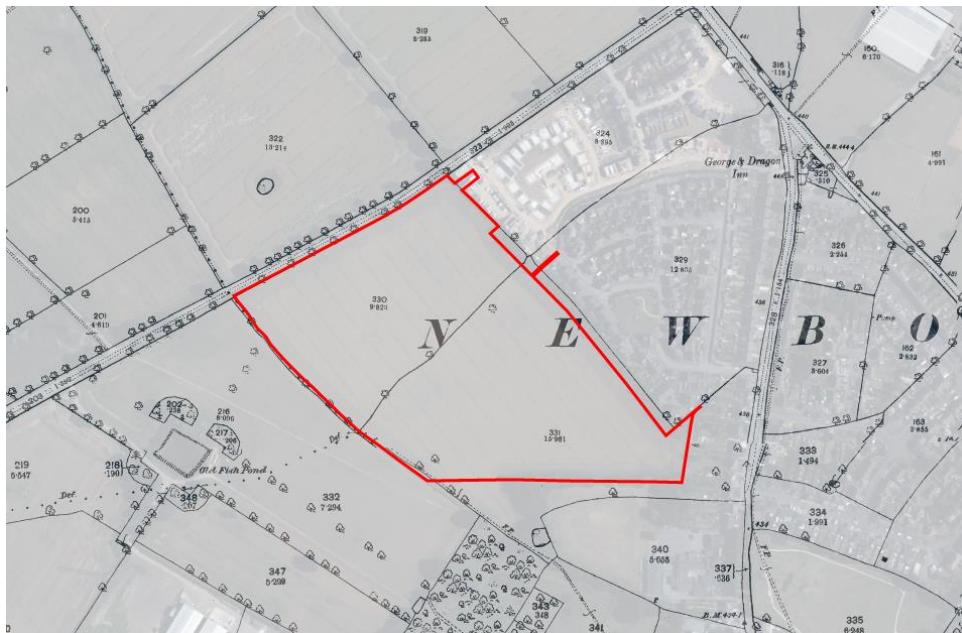
Figure 3: Current Aerial Imagery Overlain with 1886 Historical Map Data

The site comprises part of two undeveloped fields with other features on site including a footpath / track situated parallel with the south-western site boundary.

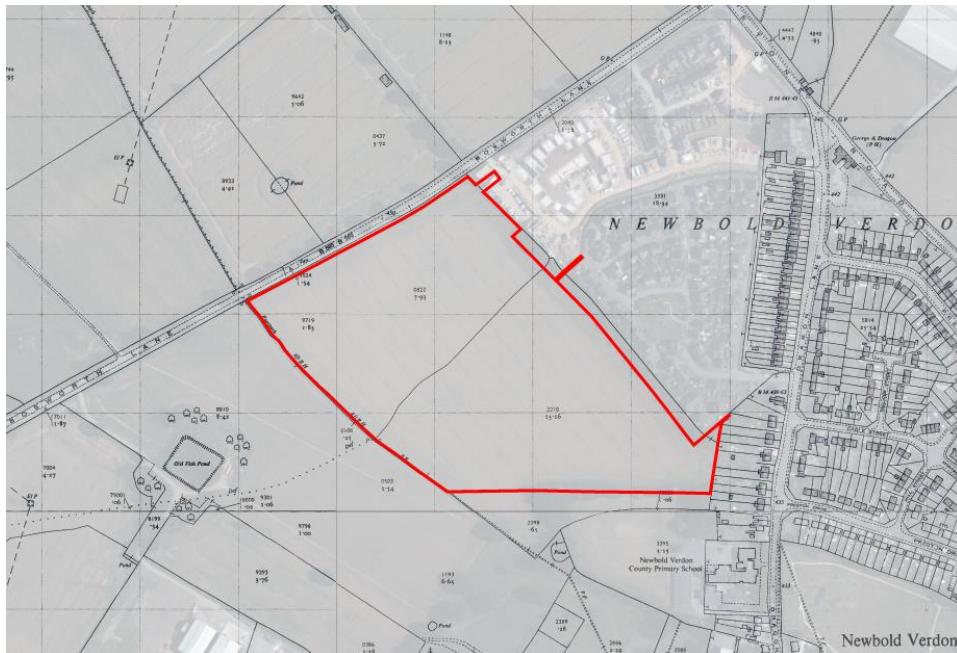
Figure 4: Current Aerial Imagery Overlain with 1958-59 Historical Map Data

The expansion of Newbold Verdon has occurred and residential properties lie adjacent to the eastern boundary of the site.

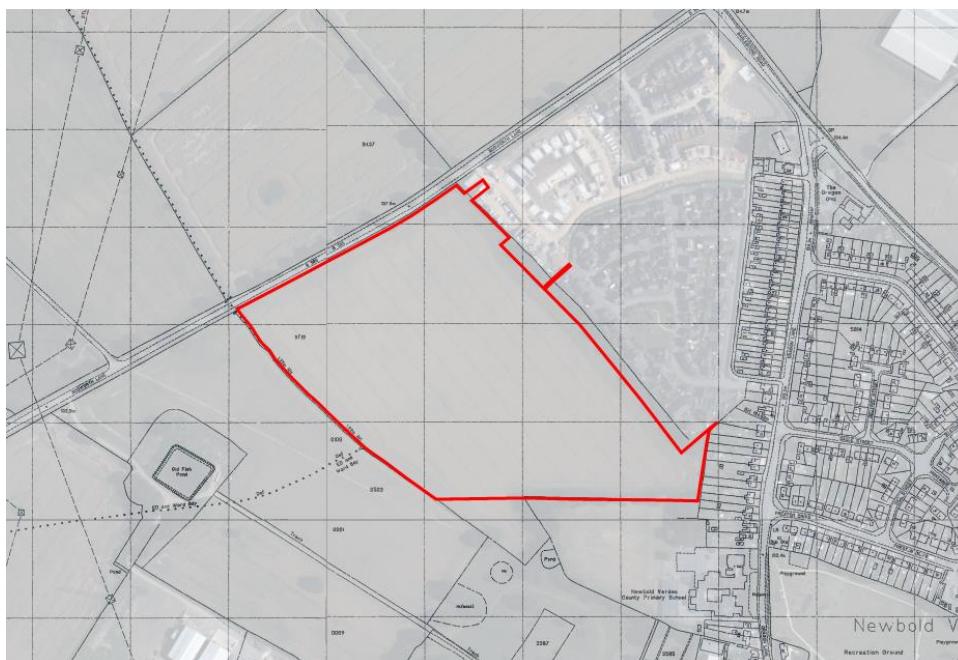
Figure 5: Current Aerial Imagery Overlain with 1994 Historical Map Data

The site is now one undeveloped field.

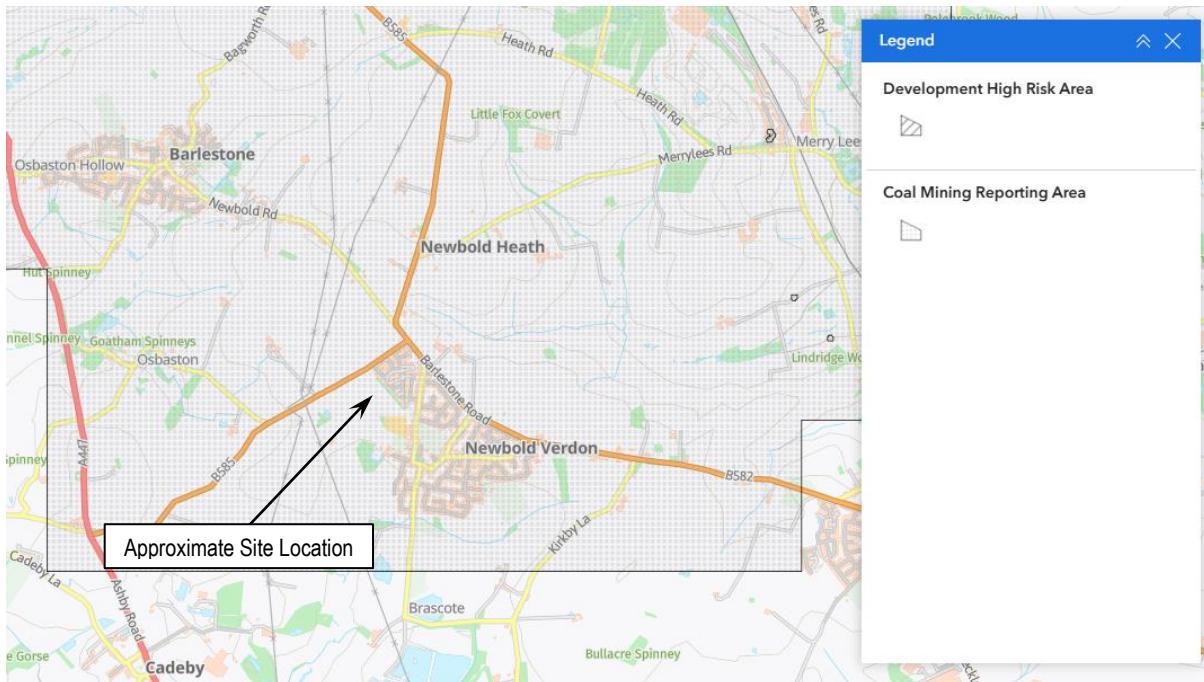
Figure 6: Mining Remediation Authority Map Viewer

The Map Viewer indicates that the site is not located within a Development High Risk Area as shown in Figure 6 below.

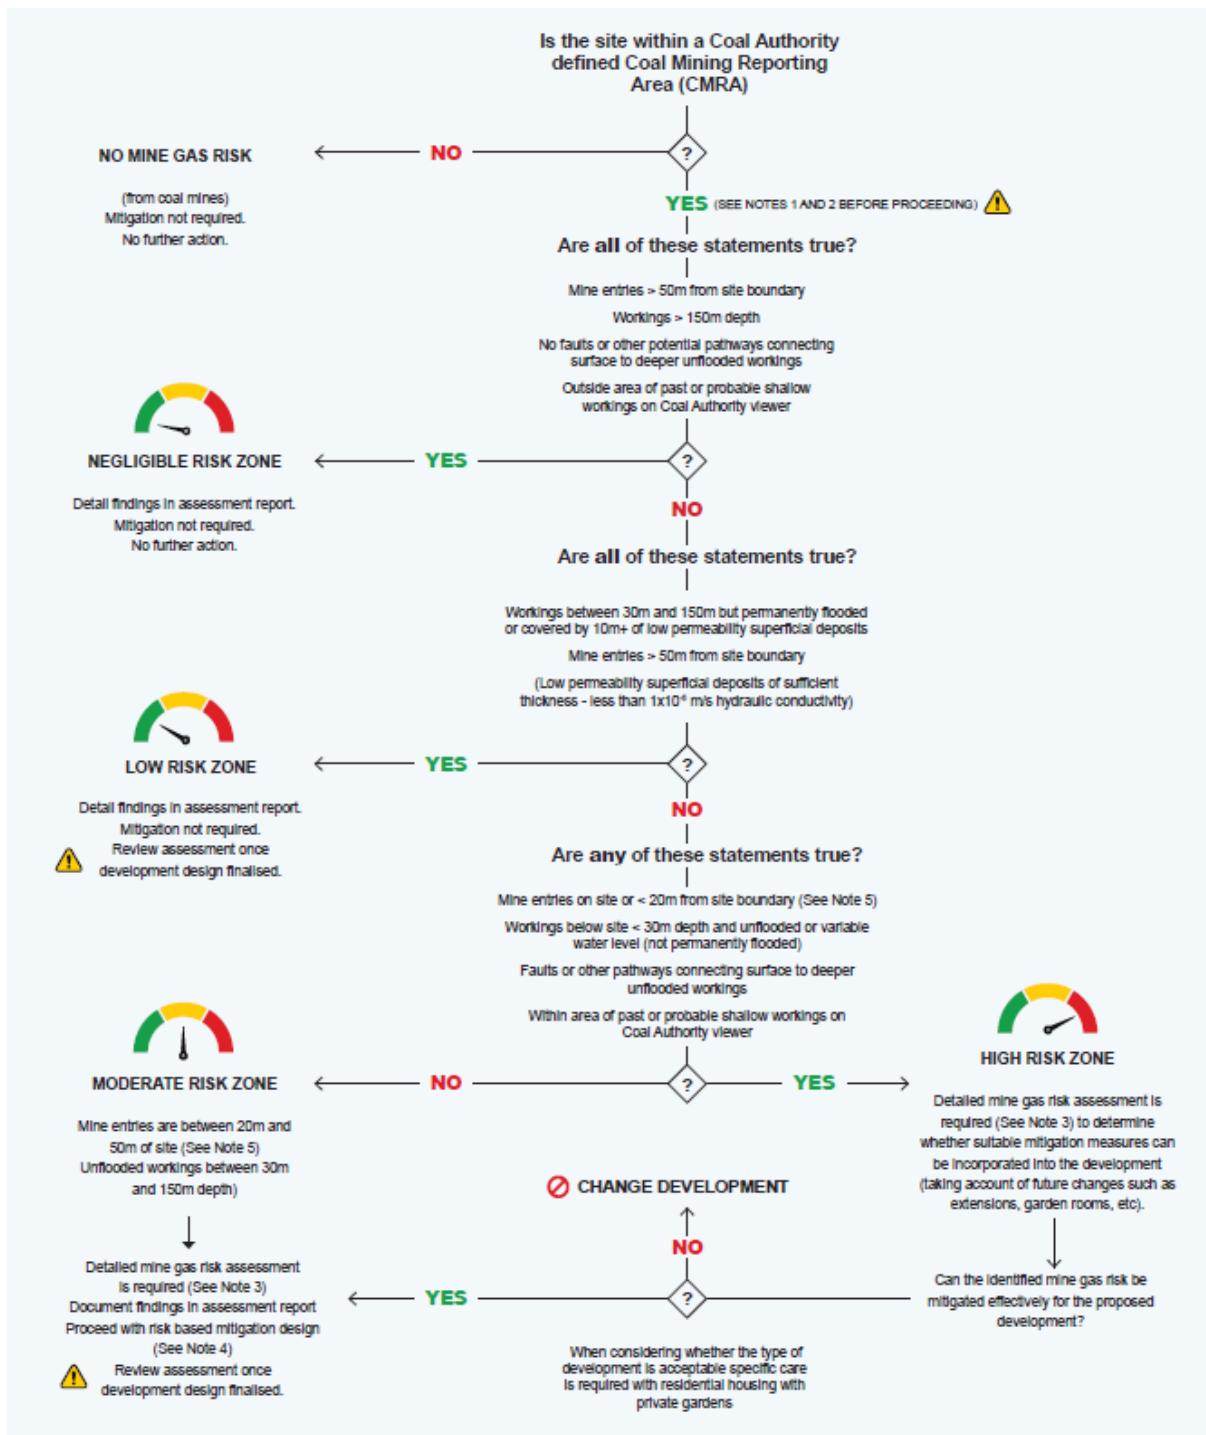
The CL:AIRE report provides the following decision tool to support a Preliminary Mine Gas Risk Assessment (PMGRA).

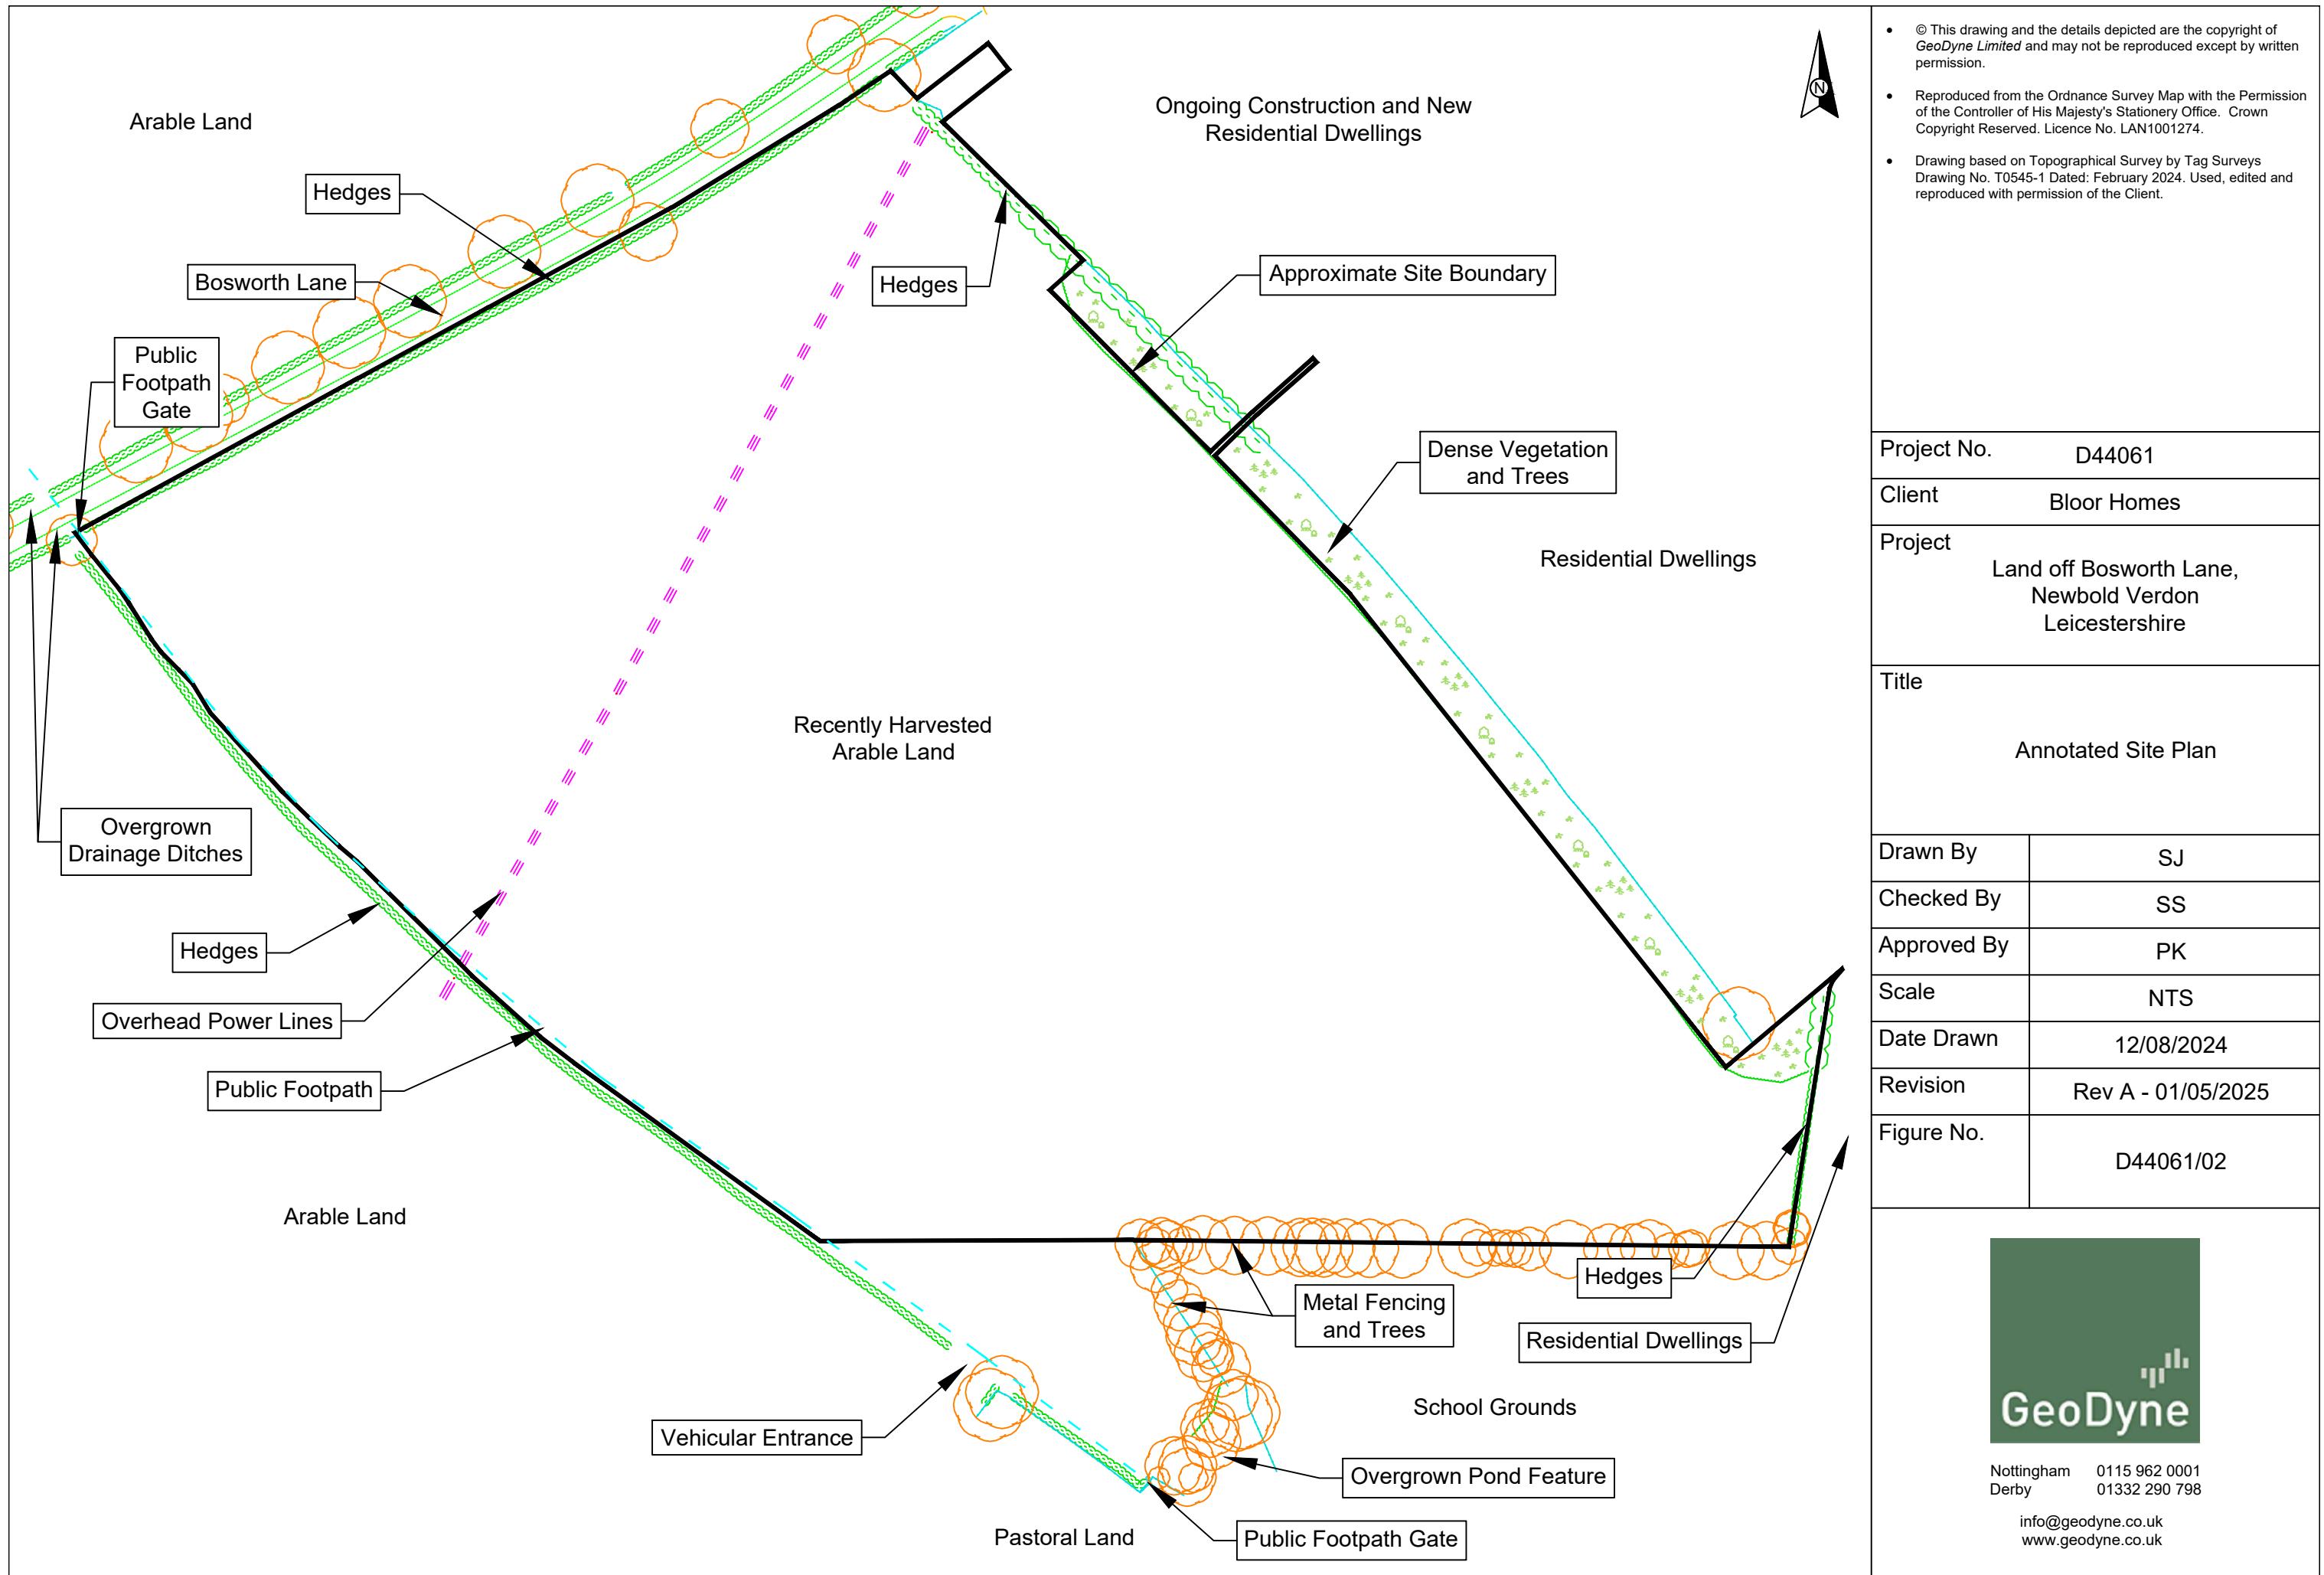
Annotated Site Plan
(Figure No. D44061/02 Rev A)

The Annotated Site Plan in Appendix III of this report (Figure No. D44061/02 Revision A) shows the main features of the site and immediate surrounding area. General views of the site are included on the plan in Appendix IV of this report (Figure No. D44061/03 Revision A).
