The Farmhouse at  
45 Main Street, Carlton,  
Nuneaton,  
CV13 0BZ

## **Preliminary Bat Roost Assessment**

Prepared by:  
**Griffin Ecology Ltd**

Project Number: GE0654

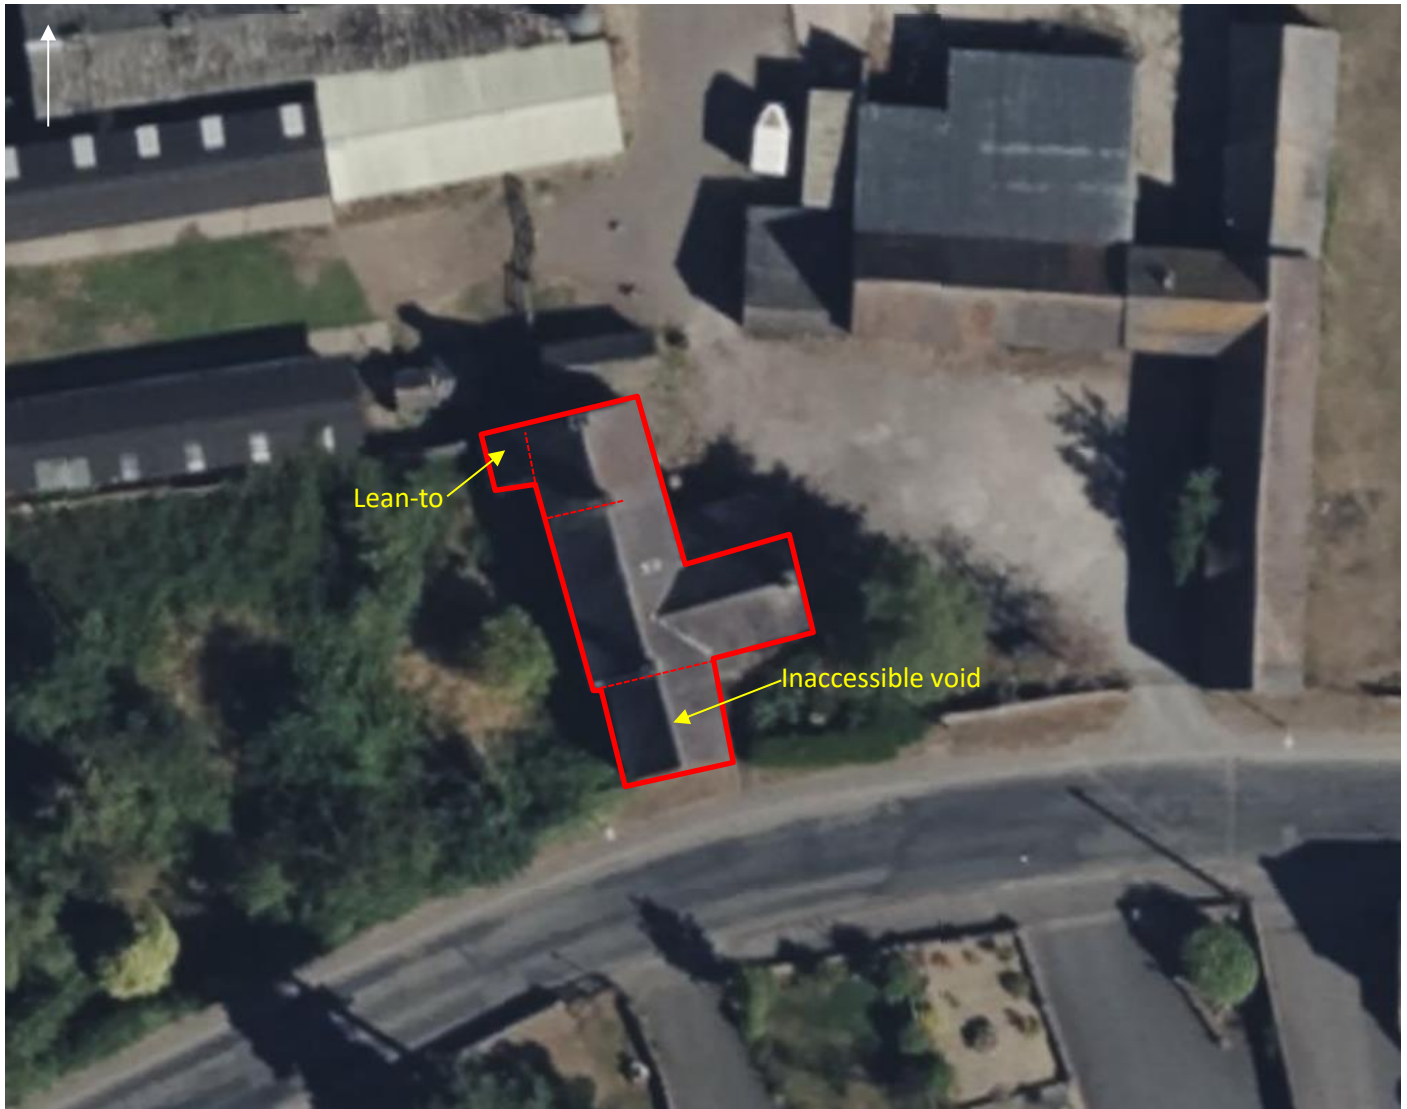
The site comprises a large residential building set adjacent to Main Street forming part of a larger complex of buildings extending to the north. Figure 2, below, aims to illustrate the location of the building subject to assessment.

*Figure 2: Building location*

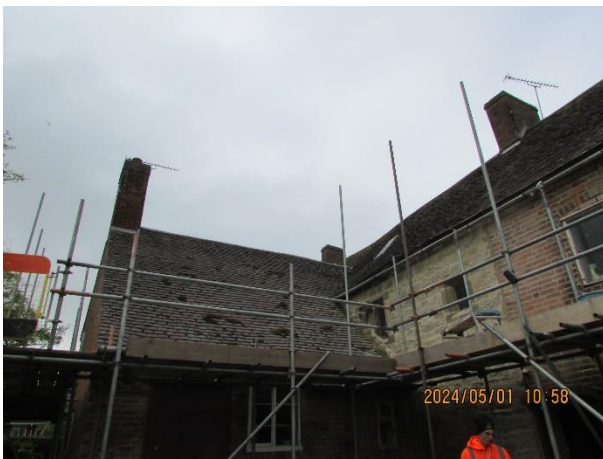
*North eastern elevation*

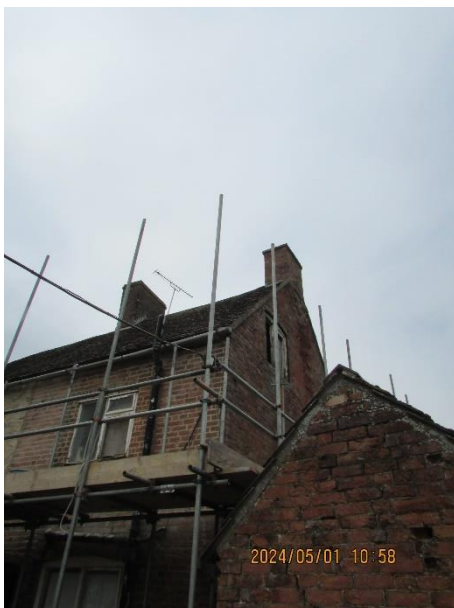
*Northern gable end*

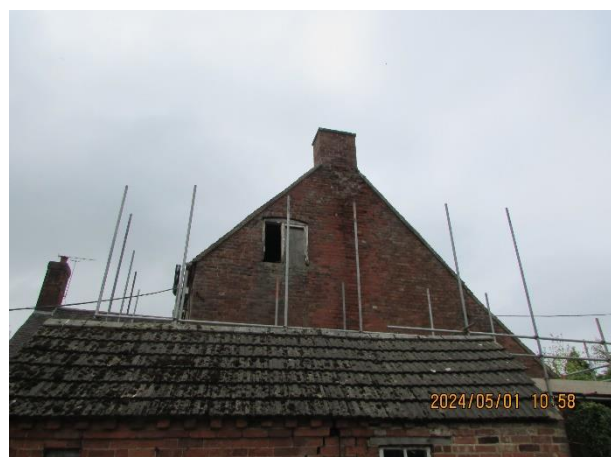
*Northern gable end with lean-to*

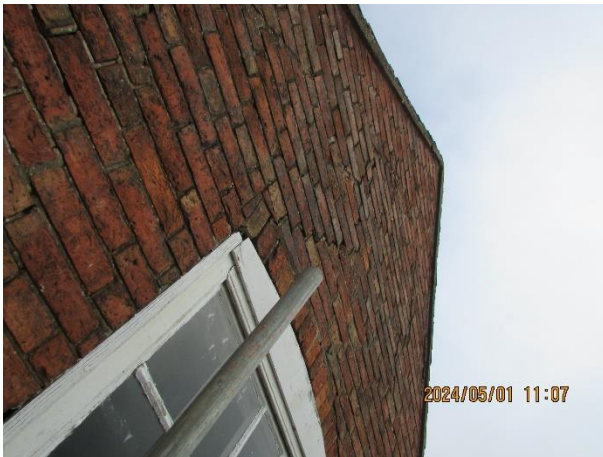
*Southern gable wall from scaffold*

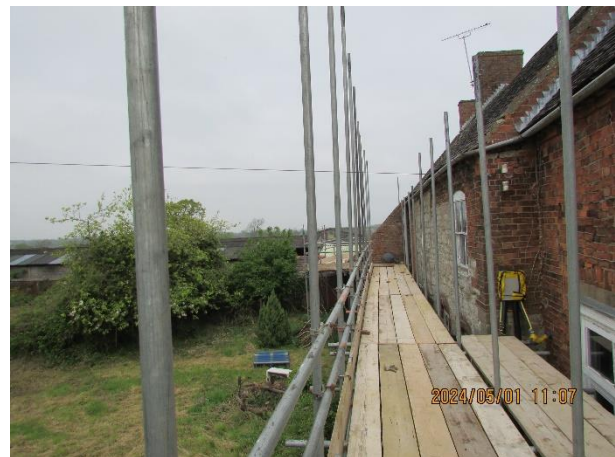
*Western elevation from scaffold*

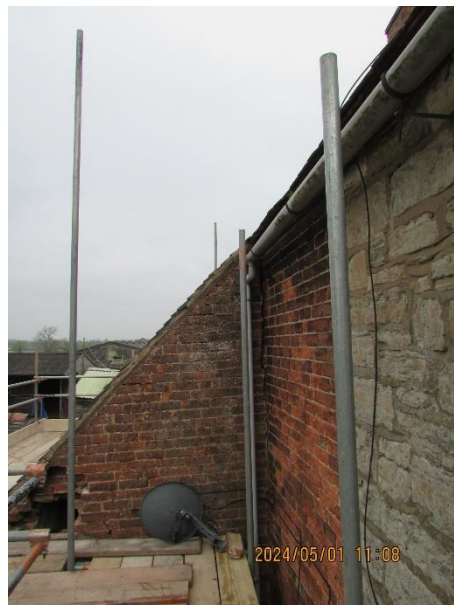
A small lean-to adjoins to the north western corner and the main roof slope extends down over the lean-to, creating a separate enclosed void above the store room below. Damage to the external wall at eaves height on this lean to enables a view inside the enclosed void.

*Lean-to view from scaffold*

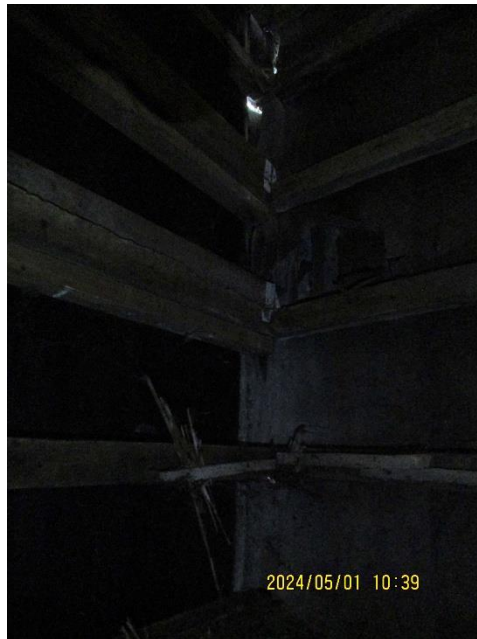
The external assessment of the farmhouse reveals ample suitable bat access opportunities within the roof finish, including missing, damaged and lifted slope and ridge tiles. The internal assessment of the roof lining also reveals corresponding damage to the felt lining below in a number of places along the ridge where daylight is visible.

*Daylight visible from within the roof space*

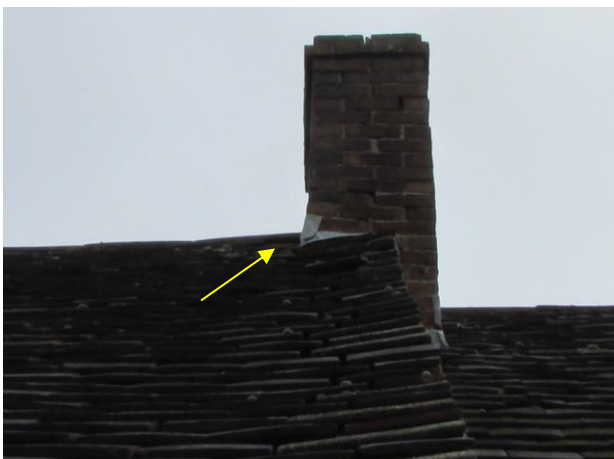
*Damaged ridge tile*

The extent of proposals include the refurbishment of the roof finish and replacement of supporting timbers where required. Additionally, areas of the external wall have deteriorated and works will also include repointing and tying where appropriate.

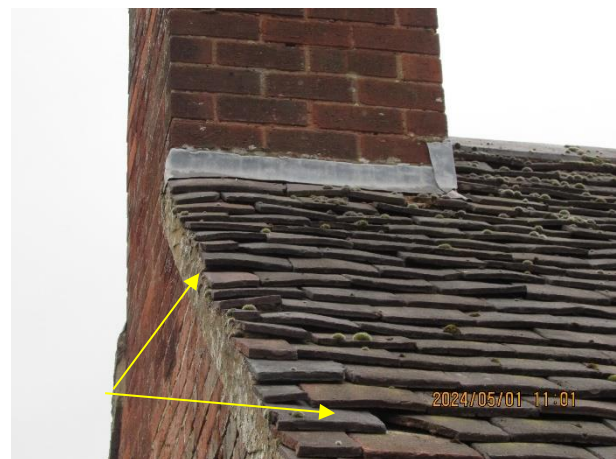
*Damaged and lifted slope tiles*

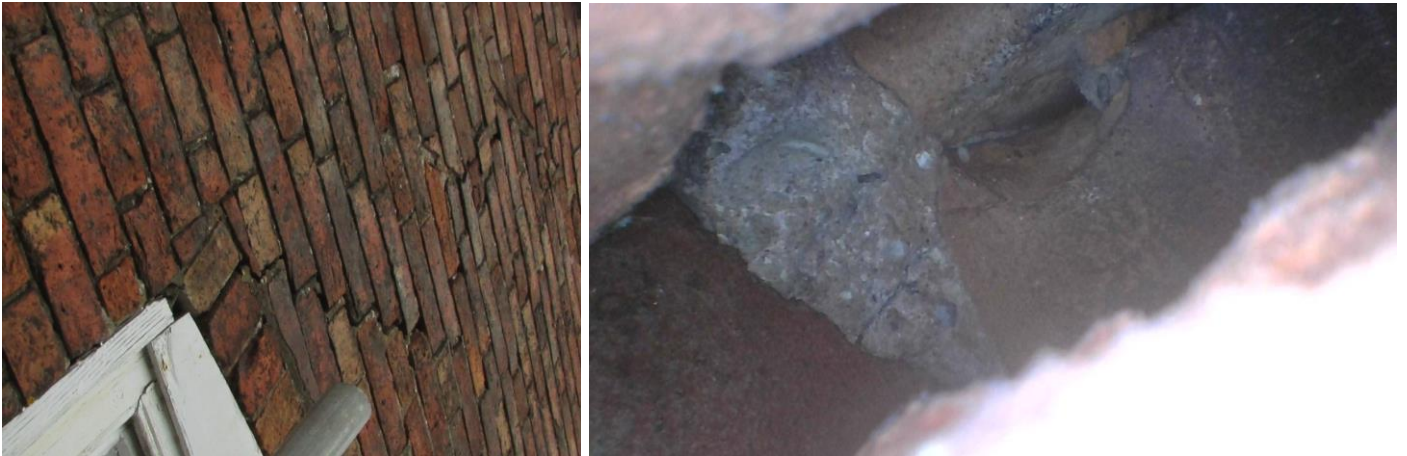
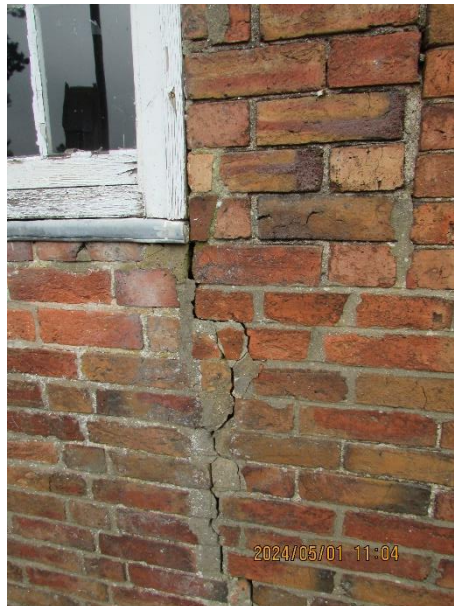
The external faces of the walls are in poor condition resulting in numerous shallow crevices. Where these crevices are more significant they relate to damage to the structural integrity of the southern gable wall. These features have been investigated with an endoscope revealing a suitable, small dry cavity at the apex of the crevice leading through the southern gable wall.

*Crevice within southern gable wall*

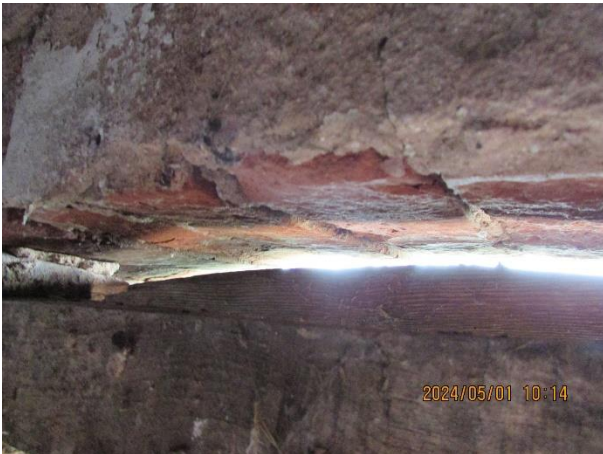
Further access points into the internal roof spaces are provided via gaps around the windows, through the open window on the northern gable and via open damage into the void above the lean-to.

*Gap above window*

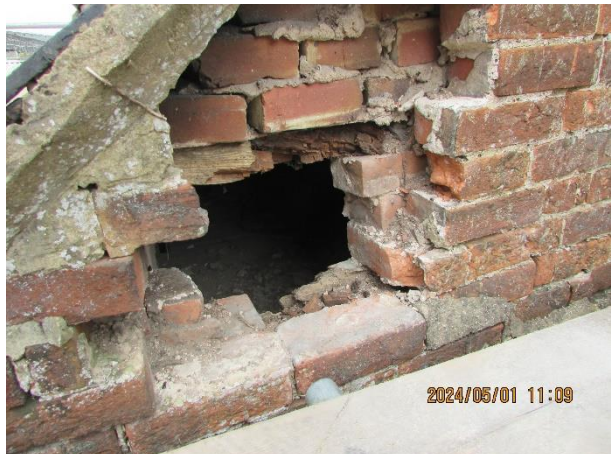
*Access into lean-to void*

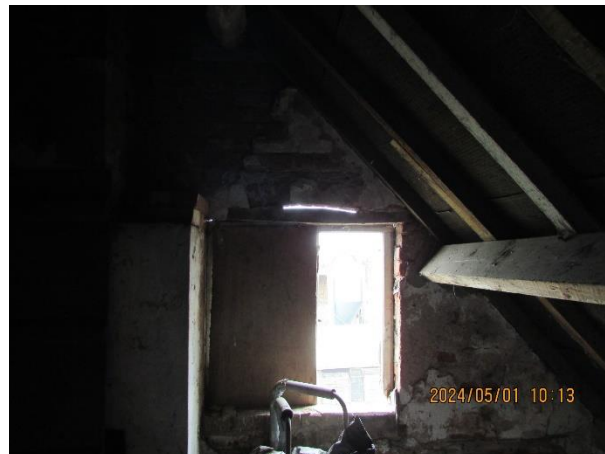
*Open window northern gable*

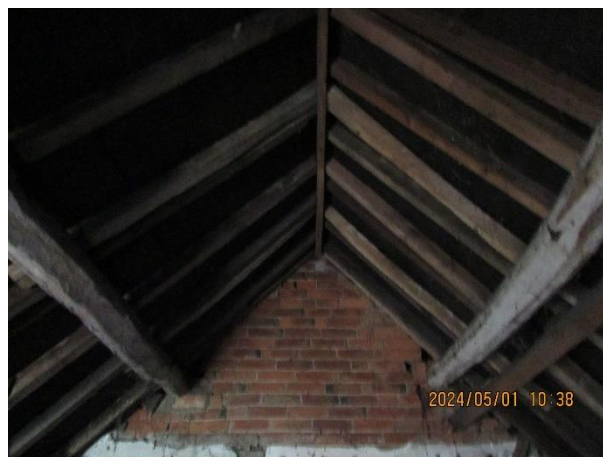
The internal inspection of the building reveals a number of potential bat roosting features within the roof space including an exposed timber ridge (with ample room provided within the roof space for social flight by species such as long-eared), timber junctions and gaps within internal brick walls, particularly where the timbers adjoin the walls.

*Exposed ridge and gaps in internal wall*

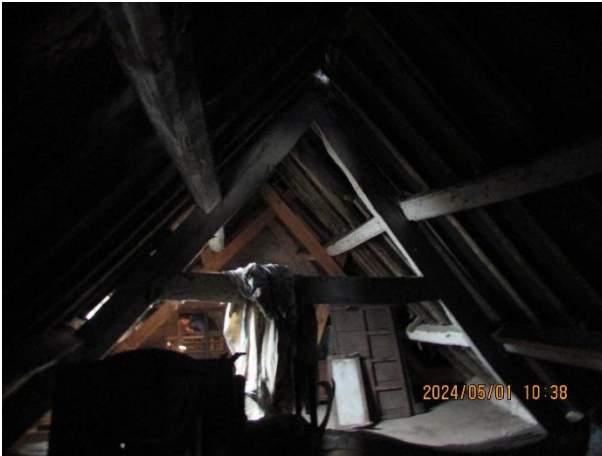
*Internal view*

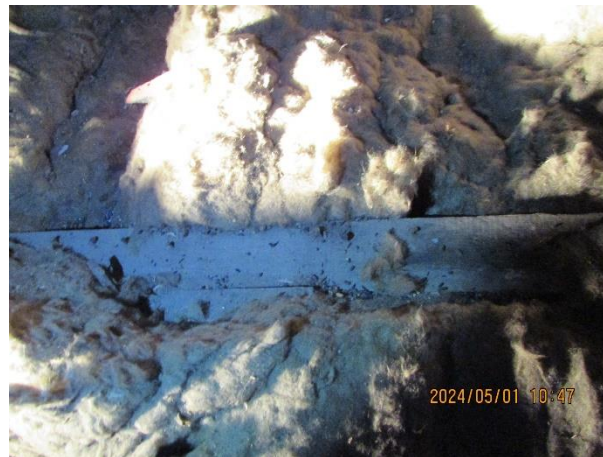
No significant accumulations of bat droppings have been recorded during the intrusive inspection of the building, however a total of three scattered small to medium sized droppings were noted atop the rockwool insulation within the eastern projection. These were identified amongst ample accumulations of mouse droppings.

*Bat dropping identified amongst  
mouse droppings*

A sample of the droppings observed have been subject to DNA analysis which has confirmed the presence of brown long-eared DNA. Detailed results of this are included within appendix 1.

Further survey work for bats should be undertaken, to include at least three bat activity surveys of building, identified as offering “moderate suitability” in accordance with the industry standard. These surveys are required to confirm the extent and importance of existing bat roosting taking place on site. The results of this further survey effort would then seek to provide sufficient information to inform a detailed mitigation strategy in support of the proposed renovation works.

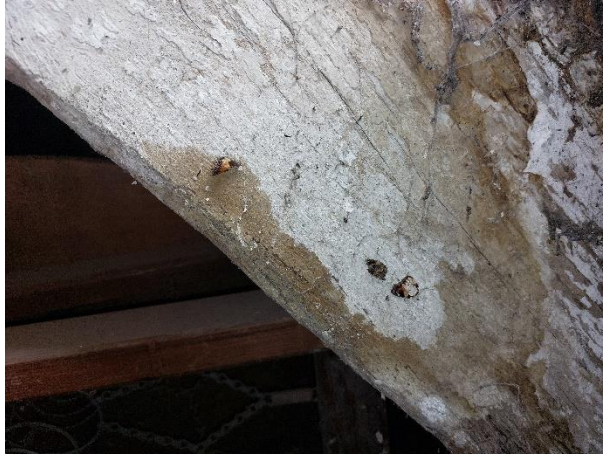
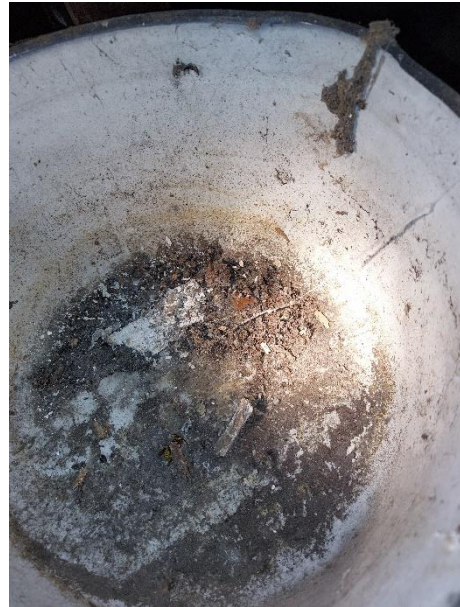
In addition to the small number of bat droppings, a number of discarded butterfly wings have been recorded. These have been caught within spider webs directly below a timber adjacent to the rooflight and within the bowl below. This evidence may be indicative of foraging bats.

*Butterfly wings*
