45 Main Street,  
Carlton,  
Market Bosworth,  
Leicestershire

**Consolidated Bat Roost Assessment  
with Mitigation Strategy**

Prepared by:  
**Griffin Ecology Ltd**

Project Number: **GE0702**

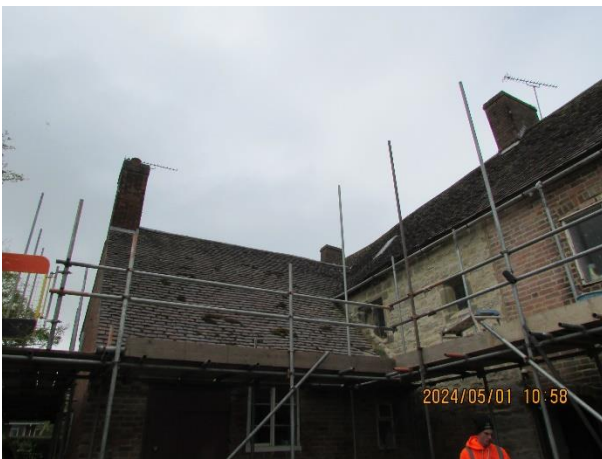
*North eastern elevation*

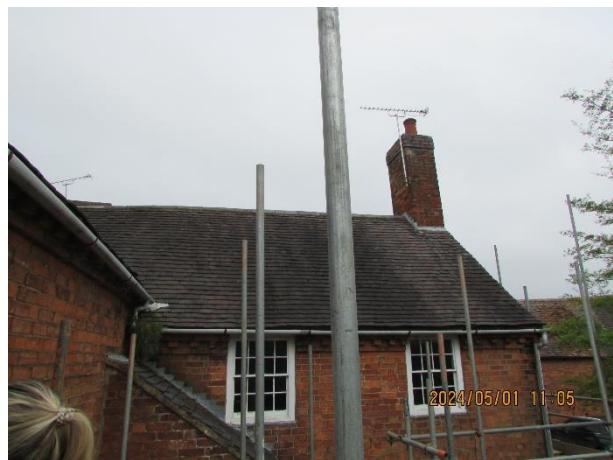
*Southern view of eastern projection from scaffolding*

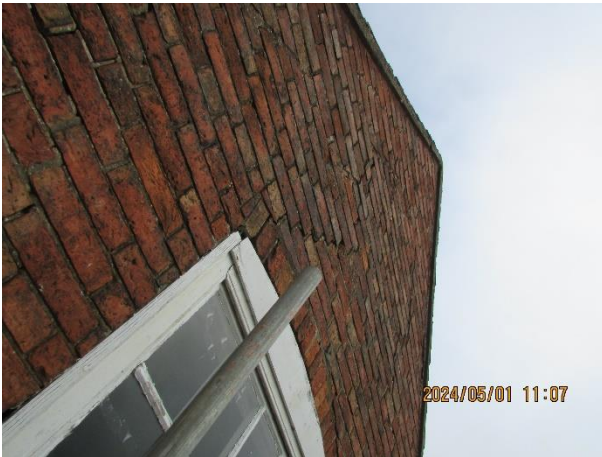
*Southern gable wall from scaffold*

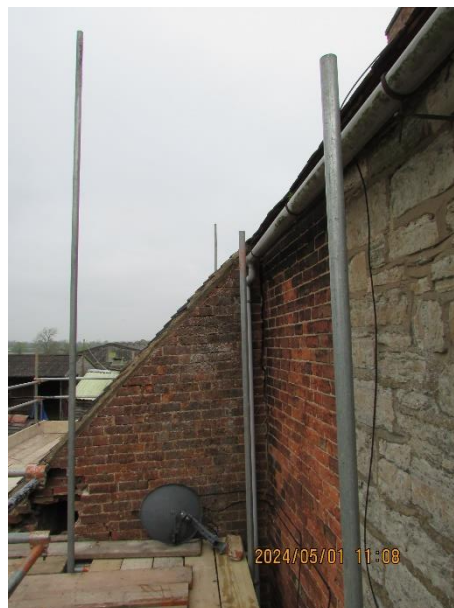
A small lean-to adjoins to the north western corner and the main roof slope extends down over the lean-to, creating a separate enclosed void above the store room below. Damage to the external wall at eaves height on this lean-to enables a view inside the enclosed void.

*Lean-to viewed from scaffold*

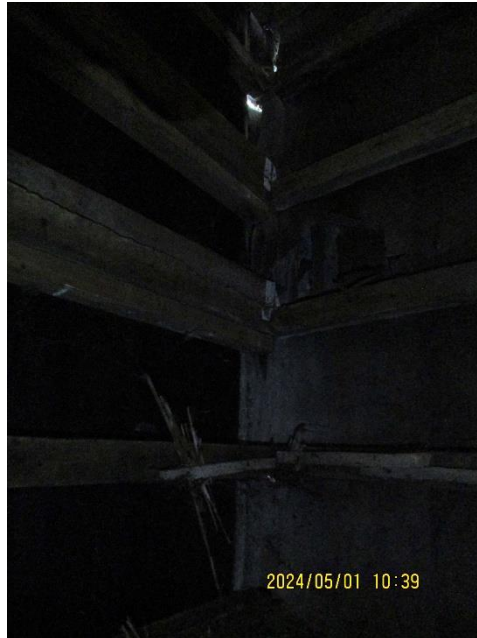
The external assessment of the house reveals ample suitable bat access opportunities within the roof finish, including missing, damaged and lifted slope and ridge tiles. The internal assessment of the roof lining also reveals corresponding damage to the felt lining below in a number of places along the ridge where daylight is visible.

*Daylight visible from within the roof space*

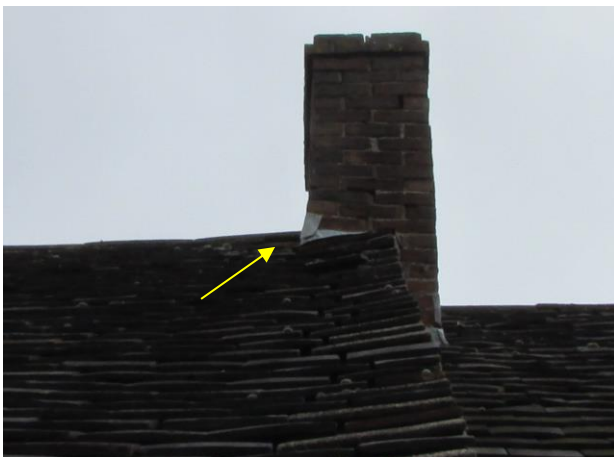
*Damaged ridge tile*

The extent of proposals include the repair of the roof finish and replacement of supporting timbers as necessary. Additionally, areas of the external wall have deteriorated and works will also include repointing and tying as appropriate.

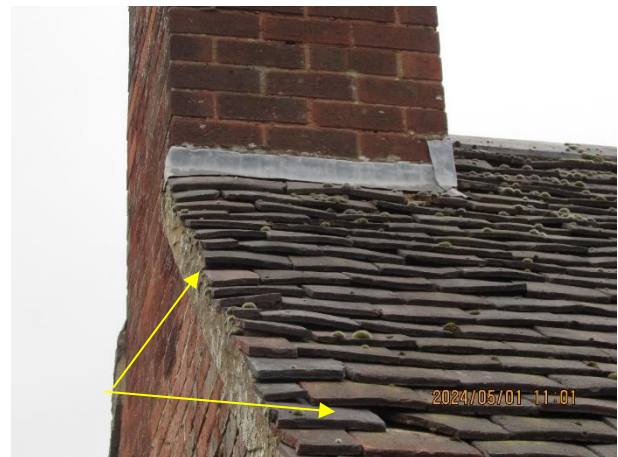
*Damaged and lifted slope tiles*

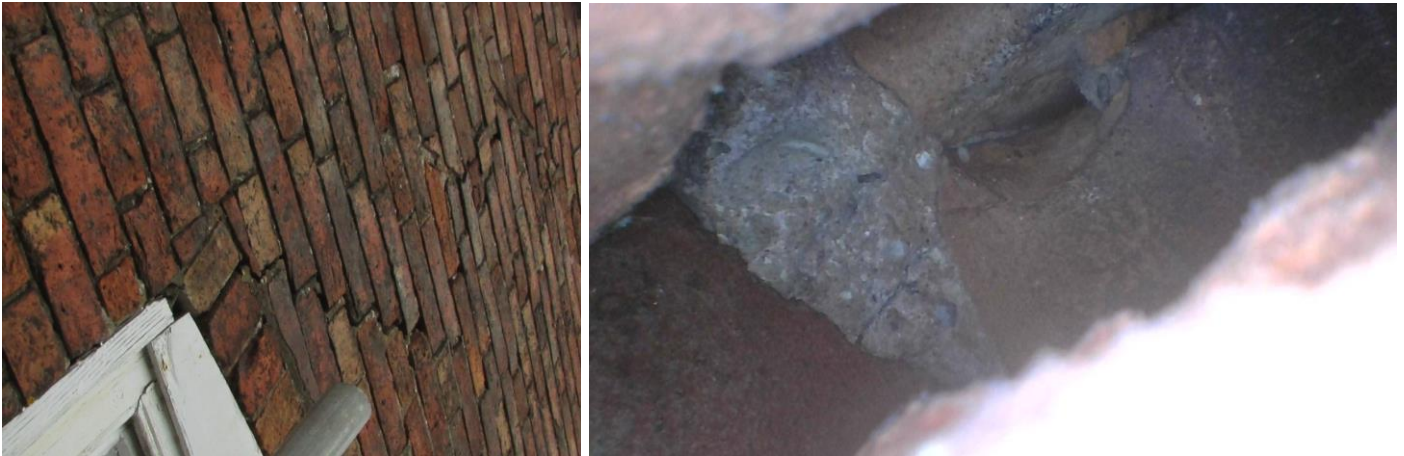
The external faces of the walls are in poor condition resulting in numerous shallow crevices. Where these crevices are more significant they relate to damage to the structural integrity of the southern gable wall. These features have been investigated with an endoscope revealing a suitable, small dry cavity at the apex of the crevice leading through the southern gable wall.

*Crevice within southern gable wall*

A common pipistrelle day roost, supporting up to 2no individuals will be directly impacted as a result of the repair and rebuild work necessary to the southern gable wall. These works do require listed building consent as they will include the reinstatement of a previously blocked up window. When retaining roosts in buildings, it is preferable to maintain entrances in their original position and of a similar size, type and orientation.

To ensure suitable replacement roosting will be permanently provided following works. Two man-made crevices, with access dimensions of (W) 15mm x (H) 100mm, will be created within the rebuilt southern gable wall. These will be at an approximate height of 3.5m from ground level and 5m from ground level. The locations of these proposed crevices will seek to replicate the existing height and orientation of known roost locations. The precise location for these crevices will be advised by the licensing ecologist on completion of the destructive search. Crevices within the solid brick walls will be created by modifying the brick to remove the rear 1/3 allowing access into a crevice behind the first course of bricks.

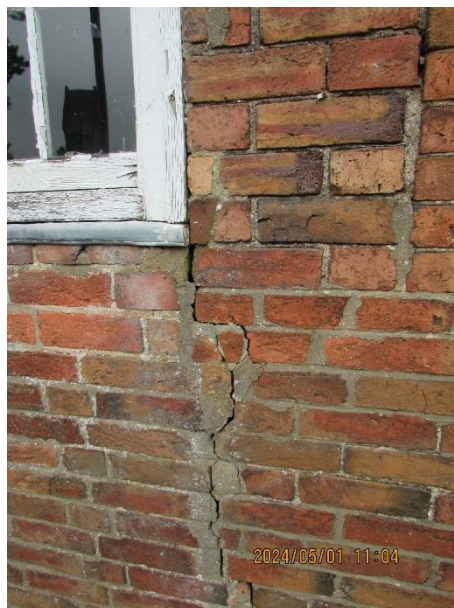
*Crevice within southern gable wall*

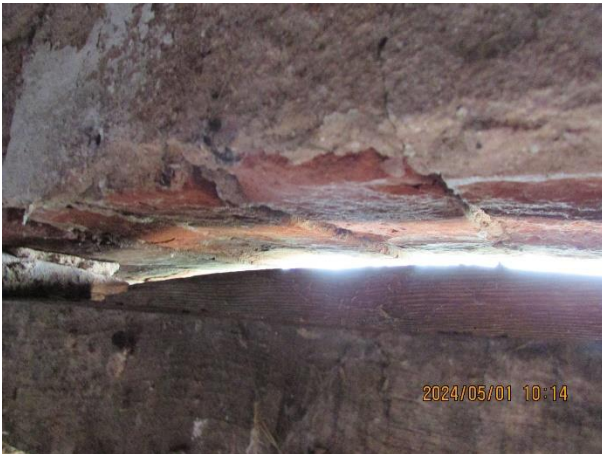
Further access points into the internal roof spaces are provided via gaps around the windows, through the open window on the northern gable and via open damage into the void above the lean-to.

*Gap above window*

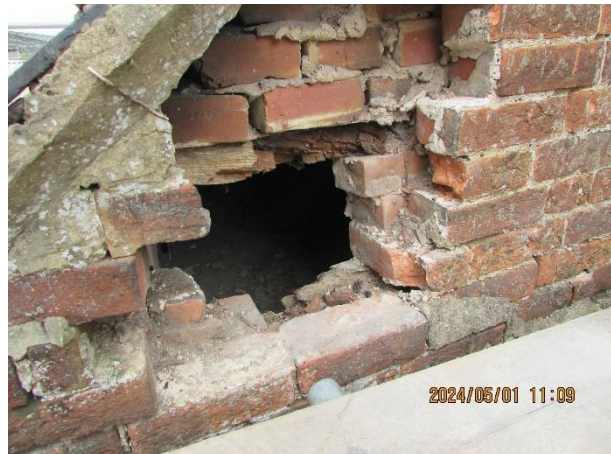
*Access into lean-to void*

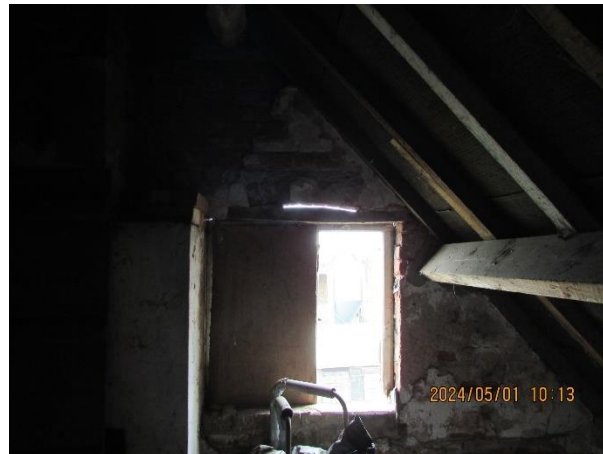
*Open window northern gable*

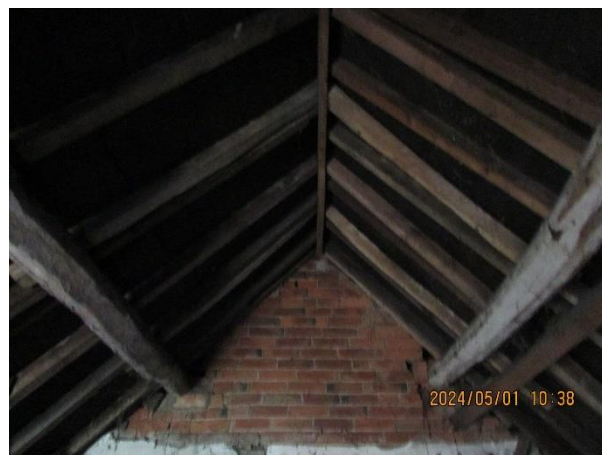
The internal inspection of the building reveals a number of potential bat roosting features within the roof space including an exposed timber ridge (with ample room provided within the roof space for social flight by species such as long-eared), timber junctions and gaps within internal brick walls, particularly where the timbers adjoin the walls.

*Exposed ridge and gaps in internal wall*

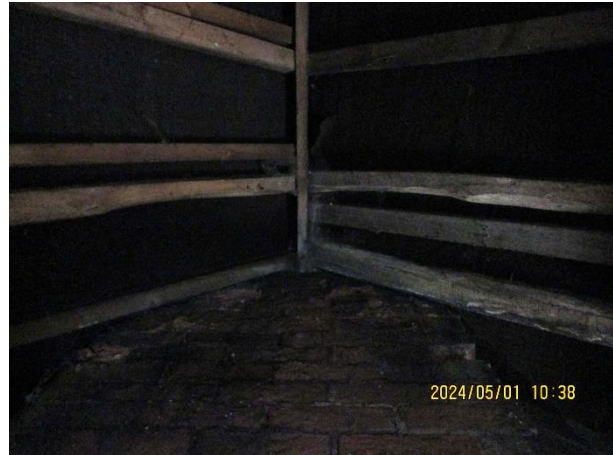
Furthermore, where access is available via damaged roof tiles, the presence of felt roof lining creates suitable crevices within which bats could roost and conceal themselves from view.

*Exposed ridge and felt lining*

The existing roof void, where droppings have been located, will be reasonably retained as part of the proposed re-roofing works. This roof space will be lined with TLX Batsafe (or similar). In this instance the use of 1f bitumen felt was not considered appropriate as the risk of creating fluctuating humidity between the two types of lining would be detrimental to the preservation of the building.

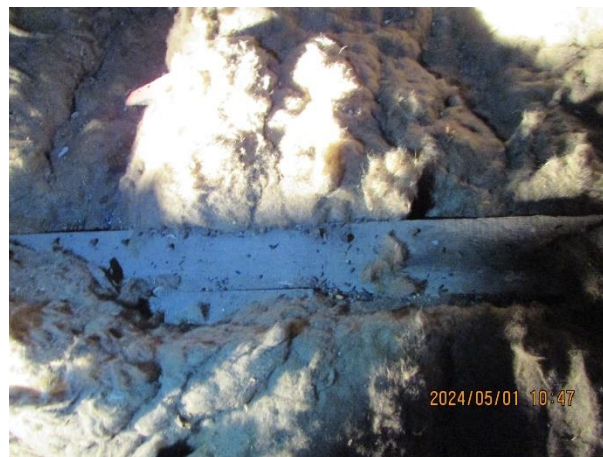
No significant accumulations of bat droppings have been recorded during the intrusive inspection of the building. However, a total of three scattered small to medium sized potential bat droppings have been noted atop the rockwool insulation within the eastern projection. These have been identified amongst ample accumulations of mouse droppings.

*Bat dropping identified amongst  
mouse droppings*

A sample of the droppings observed have been subject to DNA analysis which has confirmed the presence of brown long-eared DNA. Detailed results of this are included within appendix 1.

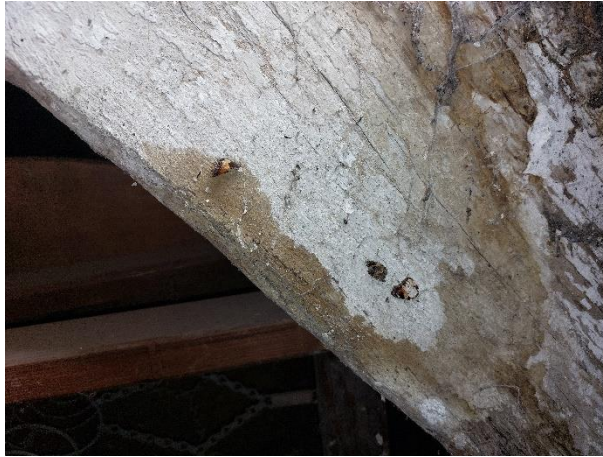
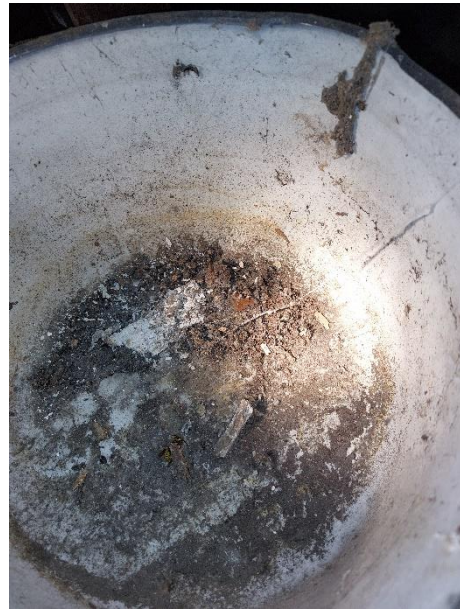
In addition to the small number of bat droppings, a number of discarded butterfly wings have been recorded. These have been caught within spider webs directly below a timber adjacent to the rooflight and within the bowl below. This evidence may be indicative of foraging bats.

*Butterfly wings*

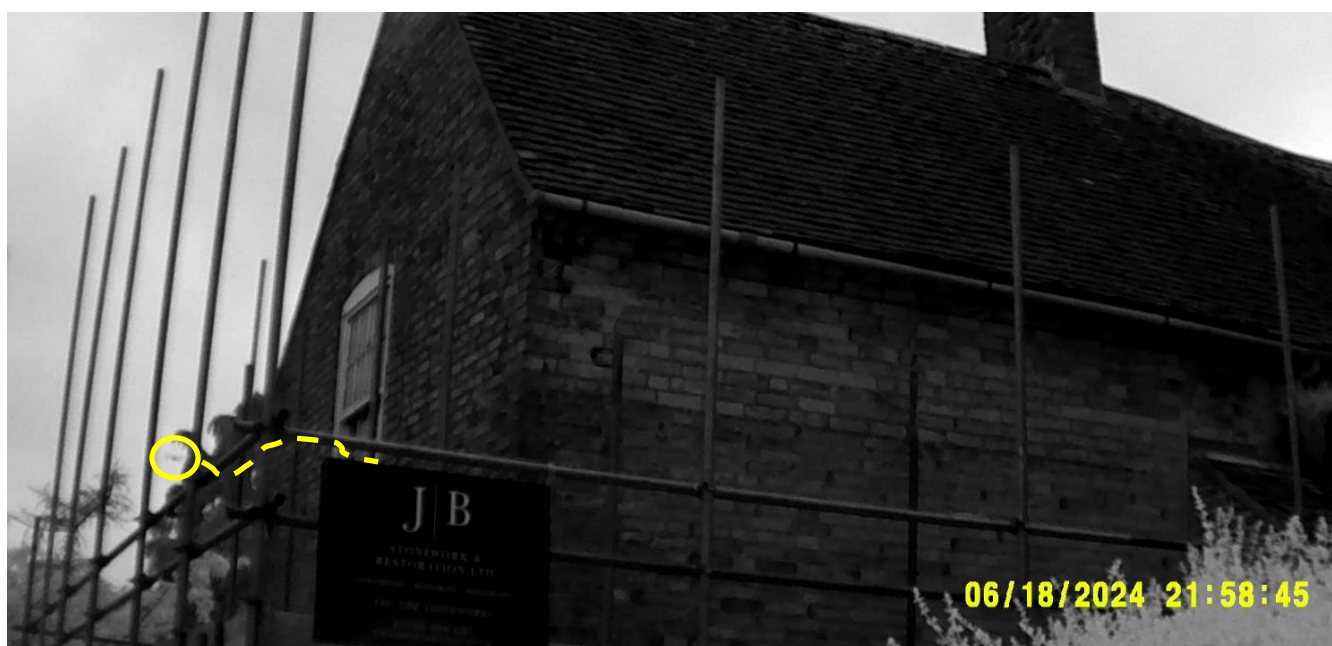
At 21:58, single common pipistrelle is recorded to emerge from near the window on the southern gable wall. This observed activity was recorded on the supporting IR camera with a snip of the footage provided below:

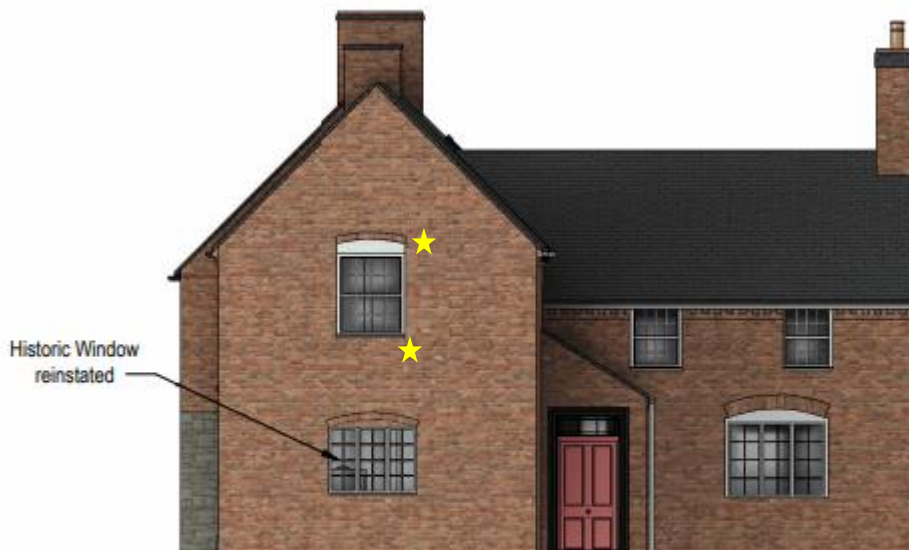
**Elevation View**

Figure 5 seeks to illustrate the access detail of replacement common pipistrelle roosts.

★ 2 No. mortar gaps of 15mm (w) x 100mm (h) to be created in rebuilt wall to allow access for crevice dwelling bats, in accordance with Ecologist's recommendations (see Griffin Ecology report ref: GE0702, page 26)
