**Re: Barton Road, Barlestone – Infiltration Testing to Assist with Soakaway Design**

Erda Associates Ltd. were requested by MyPad 2020 Ltd. (hereafter referred to as the client) to undertake infiltration testing to assist with the design of a proposed permeable driveway for a proposed residential development at the site known as *Barton Road, Barlestone*. The site currently comprises an agricultural field. Site location and boundary plans are included in **Appendix A**.

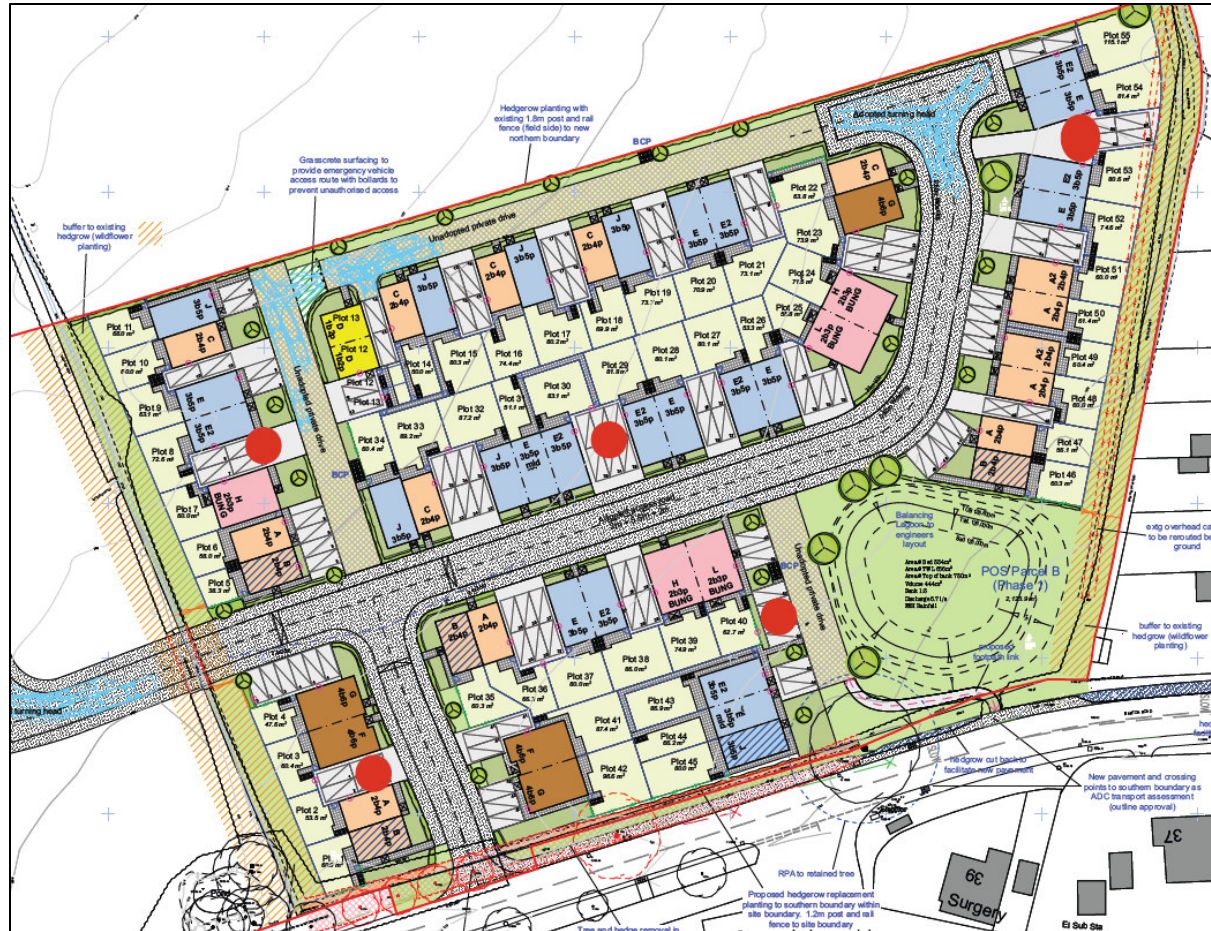
Figure 3

# Development Proposal

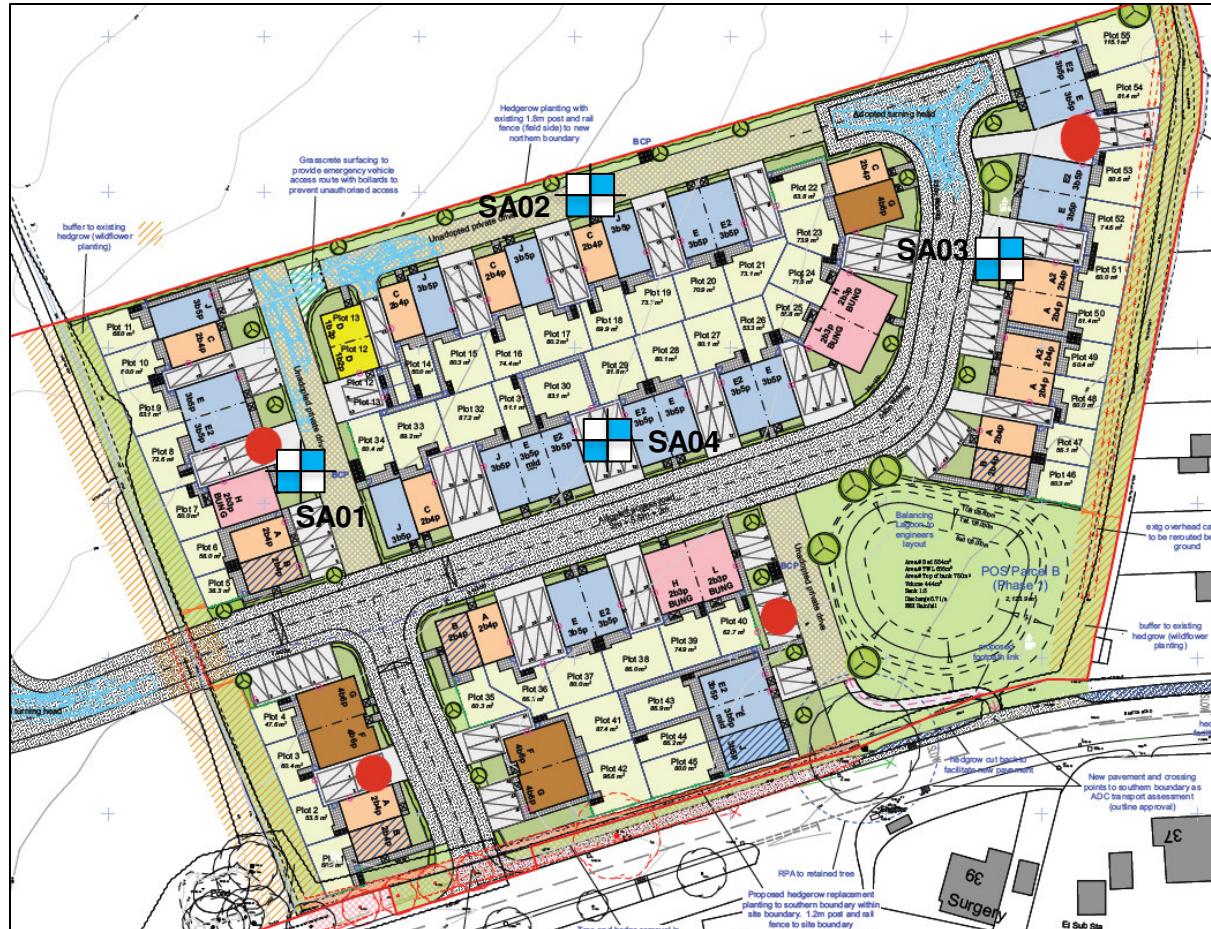
Figure 5

Four soakaway test pits (SA01-04) were excavated in areas specified by the client for potential future soakaway drainage. An exploratory hole location plan is enclosed in **Appendix A**. The excavations were limited to a maximum depth of 0.50m as specified by the client.

Approximate Shallow Soakaway  
Test Pit Location

Exploratory Hole Location Plan
