## Phase I Geo-Environmental Risk Assessment

Proposed Care Home, Land off Leicester Road,  
Markfield

November 2023

Reference: 230422.R.002

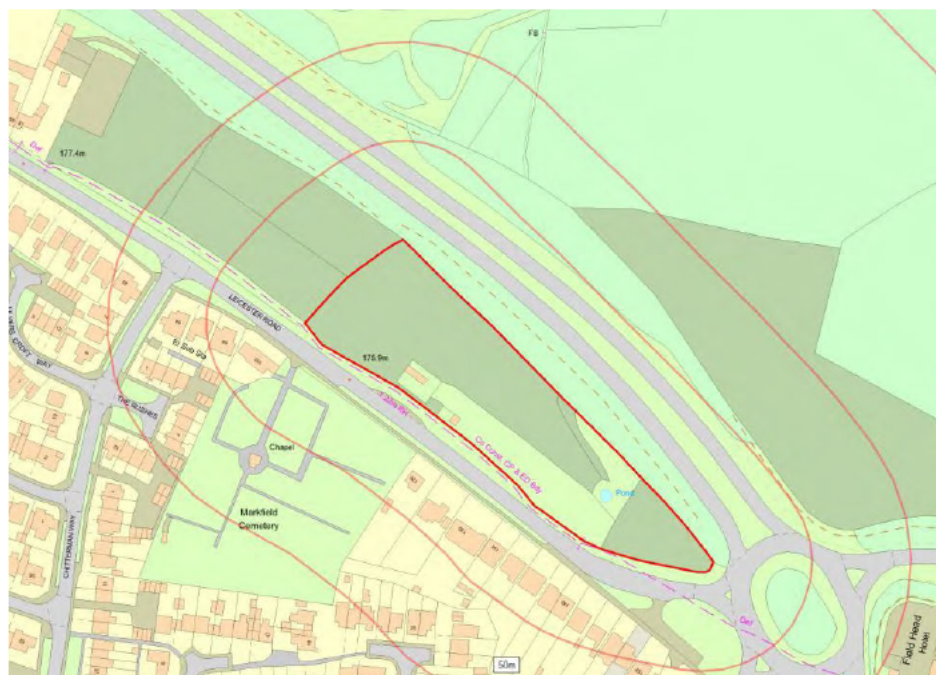
Figure 2: Site Layout Plan (emboldened site boundary indicative only)

The subject site is located off Leicester Road, bound by the A50 immediately to the north and associated roundabout to the east. The site is situated approximately 11 km to the north-west of Leicester city centre, and 1.50 km south-east of junction 22 of the M1. A site location plan is presented below as Figure 1, and a Site Layout Plan is presented as Figure 2.
