# Preliminary Roost Assessment

62 Princess Road, Hinckley LE10 1EB

This report is prepared to inform a planning application with Hinckley and Bosworth Borough Council. This proposal can be described as "Demolition of the existing detached garage and erection of a two-storey side extension."

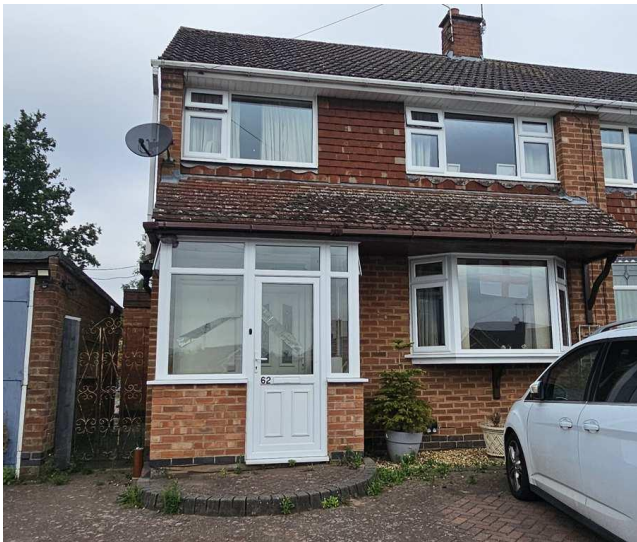
Building B1

The building is a residential dwelling with brick walls, and a concrete pan tile pitched roof. Hanging tiles are present on the front elevation. The key roosting features identified, included gaps between hanging tiles, lifted lead flashing around the chimney, and a gap between a barge board and the wall on the flat roof section, all offering potential crevice roosting opportunities for bats. The roof void presented further suitability at the ridge beam convergence points. A gap was present between the chimney and roof, at the north of the void which offered bat access into the loft void. The building has moderate habitat value.

Two bat emergence/re-entry surveys are required on building B1 during the active bat season (May – September) to confirm presence/likely-absence of bats roosting in or on the building.

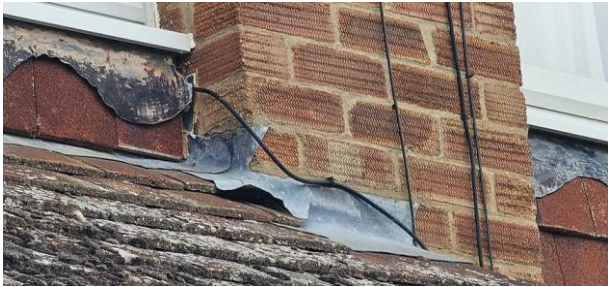
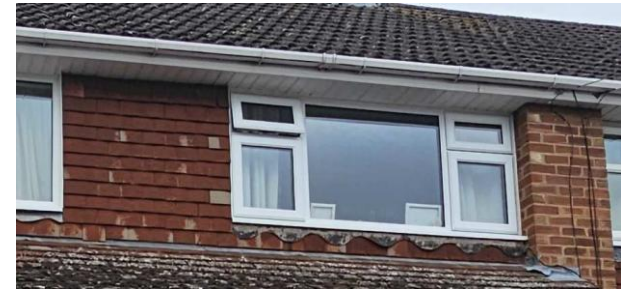
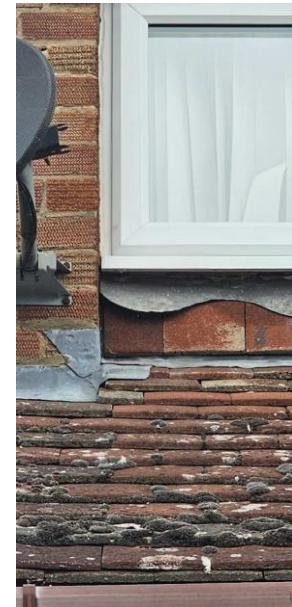
B1 walls

| Feature | Materials/Details | Condition / description / suitability | Photograph |
|---|---|---|---|
| Walls | Brick and Clay hanging tiles | <b>Condition/description</b><br>The walls are in fair to poor condition with most features being attributed to the hanging tiles and lead flashing. These features include a small number of gaps between hanging tiles and lifted lead flashing. | <br>B1 walls |

**Suitability/access/evidence of bats**

The hanging tile and lifted lead flashing offered suitable habitat for crevice dwelling bats.

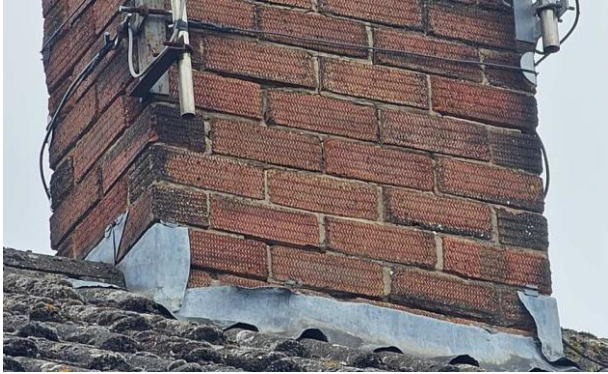
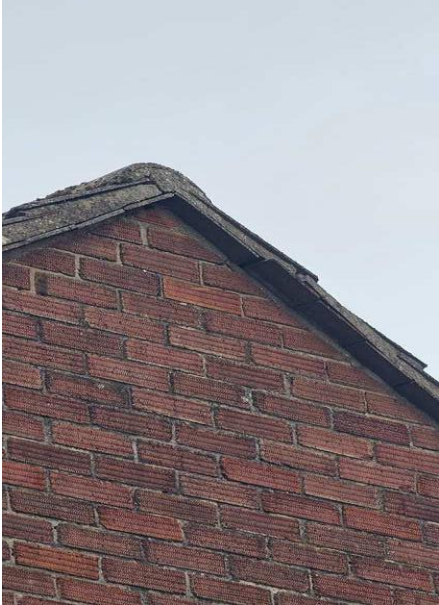
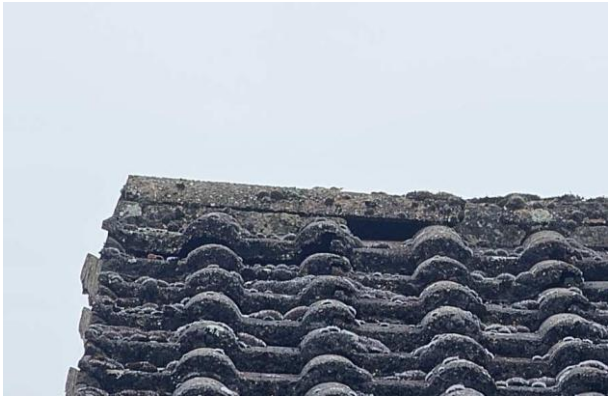
| Roof | Concrete pan tiles | <p><b>Condition/description</b></p> <p>The roof is in fair to poor condition with localised missing mortar and lifted lead flashing.</p> <p><b>Suitability/access/evidence of bats</b></p> <p>The roof is considered to provide moderate suitability for roosting bats. Potential roost features include lifted lead flashing around the chimney and localised gaps associated with the mortar which could provide access into the roof void.</p> | <div><p>B1 roof</p></div> <div><p>B1 roof</p></div> |

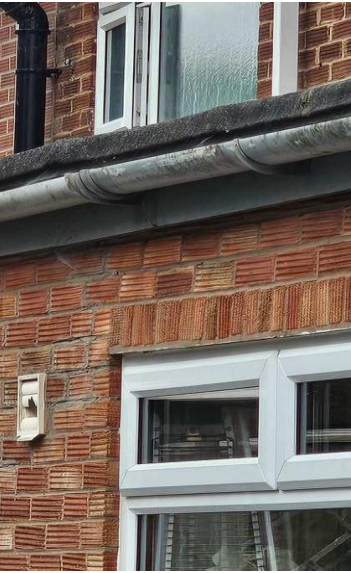
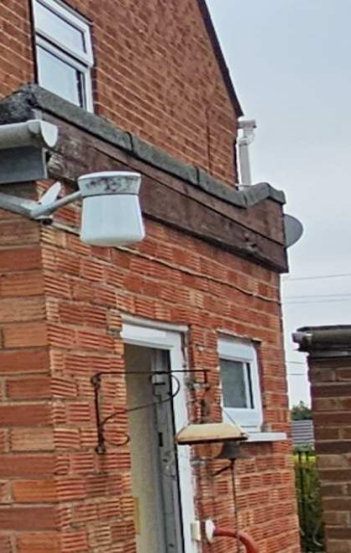
| Barge boards | Timber | <p><b>Condition/description</b><br/>A gap between the barge board and the wall was present at the flat roof section, along the southern elevation.</p> <p><b>Suitability/access/evidence of bats</b><br/>The gap between the barge board and the wall provides suitable roosting habitat to crevice dwelling bats.</p> | <p><i>B1 barge boards / fascia boards</i></p> |

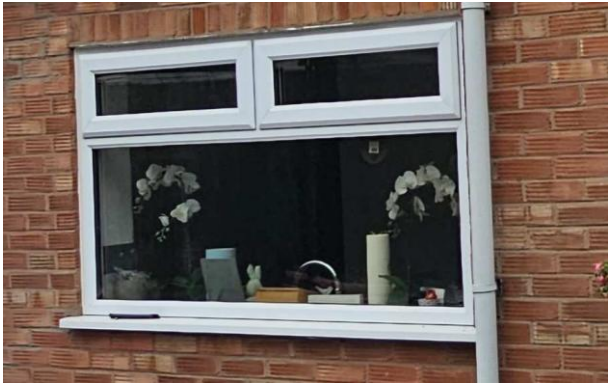
| Windows | uPVC | <p><b>Condition/description</b></p> <p>The windows were in good condition with no gaps present.</p> <p><b>Suitability/access/evidence of bats</b></p> <p>N/A</p> | <p><i>B1 window / doors frames and lintels</i></p> |

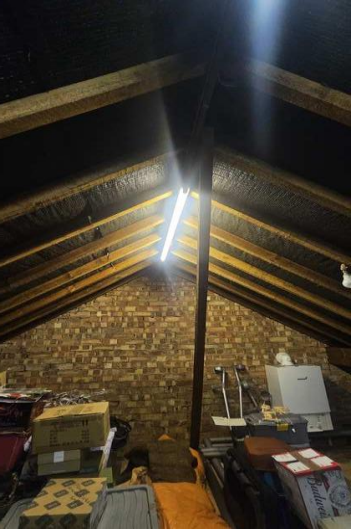
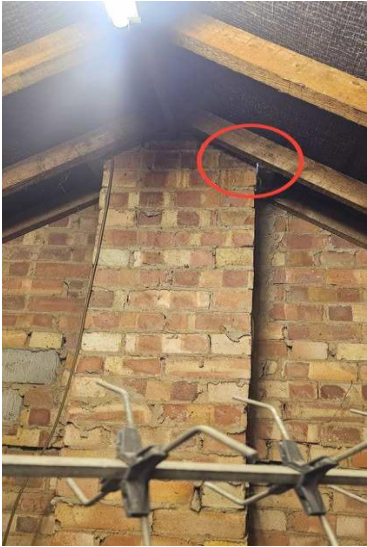
| <p>Internal void 1</p> | <p>Timber rafters.<br/>Bitumen felt lining</p> | <p><b>Condition/description</b></p> <p>The materials of the roof, including the felt and timber rafters appeared to be in good condition. A gap between the chimney and roof was present at the east of the void. Dimensions (approx): 5m in length, 7m in width and 3m in height</p> <p><b>Suitability/access/evidence of bats</b></p> <p>The gap between the chimney and roof provided suitable bat access into the loft void. Further suitable roosting features included at the ridge beam convergence points.</p> | <p><i>B1 internal void 1</i></p> <p><i>A gap between the roof and the chimney.</i></p> |

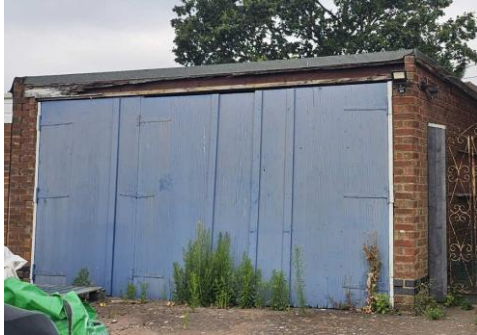
Building B2 is a brick-built garage with a flat roof lined with bitumen felt. The garage was in fairly poor condition with the internal timber roof rotting and frequent gaps present between the wall and roof. Although these features may provide bat access into the structure, the large amount of light ingress and weather ingress create unsuitable conditions for roosting bats. Therefore, the building is assessed to provide negligible suitability for roosting bats.

*East elevation of B2*

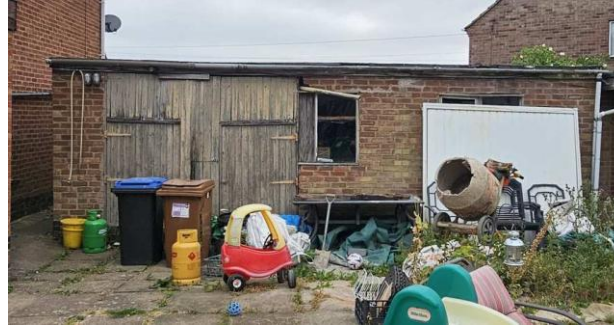
*West elevation of B2*

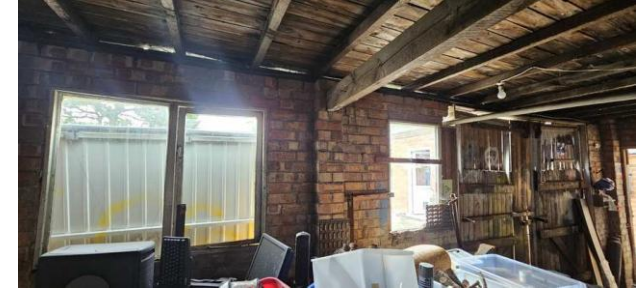
*Interior of building B2*
