## Proposed Residential Development at Land South of Bosworth Academy Desford Leicester

## Phase I Desk Study Report

R-DS-30402-01-01

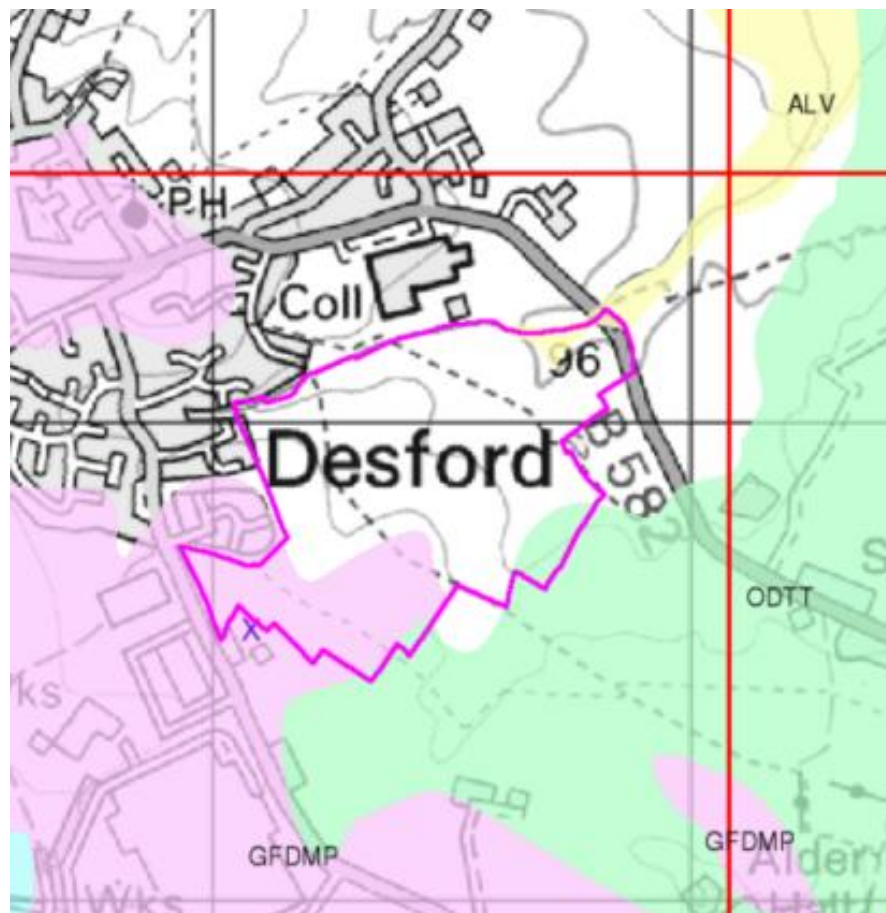
| 3.2.3 | BGS mapping records no superficial deposits in Area 1 except for a thin ribbon of alluvium in the north east associated with a watercourse and a small area to the south where the Oadby Member (Glacial Till) is mapped. In Area 2 there are no superficial deposits in the northern half, in the central and southern parts of Area 2 there are superficial deposits mapped as Glaciofluvial Deposits (Sand and Gravel), with the Oadby Member (Glacial Till) mapped directly south. In Area 3 there are no superficial deposits in the northern half, in the central and southern parts of Area 3 there are superficial deposits mapped as Glaciofluvial Deposits (Sand and Gravel). |

**Figure 3.2a: Superficial Geology extract from Envirocheck Report**  
**Key: Yellow = Alluvium, Pink = Glaciofluvial Deposits and Green = Oadby Member.**

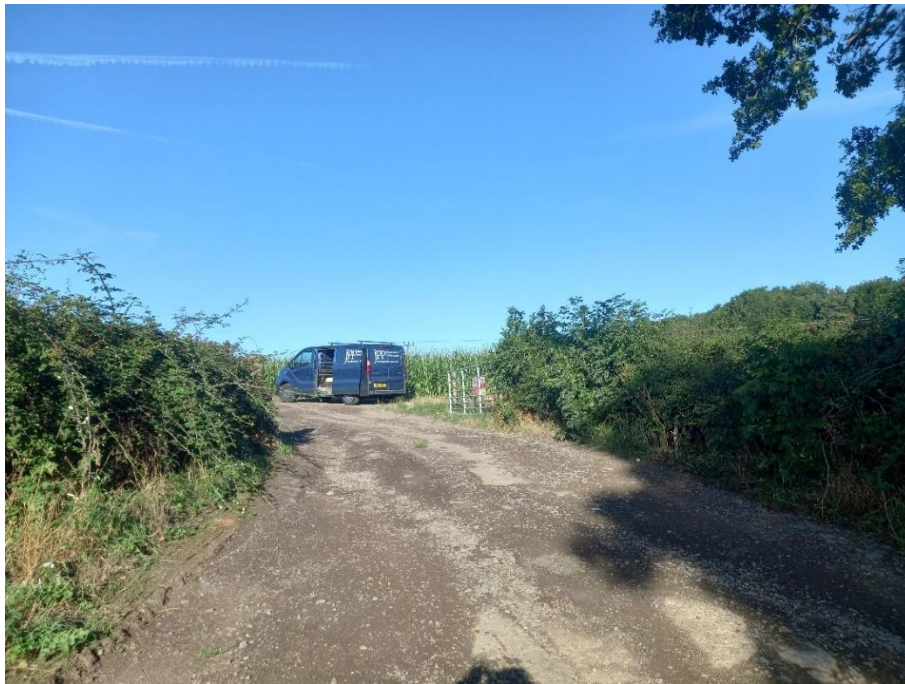
**Photograph 5.1** View of the eastern gate entrance off Leicester Lane looking west into the field (Area 1).

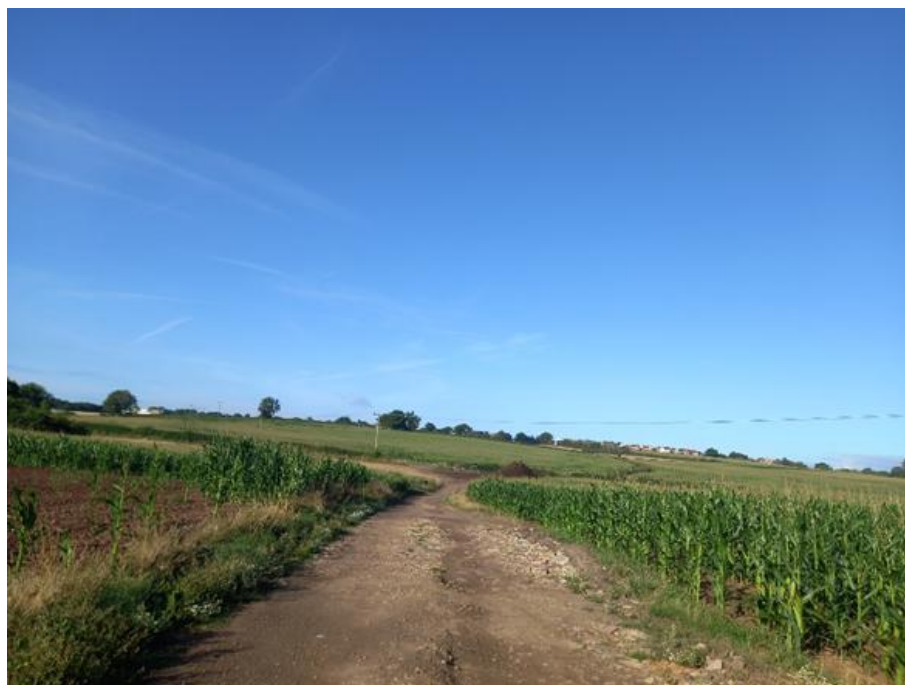
**Photograph 5.2** View off the access road within Area 1, looking west, with crops either side and pylons with overhead cabling in fields beyond.

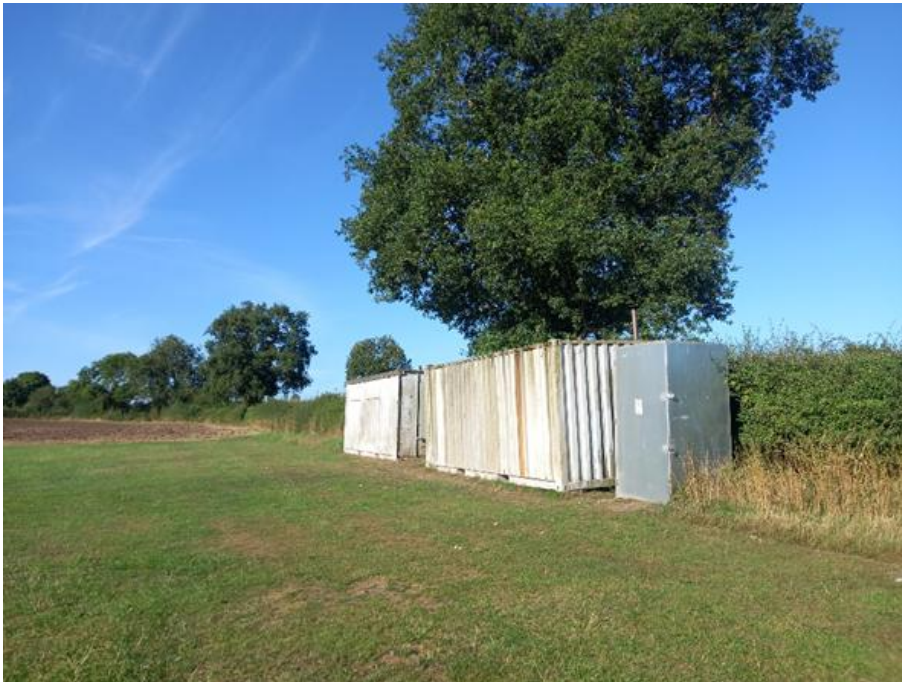
**Photograph 5.3** View of temporary buildings including a building labelled 'toilet' in the south east field of Area 1.

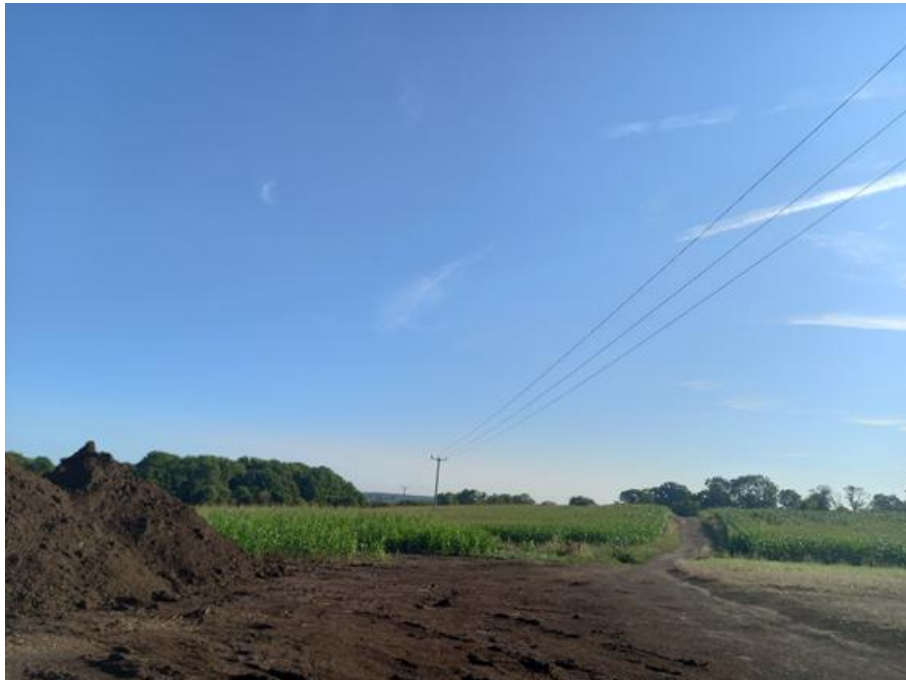
**Photograph 5.4** View centrally within Area 1, looking north east, showing overhead cabling with pylons and manure pile.

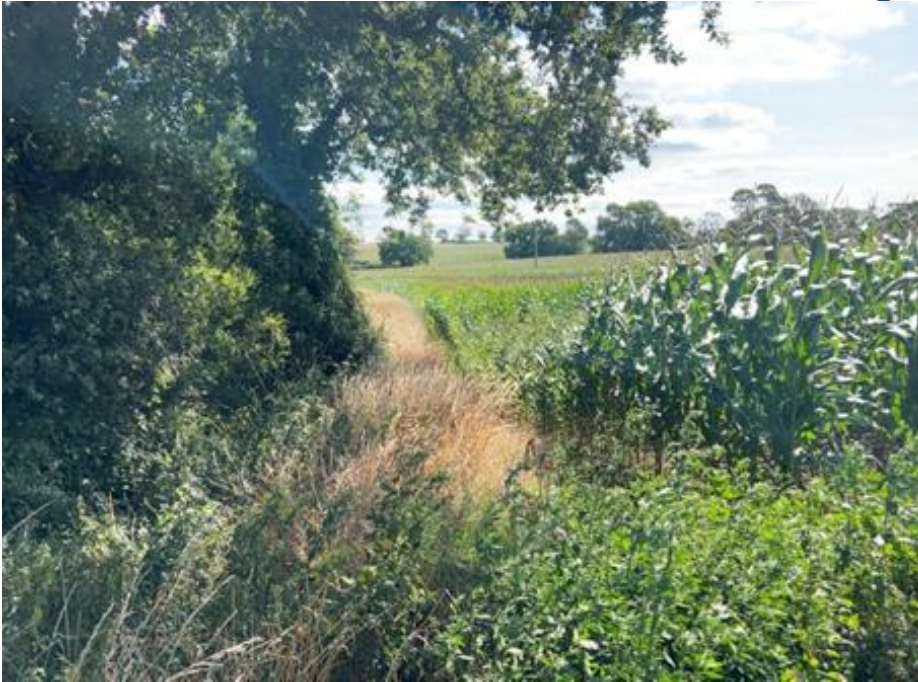
**Photograph 5.5** View of the north east corner of the Area 2, looking east.

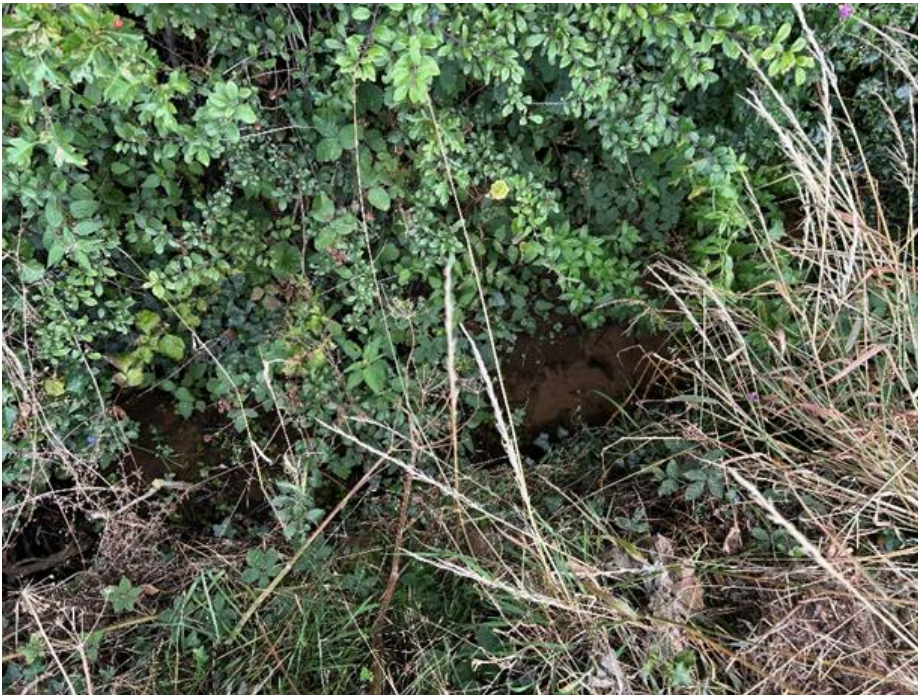
- 4.2.2 Multiple drainage ditches were noted throughout the site, some of which with standing water and some were observed to be empty. A stream with water flowing was observed within the southern part of Area 1, flowing to the northeast and a stream was also observed along the northern site boundary.

**Photograph 5.6** View of water flowing within a stream along the southern boundary of Area 1.
