# ARBORICULTURAL METHOD STATEMENT

The Old Rectory,  
Market Bosworth

1535-AMS-V1-A

Witherslack Group

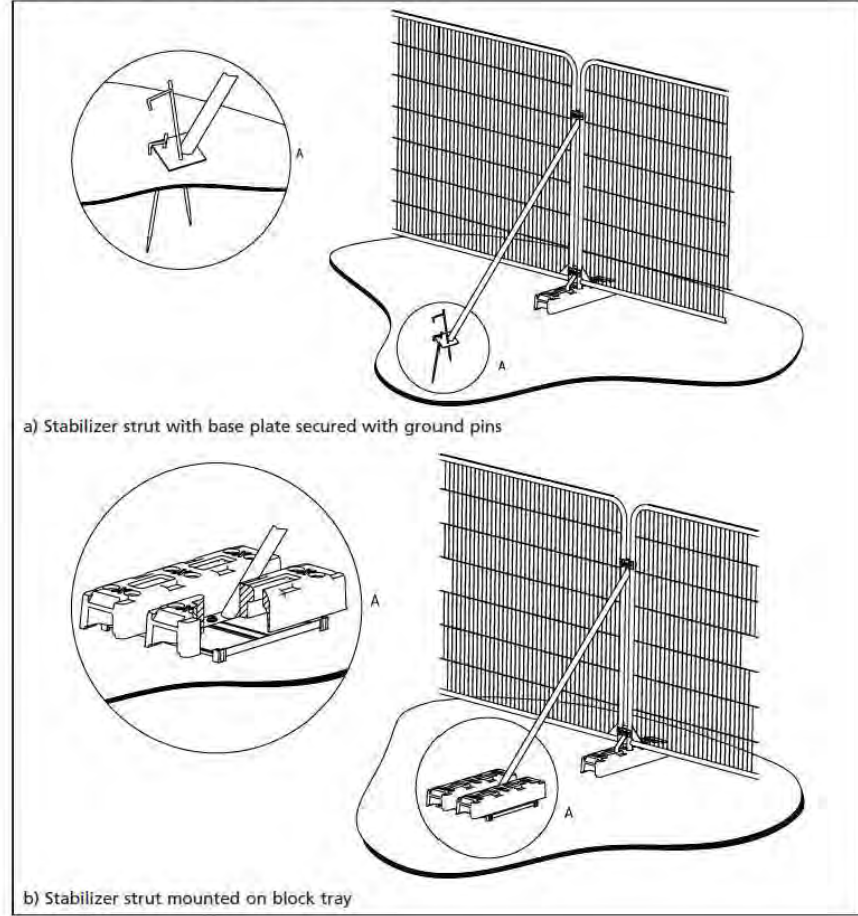
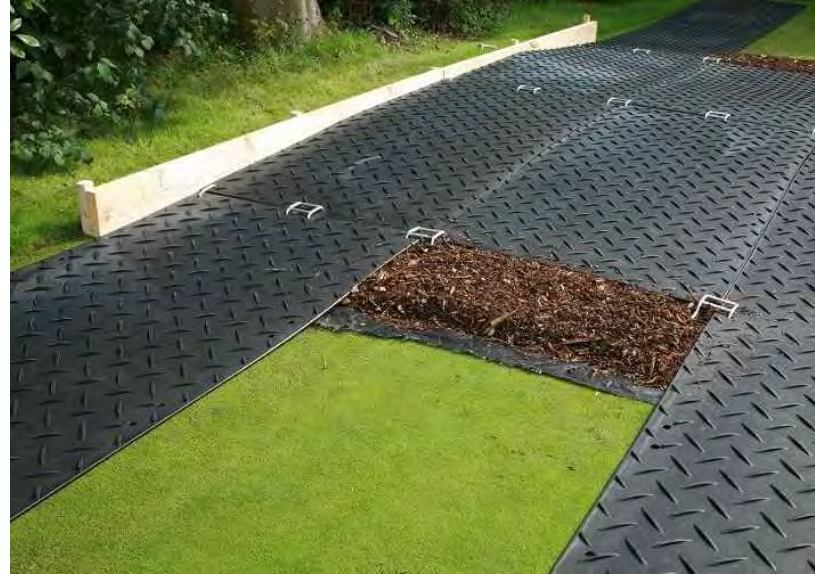
### Tree Protection Fencing - BS5837:2012 Figure 3

Prior to any on-site demolition or construction, tree protective measures and the CEZ must be in place. TPF Specification is show in Figure 3 (BS5837:2012) - pictured above.

Figure 3 Examples of above-ground stabilizing systems

- 5.1.5. The TPF specification should consist of a vertical and horizontal scaffold framework, well braced to resist impacts, as illustrated in BS5836:2012 Figure 3 (attached at **Appendix 2**). The vertical 2m tall, welded mesh panels on rubber or concrete feet, the panels should be joined using a minimum of two anti-tamper couplers, installed so that they can only be removed from within the fence. The distance between fence couplers should be at least 1m and should be uniform throughout the fence. The panels should be supported on the inner side by stabilizer struts, which should be attached to a base plate secured with ground pins.

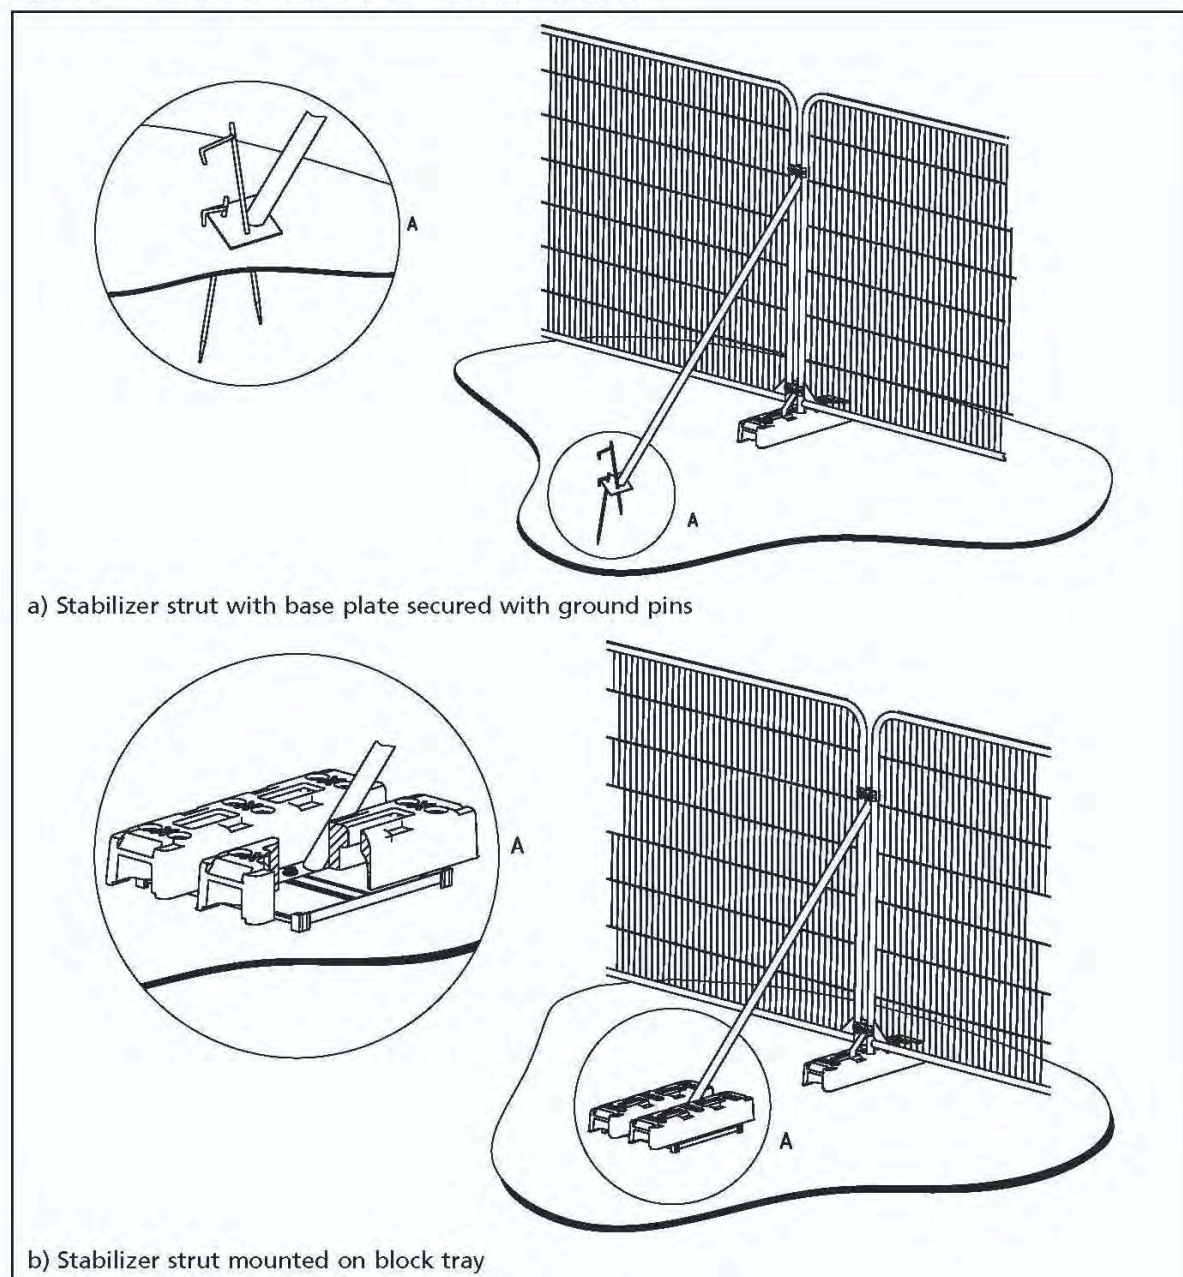
### BS5837:2012 – Figure 3

Figure 3 Examples of above-ground stabilizing systems

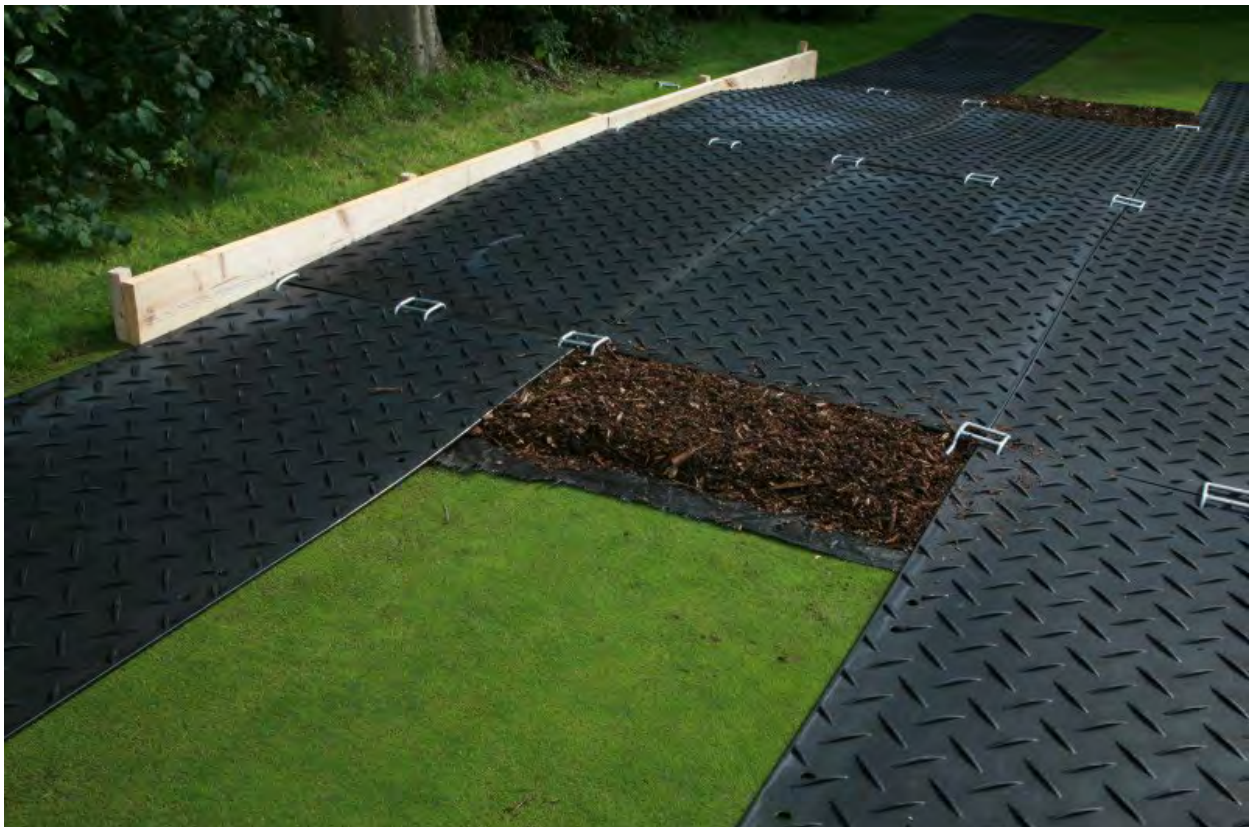
*Image 1 – Ground-Guards temporary tree root protection - example*

- 5.1.14. The ground protection might comprise one of the following:
- a) For pedestrian movements only, a single thickness of scaffold boards placed either on top of a driven scaffold frame, so as to form a suspended walkway, or on top of a compression-resistant layer (e.g. 100 mm depth of woodchip), laid onto a geotextile membrane;

- 5.1.15. For pedestrian-operated plant up to a gross weight of 2t, proprietary, inter-linked ground protection boards placed on top of a compression-resistant layer (e.g. 150 mm depth of woodchip), laid onto a geotextile membrane.

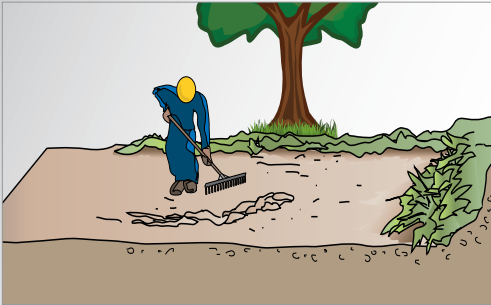
- 1 Prepare subgrade. Remove debris, rocks.

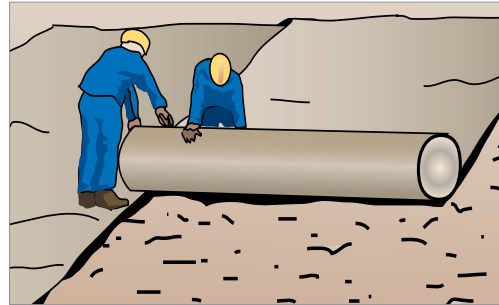
- 2 Install TRP4000 geotextile. Overlaps by minimum 300 mm.

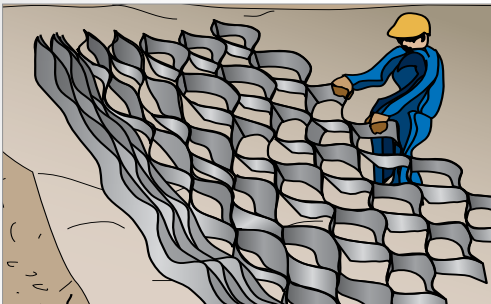
- 3 Partially expand GEOWEB® sections.

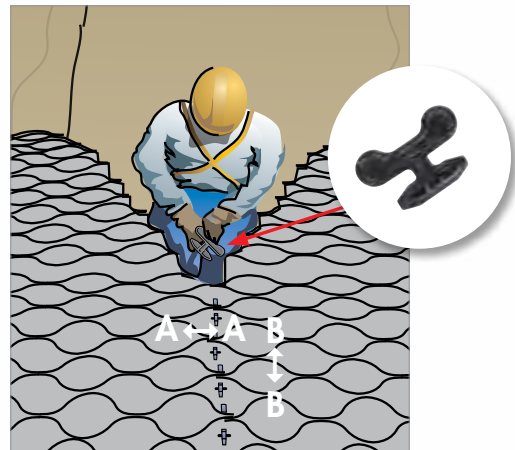
- 4 Connect GEOWEB® sections with ATRA® keys.

- 5 Connect side to side (A) and end to end (B).

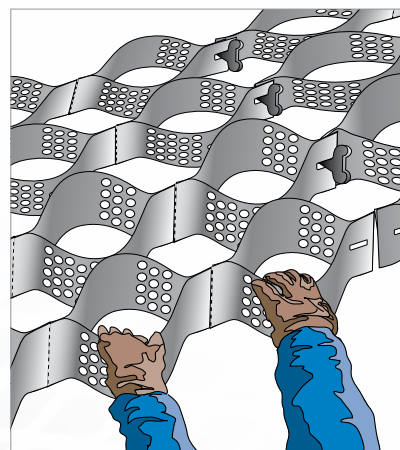
- 6 Fully expand GEOWEB® sections.

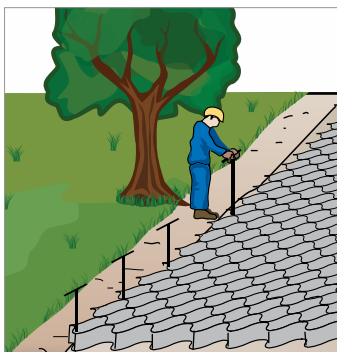
**A** T-Bars

- 7** Hold sections open. Use Options A, B, C or D.

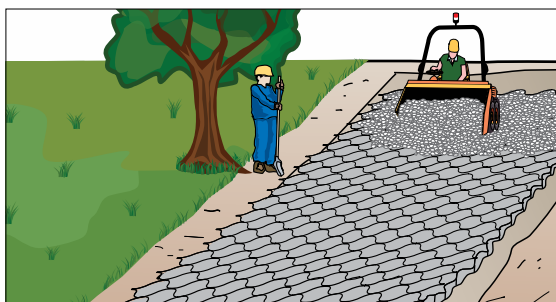
- 8** Infill GEOWEB® cells.

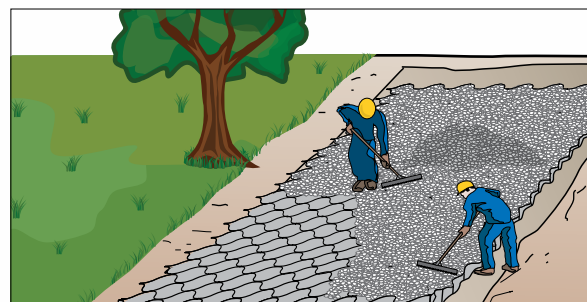
- 9** Spread Infill ensuring a 25 mm overfill at all times.

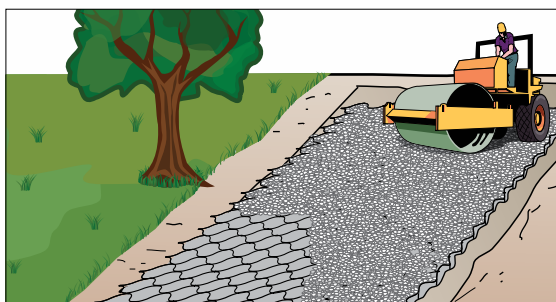
- 10** If required, use a 4t smooth, non-vibrating roller on overfilled GEOWEB® system. Refill as needed to ensure a 25 mm overfill.

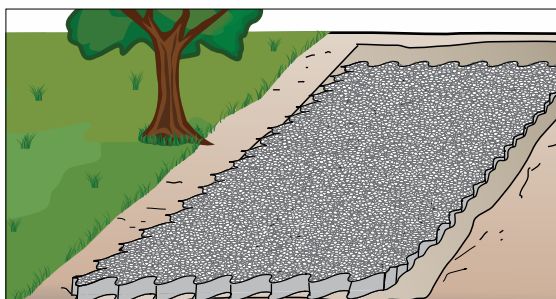
- 11** Surface option ready to install according to specification.
