# Technical Note – Biodiversity Net Gain Exemption Statement

Midlands Distribution Centre, Markfield Road, Groby,  
LE6 0FS

ATC Design and Build Ltd

September 2025

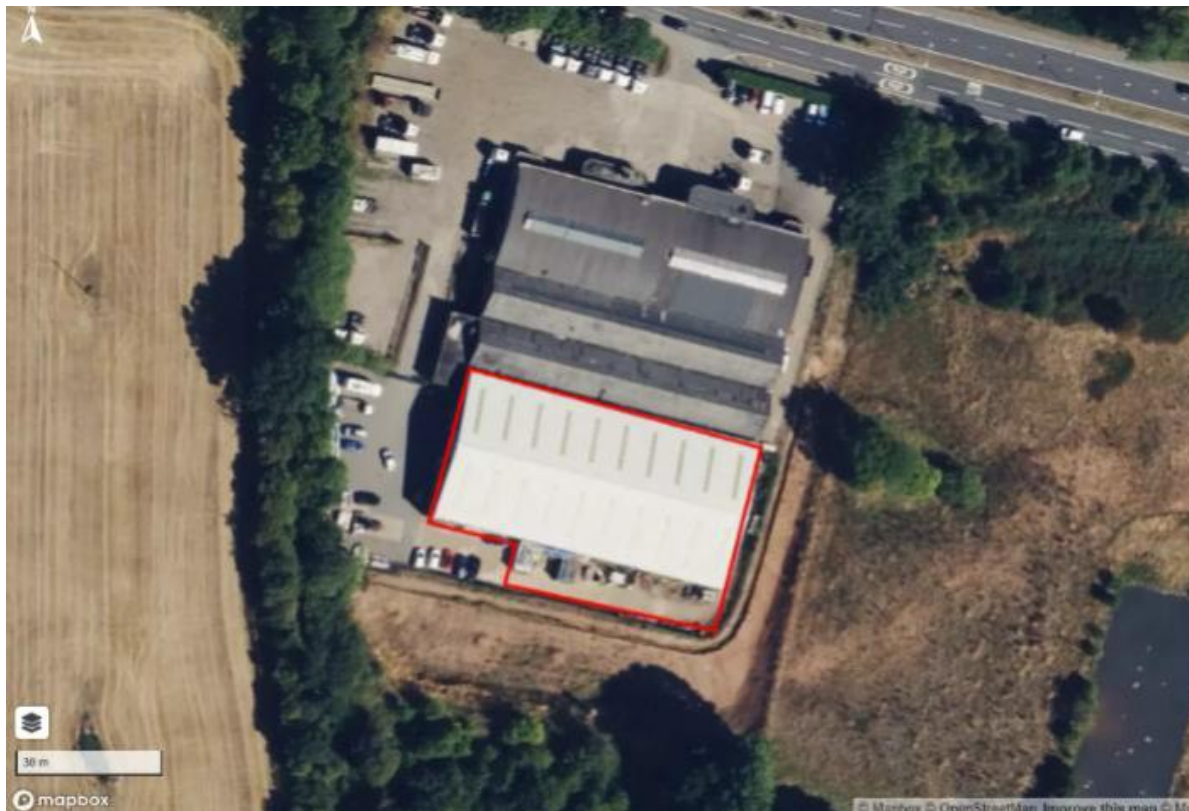
*Figure 1. Site Location Plan (as demarcated by red line boundary)*

Aval Consulting Group Limited (ACGL) was commissioned by ATC Design and Build Ltd to provide the necessary supporting information on Biodiversity Net Gain for a forthcoming planning permission in relation to the proposed extension of the existing Westernmans building. The land edged red in Figure 1 is hereafter referred to as 'the Site'. This report was based on the proposed Site plans as detailed in Figure 2 below.

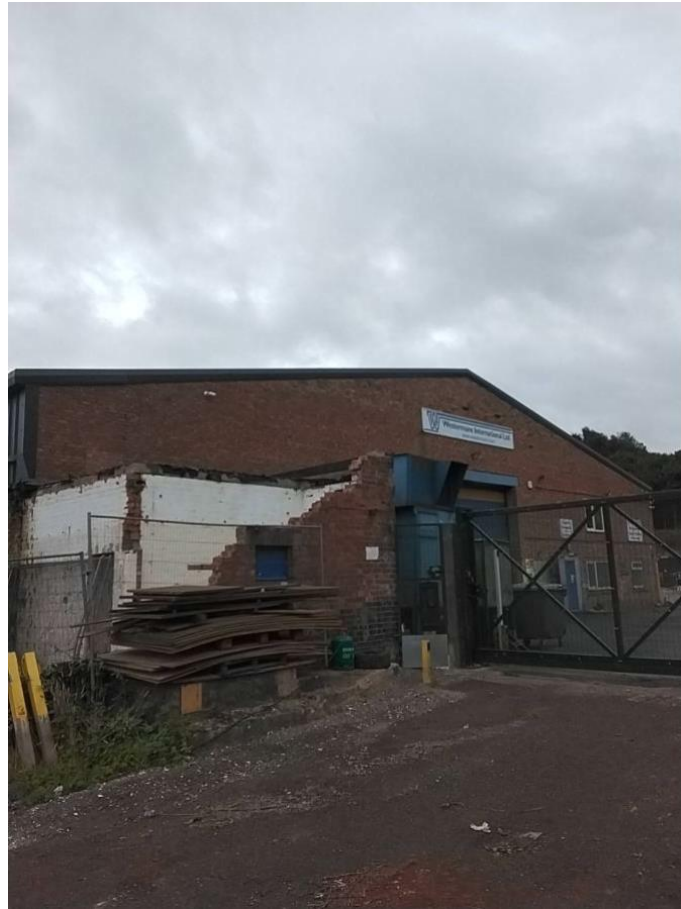
The habitats present within the red line boundary of the Site consisted of artificial unvegetated, unsealed surface. The building on Site was located at the north of the Site and comprised a large warehouse with single skin brick walls and a roof of profiled metal sheets with skylights (Figure 3). A small area of artificial unvegetated unsealed surface, was located at the south, currently used for loading with containers and machinery present (Figure 4) This area comprised of packed stone and gravel with no flora colonising this area. The boundary fence forming the southern boundary of the site was a newly installed metal fence.

*Figure 3. Main building at the Site (Northwest elevation)*

Consequently, the biodiversity gain condition is not considered to apply in this instance, although enhancement of the Site through the addition of a suitable bird or bat box(es) on a pole of suitably mature tree at the Site could provide a welcome enhancement in line with the National Planning Policy Framework.

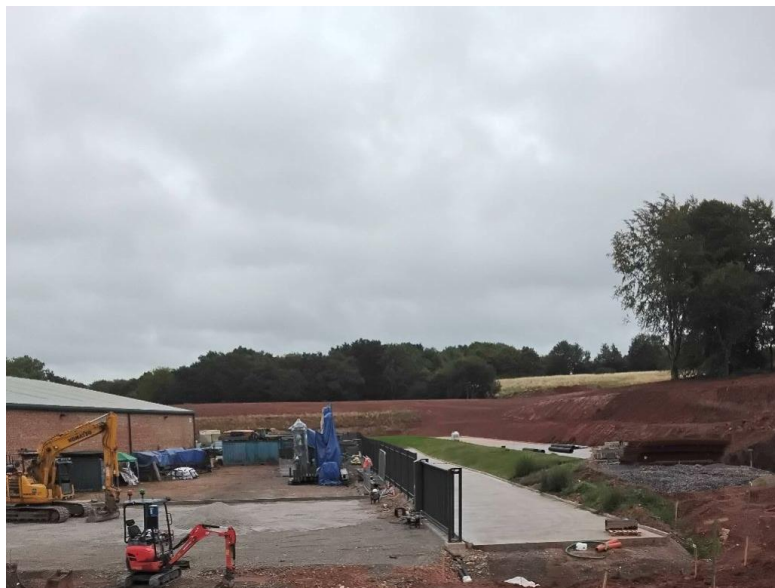
Vegetation cover was less than 10% of the area of the surface.

*Figure 4. Unsealed surface at the south of the Site, with southern elevation of the existing building to the left of shot*
