31 Newbold Road, Kirkby Mallory

Preliminary Bat Roost Assessment  
and Nocturnal Bat Surveys

RSE\_8536\_R1\_V1\_PBRA

November 2024

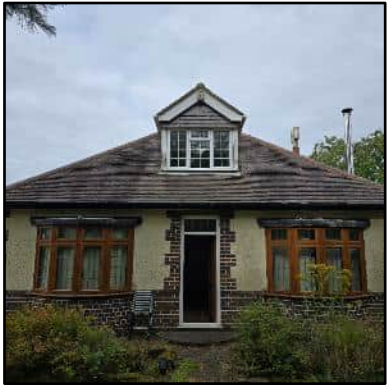
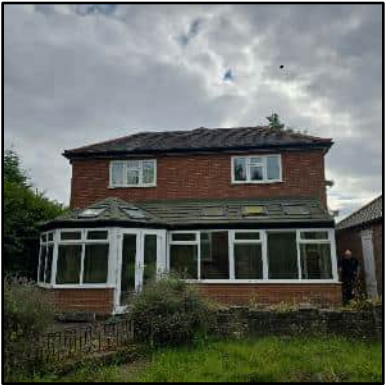
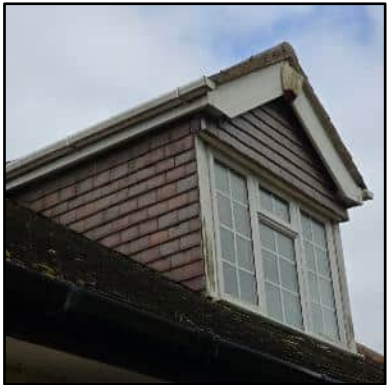
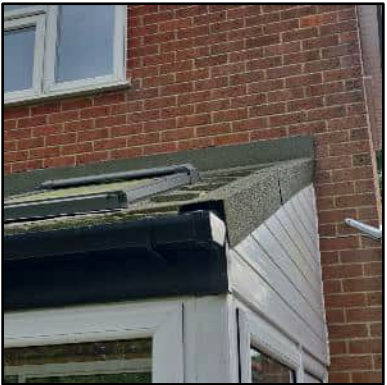
| Feature | Description | Location | Grading | Photographs |
|---|---|---|---|---|
| Building<br>Main house<br>B1<br>External | <p>A two-storey late 20<sup>th</sup> century brick built residential property with a hipped roof, clay roof and ridge tiles. There was a dormer extension to the front of the property, with hanging clay tiles. There was a brick-built extension to the rear of the property, with a hipped roof, clay ridge and roof tiles, and a conservatory made of UPVC with a composite bitumen lining. All windows and doors were UPVC and well-sealed.</p> <p>Eastern aspect:</p> <p>The dormer window to front of property was mostly well-sealed, with a small number of hanging clay tiles appearing slightly lifted.</p> <p>Western aspect:</p> <p>There was a gap in the bitumen lining at the southern end of conservatory.</p> <p>There was a small number of lifted roof and ridge tiles, mainly on rear extension.</p> <p>Northern aspect:</p> <p>There was a composite lean-to on northern elevation of property. No bat potential, however, the view of the northern extent was restricted.</p> | Centre of the Site | Potential Roost | |

- ii Less than 10 desiccated bat droppings were found within the main roof void of B1. Although this provided evidence of roosting bats, there was no evidence of recent occupation as the droppings were highly desiccated and the roof timbers were covered in cobwebs throughout, indicating no recent entries had occurred.

- i Desiccated droppings provided evidence of roosting in B1 during the inspection, however, the only features identified were a small number of lifted hanging clay tiles on the eastern aspect, and a gap in the bitumen lining at the southern end of conservatory on the western aspect.

- v Although no emergence was observed, as there was evidence of previous use, B1 will be demolished following a Precautionary Method of Working (PMW). This means that the roof of B1 will be dismantled by hand, under the observation of a suitably experienced ecologist. In the event a bat is found or suspected, works should temporarily cease whilst an EPSL is applied for through Natural England.

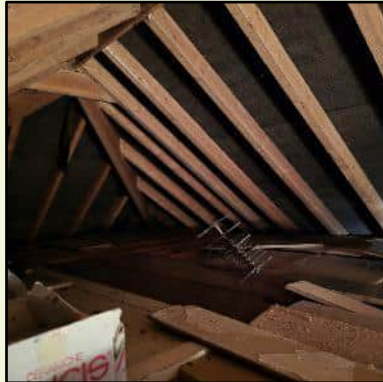
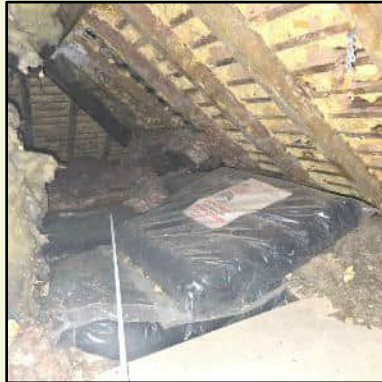
| Feature | Description | Location | Grading | Photographs |
|---|---|---|---|---|
| Building<br>Main house<br>B1<br>Internal | <p>Most of the roof area had been built out.</p> <p>There was a minor roof void present in the apex of property, approximately 1.5m high.</p> <p>There were modern, machine sawn timbers, with a ridge board, rafters and hip rafters.</p> <p>There was bitumen under the felting throughout, which was in good condition with no obvious evidence of access points.</p> <p>There was a small number of largely desiccated bat droppings in the main roof void. These were scattered in distribution and low in number (&lt;10).</p> <p>There was also a possible accumulated pile of droppings under a low timber purlin (20cm from floor level). These were also highly desiccated.</p> <p>The roof timbers had cobwebs throughout, and there was no evidence of recent occupation.</p> | Centre of the Site | | |

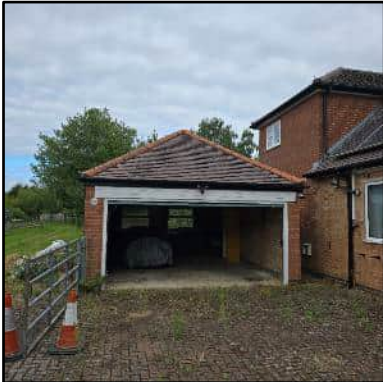
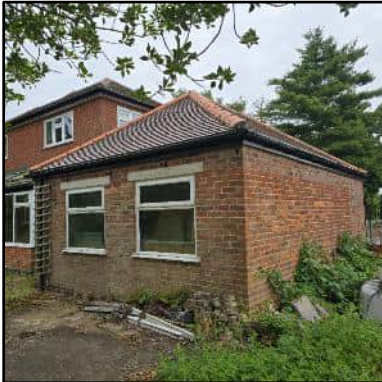
| Feature | Description | Location | Grading | Photographs |
|---|---|---|---|---|
| Ancillary Building<br>B2<br>Garage<br>External | Brick built two bay garage with a hipped roof, clay ridge and roof tiles. Roof and brickwork in good order. Appears well sealed. | Centre of the Site | Negligible | |

- v As B2 was considered to have negligible potential to support roosting bats, no further surveys were required on this building.

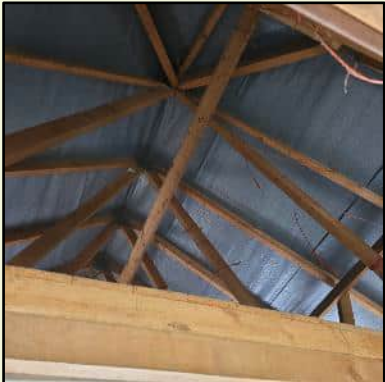
| Feature | Description | Location | Grading | Photographs |
|---|---|---|---|---|
| Ancillary Building<br>B2<br>Garage<br>Internal | Internal roof structure comprises machine sawn truss frames with a breathable membrane, no ridge board. Internal roof structure appears to be a recent addition. In good order and well-sealed. No evidence of bat droppings. Plenty of mouse droppings. | Centre of the Site | | |

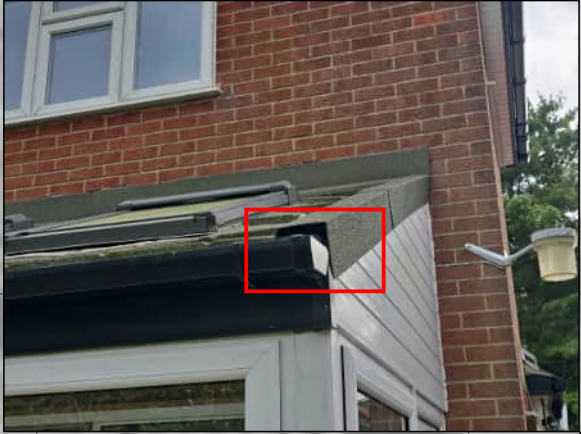
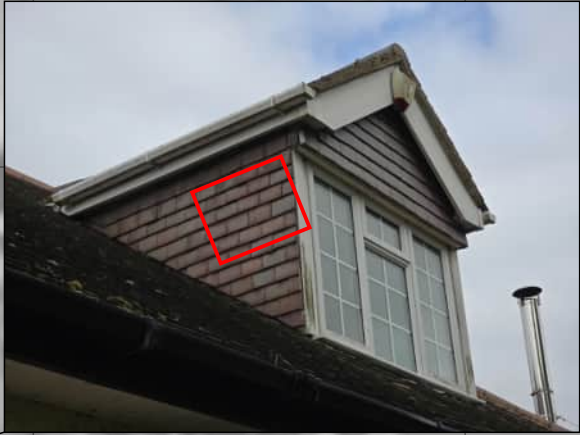
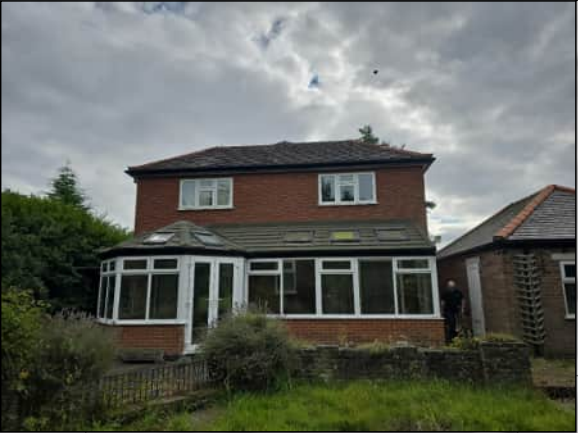
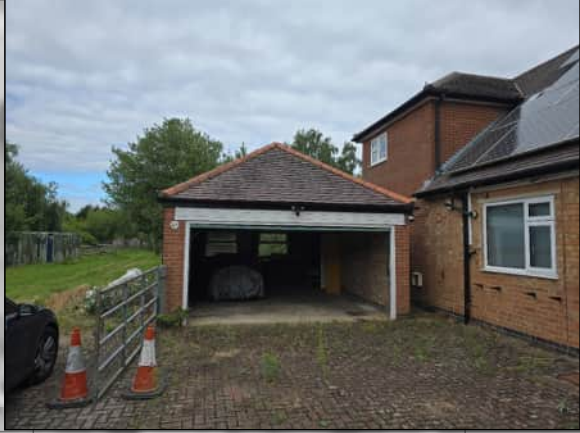
Title: Bat Building Assessment Plan

- i The B1 (a residential property) and B2 (a garage) were subject to a PBRA, whereby the internal and external areas of the properties were assessed. B1 was considered to be a potential roost, and B2 was considered to have 'negligible' potential to support roosting bats. Full results can be found in the table below, and these are shown on Figure 2.

Potential Roost

Negligible Roost Potential

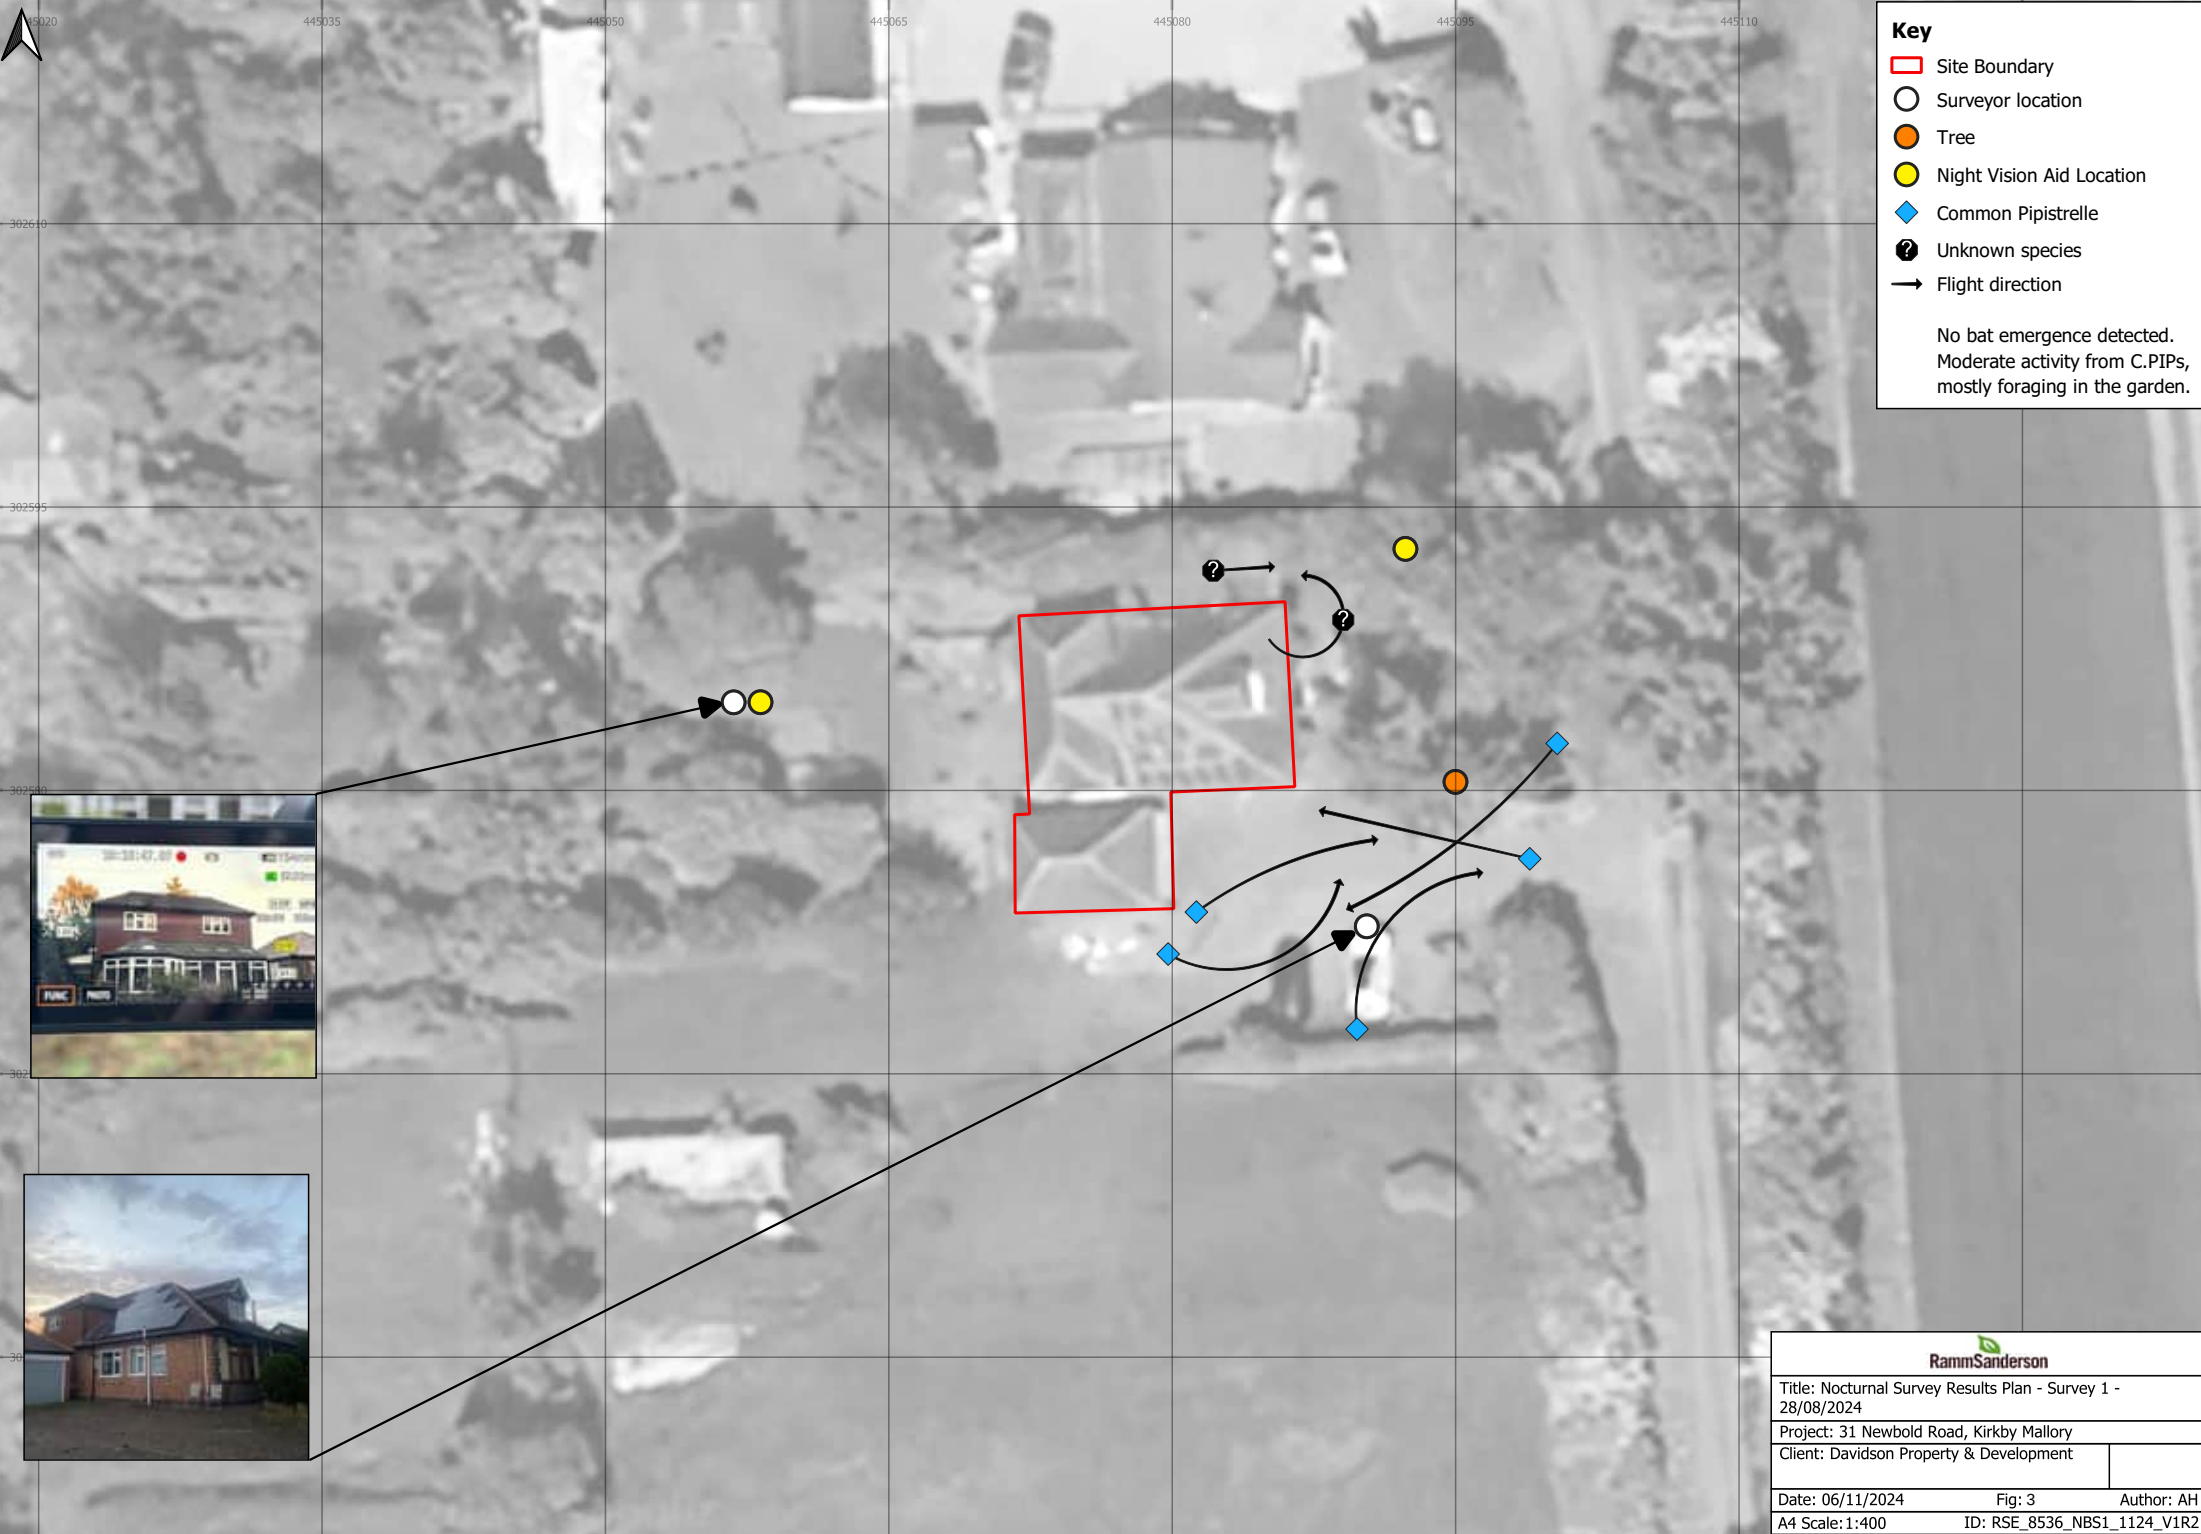
| Title: Nocturnal Survey Results Plan - Survey 1 - 28/08/2024 | | |

- i Two surveyors and two thermal imaging cameras were optimally positioned to survey B1. Sunset was at 20:01, the survey began at 19:40 and ended at 21:31.
- ii No emergences from B1 were recorded during the survey.
- iii The first recorded bat was at 20:17, the species was not identified, but the bat was seen flying over the building from the west and then commuted north. A moderate level of activity was observed from common pipistrelles (*Pipistrellus pipistrellus*) on site. Many appeared to be commuting over the Site however some were seen to be foraging in the garden or over the hedgerow.
- iv Five instances of noctule (*Nyctalus noctule*) were also recorded. The last recorded bat was at 21:30, which was a potential brown long eared bat (*Plecotus auritus*) and was heard but not seen by the surveyor.
- v Bat activity and surveyor locations for this survey can be seen on Figure 3.

No bat emergence detected.  
Moderate activity from C.PIPs,  
mostly foraging in the garden.

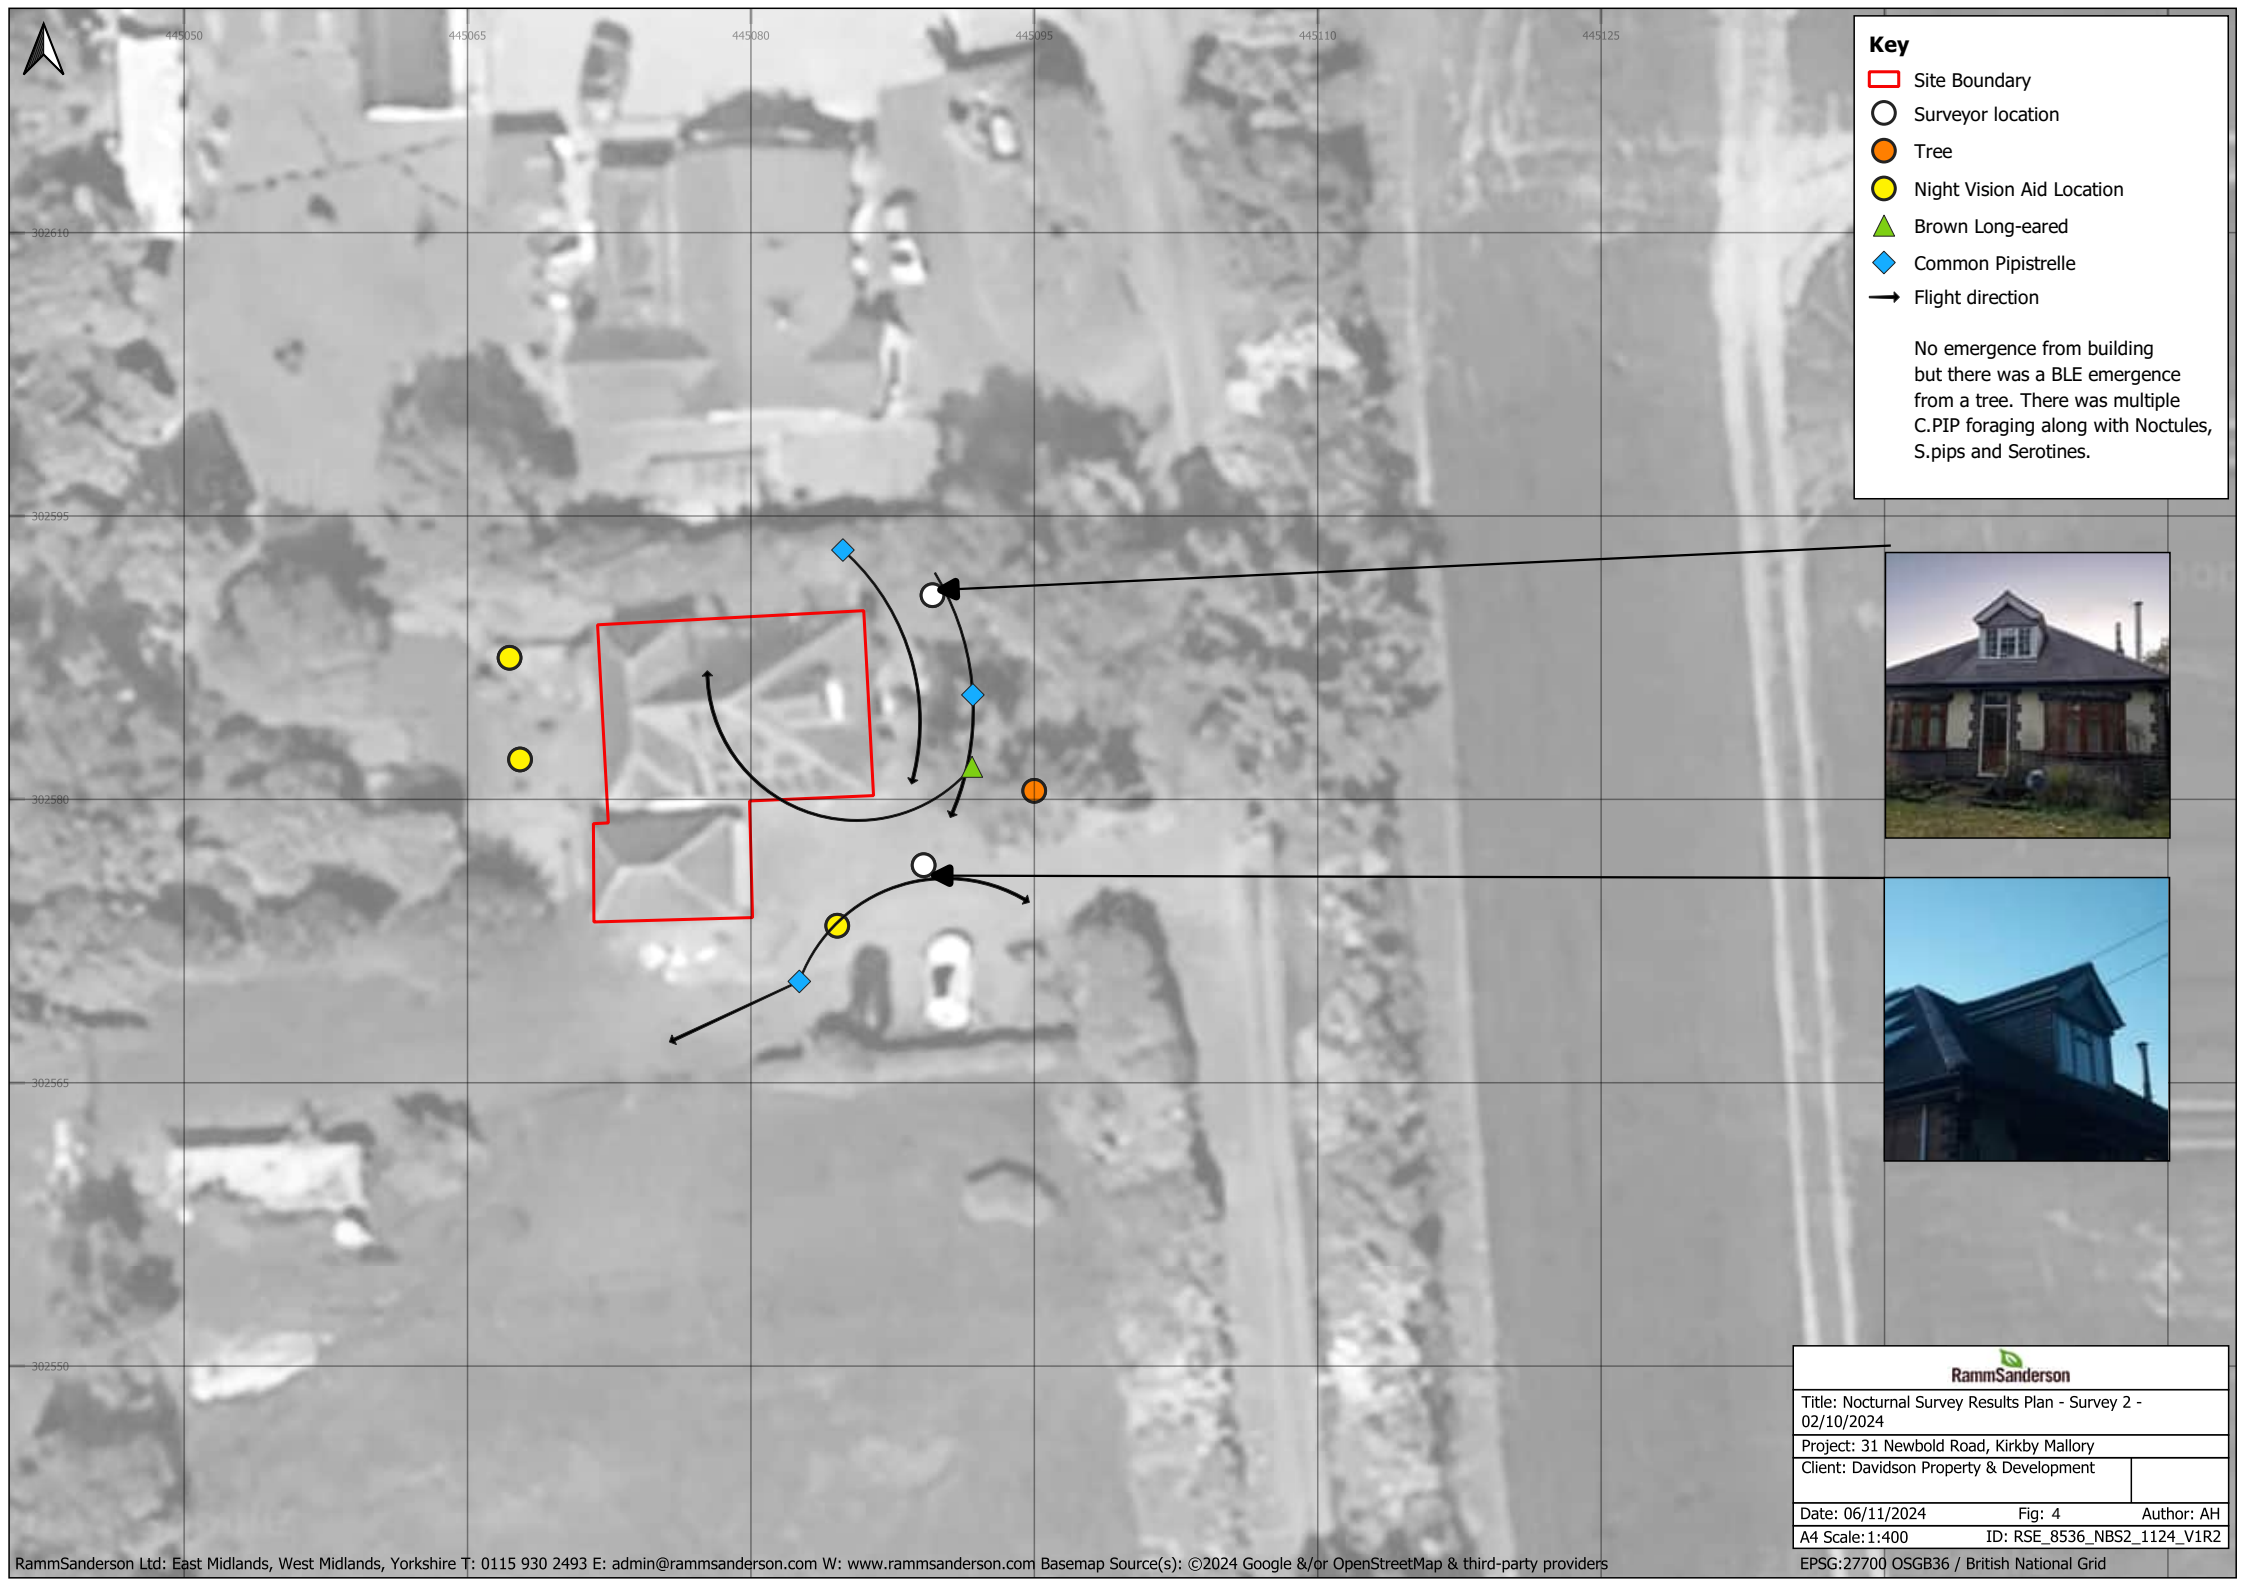
| Title: Nocturnal Survey Results Plan - Survey 2 - 02/10/2024 | | |

- vii No emergences from B1 were recorded, however a brown long eared bat emerged from a conifer tree (shown in Figure 2) in the garden to the east of the building at 19:40. Moderate brown long eared bat activity was recorded from 20:12 until the end of the survey, as well as multiple foraging common pipistrelles.

- ix Bat activity and surveyor locations for this survey can be seen on Figure 4.
- x This survey was carried out just outside of the optimal season for bats, however the survey is considered valid as the weather conditions were optimal, and normal bat behaviours were observed throughout the survey, with one emergence from the tree in the garden.

No emergence from building but there was a BLE emergence from a tree. There was multiple C.PIP foraging along with Noctules, S.pips and Serotines.

- vii A single brown long-eared bat was recorded emerging from the canopy of a conifer tree to the east of B1. This was noted as an emergence, however it was unconfirmed, and it is unlikely that a bat would roost in a conifer tree. Therefore, it has been proposed that it could be a potential lekking site for bats, or the individual bat was feeding. As the tree will not be affected by the proposed developments no further actions need to be taken, however if the development plans change then this will need to be taken into consideration and further consultation may be required.
