# Preliminary Ecological Appraisal and Roost Assessment

2 Old Forge Road, Fenny Drayton, Nuneaton, Warwickshire CV13 6BD

This report is prepared to inform a planning application with the Hinckley Bosworth Borough Council. The proposal is described as:  
Demolition of the existing garage outbuilding and rear conservatory, construction of a new ground level garage, construction of a new ground level extension to replace conservatory, roof works to lift the ridgeline and facilitate new dormer windows and roof lights, and building extensions involving internal works.

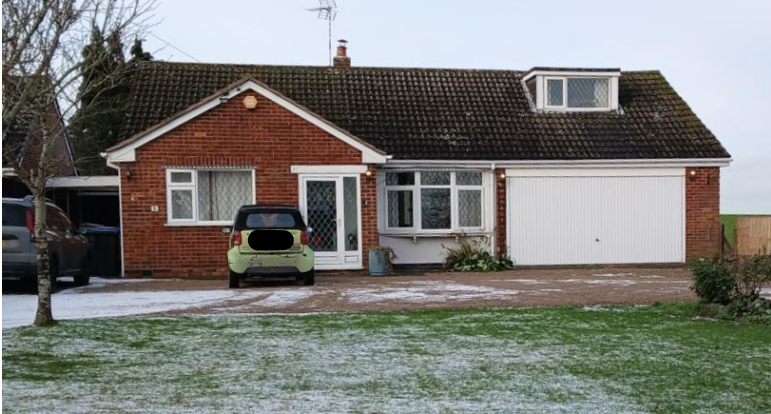
| | <p><b>Foraging and commuting habitat</b><br/>Habitats recorded on site are assessed to provide suitable foraging opportunities for bats in the form of the vegetated gardens which contains ornamental hedgerow, amenity grass, and individual trees. These habitats are likely to provide micro-climatic conditions that support invertebrates that will in turn provide foraging opportunities for local bat populations. Linear features in the form of the timber fencing may aid navigation for local bats, as bats are well known to utilise linear features to aid navigation whilst travelling between foraging resources and roost sites. The fencing along the northern boundary is of particular value as this fence line continues northwest between further private residential properties and the field, creating a continuous landmark suitable for navigational aid. However, due to the relatively small size of the site, the foraging and commuting value of the site has been assessed in the local context as <b>low</b>.</p> <p><b>Roosting habitat (trees)</b><br/>No suitable roosting features for bats (i.e., cavities, suitably thick ivy, deadwood cavities, lifted bark, etc) were found across the trees and tree groups. The trees have been assessed as NONE.</p> <p><b>Roosting habitat (buildings)</b><br/>The on-site buildings have been assessed for roosting value for bats below:</p> |
|---|---|
| <p>B1 is a residential dwelling of brick construction and interlocking machine-made tiles. A glass conservatory is present to the west; the conservatory jack rafters and ridge comprise non-porous material which is not suitable for roosting bats. The building contains a small, well-sealed loft at the northwest elevation. The roof tiles appear to be in relatively good condition. One gap was noted at the northwest elevation. The southeastern edge tiles are unsealed; when inspected by torch, these edge gaps provide further access to crevices beneath the roof tiles. As such the building is assessed to contain <b>moderate</b> value for crevice roosting bats during the activity season.</p> <p>The building is considered unsuitable for hibernating bats due to the fluctuations in temperature caused by central heating within the dwelling.</p> | |

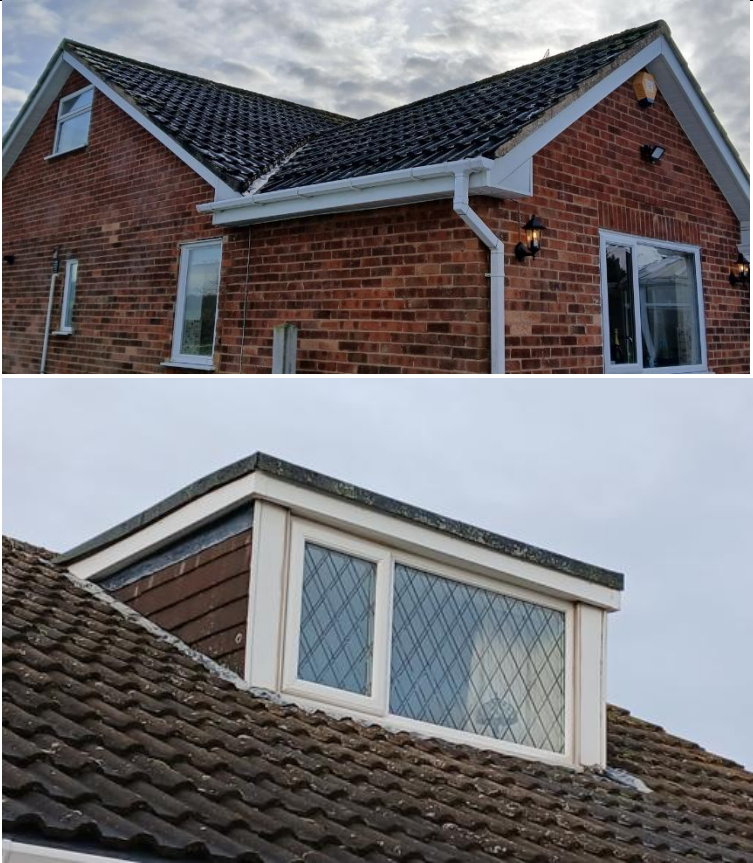
| <b>Feature</b> | <b>Materials</b> | <b>Condition/description/suitability</b> | <b>Photograph(s)</b> |
|---|---|---|---|
| Walls | Brick,<br>machine<br>made tiles | <p><b>Condition/description</b></p> <p>The brick walls are in good condition with no gaps or damages noted. Machine made tiles are present at the sides of the dormer window and are well sealed.</p> <p><b>Suitability/access/evidence of bats</b></p> <p>Not suitable for roosting bats.</p> | |

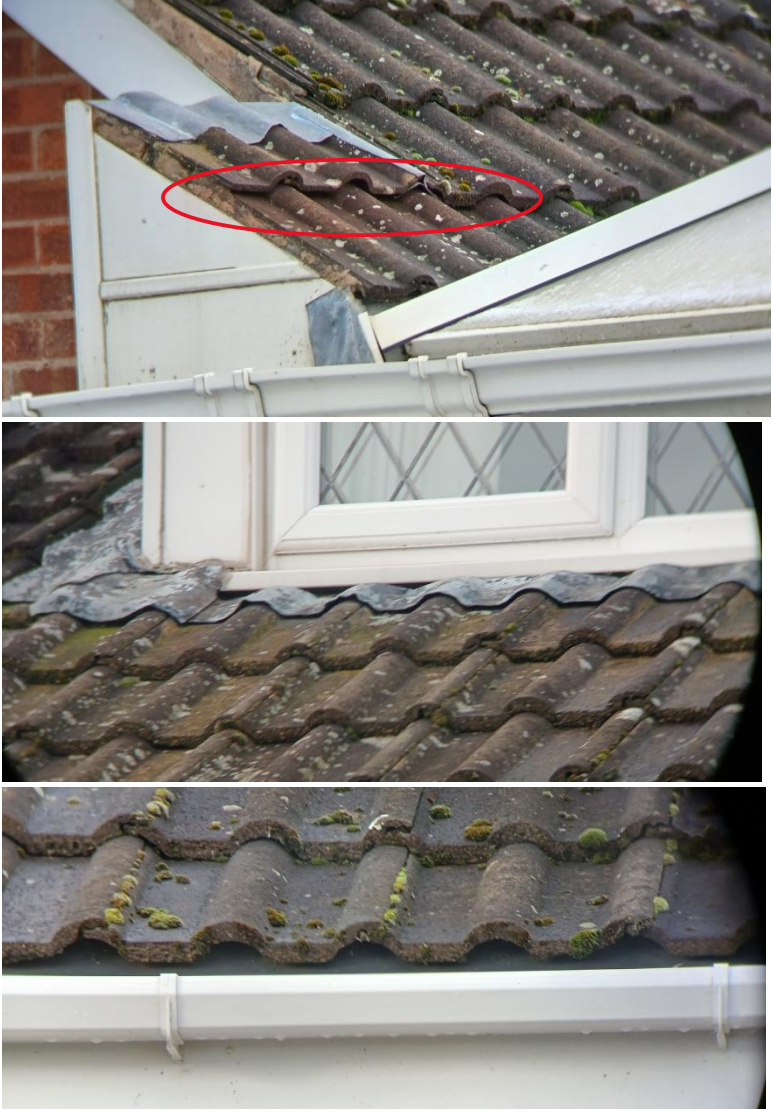
| Roof | Interlocking machine-made tiles, lead flashing; flat rolled roofing (dormer window); glass, pvc (conservatory) | <p><b>Condition/description</b></p> <p>The roof tiles are generally well-sealed throughout with the exception of a lifted tile at the northwest elevation. The southeastern edge tiles are unsealed with gaps beneath tile edges which lead to further crevices between the adjacent tiles and the internal linings. Lead flashing around the chimney to the west is well sealed. The lead flashing below the southeastern dormer is gapped slightly. Several conservatory jack rafters are missing end caps.</p> <p><b>Suitability/access/evidence of bats</b></p> <p>Gaps beneath the interlocking roof tiles where tiles are damaged or where access is provided via the edge tiles may provide suitable roosting habitats for crevice dwelling bats. Lifted lead flashing may provide suitable roosting habitat for individual crevice dwelling bats. No evidence found but weather conditions erode external evidence rapidly.</p> | |

| | Two bat emergence/re-entry surveys (BERS) are required for B1 during the active bat season (May – August, suboptimal September) to assess the present roost and further roosting features. Two surveys must be held within the maternity season (Mid-may – June inclusive). The surveys are to be held at minimum three weeks apart. A team of three surveyors equipped with night vision aids (NVAs) are required to provide full coverage of the buildings' elevations to look for emerging/re-entering bats. One additional NVA may be deployed at the lead surveyor's discretion to provide additional coverage. One member of the surveyor team should be positioned in the adjacent field to assess the northern roof elevations. If any bat roosts are confirmed | | |

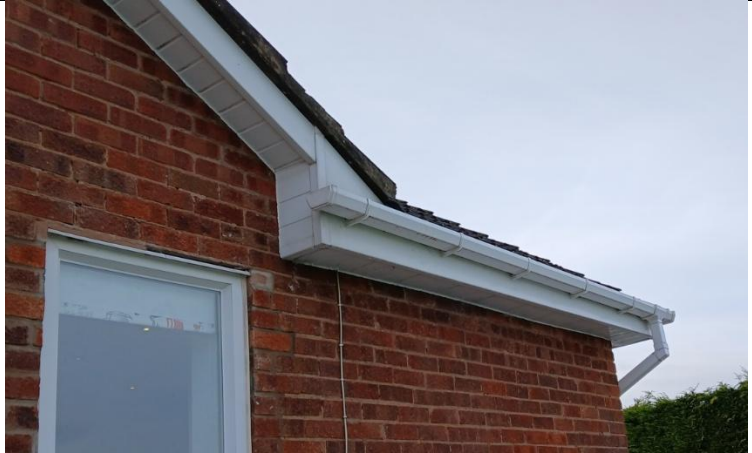
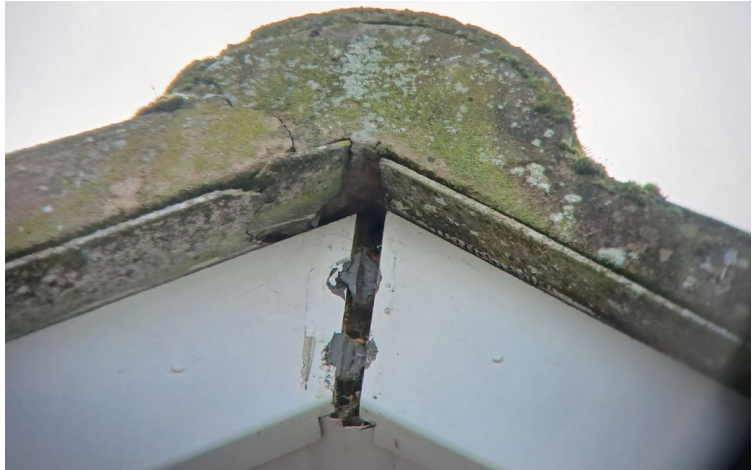
| Soffits/overhangs | PVC | <p><b>Condition/description</b></p> <p>Good condition with no cracks or damages noted. A small gap was noted at the north elevation. The gap does not lead to the loft void.</p> <p><b>Suitability/access/evidence of bats</b></p> <p>The gap at the north elevation may provide suitable roosting habitats for individual bats.</p> | |

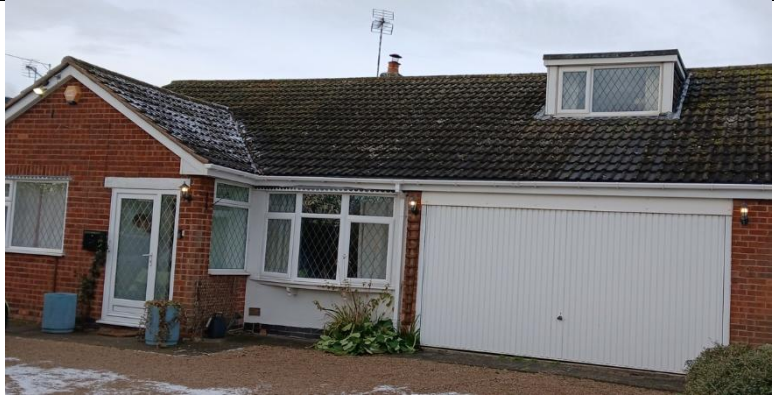
| Windows/door frames and lintels | PVC | <p><b>Condition/description</b><br/>Tightly sealed throughout.</p> <p><b>Suitability/access/evidence of bats</b><br/>Not suitable for roosting bats.</p> | |

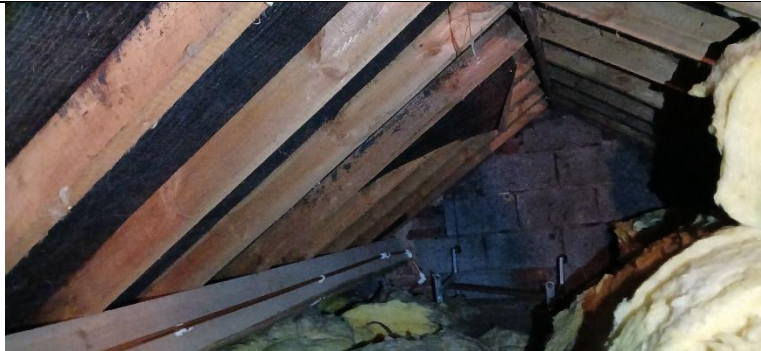
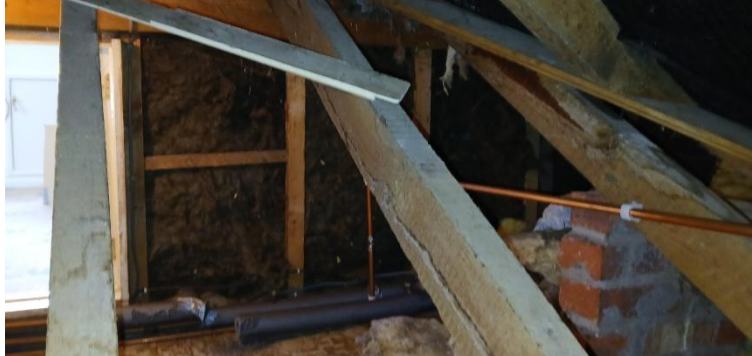
| Internal voids/loft | Timber support beams, cinderblocks, mineral wool insulation, plywood, bitumen felt | <p><b>Condition/description</b><br/>The loft area measures approximately 5.5m x 5m, with an apex height of approximately 1m. Abiotic conditions were noted at 5°C with humidity at 79%. The loft is lined in bitumen felt throughout. A portion of felt has come loose but no exposed tile areas are present due to tightly overlapped felt beneath. The mineral wool insulation is densely packed over the eaves and no visible light spill was noted. Rodent droppings and one deceased mouse was found in the loft.</p> <p><b>Suitability/access/evidence of bats</b><br/>No evidence of bats found. No access available into the loft for bats was found. The loft is not suitable for roosting bats due to the low height of the ridgeline and lack of suitable access into the void.</p> | <br> |

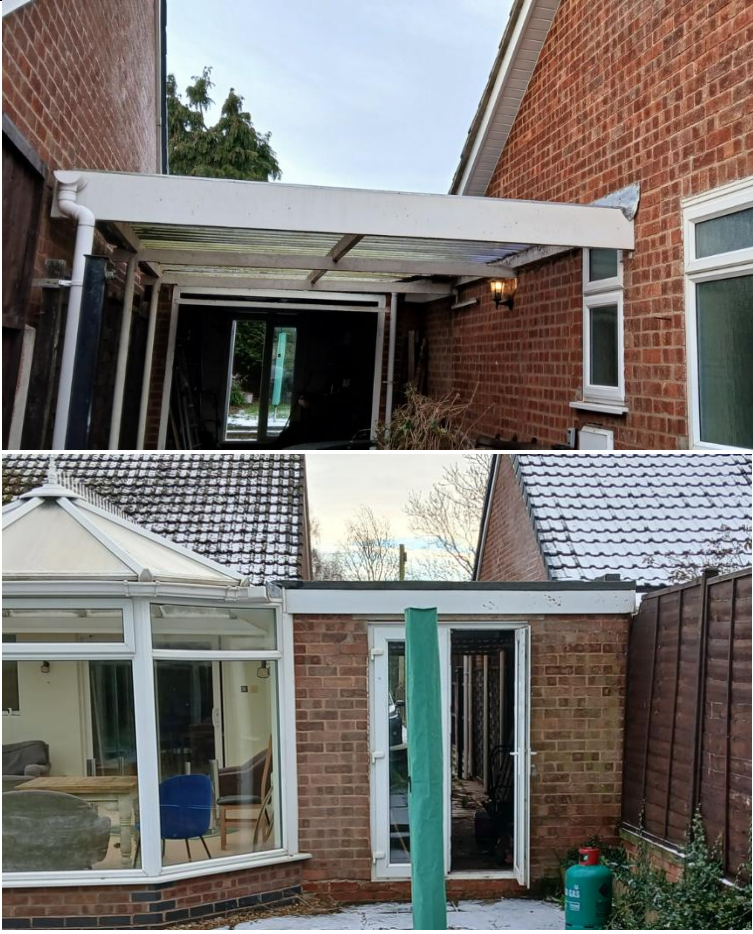
| <b>B2 Building description</b> | <b>Photographs</b> |
|---|---|
| <p>B2 is a ground level garage outbuilding with flat roofing and PVC fascia boards. The eastern portion of the garage overhang comprises translucent corrugated roofing materials. The garage measures approximately 11m x 2m with a height of approximately 2m. The structure is well-sealed throughout with no suitable access from the exterior and no suitable external roosting features. The building is assessed to contain <b>negligible</b> value for roosting and hibernating bats due to the lack of suitable roosting features throughout.</p> | |

| | B2 will be demolished to facilitate the new storage structure. As no suitable roosting features are present no effects of roosting bats are anticipated. | | |

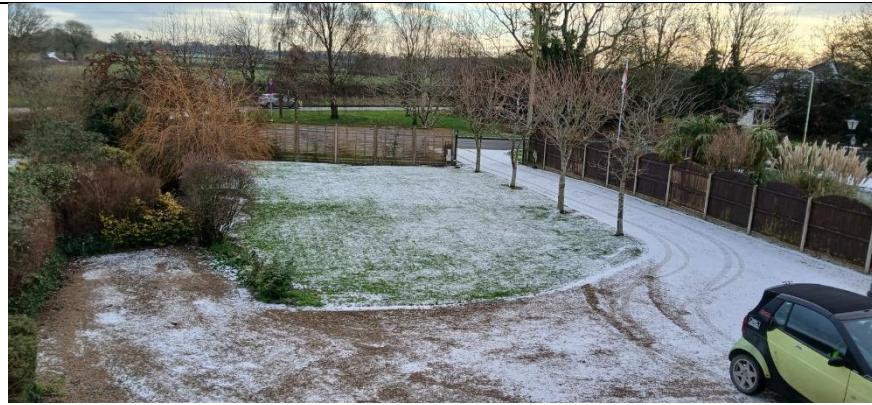
**1** Vegetated garden and unsealed surfacing access drive, timber fencing

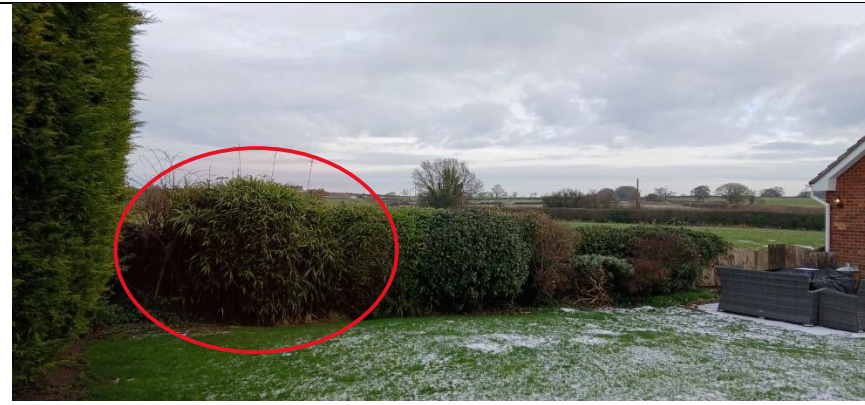
**2** Vegetated garden with flowerbeds and bamboo circled

| <i>Recommendations</i> | It is highly advised that bamboo should be removed in totality via hand-digging without the use of machinery to avoid separation of rhizomes. An invasive species management plan is not required. Area should be monitored for new growth at least yearly to ensure spread is eradicated. New growth should be targeted as above. |

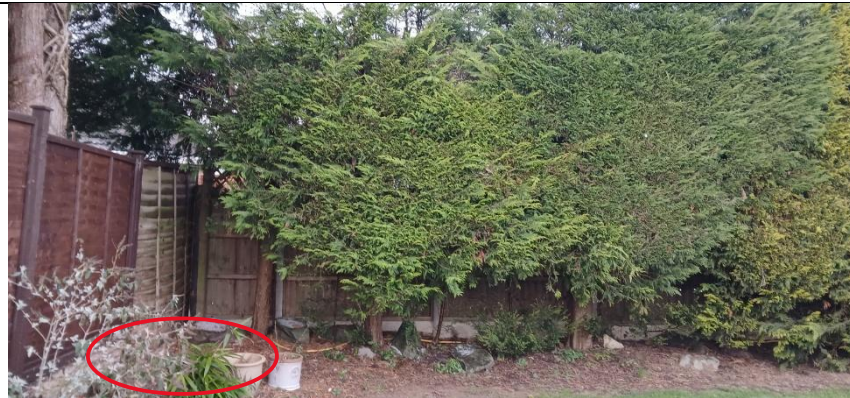
**3** Ornamental hedgerow, bamboo circled

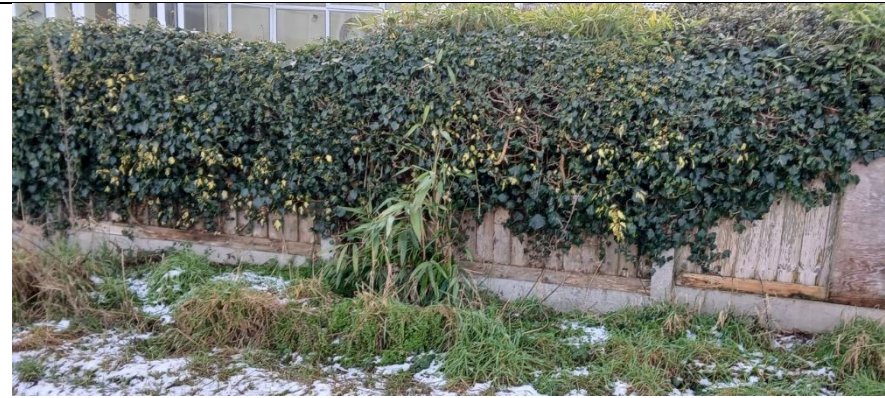
| <i>Summary of Survey Findings</i> | Two clusters of yellow bamboo were found on site. Bamboo is not listed as a Schedule 9 invasive plant; however, the species is known for aggressive and rapid spread. No maintenance to restrict spreading were noted and as such the bamboo is noted to have spread throughout the northern flowerbed and beyond the north boundary into the adjacent field. |

**4** Bamboo encroaching beyond site boundaries to the north

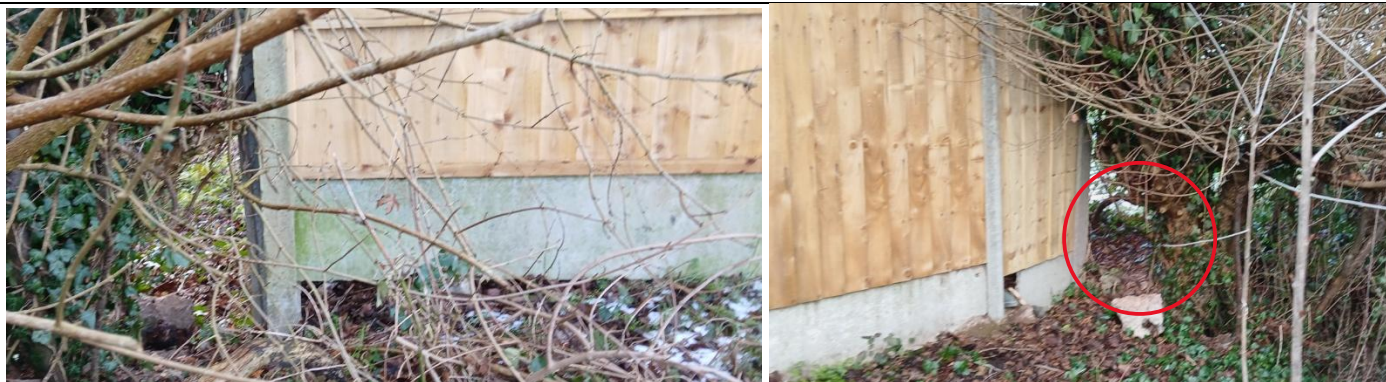
Timber privacy fencing is present to the southwest and northwest. A low timber fence delineates the site boundary from the adjacent field; ivy *Hedera helix* covers most of the fence. A timber slat fence is present at the southeast. Small gaps were noted beneath the fencing at the southeast corner boundary.

**5** Eastern fencing gaps and off-site hedgerow with mammal path beneath (circled)
