CRABTREE FARM, BARWELL (PARCEL 2)

SITE INVESTIGATION FACTUAL REPORT  
FOR  
JAMES MADISON HOMES LIMITED

**Project Ref:**  
EAL.02.20

**Date:**  
October 2020

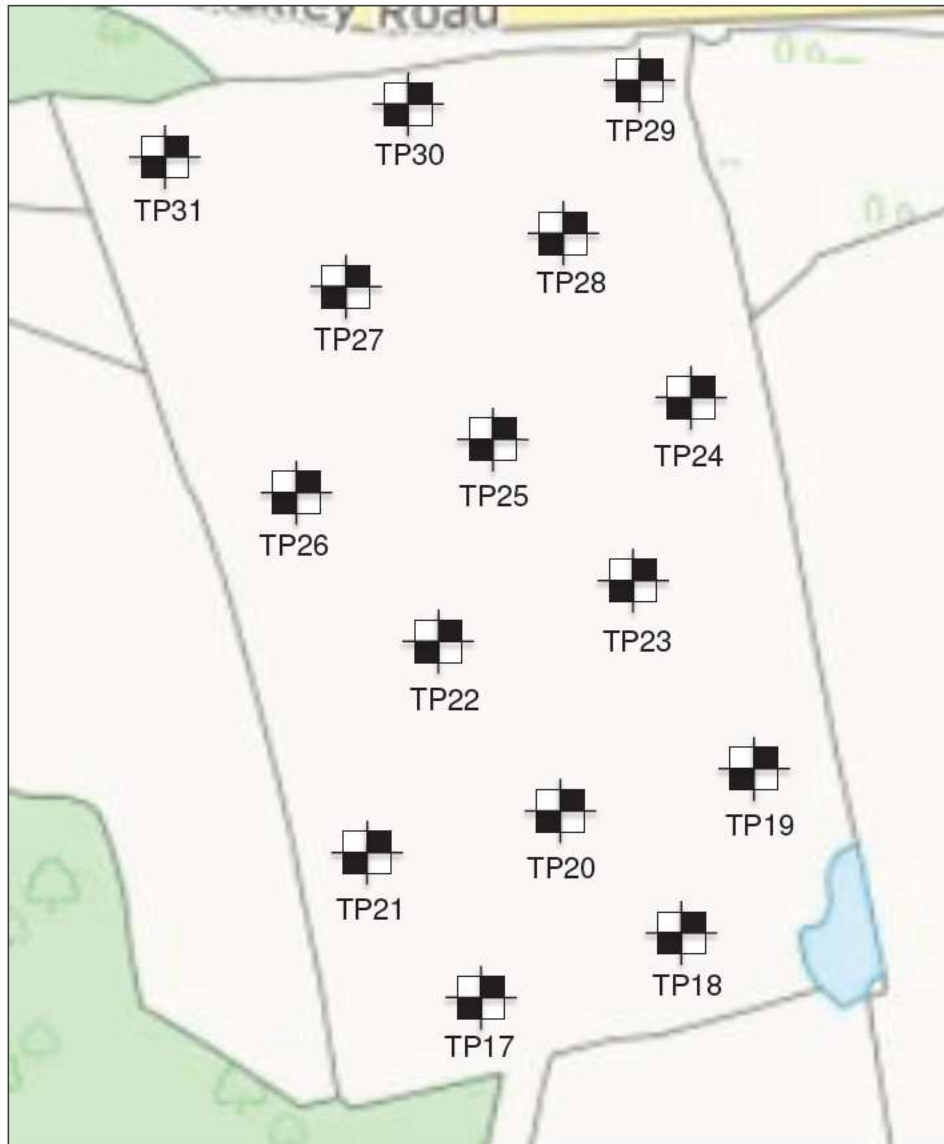
Figure 4

Trial Pit

Exploratory Hole Location Plan

The exploratory hole location plan along with all exploratory hole records are contained in **Appendix B**.

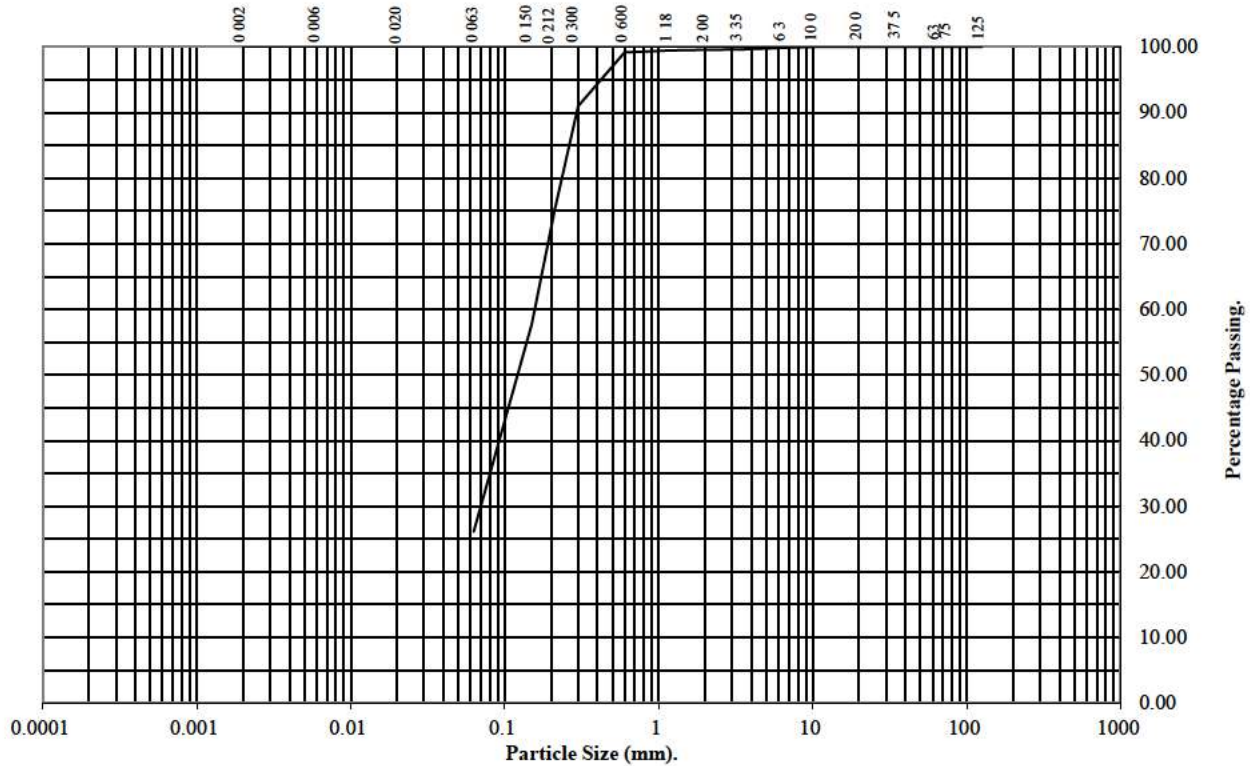
| BS Test Sieve (mm) | Percentage Passing |

Particle size distribution (PSD) testing has generally confirmed the findings illustrated in the exploratory hole logs.
