LAND AT CRABTREE FARM, BARWELL (PARCEL 1)

PHASE II GEO-ENVIRONMENTAL ASSESSMENT  
FOR  
JAMES MADISON HOMES LIMITED

**Project Ref:**  
EAL.02.20

**Date:**  
September 2020

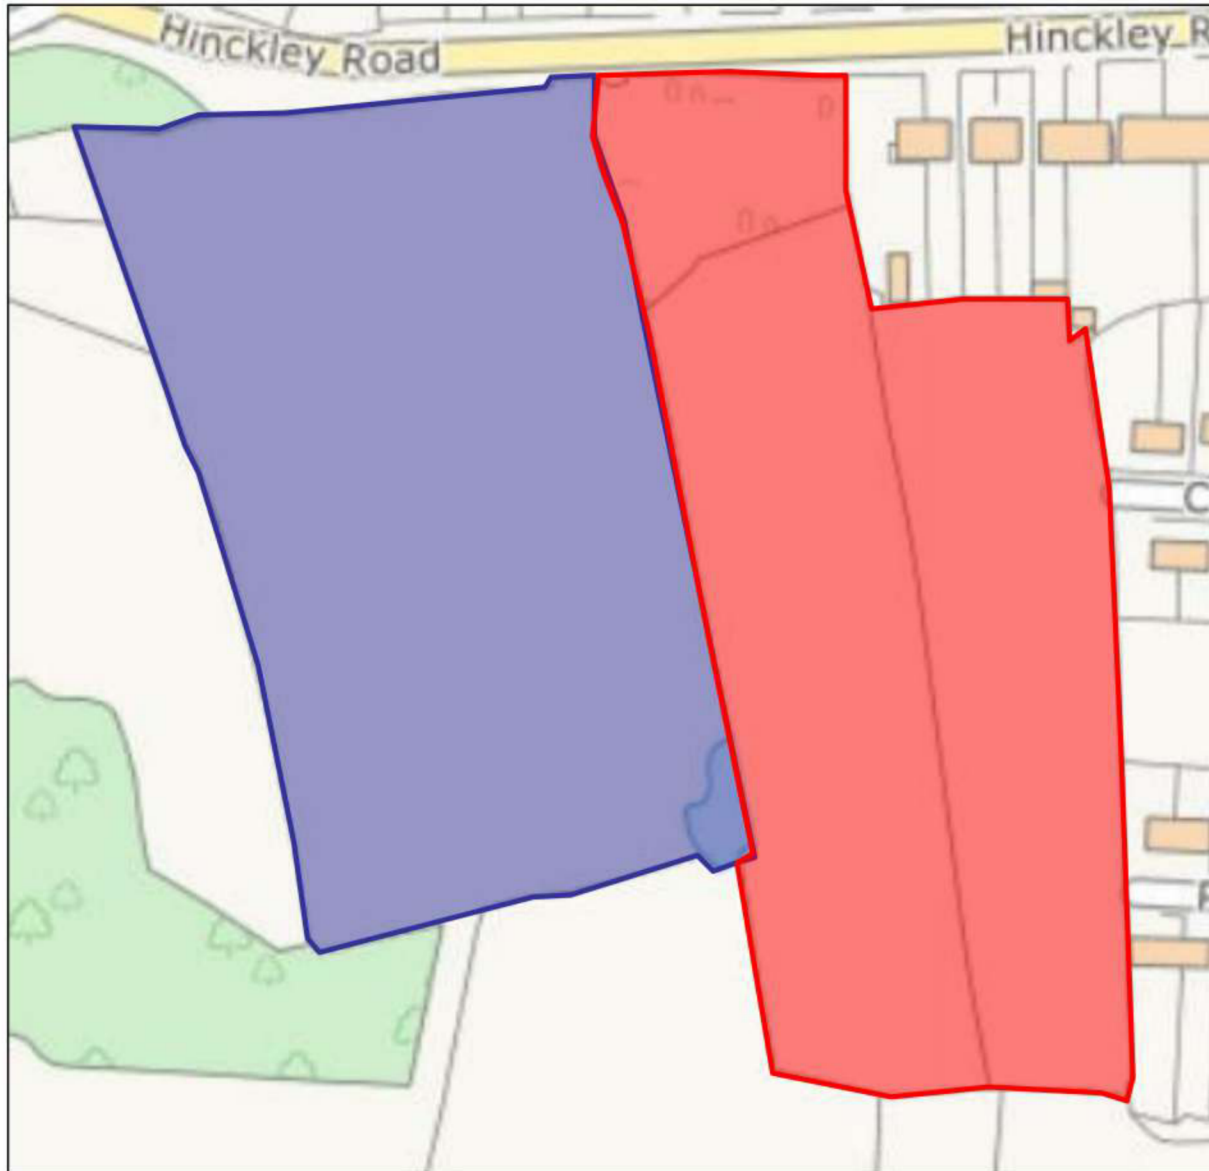
Proposed End Use Plan

Parcel 2 - area of proposed burial ground (not included in Phase II Report)

The intrusive investigation incorporated both the area of the proposed residential (Parcel 1) and the area of the proposed burial ground (Parcel 2). This report will focus solely on the proposed residential development area (Parcel 1). A separate report will be issued for the burial ground (Parcel 2). A site plan showing the extents of Parcel 1 and 2 is included in **Appendix A** for clarity.
