LAND AT CRABTREE FARM, BARWELL (PARCEL 1)

PHASE II GEO-ENVIRONMENTAL ASSESSMENT  
FOR  
JAMES MADISON HOMES LIMITED

**Project Ref:**  
EAL.02.20

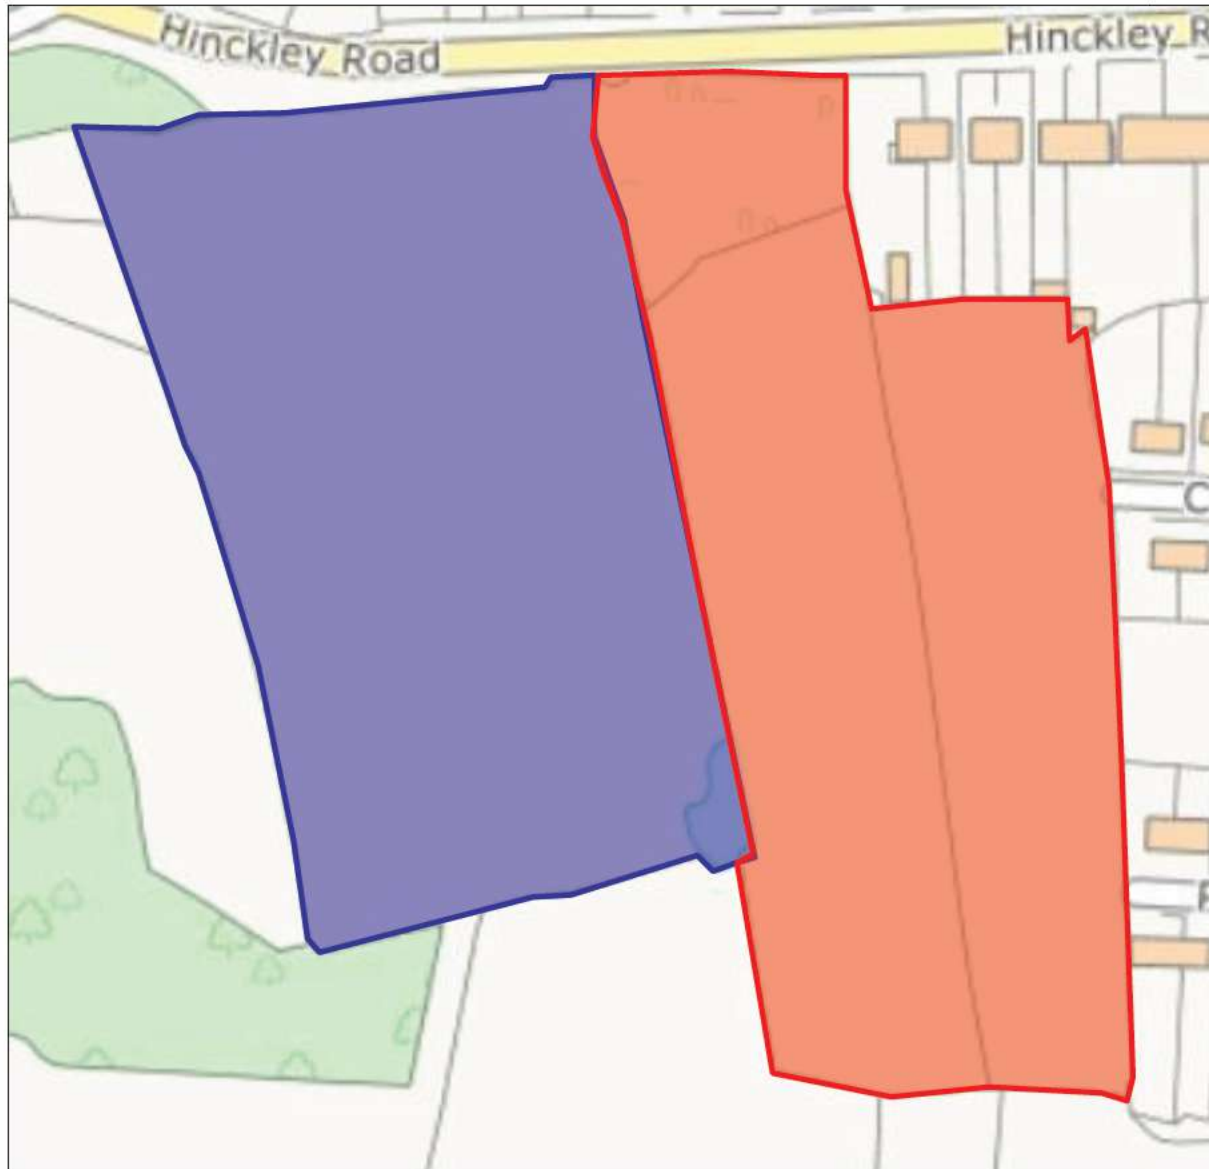
Figure 3

Parcel 2 - area of proposed burial ground (not included in Phase II Report)

Proposed End Use Plan

The intrusive investigation incorporated both the area of the proposed residential (Parcel 1) and the area of the proposed burial ground (Parcel 2). This report will focus solely on the proposed residential development area (Parcel 1). A separate report will be issued for the burial ground (Parcel 2). A site plan showing the extents of Parcel 1 and 2 is included in **Appendix A** for clarity.

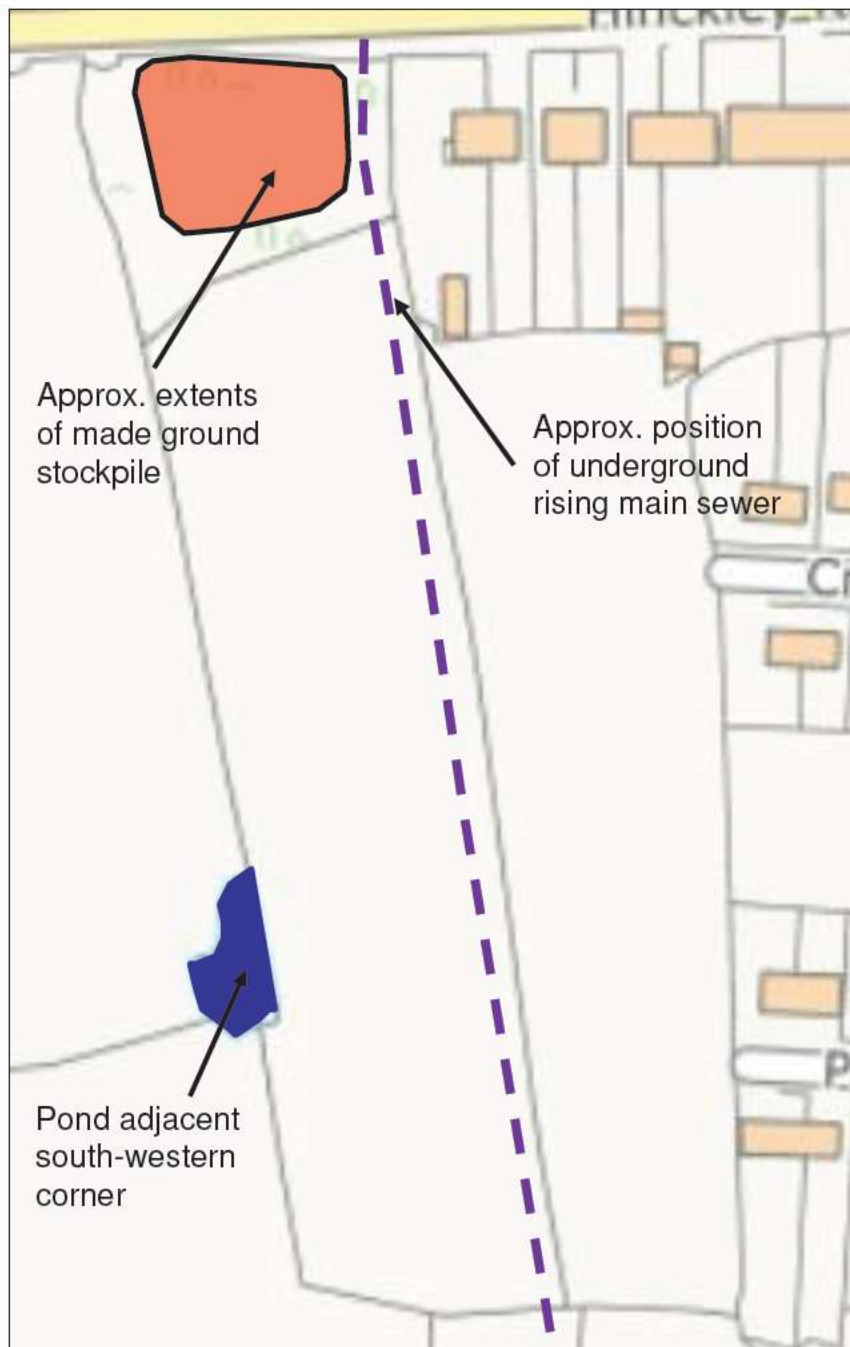
Site Features Plan

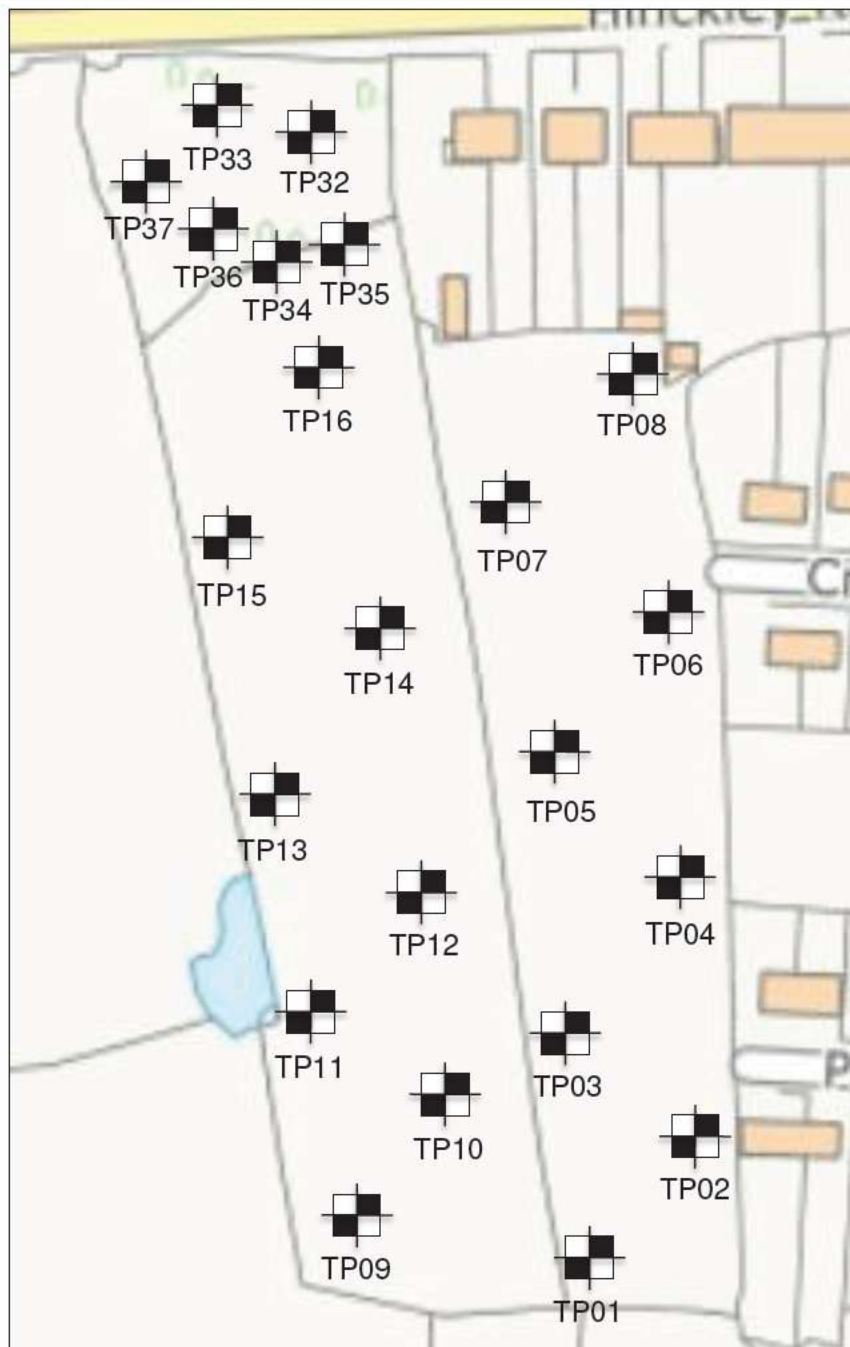
Figure 5

Trial Pit

Exploratory Hole Location Plan

The exploratory hole location plan along with all exploratory hole records are contained in **Appendix B**.

The Phase II investigation has been designed to facilitate an assessment of the general ground conditions across the site, including contaminant sources, pathways and receptors. The investigation has also been designed in consideration of the current site layout and access restrictions, the development proposal and health and safety issues. The rationale behind the location of each exploratory hole is detailed in table 3.2 below:

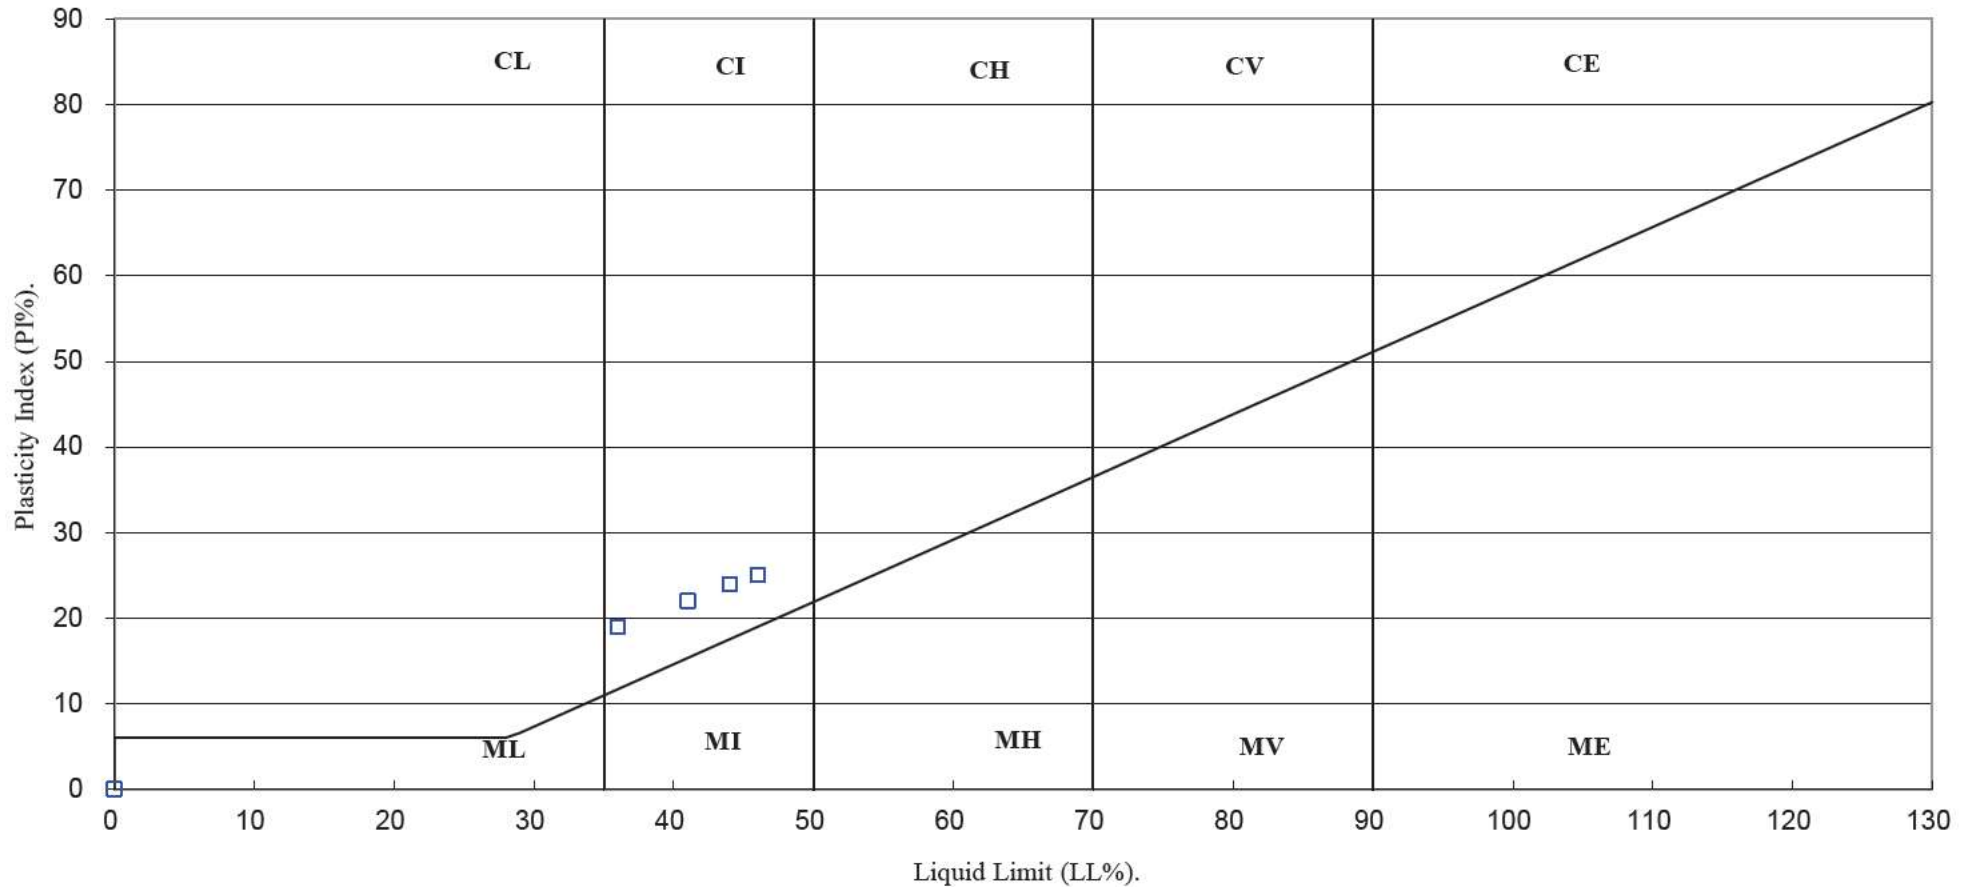
# PLASTICITY CHART FOR CASAGRANDE CLASSIFICATION.

The results contained in **Appendix C** illustrate PI values of between 19% and 25% and moisture contents between 17% and 19%, indicating the cohesive deposits to be of medium volume change potential as a maximum classification which should be used across the site.
