CRABTREE FARM, BARWELL (PARCEL 2)

SITE INVESTIGATION FACTUAL REPORT  
FOR  
JAMES MADISON HOMES LIMITED

**Project Ref:**  
EAL.02.20

**Date:**  
October 2020

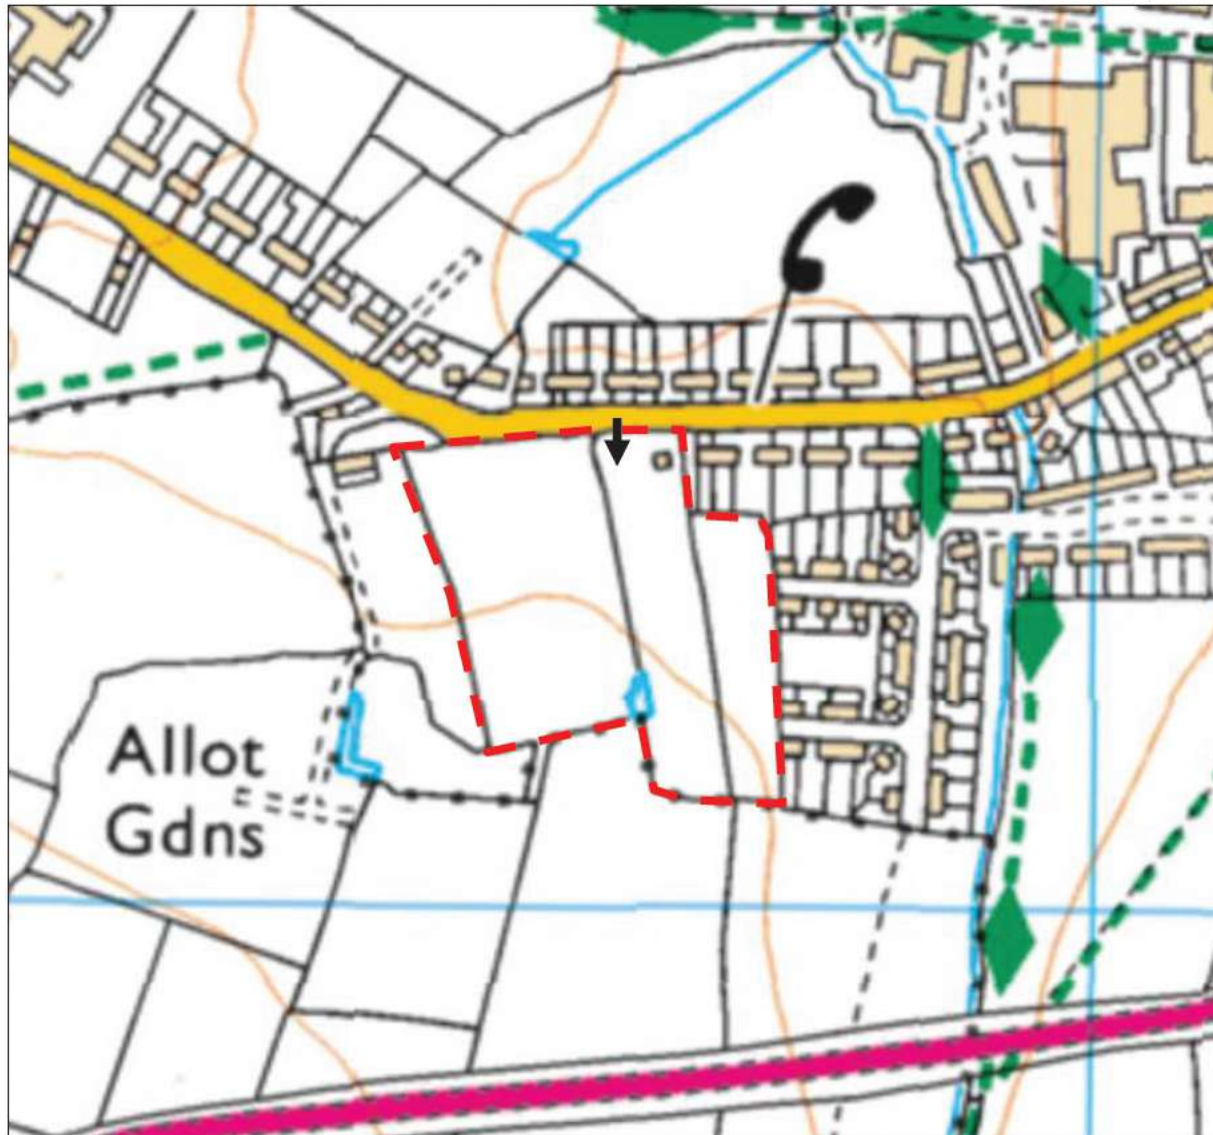
Figure 2

Site Layout

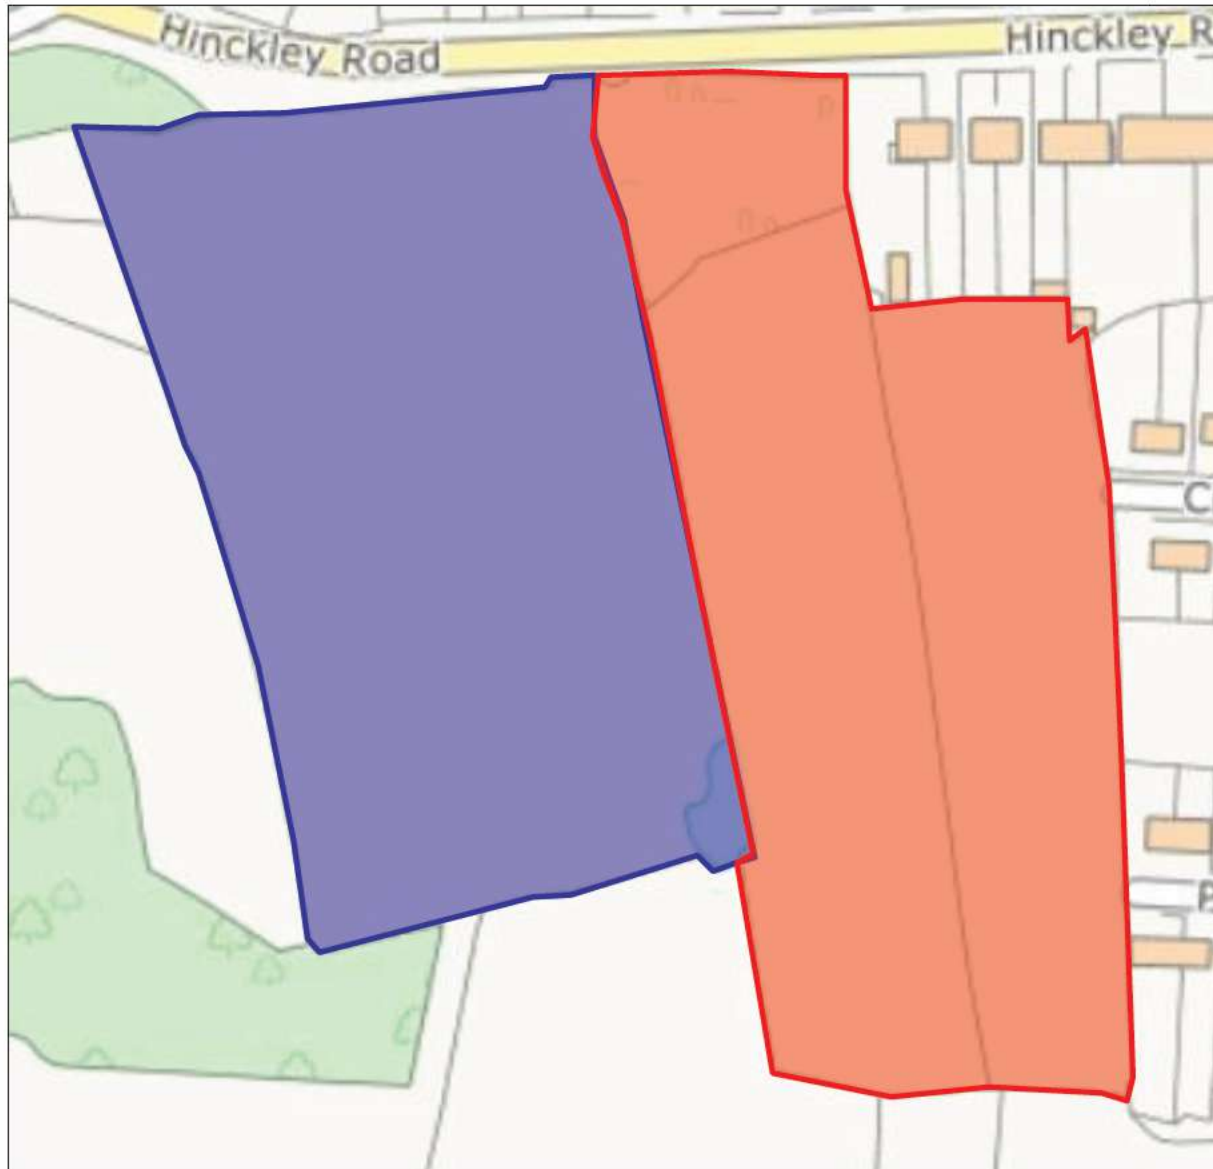
Figure 3

Parcel 1 - area of proposed residential redevelopment (not included in letter report)

Parcel 2 - area of proposed burial ground (subject of letter report)

Proposed End Use Plan

At the time of writing, a proposed development plan is not available for the site. However, it is understood that the Client proposes to develop the site with a burial ground and balancing pond.

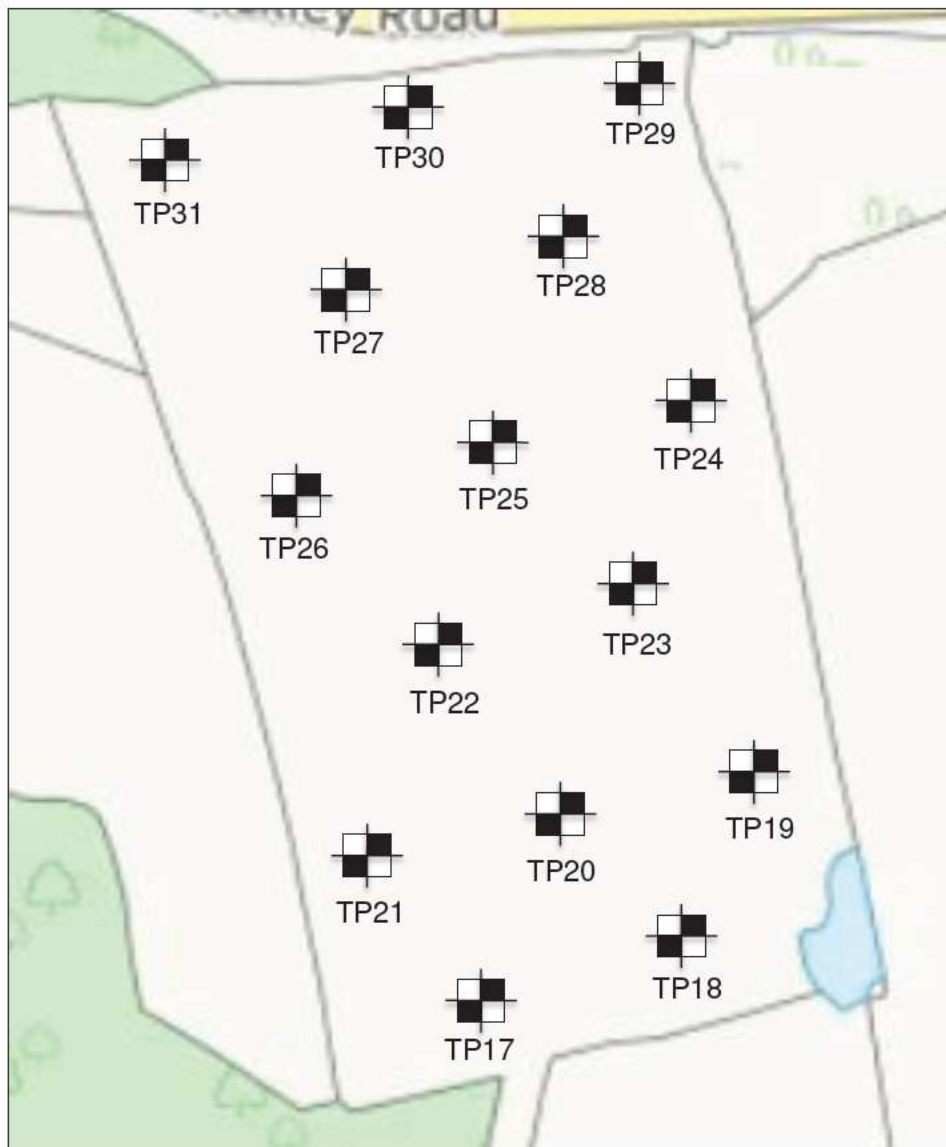
Figure 4

Trial Pit

Exploratory Hole Location Plan

The exploratory hole location plan along with all exploratory hole records are contained in **Appendix B**.

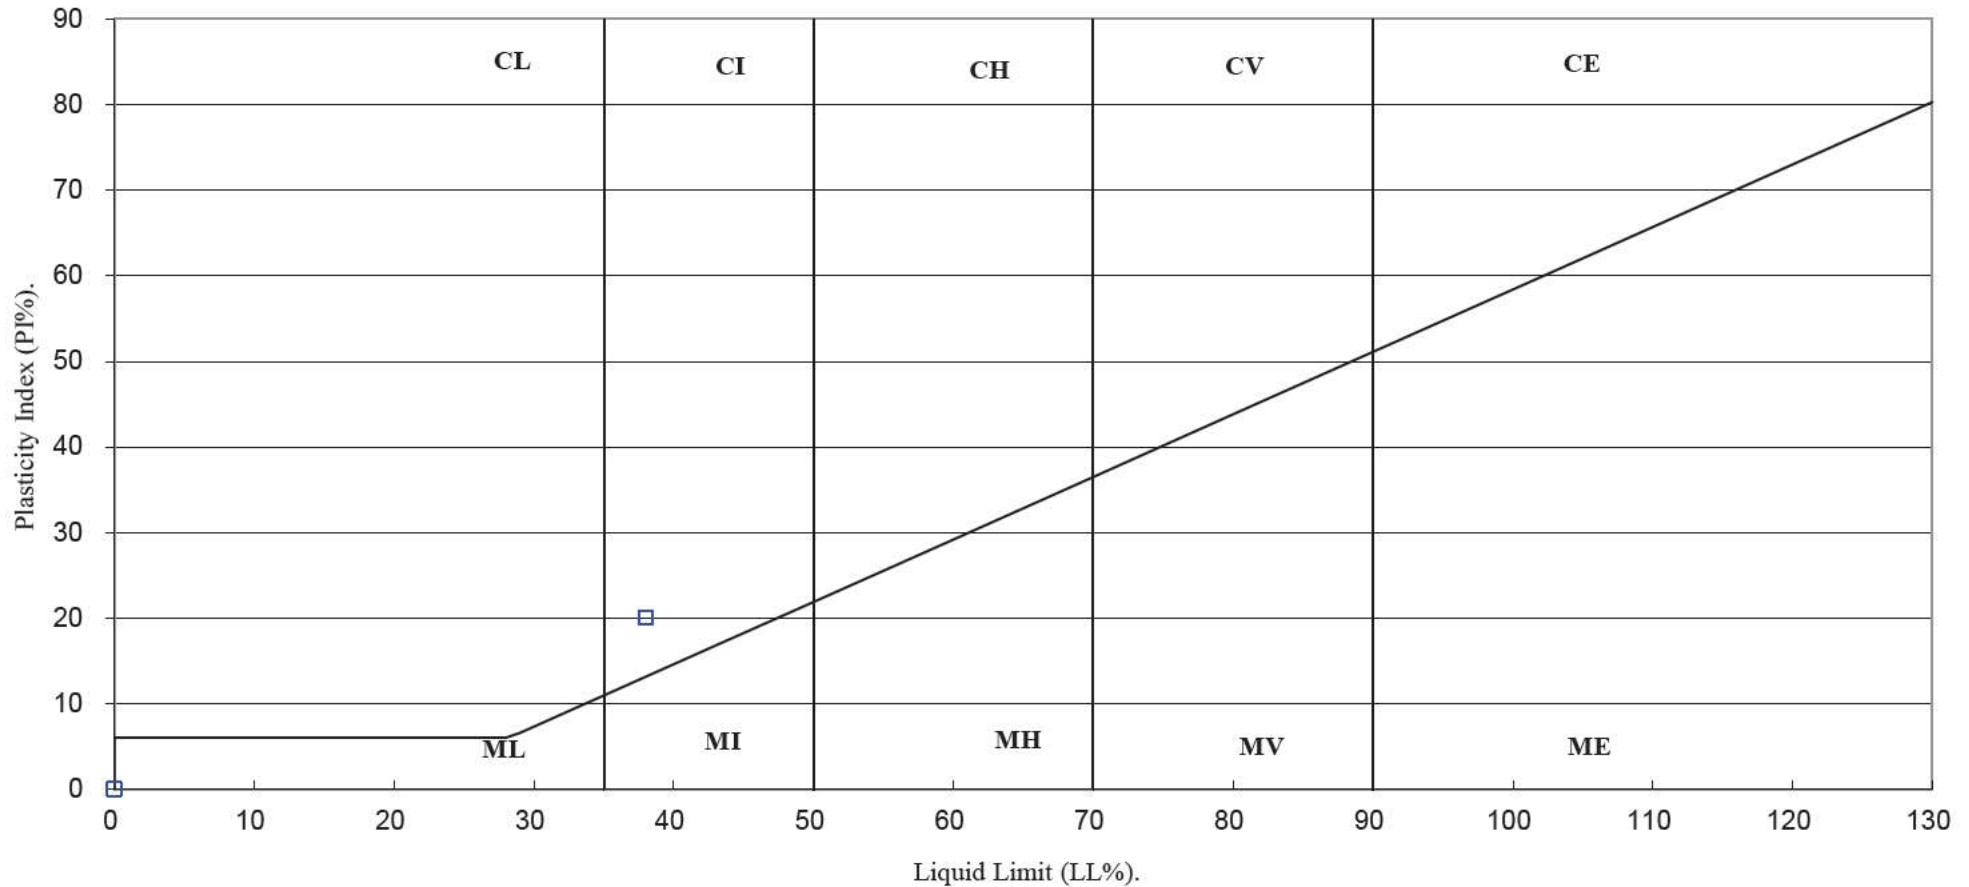
# PLASTICITY CHART FOR CASAGRANDE CLASSIFICATION.

The results contained in **Appendix C** illustrate a PI value of 20% and moisture content of 17%, indicating the cohesive deposits to be of medium volume change potential.

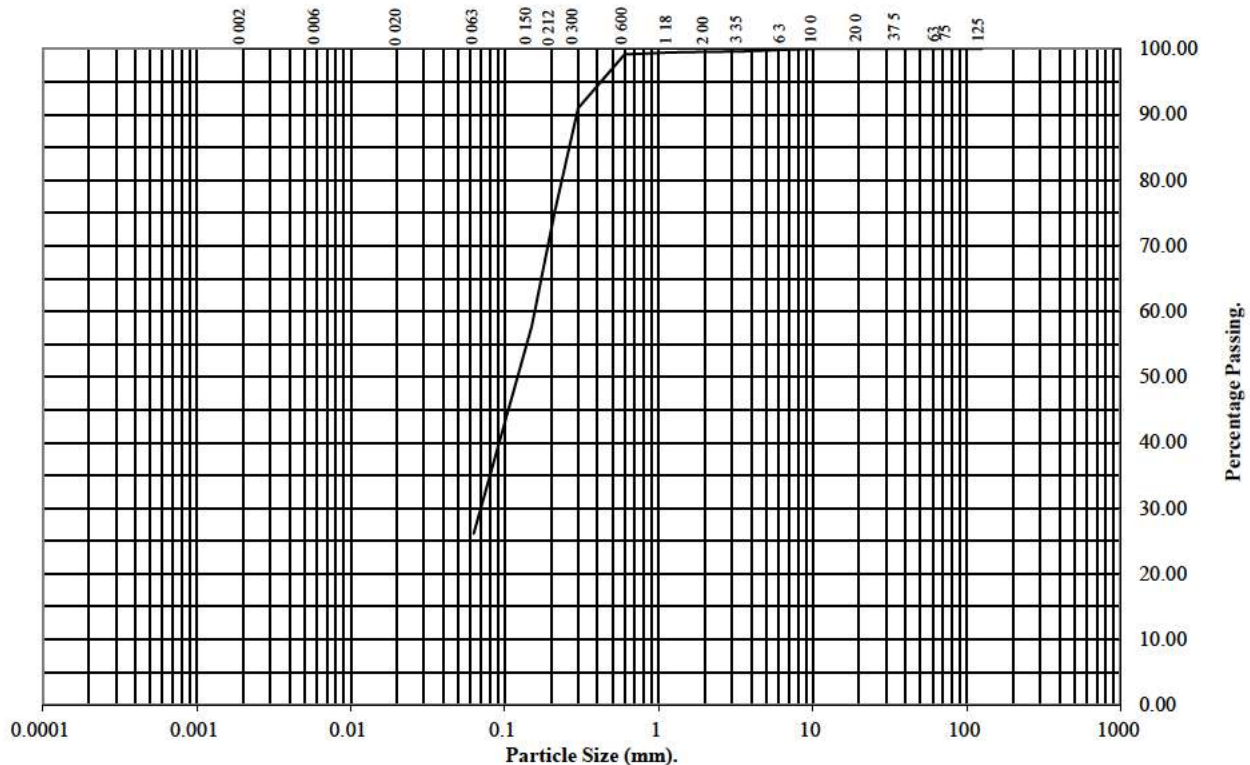
| BS Test Sieve (mm) | Percentage Passing |

Particle size distribution (PSD) testing has generally confirmed the findings illustrated in the exploratory hole logs.
