LAND AT CRABTREE FARM, BARWELL (PARCEL 1)

PHASE II GEO-ENVIRONMENTAL ASSESSMENT  
FOR  
JAMES MADISON HOMES LIMITED

**Project Ref:**  
EAL.02.20

**Date:**  
September 2020

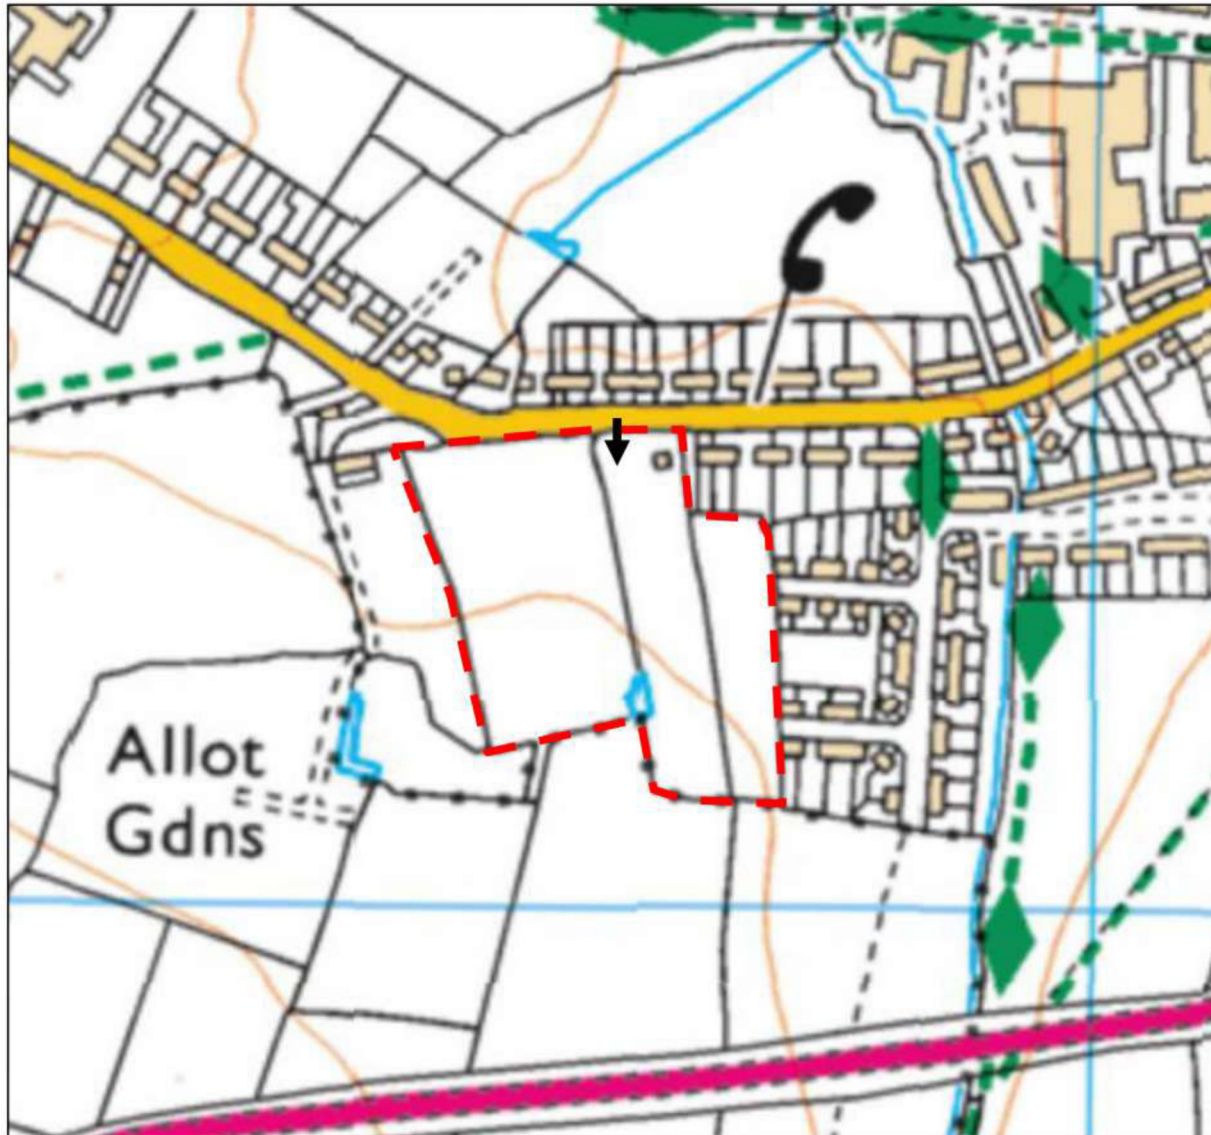
Site Layout

Site Boundary

Access

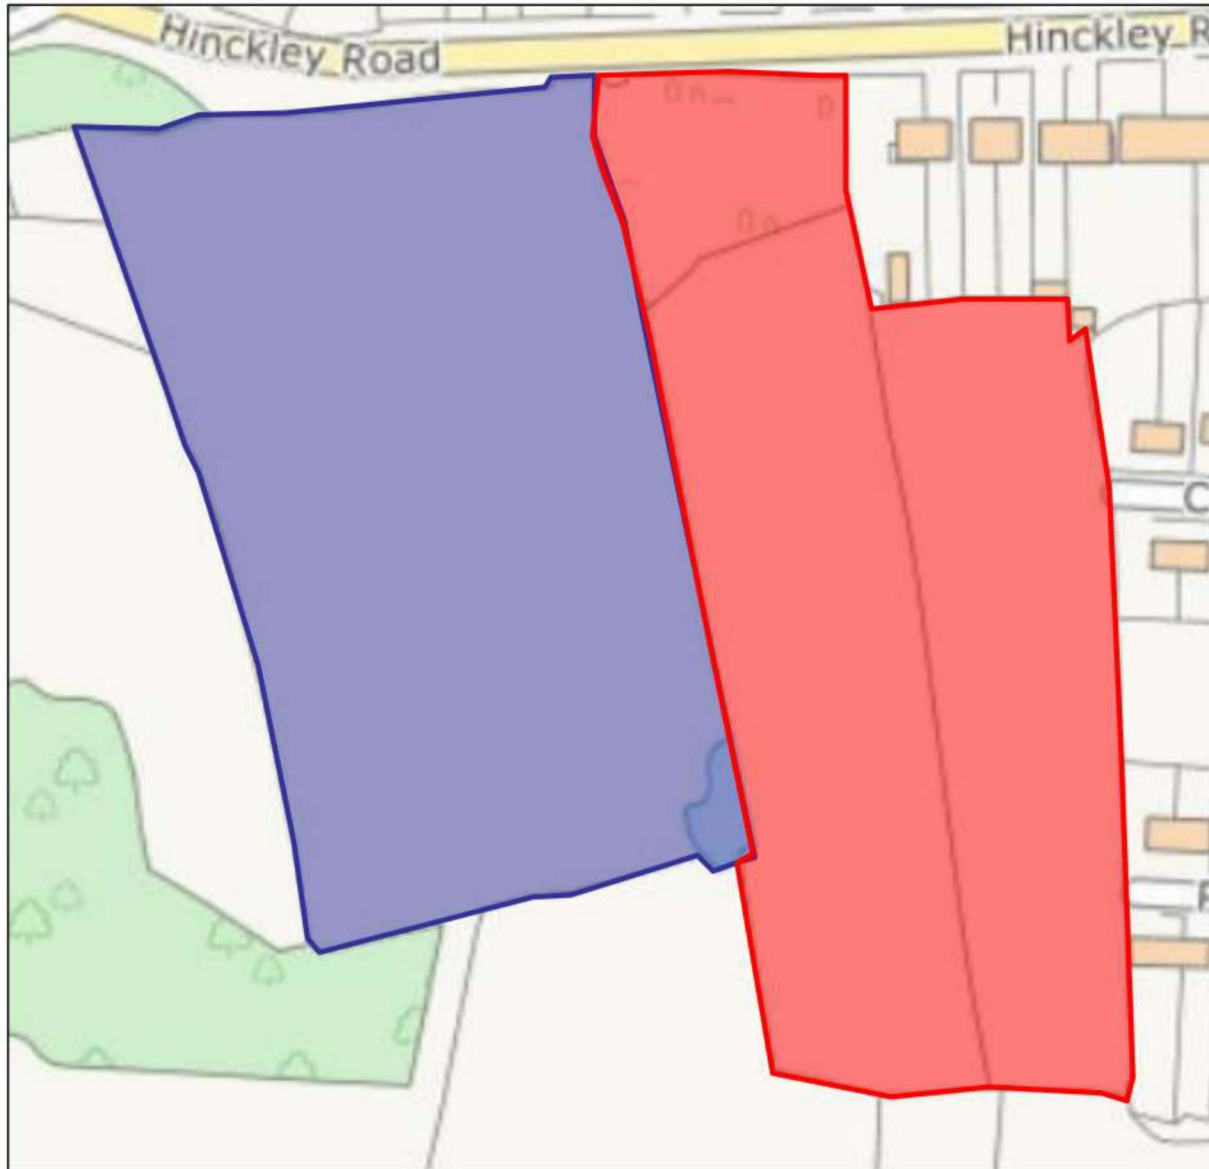
Proposed End Use Plan

Parcel 2 - area of proposed burial ground (not included in Phase II Report)

The intrusive investigation incorporated both the area of the proposed residential (Parcel 1) and the area of the proposed burial ground (Parcel 2). This report will focus solely on the proposed residential development area (Parcel 1). A separate report will be issued for the burial ground (Parcel 2). A site plan showing the extents of Parcel 1 and 2 is included in **Appendix A** for clarity.

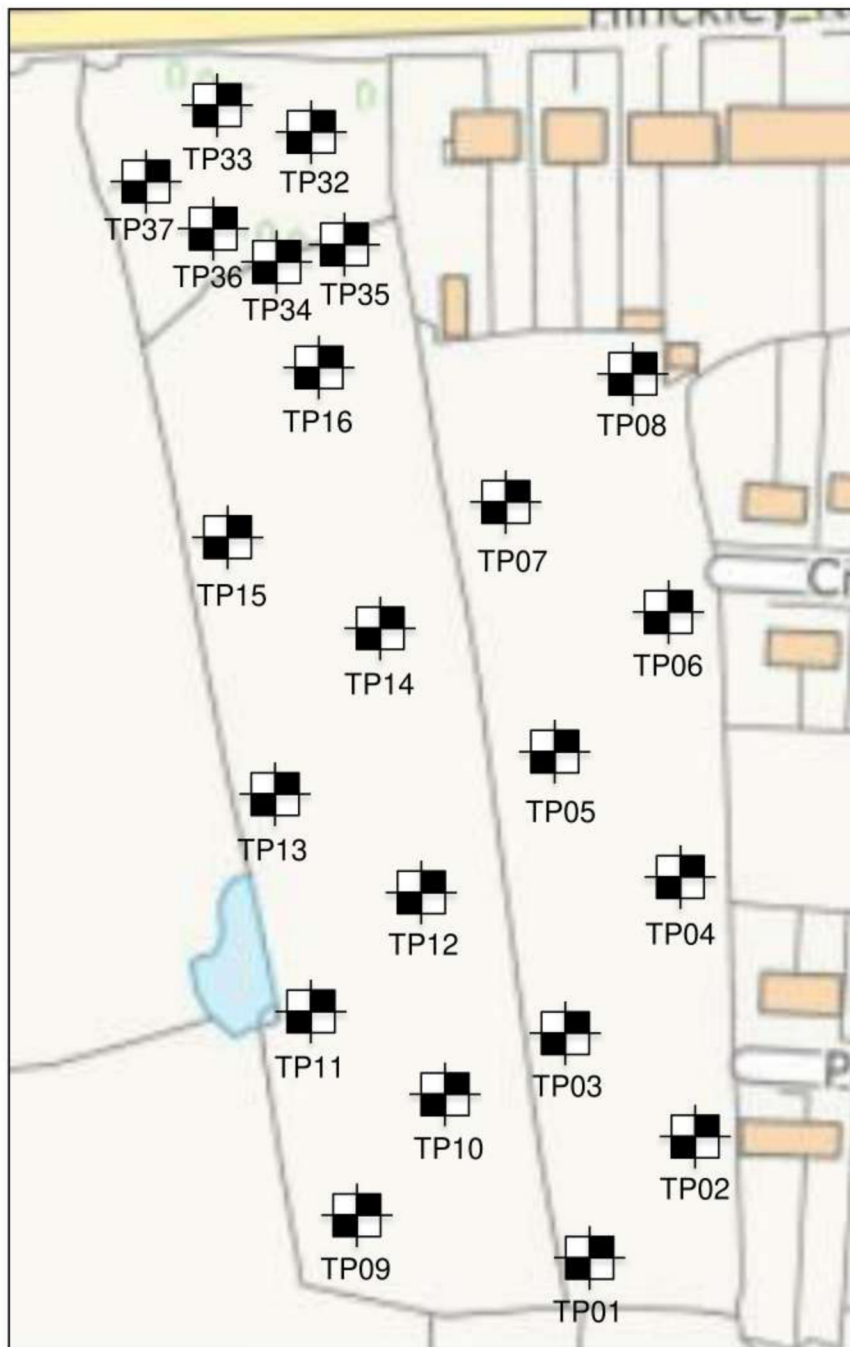
Exploratory Hole Location Plan

Trial Pit

The exploratory hole location plan along with all exploratory hole records are contained in **Appendix B**.

| Hole ID | Location | Notes |
|---|---|---|
| TP01 – TP16 & TP37 | General Grid | Shallow Sampling/Aid Foundation Design |
| TP32 & TP33 | Historic Farm Property | Shallow Sampling/Aid Foundation Design/Assess Ground Gas Risk |
| TP34 – TP36 | Historic Pond | Shallow Sampling/Aid Foundation Design/Assess Ground Gas Risk |

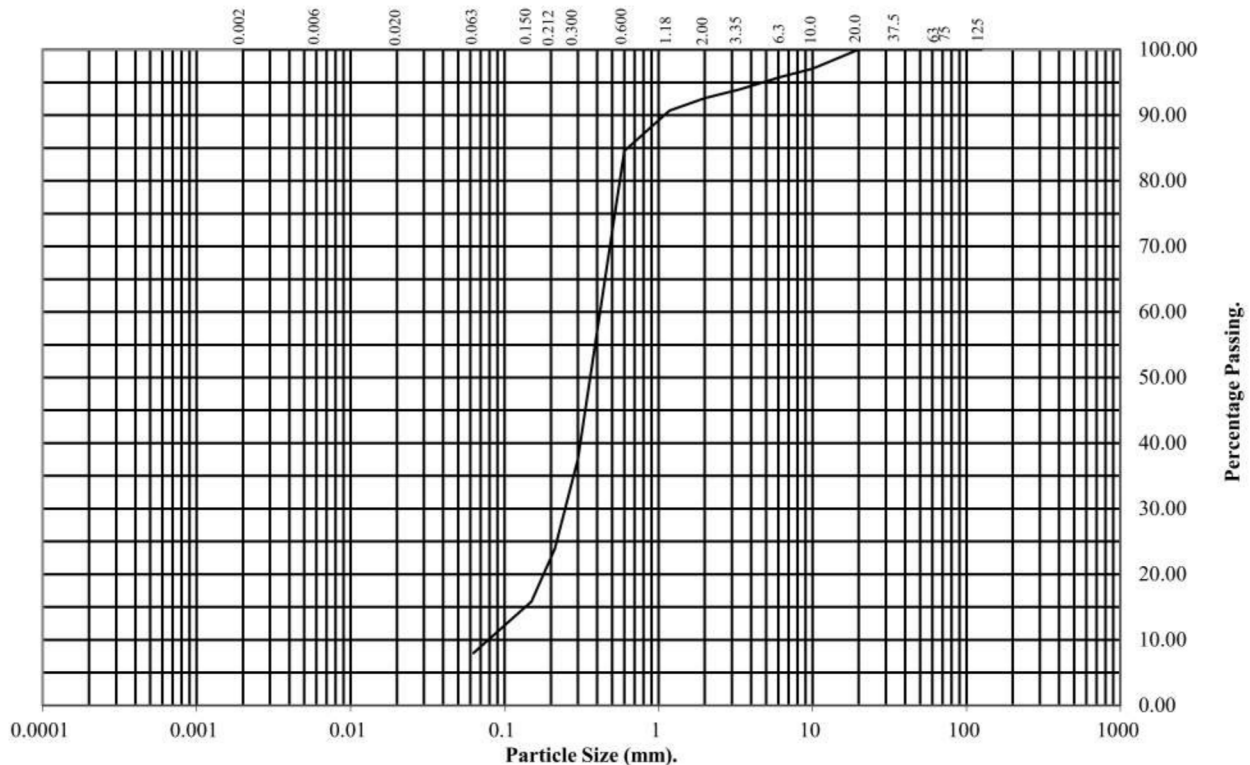
| BS Test Sieve (mm) | Percentage Passing |

Particle size distribution (PSD) testing of the glaciofluvial soils encountered in the northern area of the site has generally confirmed that these soils are predominantly granular.
