## Bat Emergence and Re-Entry Surveys (BERS)

143 The Park, Market Bosworth, CV13 0LP

This report is prepared to inform a planning application for the proposal described as: Two storey side extension and single storey rear extension.

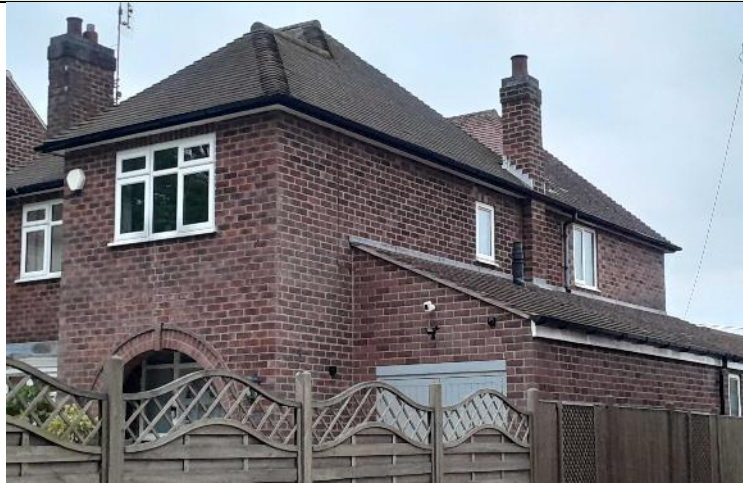
| Surveyor observations | | |
|---|---|---|
| Surveyor 1 | <p><b>No emergences observed.</b></p> <p>Summary of general activity:<br/> Species – Common pipistrelle (CP), noctule (NOC)<br/> Flight paths – Frequent bat passes along the southern elevation from the west and from neighbouring building to the east.<br/> Foraging areas – Constant foraging in the driveway to the south of B1 and the neighbouring property.</p> <p>The first bat was a CP seen passing south to east over the surveyor. Further passes were seen from CP at 21:14 and 21:23 from northeast to south over the neighbouring driveway, and from west to east along the southern elevation of B1 at 21:22 and 21:24, with constant foraging activity in this area throughout the survey until 22:24. At 21:26, a CP passed from east to south. This looked to be an emergence from the neighbouring building to the east but cannot be confirmed as this building was not being surveyed. At 21:48 a CP was seen to pass around the chimney on the eastern elevation of B1.</p> <p>A NOC was seen commuting high over B1 at 21:21 and again at 21:34 and 21:58.</p> | |

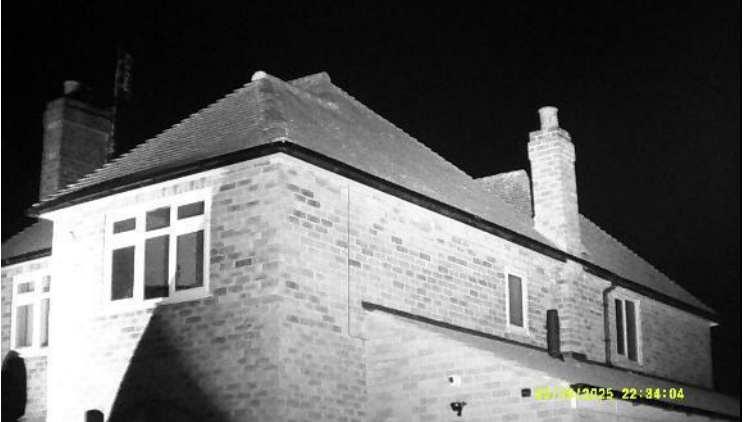
| <i>IR position 1</i> | <p>Camera position: observing eastern and southern elevation of B1</p> <p><b>Emergences observed: No.</b></p> <p>Additional activity includes a pass from west to east, along the southern elevation of B1 at 21:28. This matched a CP heard not seen by the surveyor at this time.</p> | |

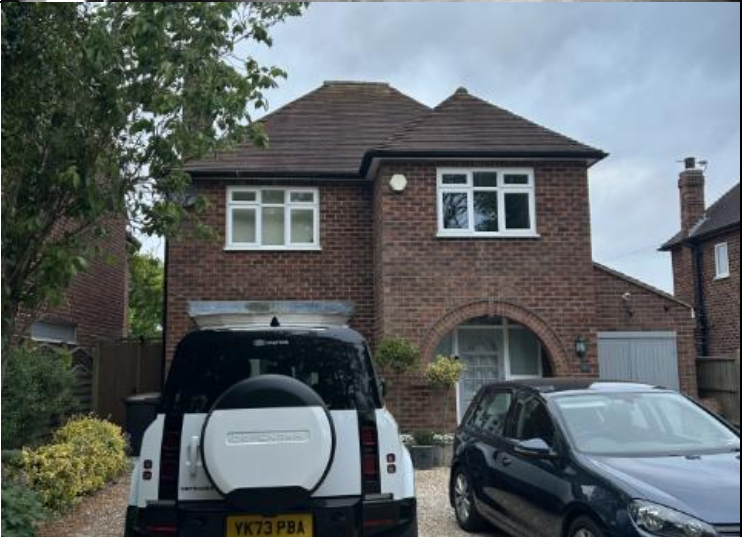
| <i>Surveyor 2</i> | <p><b>No emergences observed.</b></p> <p>Summary of general activity:<br/> Species – CP, NOC, Brown long-eared bat (BLE)<br/> Flight paths – Frequent bat passes along the southern elevation and along neighbouring houses as well as along the western elevation between B1 and the dwelling to the west.<br/> Foraging areas – Foraging to southwest over driveway area.</p> <p>Activity began at 21:07 with a CP heard not seen. From 21:14 to 21:20 a CP was seen foraging over the driveway to the southwest. Further CP activity was heard not seen at 21:46, 21:48, 22:02 and 22:16 with the last CP heard at 22:20. NOC were heard not seen at 21:22, 21:34 and 21:59. BLE was heard not seen at 22:18, 22:21 and 22:24.</p> | |

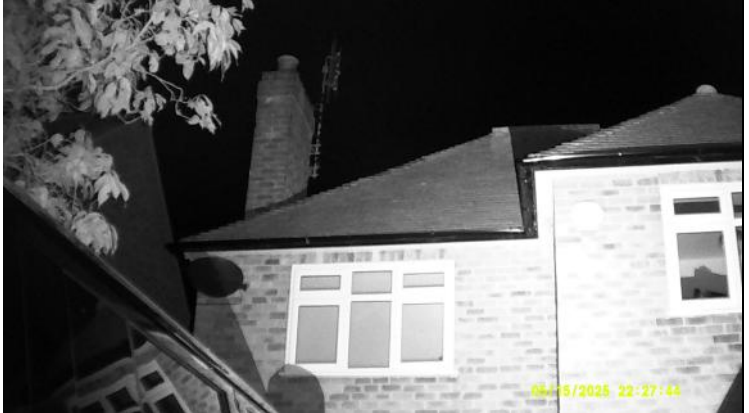
| <i>IR position 2</i> | <p>Camera position: observing southern elevation of B1</p> <p><b>Emergences observed: No.</b></p> <p>No emergences were observed and the footage was in line with the observations of surveyor 2 with no additional activity.</p> | |

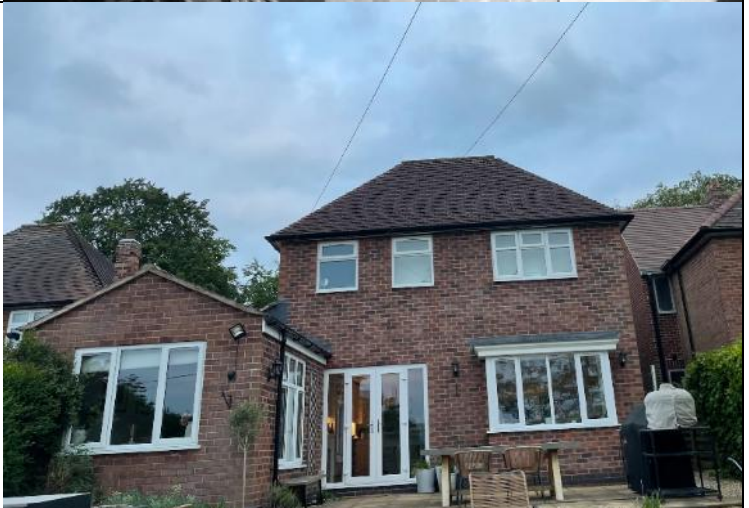
| <i>Surveyor 3</i> | <p><b>No emergences observed.</b></p> <p>Summary of general activity:<br/> Species – CP<br/> Flight paths – Frequent bat passes from north to east past B1<br/> Foraging areas – Constant foraging in the neighbouring gardens.</p> <p>Two CPs were seen passing from north to east over the surveyor at 21:33 and again at 21:48. Constant foraging activity was heard not seen from CP throughout the survey.</p> | |

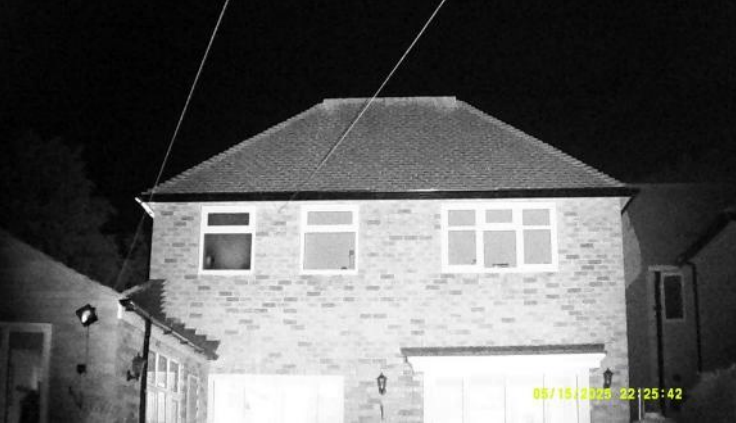
| <i>IR position 3</i> | Camera position: observing northern elevation of B1<br><b>Emergences observed: No.</b><br><br>No emergences were observed, and the footage was in line with the observations of surveyor 3 with no additional activity. | | | | |

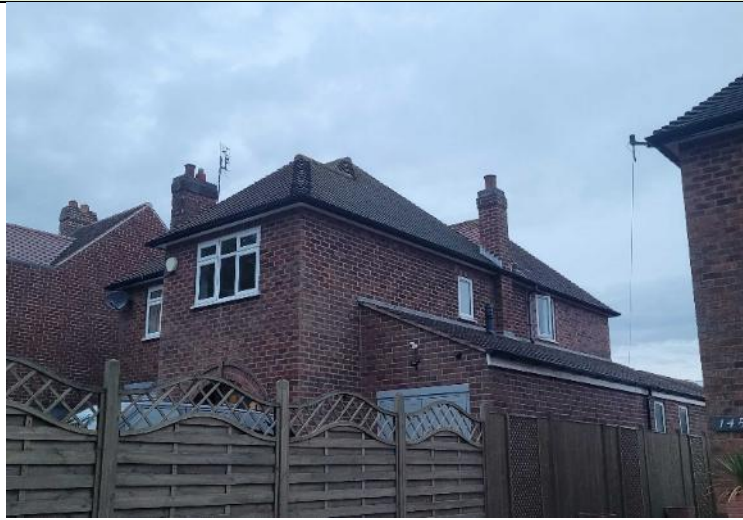
| Surveyor observations | | |
|---|---|---|
| Surveyor 1 | <p><b>No emergencies observed.</b></p> <p>Summary of general activity:<br/> Species – CP, soprano pipistrelle (SP), NOC, Myotis sp. (MYO)<br/> Flight paths – Frequent bat passes from the south to the north, past the eastern elevation<br/> Foraging areas – Foraging in the driveway to the south of B1 and the neighbouring property.</p> <p>The first bat was CP passing south of B1 at 21:40 and again at 21:41. CP was then heard not seen at 21:45 and again at 22:31 and 22:45. A SP was heard not seen at 21:51. At 22:18 and 22:26, a NOC was heard not seen. MYO (Daubenton's) was heard not seen at 22:19.</p> | |

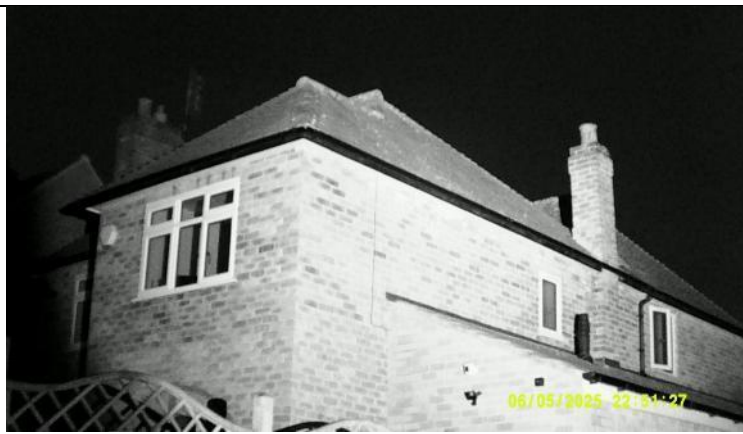
| Surveyor observations | | |
|---|---|---|
| IR position 1 | <p>Camera position: observing eastern elevation and southern corner of B1</p> <p><b>Emergences observed: No.</b></p> <p>No emergencies were observed, and the footage was in line with the observations of surveyor 1 with no additional activity.</p> | |

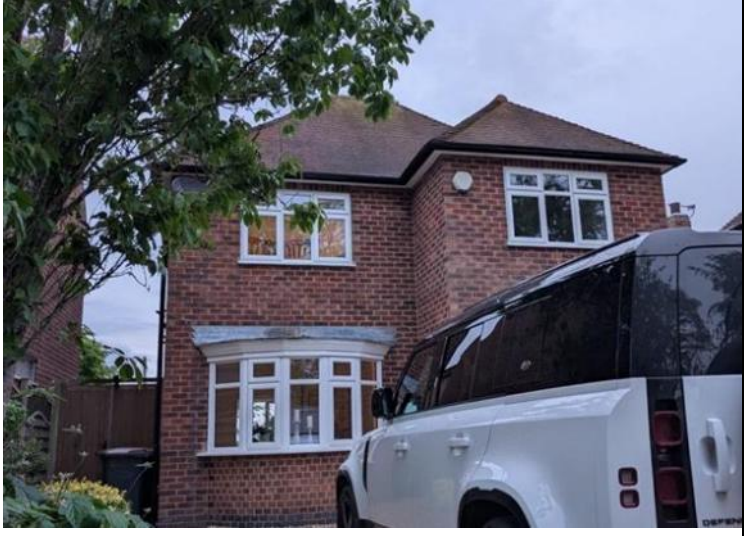
| <p><i>Surveyor 2</i></p> | <p><b>No emergencies observed.</b></p> <p>Summary of general activity:<br/> Species – CP, SP, NOC, MYO<br/> Flight paths – Frequent bat passes along the alleyway next to the western elevation<br/> Foraging areas – Foraging in the driveway to the south of B1</p> <p>A CP was seen passing between B1 and the neighbouring building to the west at 21:41. At 21:45 a CP was heard not seen and again at 22:45. A SP was seen coming from the south of the surveyors position, before foraging over the tree and garden to the west of the site at 21:52. A NOC was heard not seen at 22:18 and 22:26. A distant MYO (Daubenton's) was heard not seen at 22:20.</p> | |

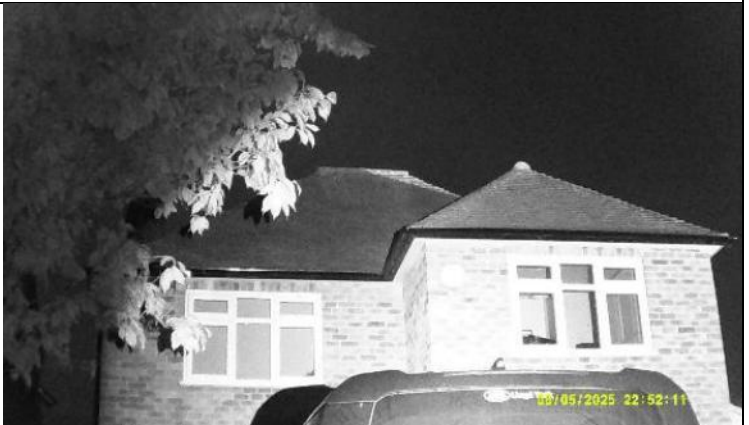
| <p><i>IR position 2</i></p> | <p>Camera position: observing southern elevation of B1<br/> <b>Emergences observed: No.</b></p> <p>No emergencies were observed, additional activity comprised multiple CP passes between B1 and building to the west, heading from the north to east and back</p> | |

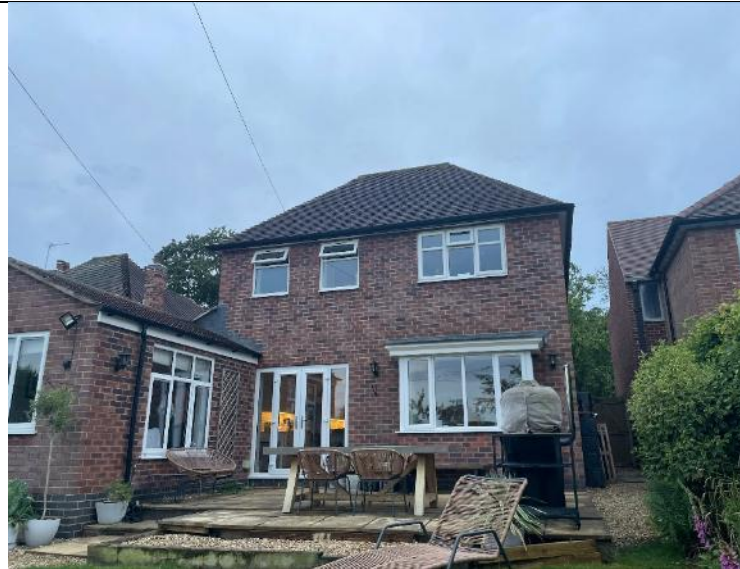
| Surveyor 3 | <p><b>No emergencies observed.</b></p> <p>Summary of general activity:<br/>Species – CP, SP, NOC<br/>Flight paths – From northwest to southeast alongside the western elevation<br/>Foraging areas – N/A</p> <p>The first bat was a CP at 21:40, with activity heard not seen from CP until 22:45. A NOC was heard not seen at 22:25. At 21:40, a SP was seen passing alongside the western elevation.</p> | | | | | |

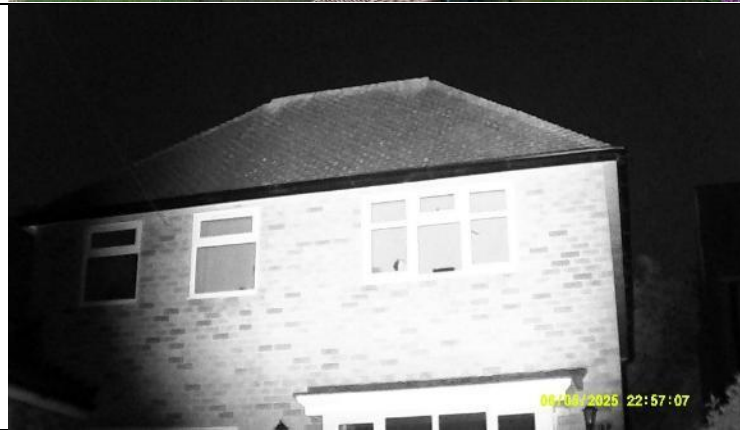
| IR position 3 | <p>Camera position: observing northern elevation of B1</p> <p><b>Emergences observed: No.</b></p> <p>No emergencies were observed, and the footage was in line with the observations of surveyor 3 with no additional activity.</p> | | | | | |

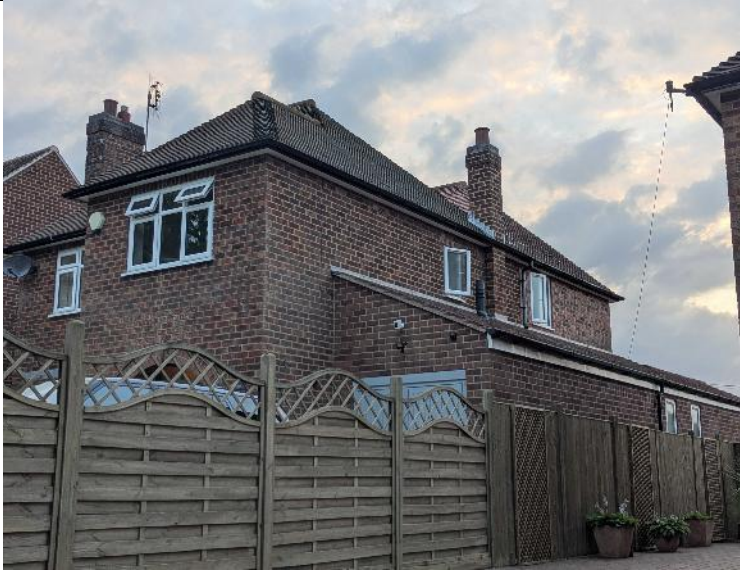
| <i>Surveyor 1</i> | <b>No emergences observed.</b><br><br>Summary of general activity:<br>Species – CP, SP<br>Flight paths – Frequent bat passes along the southern and eastern elevation, around B1<br>Foraging areas – Foraging seen to the south of B1, over driveway area<br><br>Activity began at 22:01 with a CP pass along the southern elevation of B1, from southwest to northeast. A CP passed southwest to northeast along this elevation again at 22:06 and 22:18. Two CP were seen passing along the eastern elevation and foraging to the south of B1 from 22:22 to 22:30. At 22:31 a distant SP was heard not seen. The last activity was a CP pass at 22:37.<br><br>A suspected CP emergence was noted at 22:07 from the neighbouring building to the east. | | | | | | |

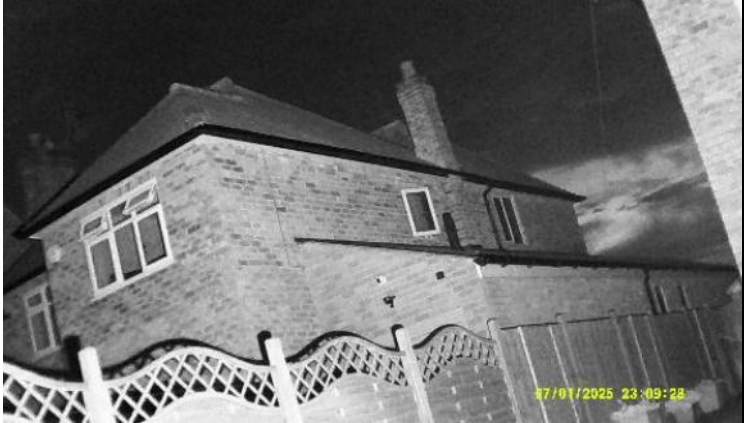
| <i>IR position 1</i> | <p>Camera position: observing eastern elevation of B1</p> <p><b>Emergences observed: No.</b></p> <p>No emergences were observed and the footage was in line with the observations of surveyor 1 with no additional activity.</p> | |

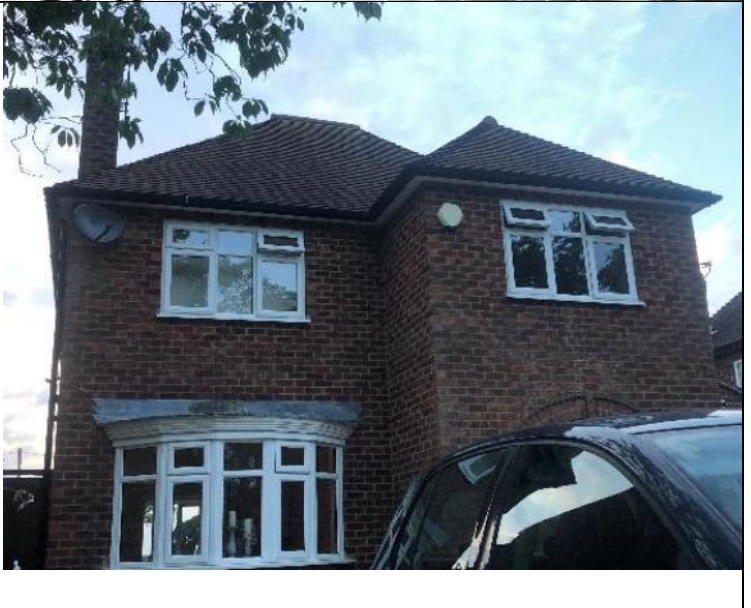
| <i>Surveyor 2</i> | <p><b>No emergences observed.</b></p> <p>Summary of general activity:<br/> Species – CP<br/> Flight paths – Frequent bat passes along the alleyway next to the western elevation and along the southern elevation<br/> Foraging areas – Foraging in the driveway to the south of B1 and within the driveway of the house to the west of B1</p> <p>The first activity was a CP pass at 21:57 from the west of the surveyor's position, with further passes along this route from 22:00 repeatedly, from west to east and back until 22:24. At 22:04 a CP was seen passing from north to south along the alleyway to the west of B1 and the neighbouring building and again at 22:05 and 22:06. CP were seen foraging to the south of B1 at 22:23. Further CP passes were seen at 22:26 and 22:29 along the western elevation of B1.</p> | |

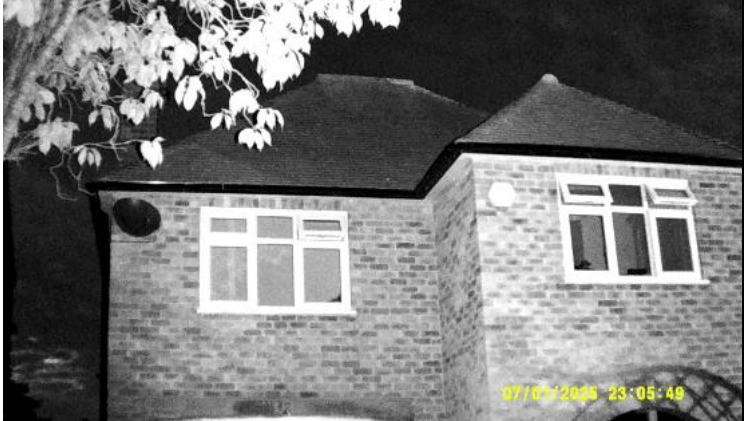
| <i>IR position 2</i> | <p>Camera position: observing southern and western elevation of B1</p> <p><b>Emergences observed: No.</b></p> <p>No emergences were observed and the footage was in line with the observations of surveyor 2 with no additional activity. The footage confirmed that the passes from CP along the western elevation were bats foraging and passing from the northwest.</p> | |

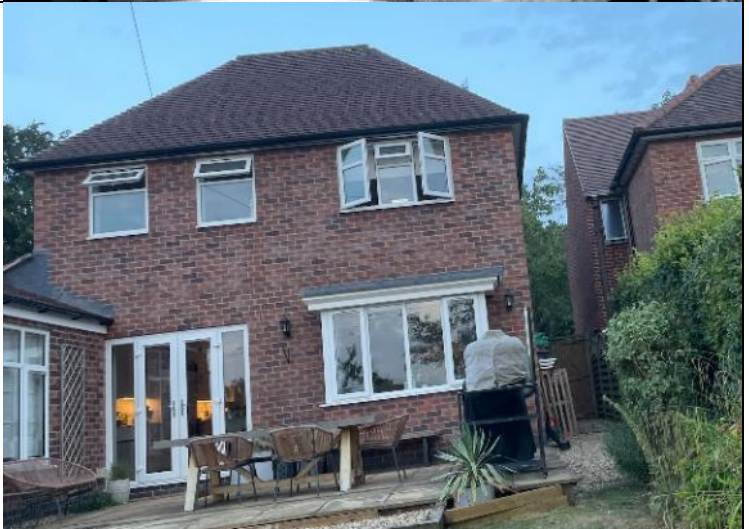
| <i>Surveyor 3</i> | <p><b>No emergences observed.</b></p> <p>Summary of general activity:<br/> Species – CP<br/> Flight paths – From the southwest to northeast around B1<br/> Foraging areas – Foraging in the neighbouring garden to the northeast of B1.</p> | |

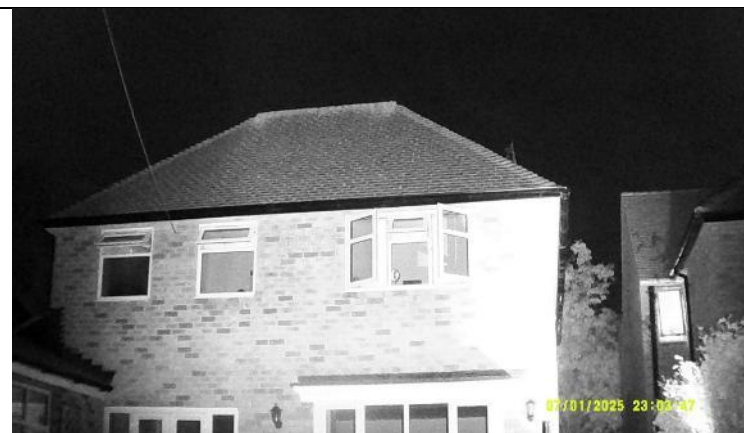
| IR position 3 | <p>Camera position: observing northern elevation of B1</p> <p><b>Emergences observed: No.</b></p> <p>No emergences were observed and the footage was in line with the observations of surveyor 3 with no additional activity.</p> | | | | | |

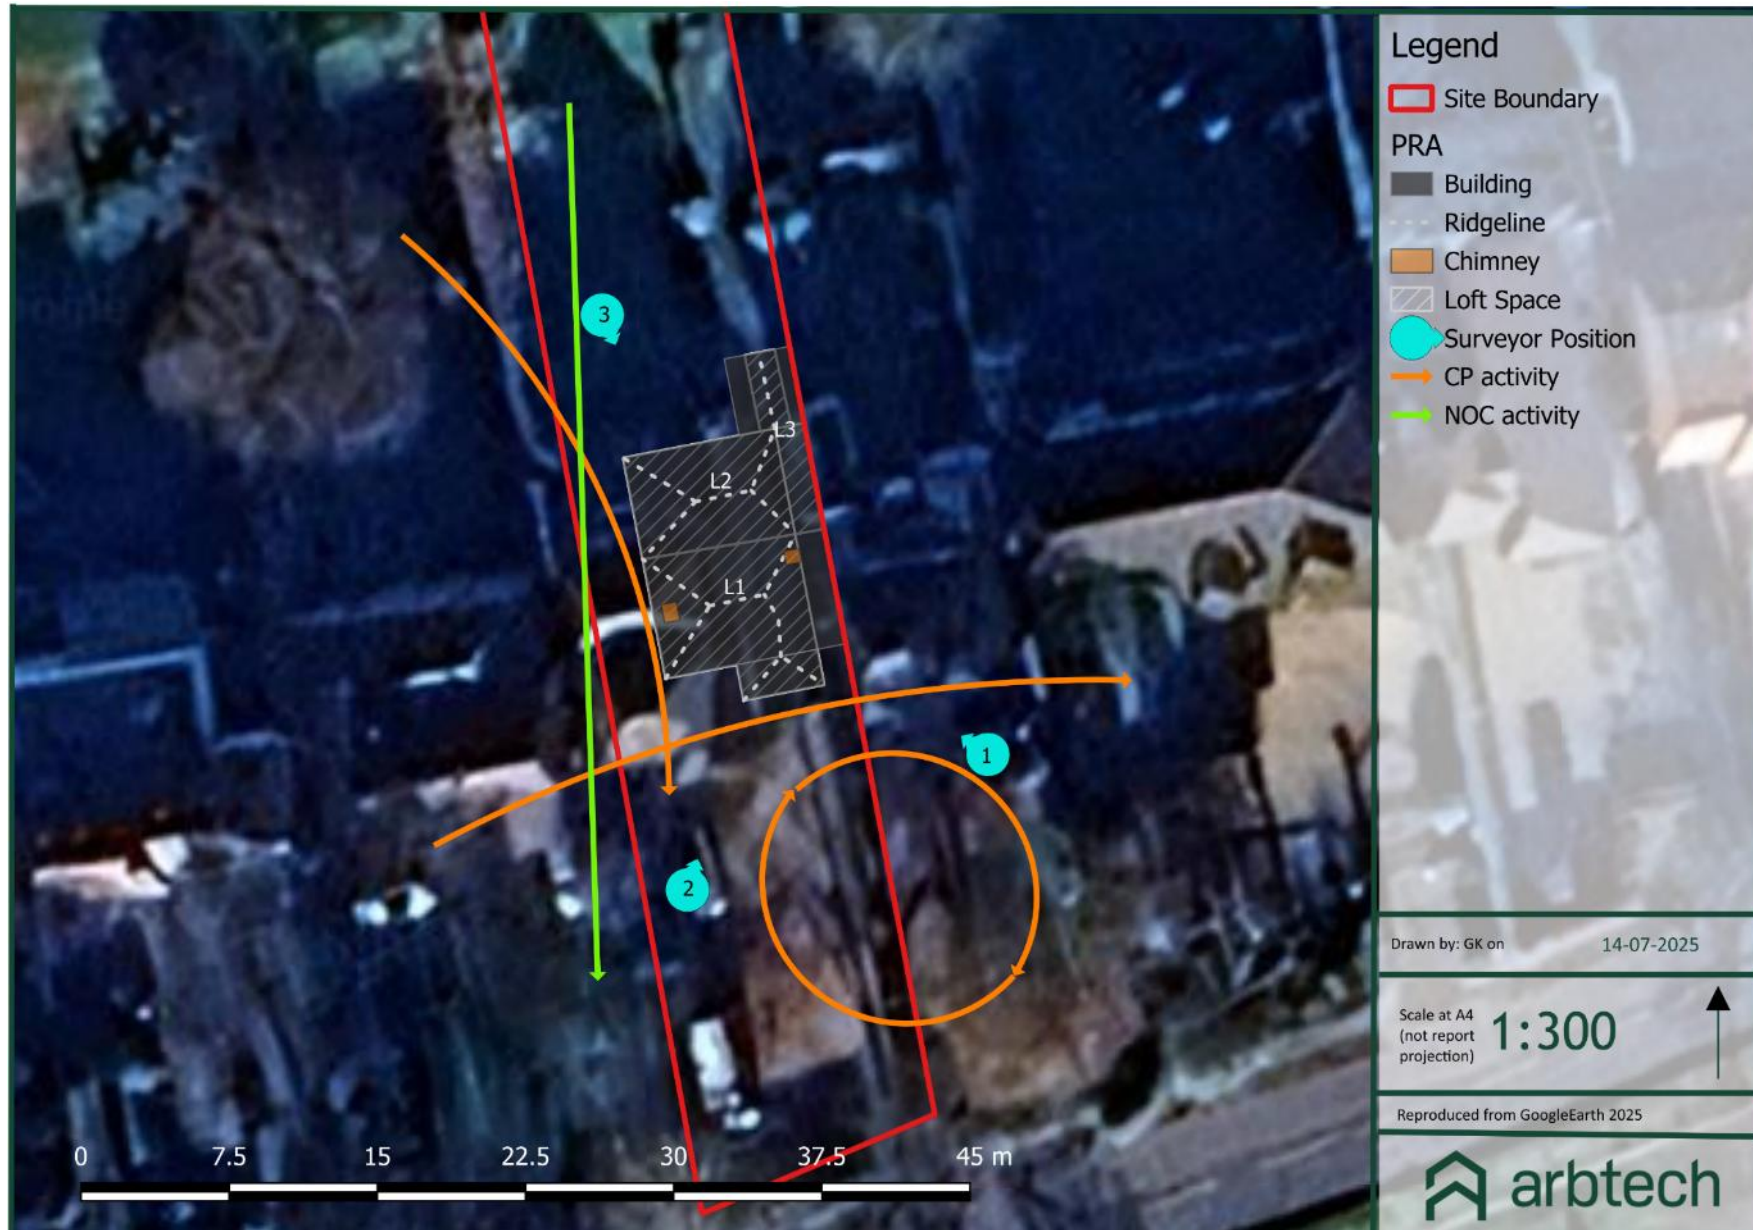
## Appendix 1b: BERS plan

| Field Survey | | | | | |
|---|---|---|---|---|---|
| <i>Surveyor and position</i> | Surveyor Position | Name | BERS Experience / Bat Licence | BCT Competency | Elevation |
| | 1 - Lead | Georgia Knight | 4 years | Level 2 | Observing eastern and southern elevation |
| | 2 | Joshua New | 1 year | Level 2 | Observing northern and western elevation |
| | 3 | Will Burdett | 1 year | Level 2 | Observing southern and western elevation |

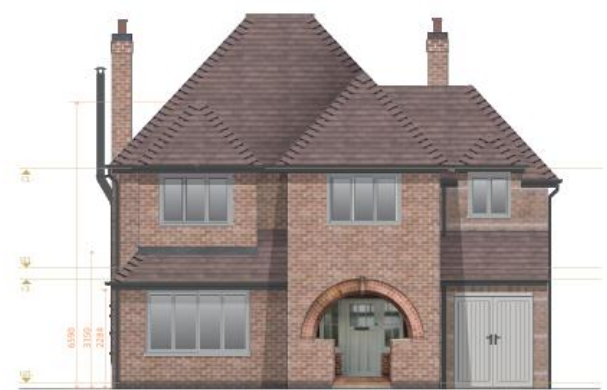
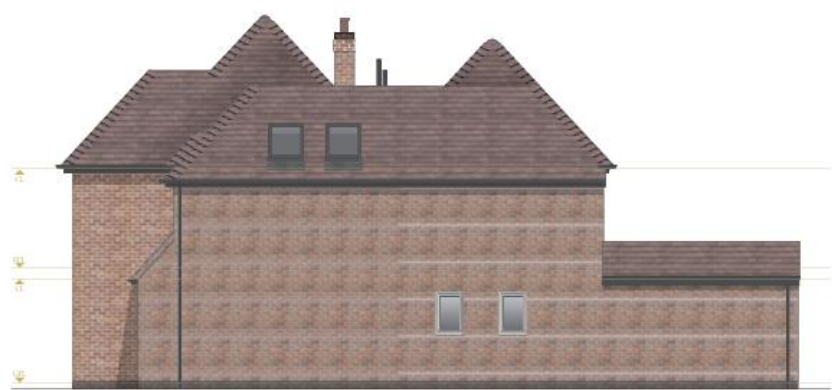
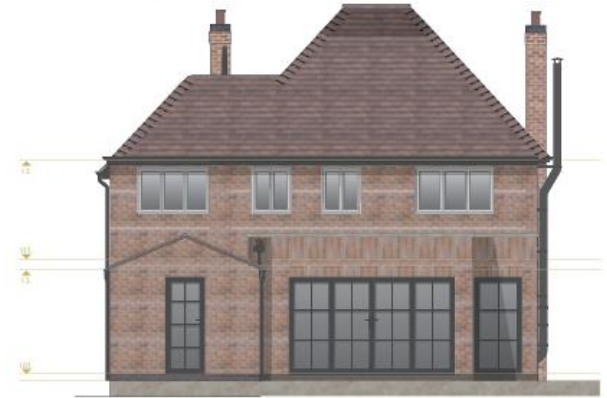
## Appendix 2: Proposed plans

Structural changes to building – Roof tiles removed and two storey extension added to eastern elevation. Single storey extension on northern elevation.

Dormer window extension on southern elevation.

- MATERIALS**
- Proposed pitched roof in clay tile to match existing with bonner hips- suggest Heritage Roof Tiles Clayhall medium blend/Hamlet Mix or similar. Wet ridges only. No dry system to be used.
  - EPDM/GRP/felt faced flat roof to contractors preference with moulded stone capping
  - Facing brick weathered rustic red/heather to closely match existing. Two courses of soldier bricks below stone capping.
  - New flush casement premium uPVC windows in RAL7012 'Pebble' beige or 'claystone' TBC.
  - 2 no. VeluxFK66 60 x 1178
  - Flat fixed roof light 1000 X 1000 to flat roof
  - Timber front door set and garage doors to be natural timber painted to clients specification
  - Aluminium rear doors and glazing powder coated in black. Doors to have parliament hinge to allow for full swing.
  - Black aluminium rainwater goods
