253278 Cunnery Close  
Barlestone

## Appendix E

### PHOTOGRAPHIC RECORD

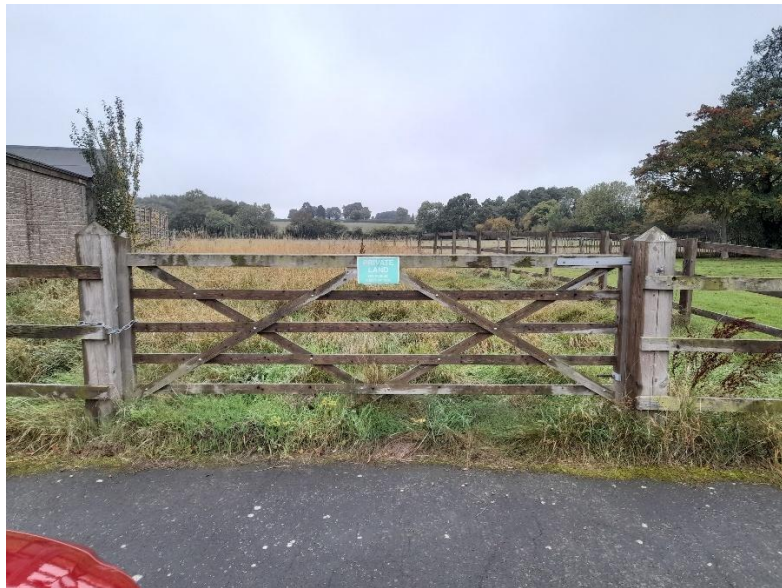
| 1 | 03/10/2025 |

| Access gate off Cunnery Close, note main site area is fenced off from this entry point. | |

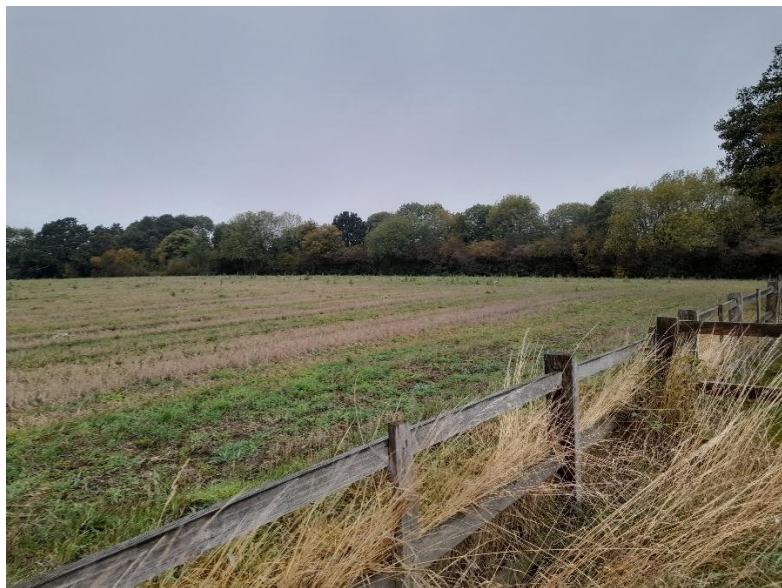
| 2 | 03/10/2025 |

| View of the northwest portion of site, looking west | |

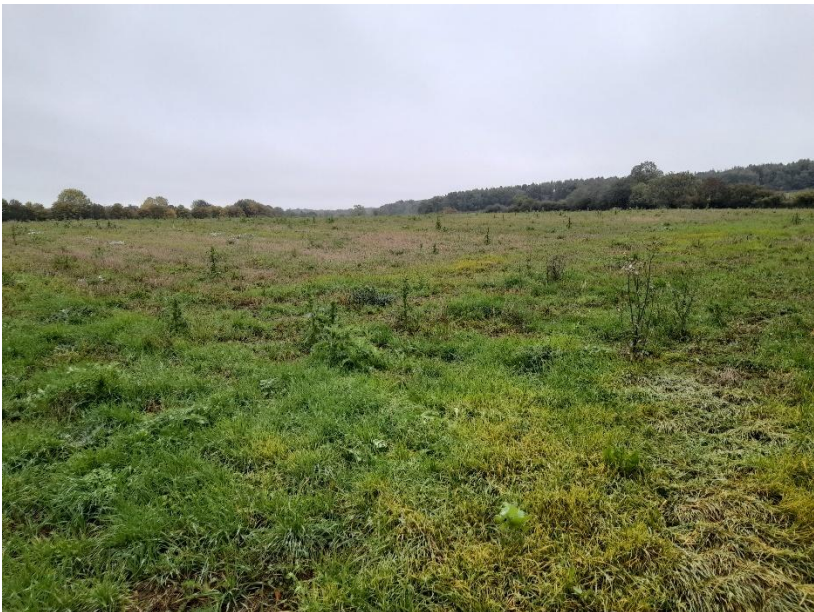
| <b>Photo No.</b><br><br>3 | <b>Date:</b><br><br>03/10/2025 | |

| <b>Description:</b><br><br>View of the northern portion of site, looking southeast | | |

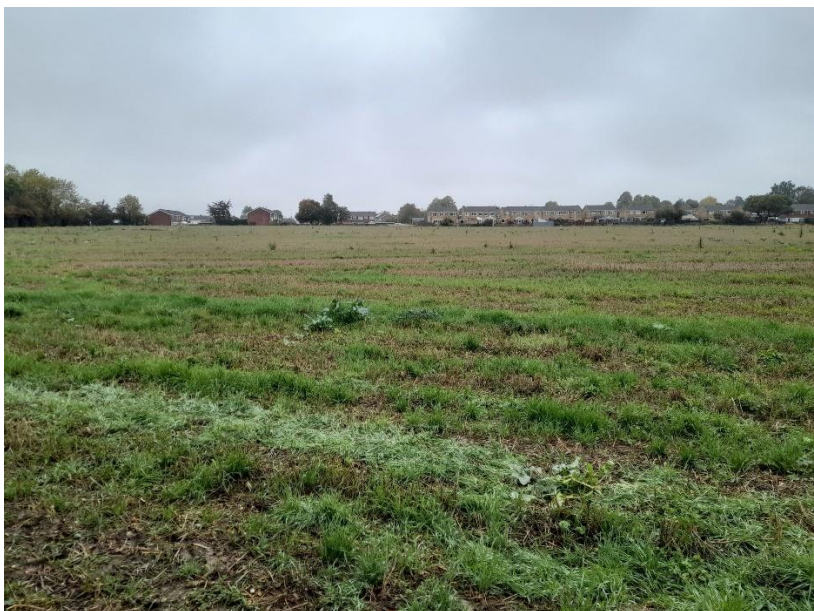
| <b>Photo No.</b><br><br>4 | <b>Date:</b><br><br>03/10/2025 |

| <b>Description:</b><br><br>View of the western half of site,<br>looking north | |

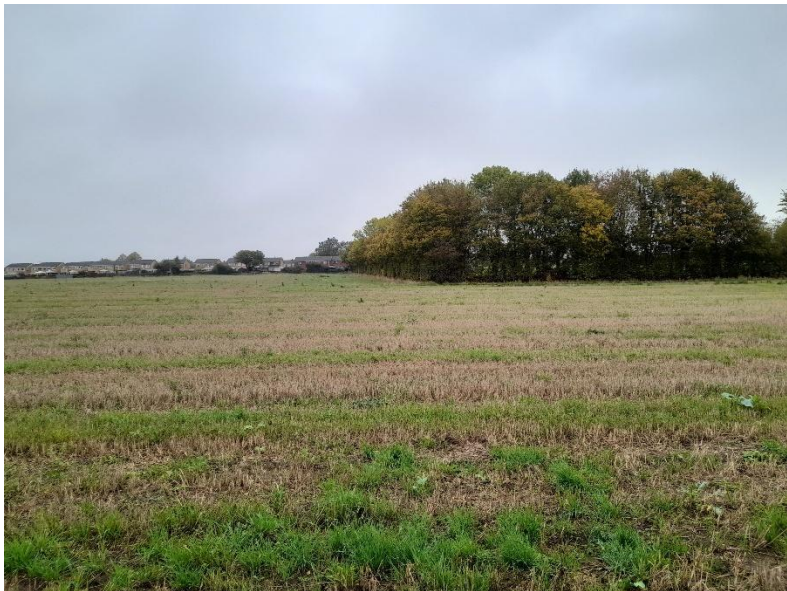
| <b>Photo No.</b><br><br>5 | <b>Date:</b><br><br>03/10/2025 | |

| <b>Description:</b><br><br>View of the central southern portion of site, looking north | | |

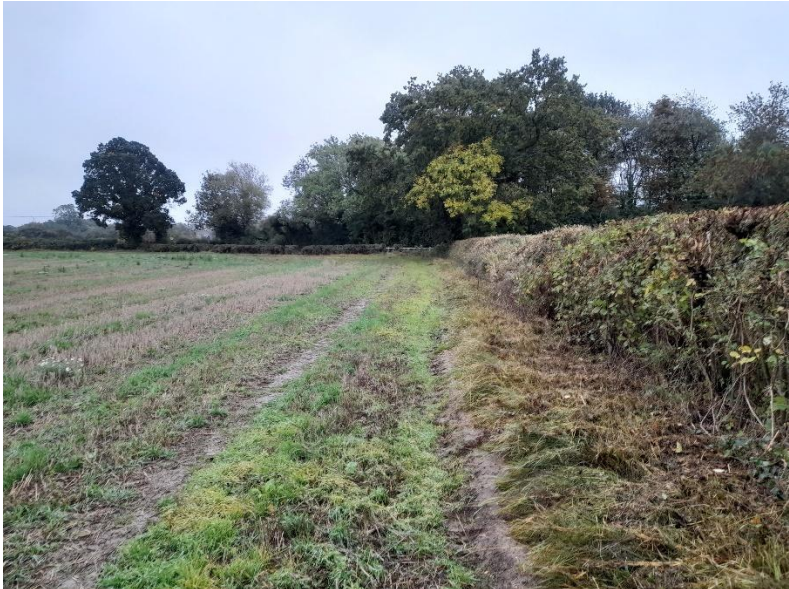
| <b>Photo No.</b><br><br>6 | <b>Date:</b><br><br>03/10/2025 | |

| <b>Description:</b><br><br>View of the southeast portion of site, looking east | | |

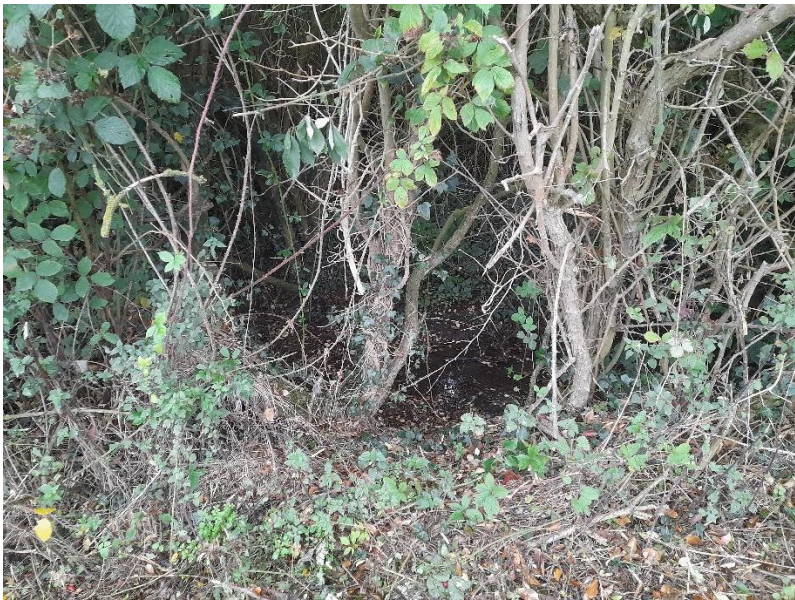
| <b>Photo No.</b><br><br>7 | <b>Date:</b><br><br>03/10/2025 | |

| <b>Description:</b><br><br>View of the off-site surface waters south of site, looking south. | | |

| Feature observed | Presence Y/N | Description |
|---|---|---|
| | Y | Surface waters are present along the southernmost boundary, running eastward under Bosworth Road away from site. |
| | - | c) Waters looked to be generally clear and clean. |

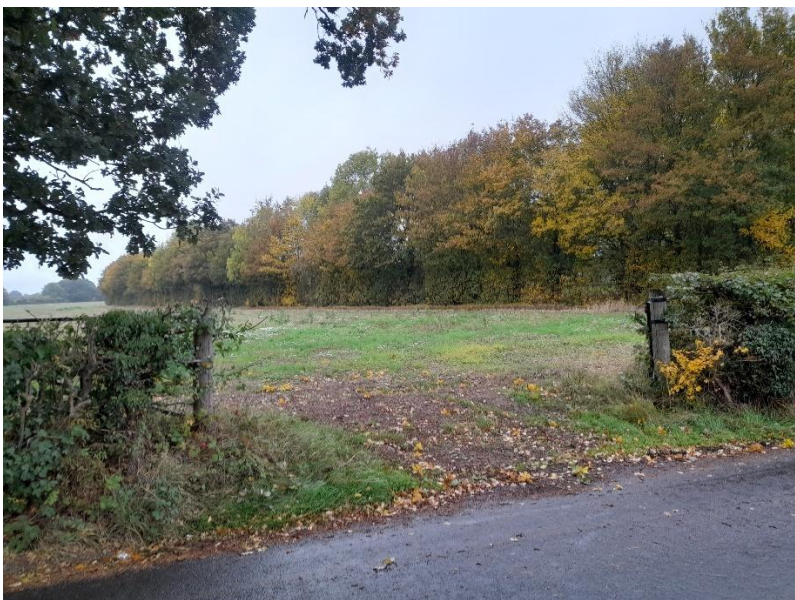
| <b>Photo No.</b><br>8 | <b>Date:</b><br>03/10/2025 | |

| <b>Description:</b><br>View of the site access off Bosworth Road. | | |

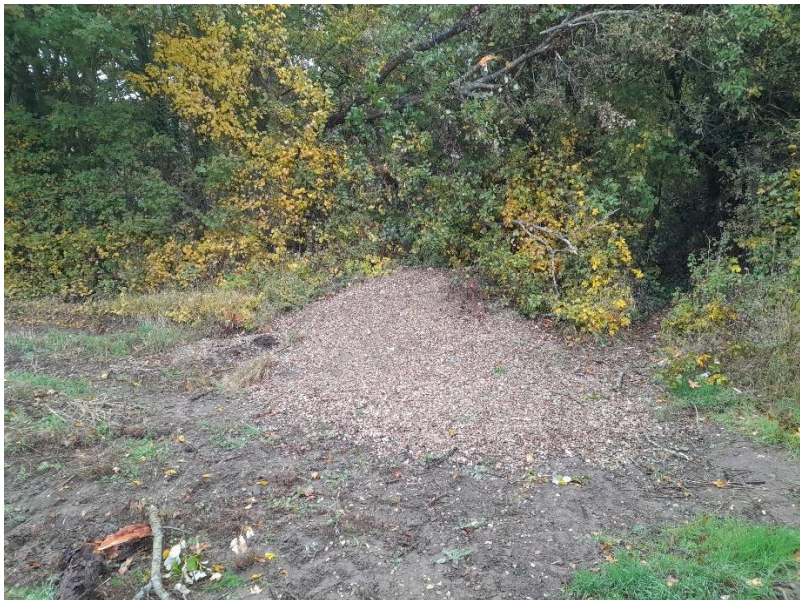
| <b>Photo No.</b><br><b>9</b> | <b>Date:</b><br>03/10/2025 | |

| <b>Description:</b><br>View of the gravel stockpile observed in the eastern portion of site. | | |

| Feature observed | Presence Y/N | Description |
|---|---|---|
| 29. Is there any visual evidence of potential contamination on site? | Y | Stockpiles of soil were noted in the eastern portion of site, comprising primarily pea shingle, and the northern portions of site, comprising a mix of soil, vegetation and fly tipped materials. No olfactory evidence of contamination was noted during the site inspection. |

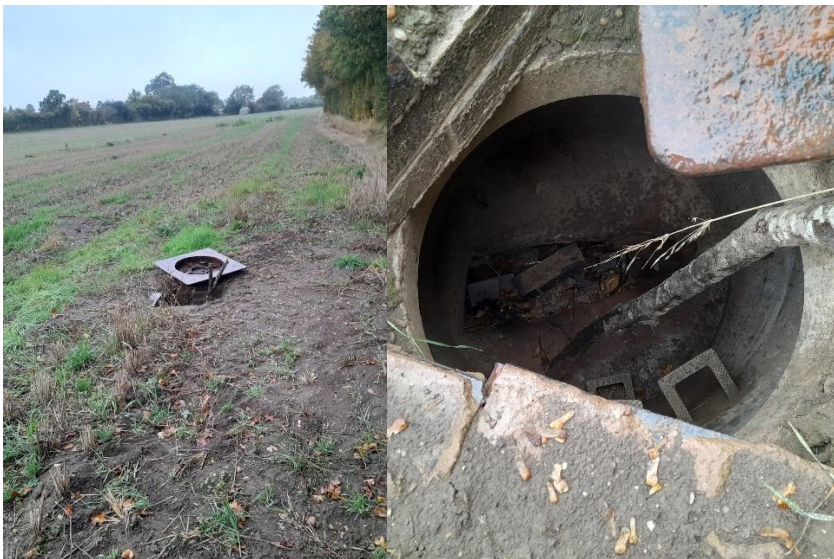
| <b>Photo No.</b><br><br>10 | <b>Date:</b><br><br>03/10/2025 | |

| <b>Description:</b><br><br>View of the service cover in the eastern portion of site (Left) and its interior, observing a drain pipe running approximately northwest to southeast (Right). | | |

| Feature observed | Presence Y/N | Description |
|---|---|---|
| | N | b) No soakaways/ interceptors/ lagoons were noted on site. A surface water drain cover is present in the eastern portion of site, however appears to be sourced offsite. |
| 12. Buried and overhead services present | Y | a) A manhole cover associated with off-site drainage is present in the eastern portion of site, the service is indicated to run northwest-southeast, toward Bosworth Road. |
| 13. Underground structures | Y | c) The service chamber for the drain in the east portion of site was noted approximately 2m deep. |

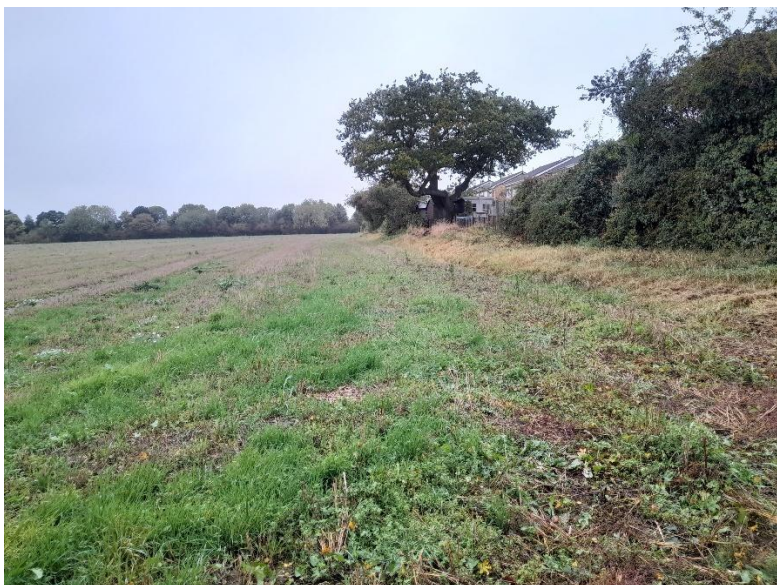
| <b>Photo No.</b><br><br>11 | <b>Date:</b><br><br>03/10/2025 | |

| <b>Description:</b><br><br>View of the northern site boundary, looking west | | |

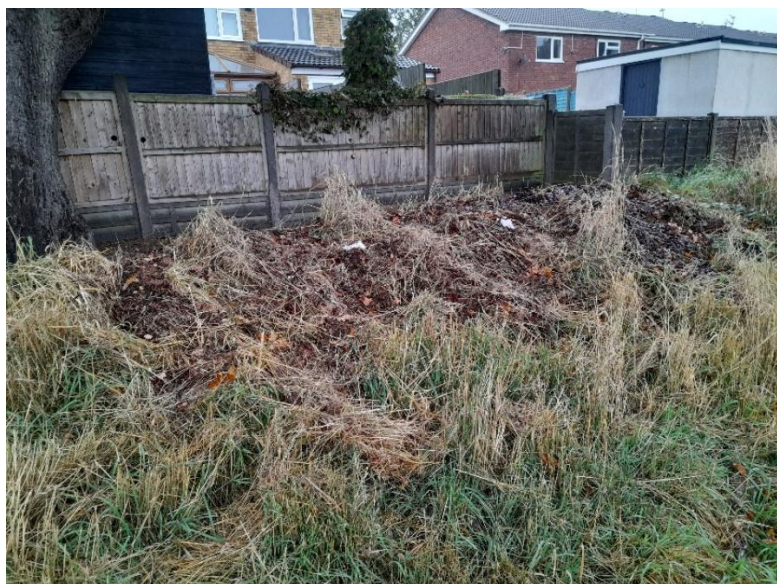
| <b>Photo No.</b><br><b>12</b> | <b>Date:</b><br>03/10/2025 | |

| <b>Description:</b><br>View of the small soil and vegetation stockpiles along the northern site boundary, looking northeast | | |

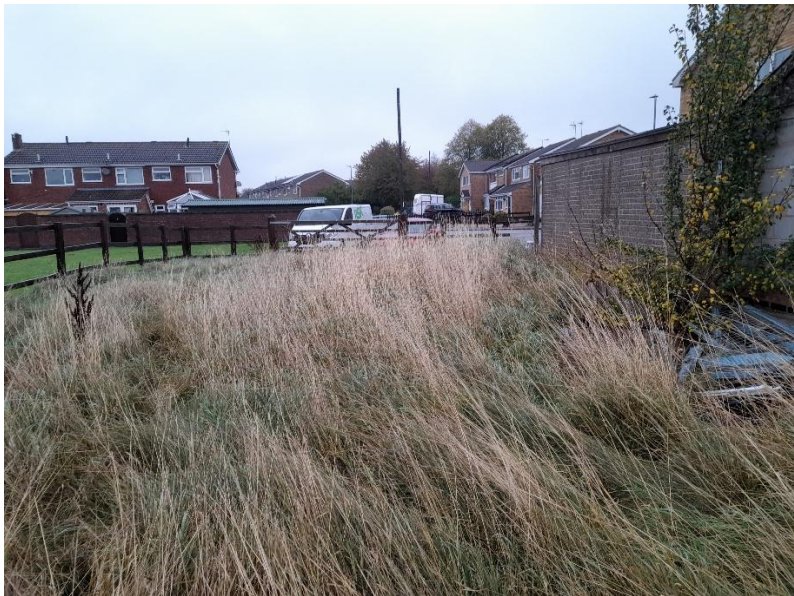
| <b>Photo No.</b><br><b>13</b> | <b>Date:</b><br>03/10/2025 | |

| <b>Description:</b><br>View of fly-tipped materials in the northern site corridor off Cunnery Close, looking north. | | |

| Feature observed | Presence Y/N | Description |
|---|---|---|
| 24. Fly-tipping | Y | Sporadic fly-tipping was noted around the site perimeter, being more abundant in the northern portion around the residential properties. |
