# Flood Risk Assessment

Land off Cunnery Close, Barlestone, Leicestershire

Gladman Developments Ltd

**Ref:** 14023

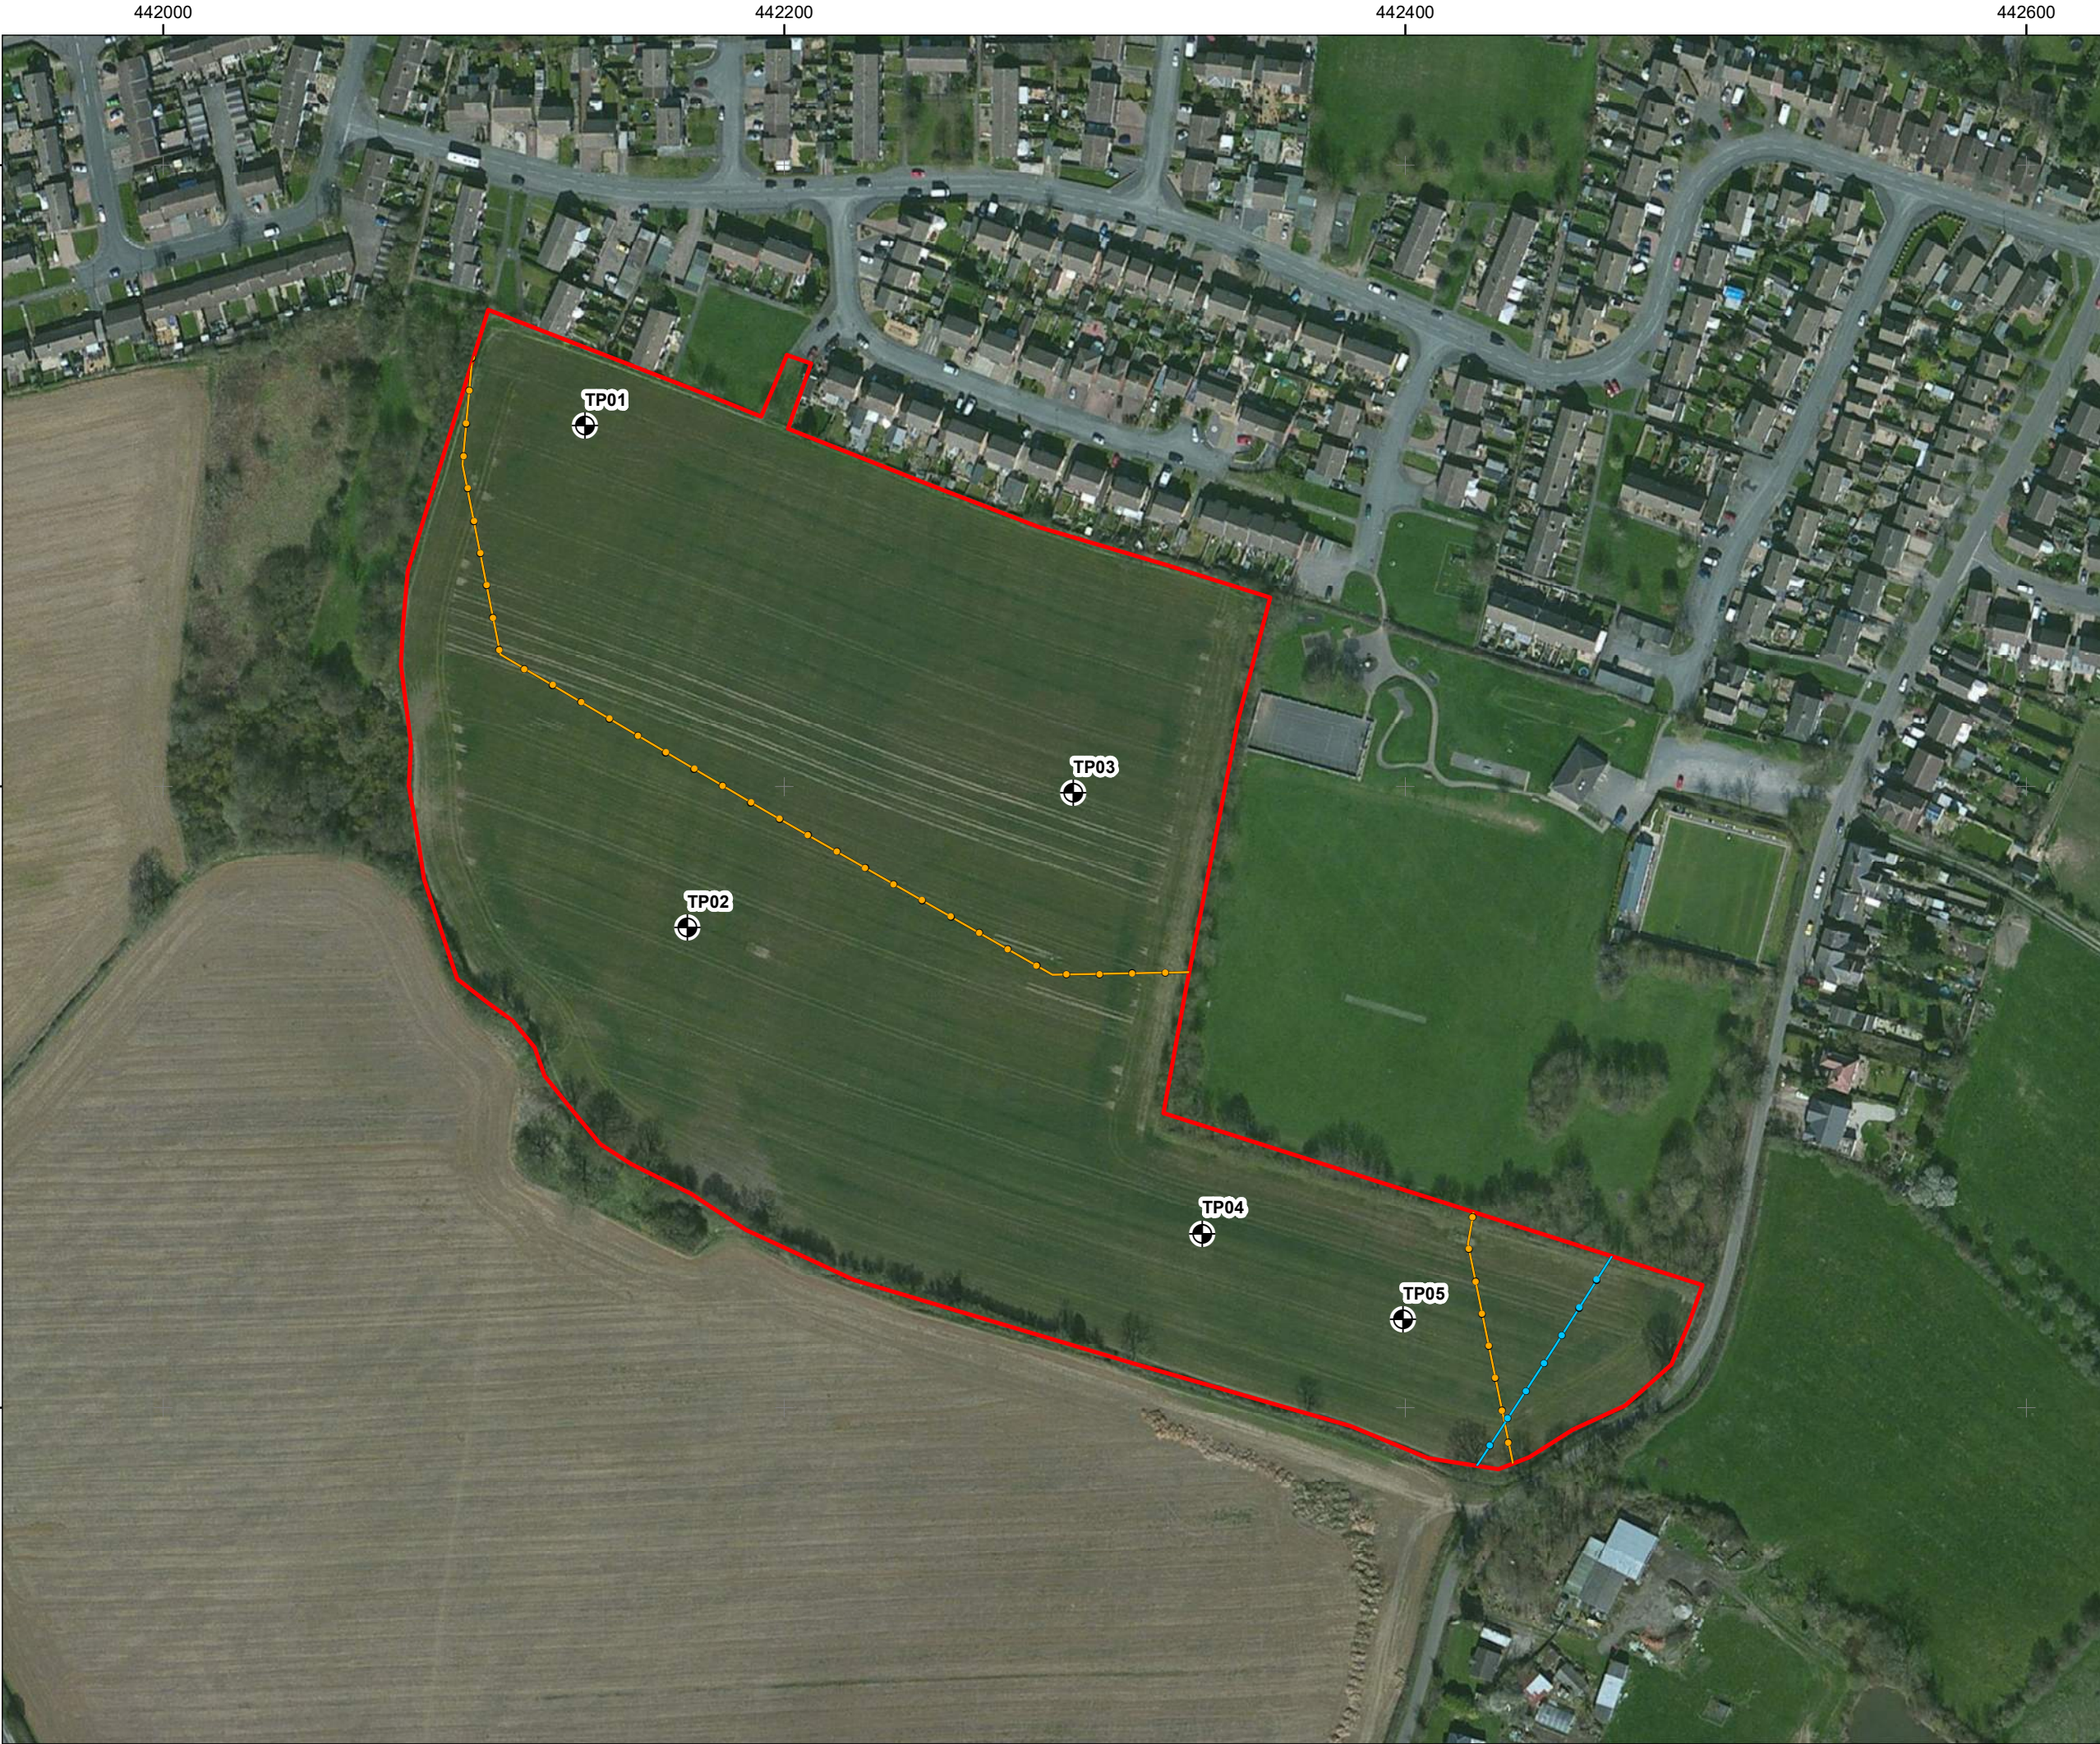
- Legend:
- Site Boundary
  - Exploratory Hole Locations with Soakaways at each end
  - Indicative Sewer Record
  - Indicative Water Record

- GPR and CAT scanning for service clearance;
- Excavation of 5No. trial pits, using an operated JCB excavator to a provisional depth of 2.50 metres below ground level (m bgl);
- Infill each trial pit with stone to maintain stability (in accordance with BRE Digest DG365, 2016);
- Undertake up to three soakage tests (depending on the amount of infiltration occurring) within each trial pit where possible to full BRE specification to assess infiltration characteristics;
- Excavate gravel on the completion of tests and stockpile in one location and backfill holes with arisings

there was an established wheat crop present in the fields. As such exploratory positions were relocated close to existing vehicle routes over the site in order to limit damage to the crop.

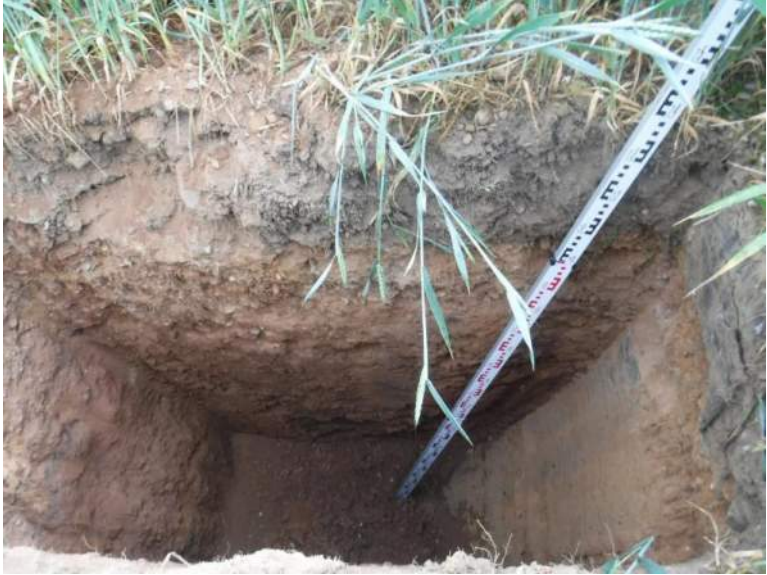
| 1 | 04/06/2019 | |

| <b>Description:</b><br>Geology of trial pit TP01 | | |

Glaciofluvial Deposits were encountered in TP01 beneath the agricultural topsoil in the north-west of the site only. This corresponded with the mapped location noted on BGS geological mapping for the site. The stratum comprised slightly gravelly, fine to coarse sand, with a gravel content of sub-angular to sub-rounded fine to coarse quartzite and was present to the base of the trial pit at a depth of 2.50m bgl.

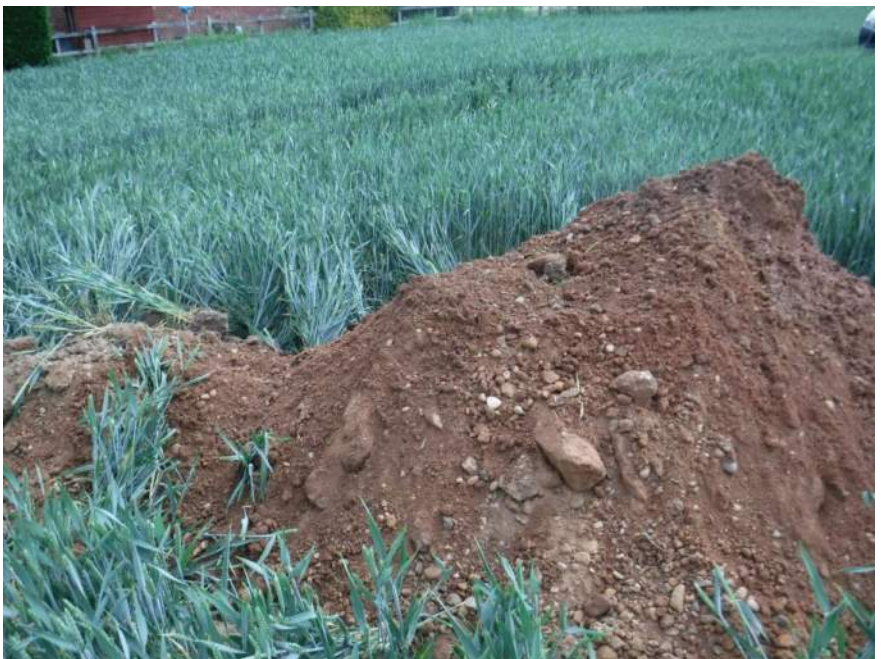
| 2 | 07/05/2019 | |

| <b>Description:</b><br>Soil arisings from trial pit TP01 | | |

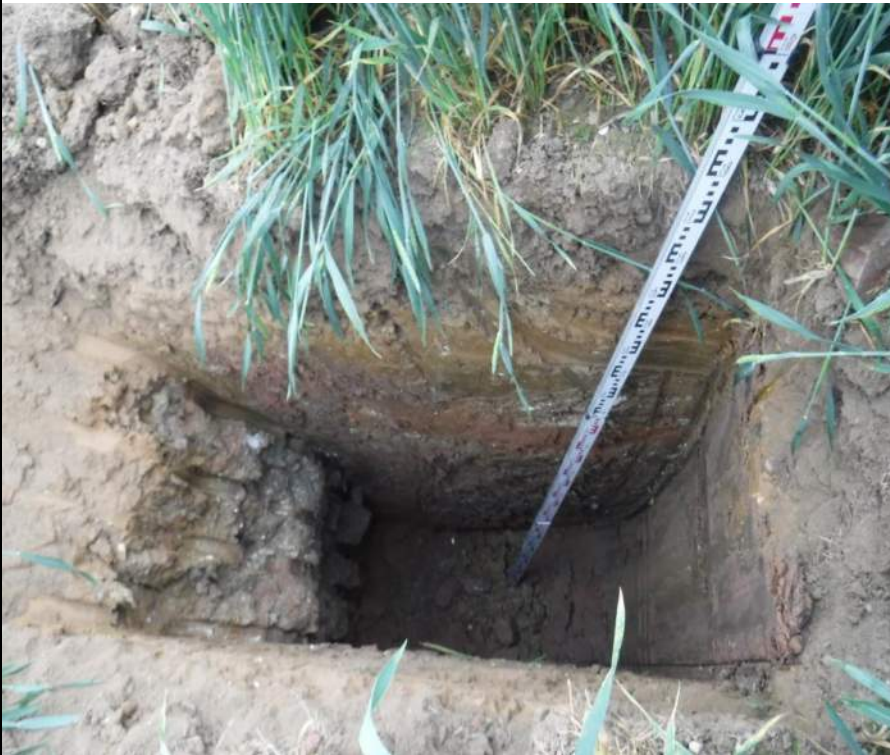
| 3 | 04/06/2019 | |

| <b>Description:</b><br>Geology of trial pit TP02 | | |

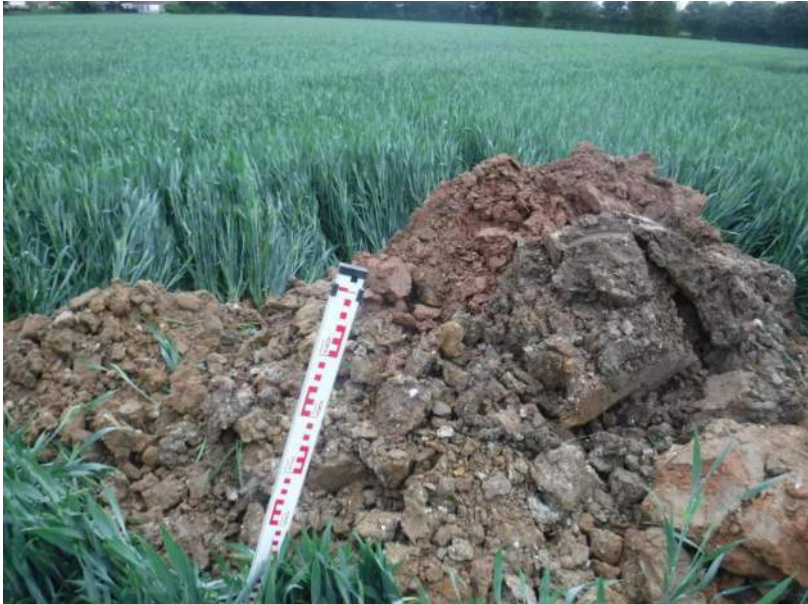
| 4 | 08/06/2019 | |

| <b>Description:</b><br>Soil arisings from TP02 | | |

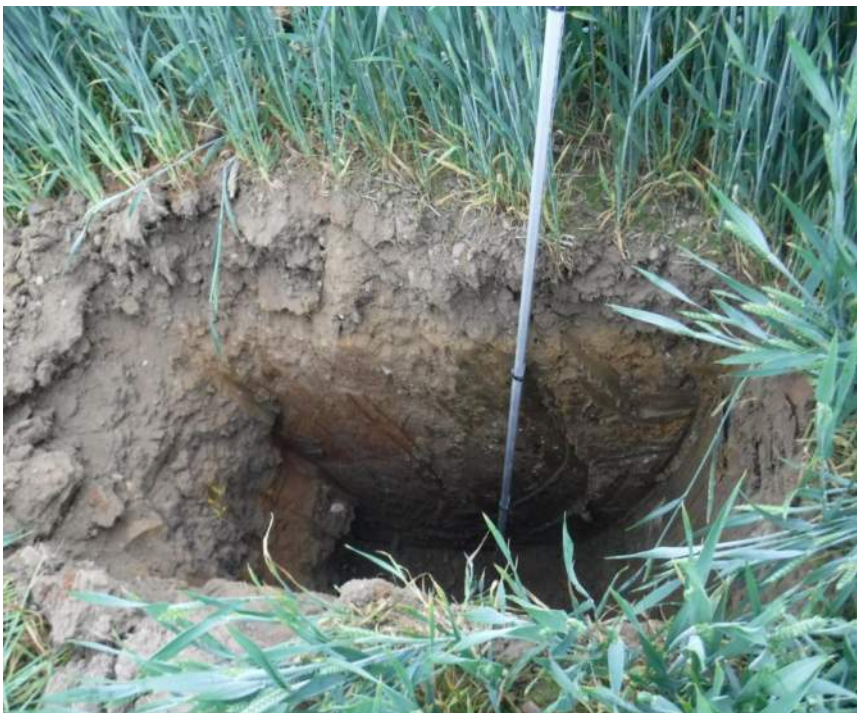
| 5 | 04/06/2019 | |

| <b>Description:</b><br>Geology of TP03 | | |

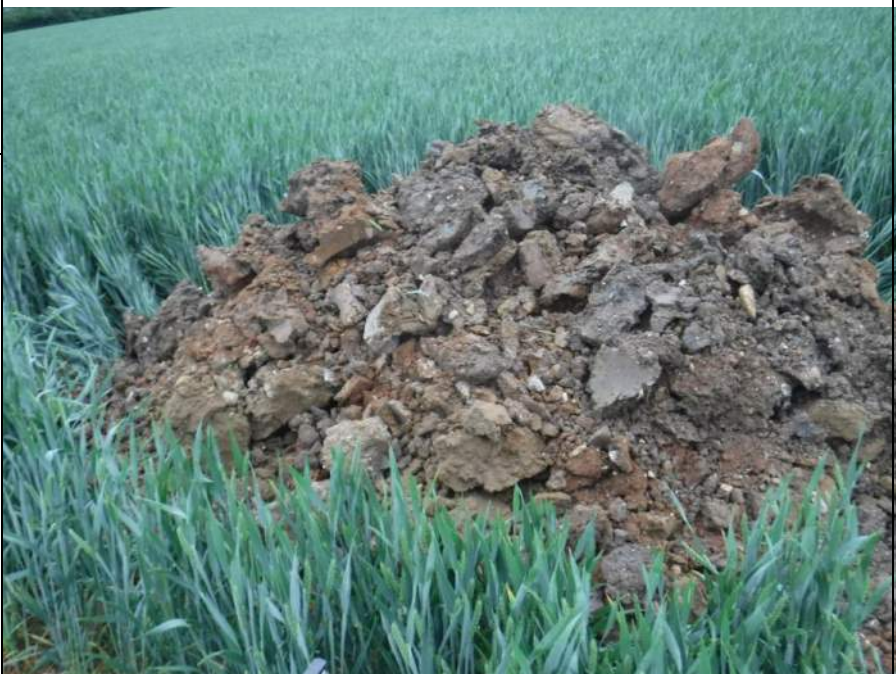
| 6 | 04/06/2019 | |

| <b>Description:</b><br>Soil arisings from TP03 | | |

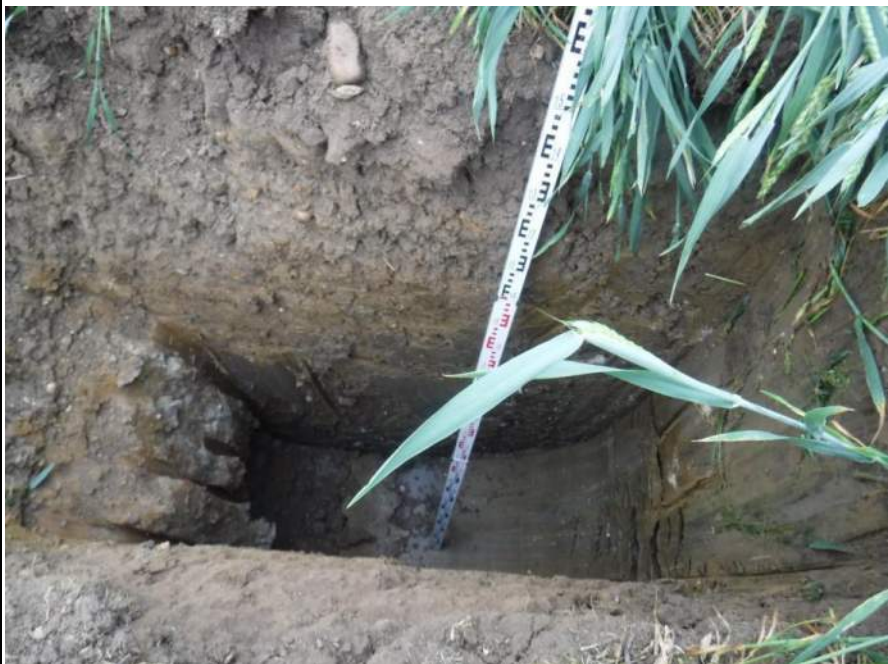
| 7 | 04/06/2019 | |

| <b>Description:</b><br>Geology of TP04 | | |

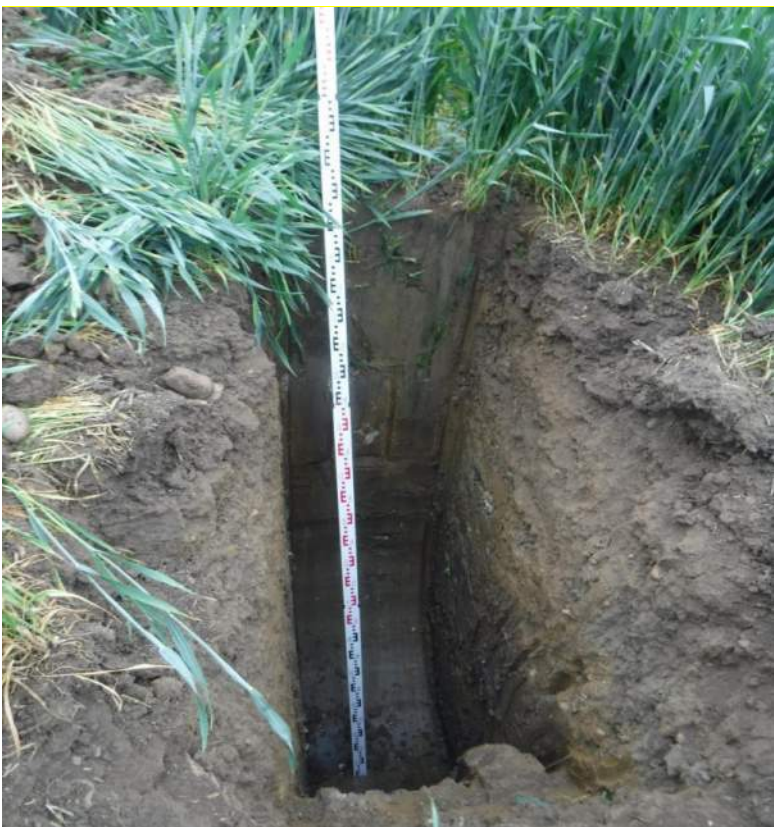
| 8 | 04/06/2019 | |

| <b>Description:</b><br>Length view of TP04 | | |

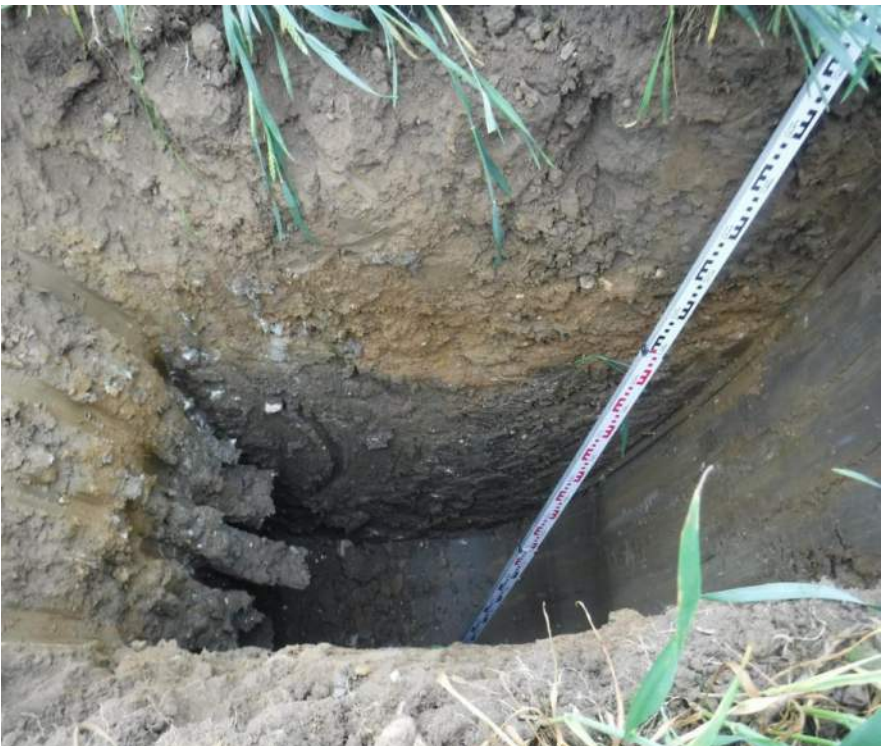
| 9 | 04/06/2019 | |

| <b>Description:</b><br>Geology of TP05 | | |

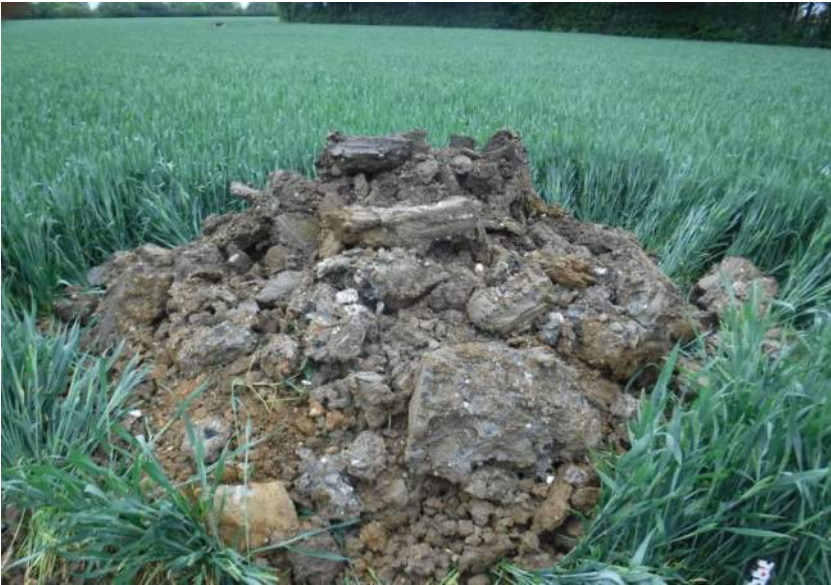
| 10 | 08/05/2019 | |

| <b>Description:</b><br>Soil arisings from TP05 | | |

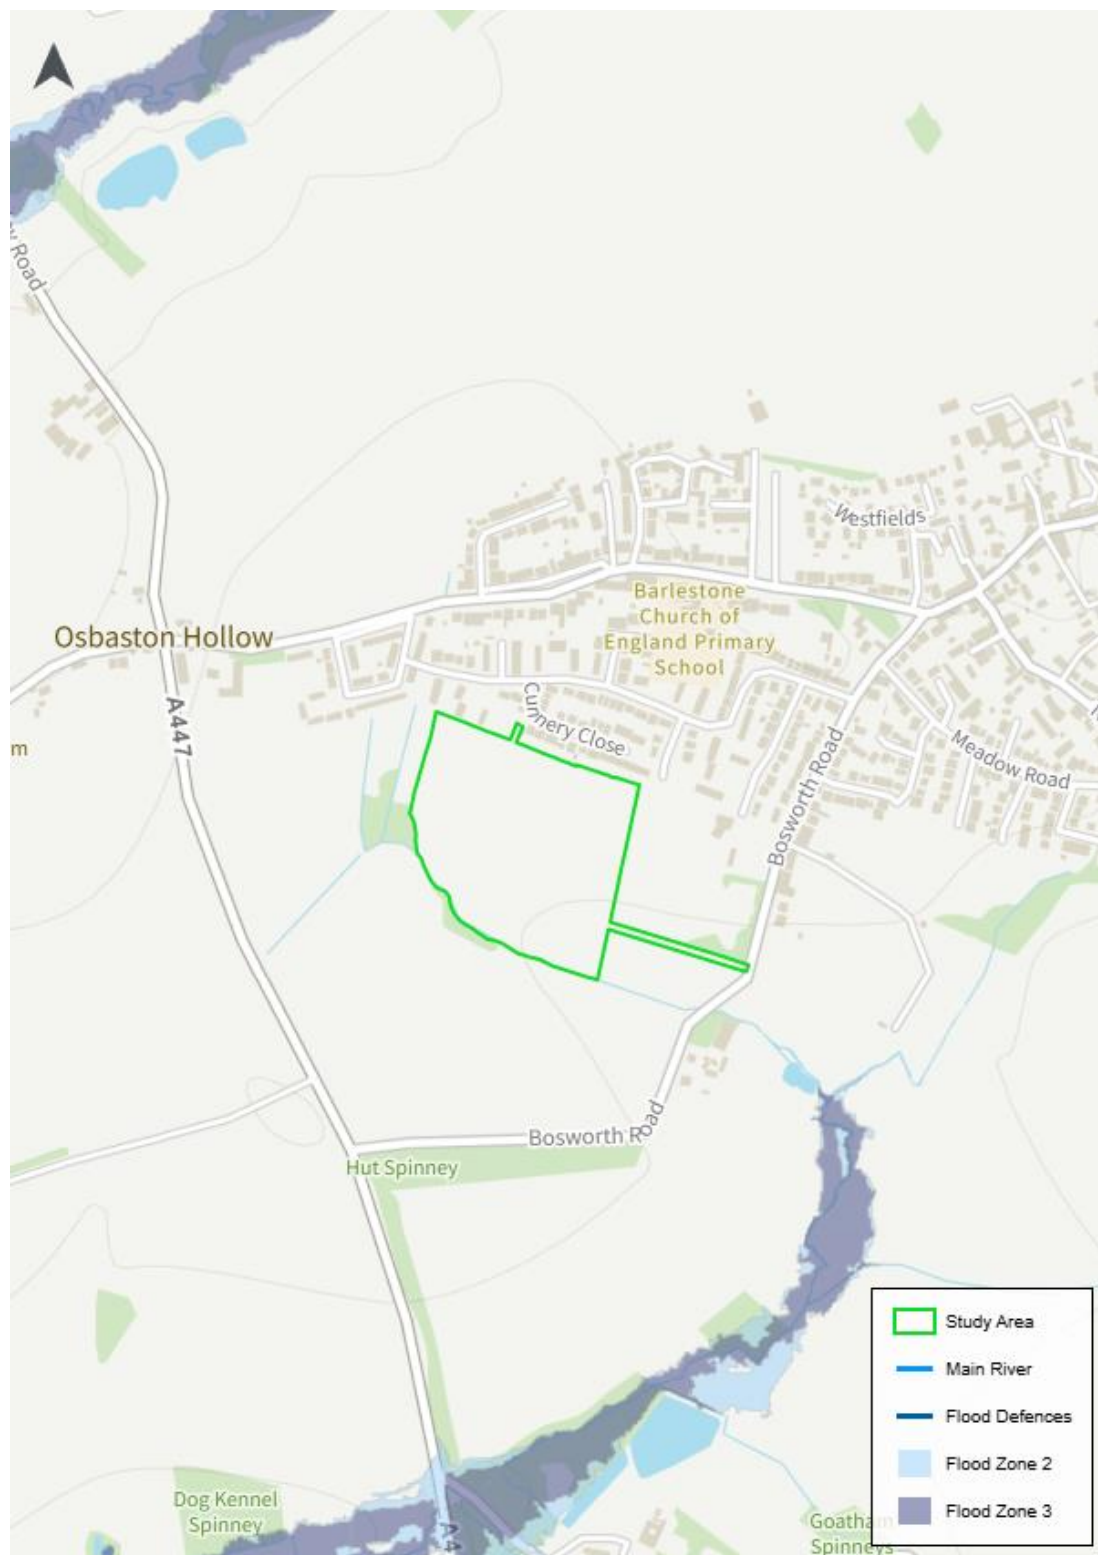
### **Environment Agency Flood Map for Planning**

The site is located in Flood Zone 1.

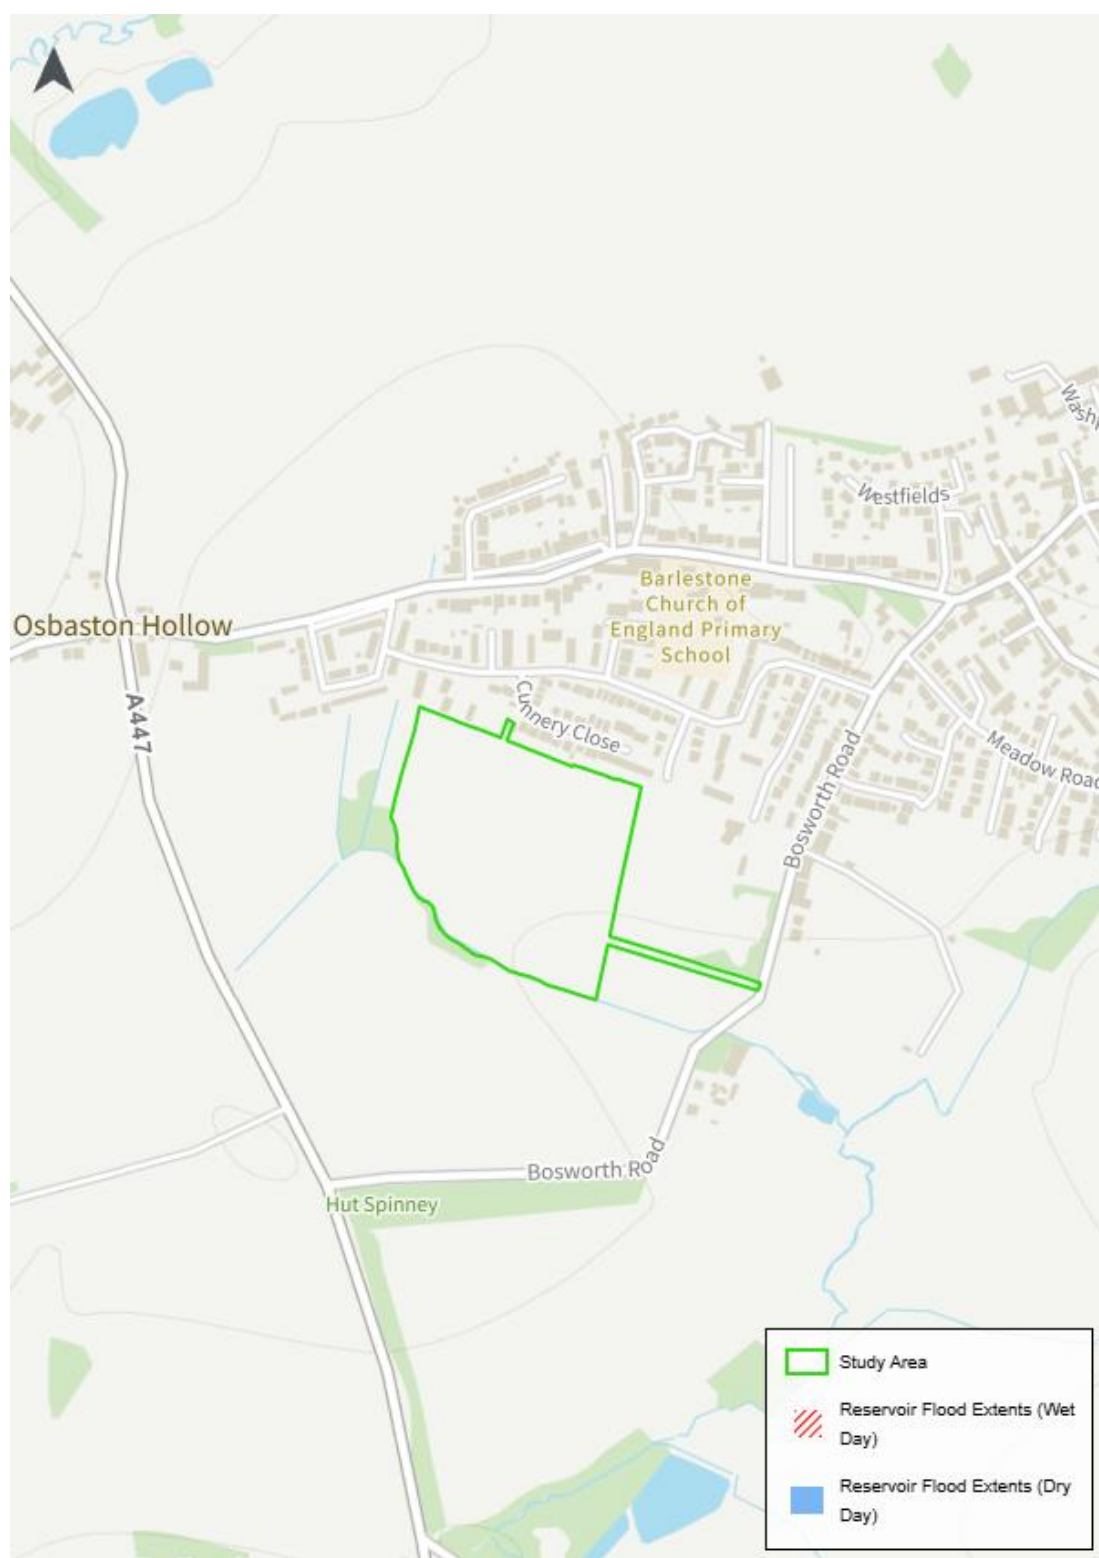
### **Environment Agency Flood Risk from Reservoirs**

The site is clear from the risk of flooding from this source

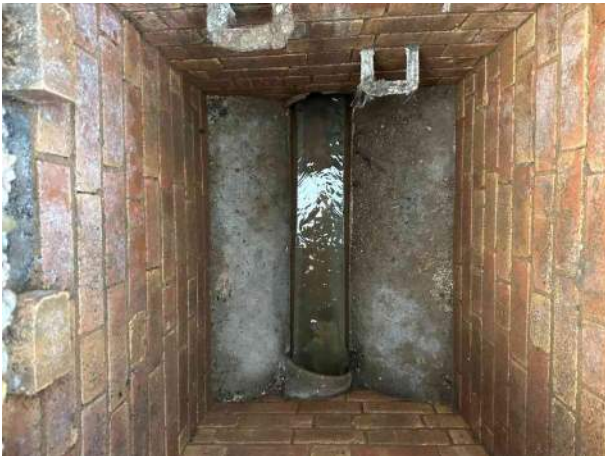
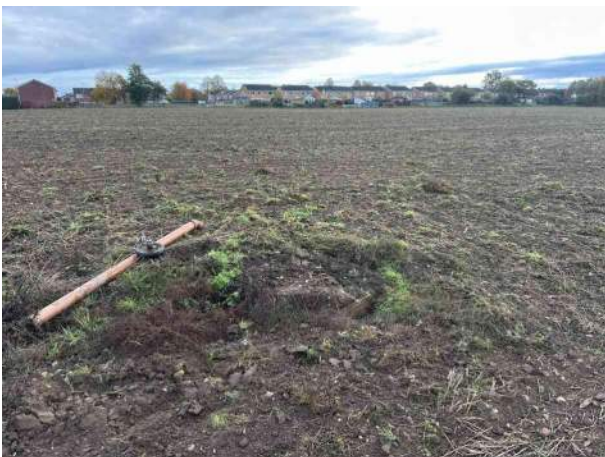
FW2

| Section | PLR | Grade | Description |
|---|---|---|---|
| 2 | FW2X | 4 | Broken pipe at joint from 10 o'clock to 2 o'clock |

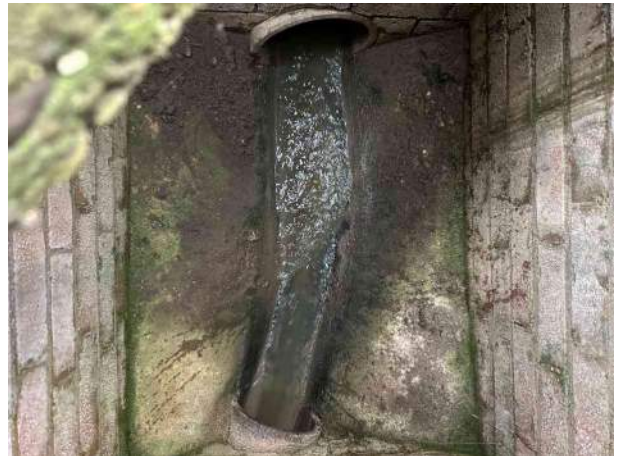
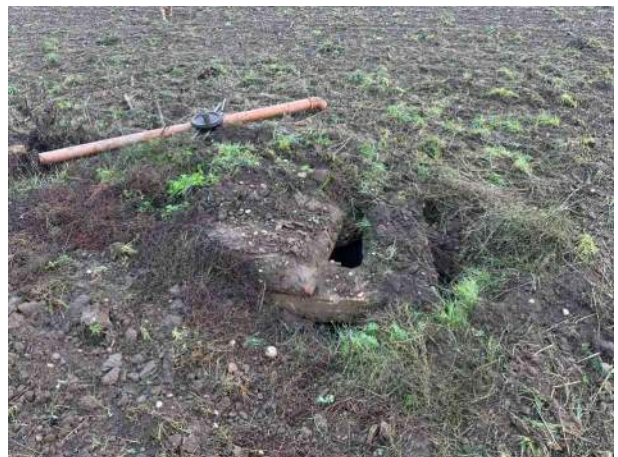
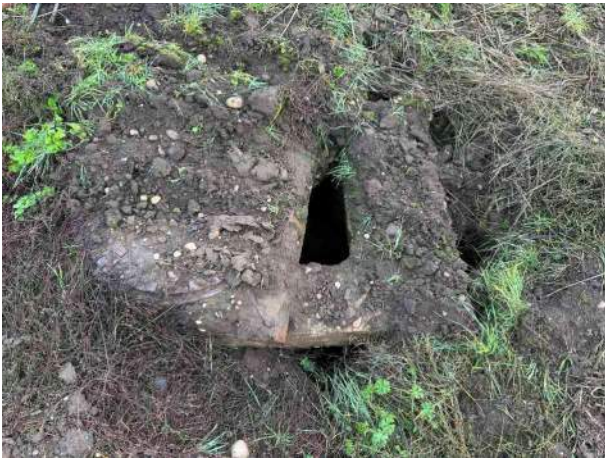
FW3

| Section | PLR | Grade | Description |
|---|---|---|---|
| 3 | FW3X | 3 | Multiple defects |

| Section | PLR | Grade | Description |
|---|---|---|---|
| 3 | FW3X | 2 | Multiple defects |

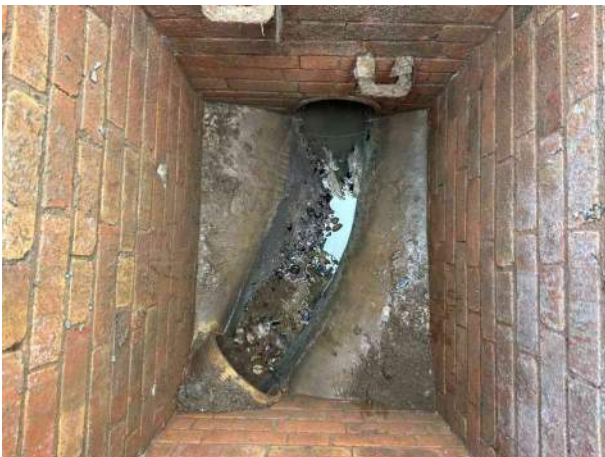
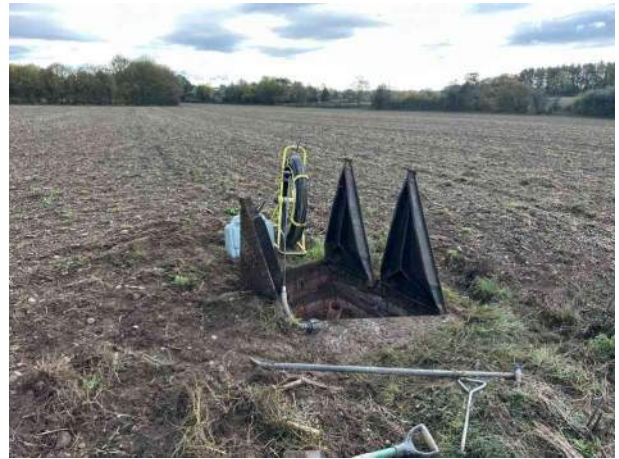
FW4

| Section | PLR | Grade | Description |
|---|---|---|---|
| 4 | FW4X | 4 | Fractures, multiple at joint from 9 o'clock to 2 o'clock |

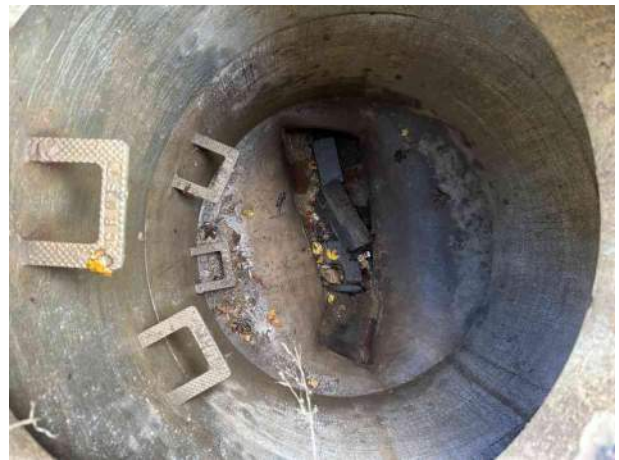
SW1

| Section | PLR | Grade | Description |
|---|---|---|---|
| 6 | SW1X | 5 | Multiple defects |

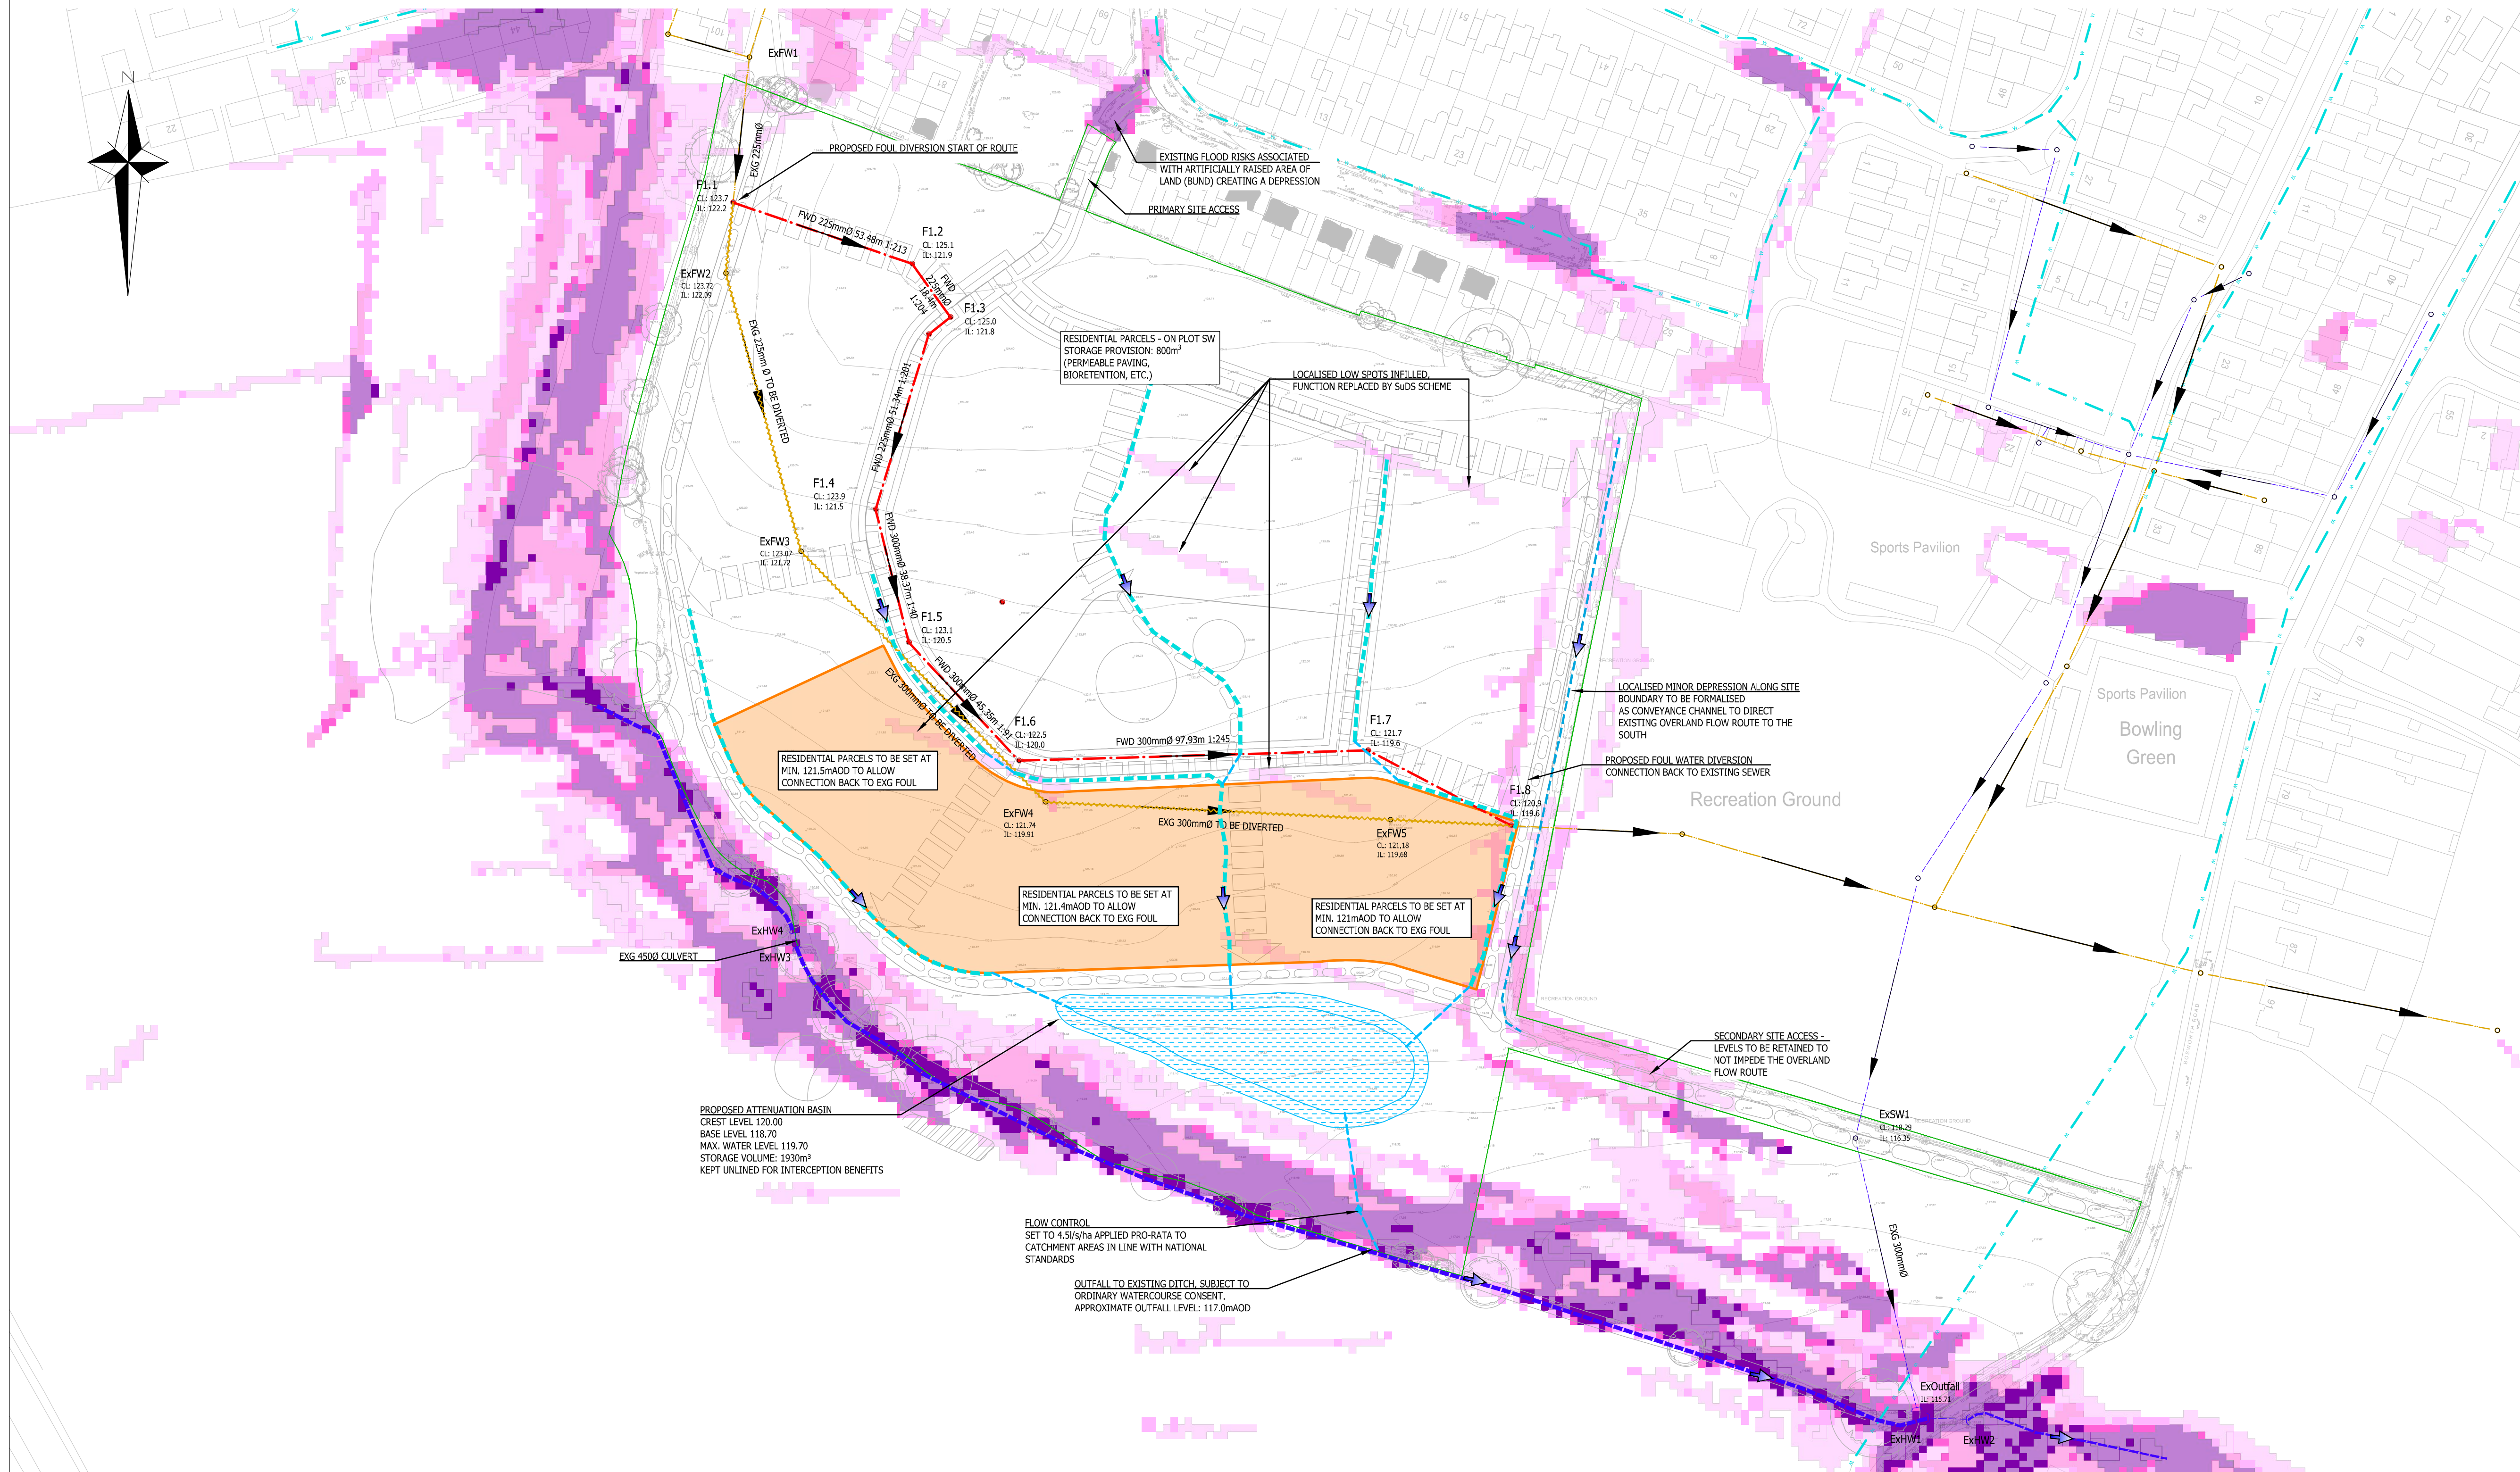
PROPOSED DESIGN

1. THE PUBLISHED BEDROCK IS MUDSTONE WITH SUPERFICIAL DEPOSITS OF SAND AND GRAVEL, AND PREVIOUS INFILTRATION TESTING CARRIED OUT IN JUNE 2019 INDICATES THAT INFILTRATION-BASED DISCHARGE STRATEGY IS NOT SUITABLE. DRAINAGE STRATEGY RELIES ON OFF-SITE DISCHARGE TO WATERCOURSE, SHALLOW INFILTRATION WITHIN THE PARCELS TO BE CONFIRMED SUBJECT TO FURTHER INVESTIGATIONS.

- Shallow depression for overland flow
- Proposed Attenuation Basin
- Indicative conveyance swale route
- Surface Water Piped route
- Foul Water Sewer
- Area of localised land raising
- Foul Water Sewer to be diverted
- Subject to S185 application
