Our Ref: P8079 - AGIR  
Date: 17<sup>th</sup> April 2024

**Re: Additional Ground Investigation Letter Report for Upton Steel, Stanton Lane,  
Stanton under Bardon – Phase 1**

GRM Development Solutions Limited (GRM) were appointed by Sutton Land Development (Client), to undertake additional ground investigation works for the new commercial development (referred to as 'Phase 1') at 'Upton Steel, Stanton Lane, Stanton under Bardon'. It should be noted that previous reports were issued in 2017 and 2018 for this site, and then an updated Phase II Site Appraisal Report covering 'Phase 1' of the development was issued in November 2023 (Ref: P8079/PIISAR.1\_Rev A).

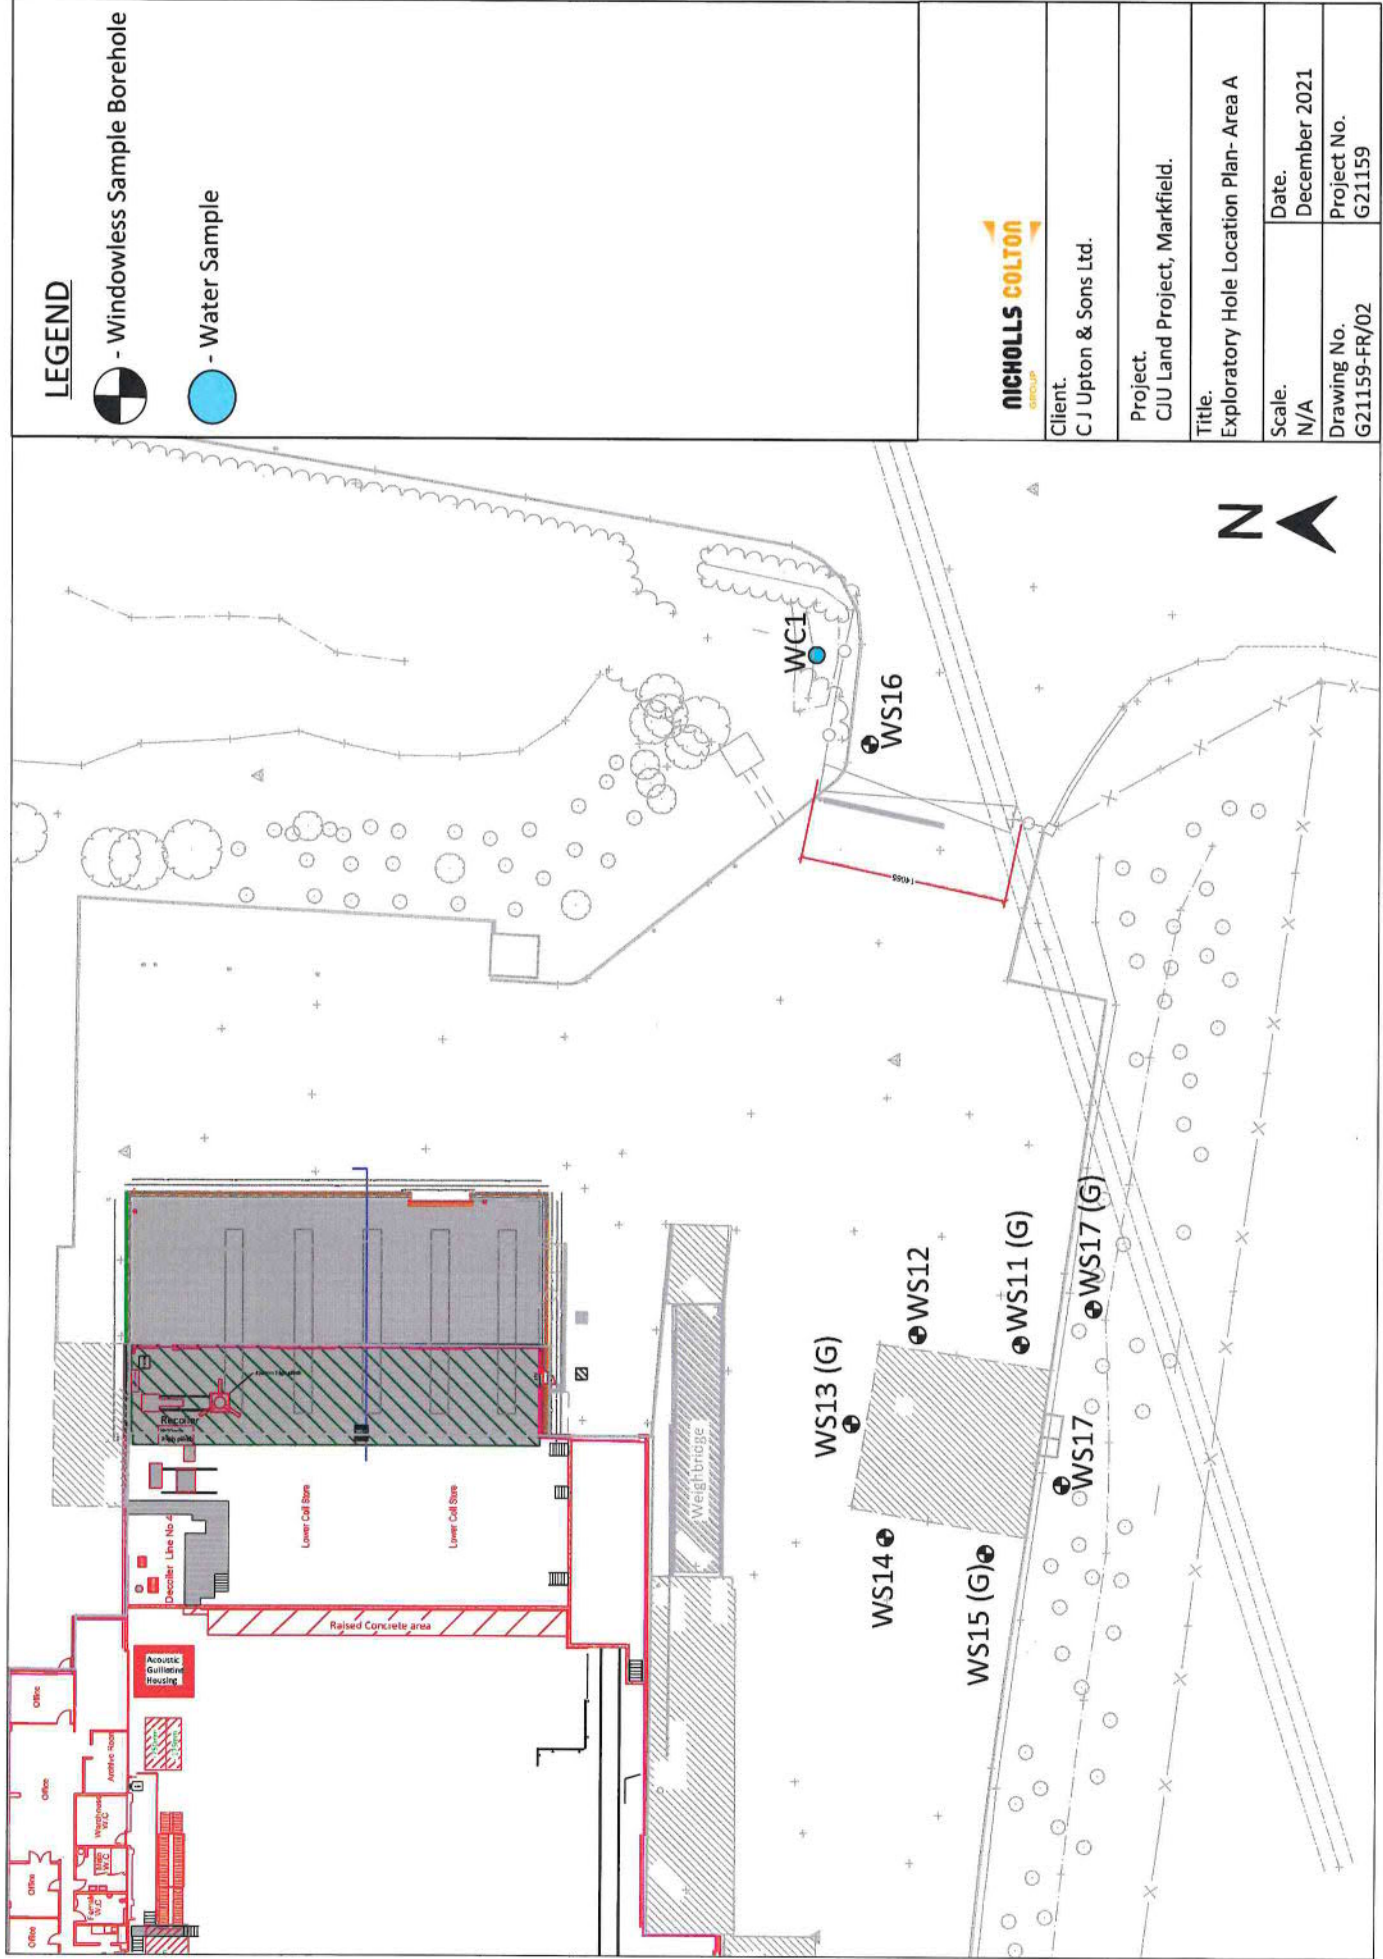
## BOREHOLE RECORD - WS11

Window Sampler
