**Level 2/3 Historic Building Survey**

**A Former Hosiery Factory at**

**23 Wood Street, Hinckley,**

**Leicestershire**

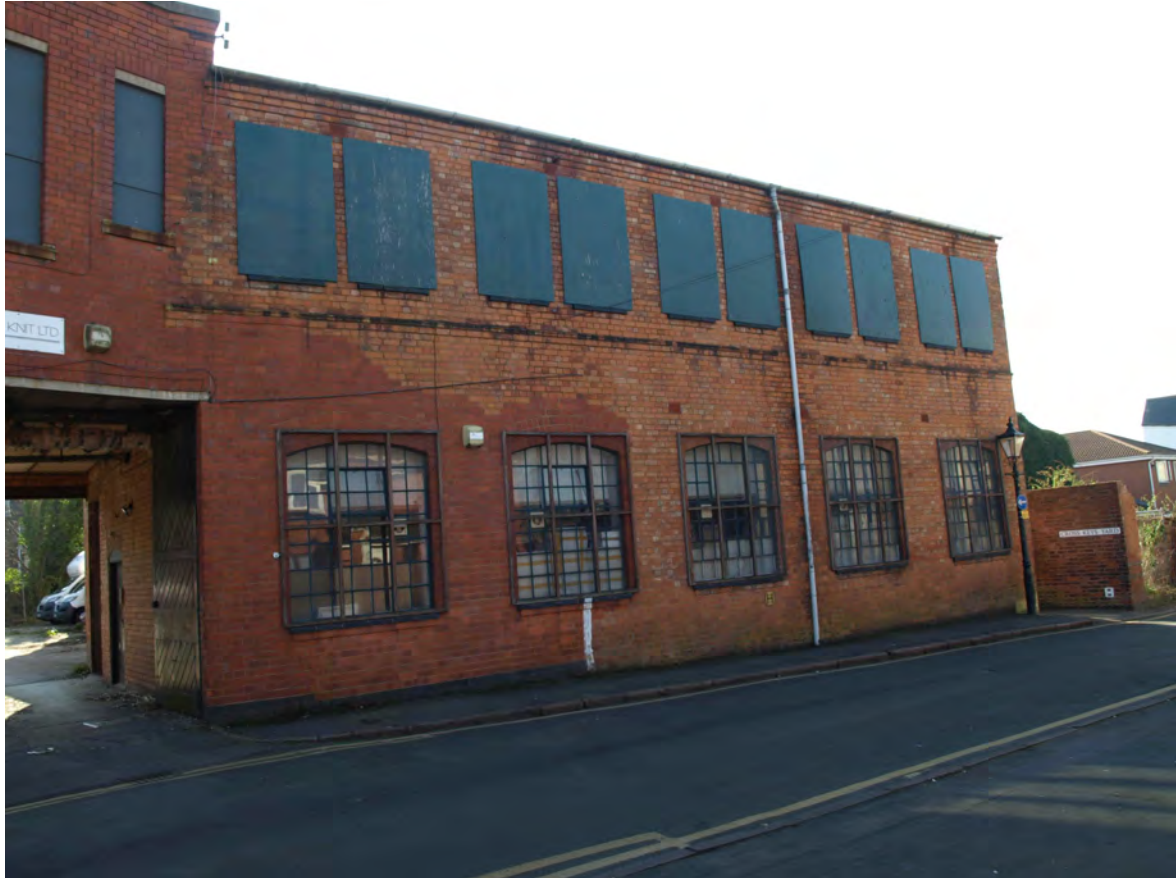
- 6.2 The original T shaped factory was built around 1903 and is of two storeys, constructed in English bond orange brick and a welsh slate roof. The elevation fronting onto Wood Street (forming the head of the T) is of five bays with cast iron framed casements (each with a single hopper opening) set into segmented head openings. The windows on the first floor are of similar design but paired. There is a moulded string course at first floor level and a stepped eaves cornice. The two eastern most bays on the ground floor have been rebuilt in a brighter orange brick (plate 1).

*Plate 1: North elevation of original T shaped factory*

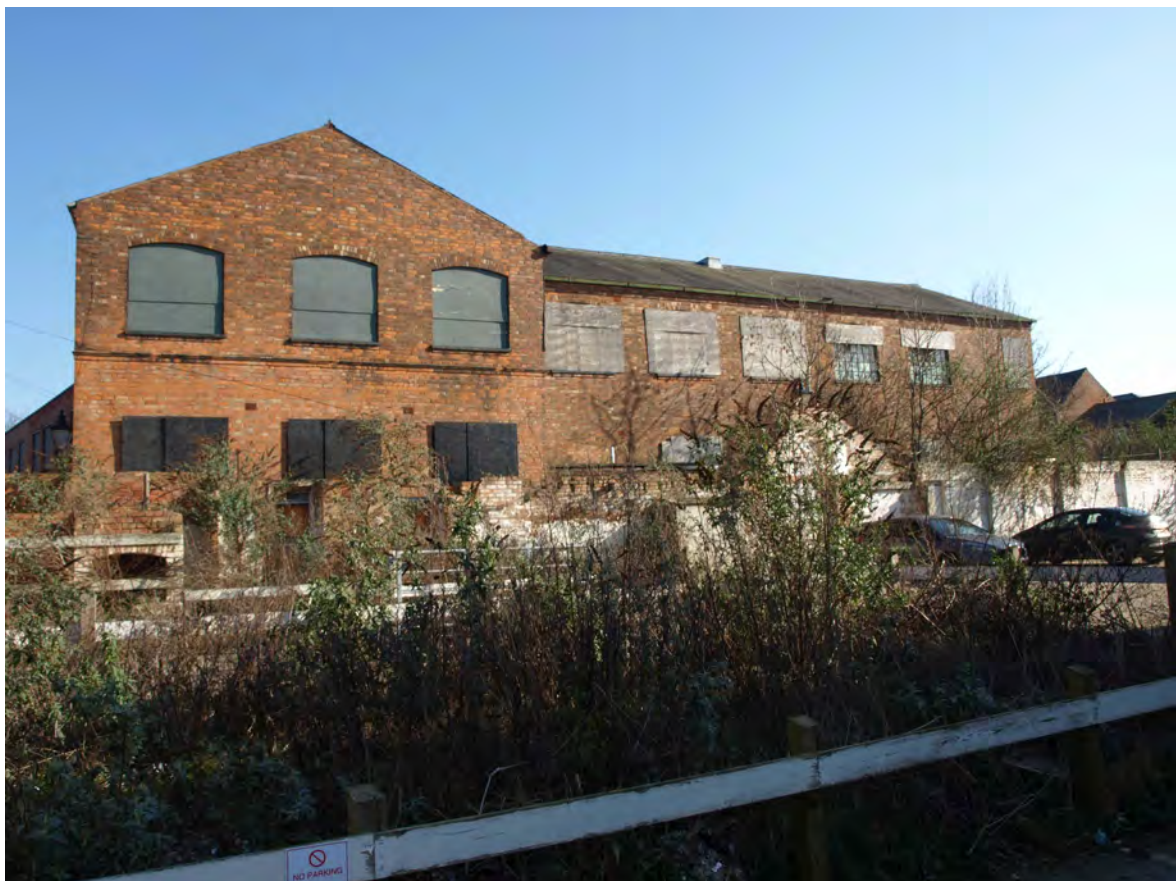
- 6.3 The western elevation comprises a three-bay gable end which is then stepped back to a six-bay wing (forming the shaft of the T). The moulded string course continues along the gable end but terminates where the five bay wing steps back (plate 2). This elevation faces onto a jitty and the lower elevation is largely obscured. A toilet block was added in the mid-20<sup>th</sup> century and is located in the angle where the rear wing steps back.

*Plate 2: West facing elevation of original T shaped factory*

- 7.7 The condition of the original factory structure is relatively poor with large cracks evident on the western gable wall of the northern wing and bowing of the southern gable end. This suggests some degree of subsidence. The 1930's extension is in good condition and preserves elements of external decoration not seen elsewhere in Hinckley.

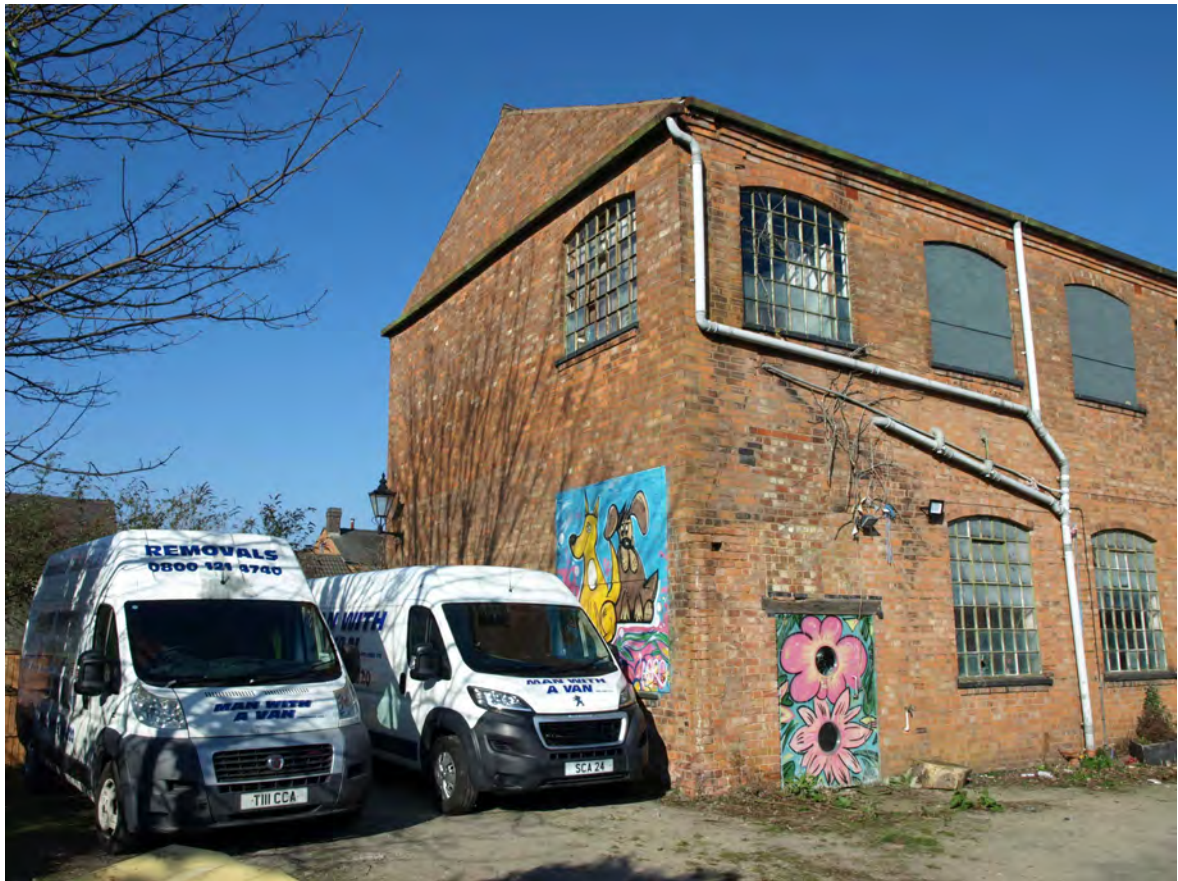
- 6.4 The Southern gable end contains a single window to both the first floor and ground floor on the eastern side. The ground floor window is boarded up externally and bricked up internally (plate 3). A smaller window is located on the western side at ground floor level to provide light to the area below the stairs.

*Plate 3: South facing gable end of original T shaped factory*

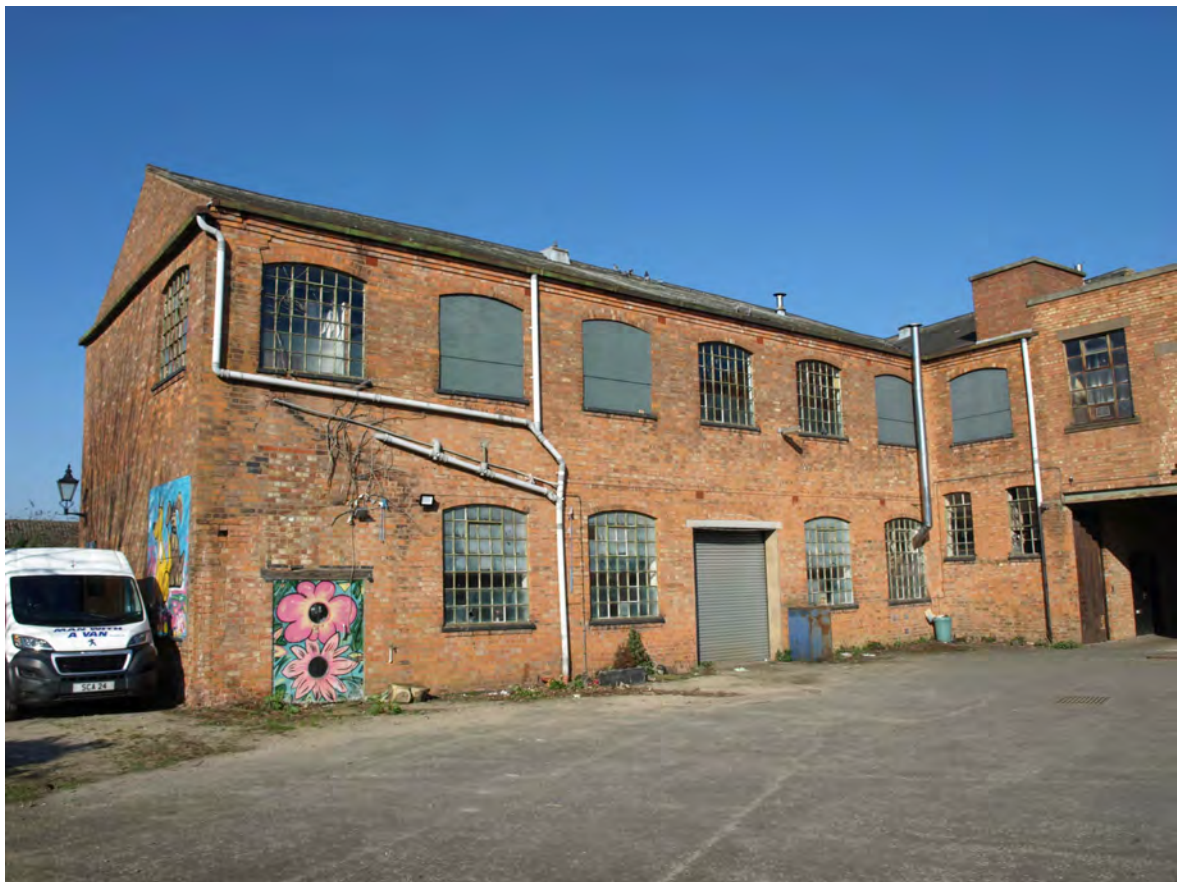
- 6.5 The eastern elevation, which faces into the yard, largely mirrors the western elevation and is of six bays. The southern most ground floor bay contains a door which leads onto the internal stairwell. The window of the fourth bay has been replaced by a roller door, this is a recent modification undertaken in the last 10 years (plate 4).

*Plate 4: East facing elevation of original T shaped factory*

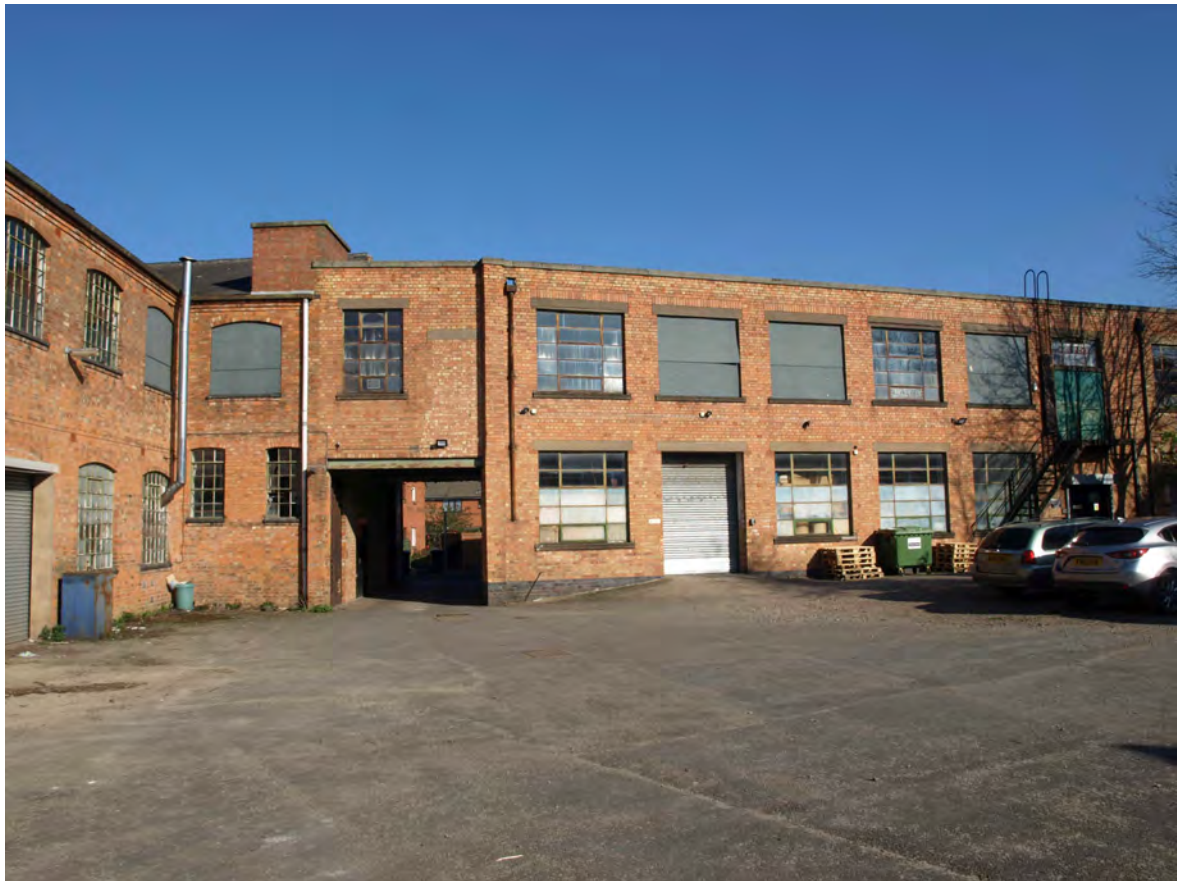
- 6.6 The southern elevation shows that the rear of the T shaped wing fronting onto Wood Street comprises of a single bay with single window to the upper floor while the windows are paired on the ground floor (plate 5). The original eastern gable wall is now mostly obscured by the 20<sup>th</sup> century extension. However, plate 6 shows the original form of the ground floor with the original entrance in the centre of the gable wall. The concertina door to the left is for a lift installed in the 20<sup>th</sup> century. Note the brick "tower extension" above the lift on the roof (plate 5), this was added to house the lift machinery.

- 6.7 Plate 5 clearly show the late 1930's extension which was added to the eastern gable wall of the original factory. A carriageway was formed with steel lintel above to allow access into the rear yard which provides a clear break between the two phases of construction. This later extension is again built in English bond orange brick (with the lowest five courses in blue brick) It is of two stories and originally of 6 bays latterly extended to 11 with a flat pre-cast concrete roof finished with felt and asphalt. The southern elevation of the later extension as seen in plate 5 and 7 shows that the ground floor window of the second bay has been replaced by a roller door (this is a recent modification) while bay 6 contains an original door. A fire escape is clearly visible in bay six of the first floor with box frame staircase and a ladder to the roof.

*Plate 5: Southern elevation showing interface between original factory and later extension*

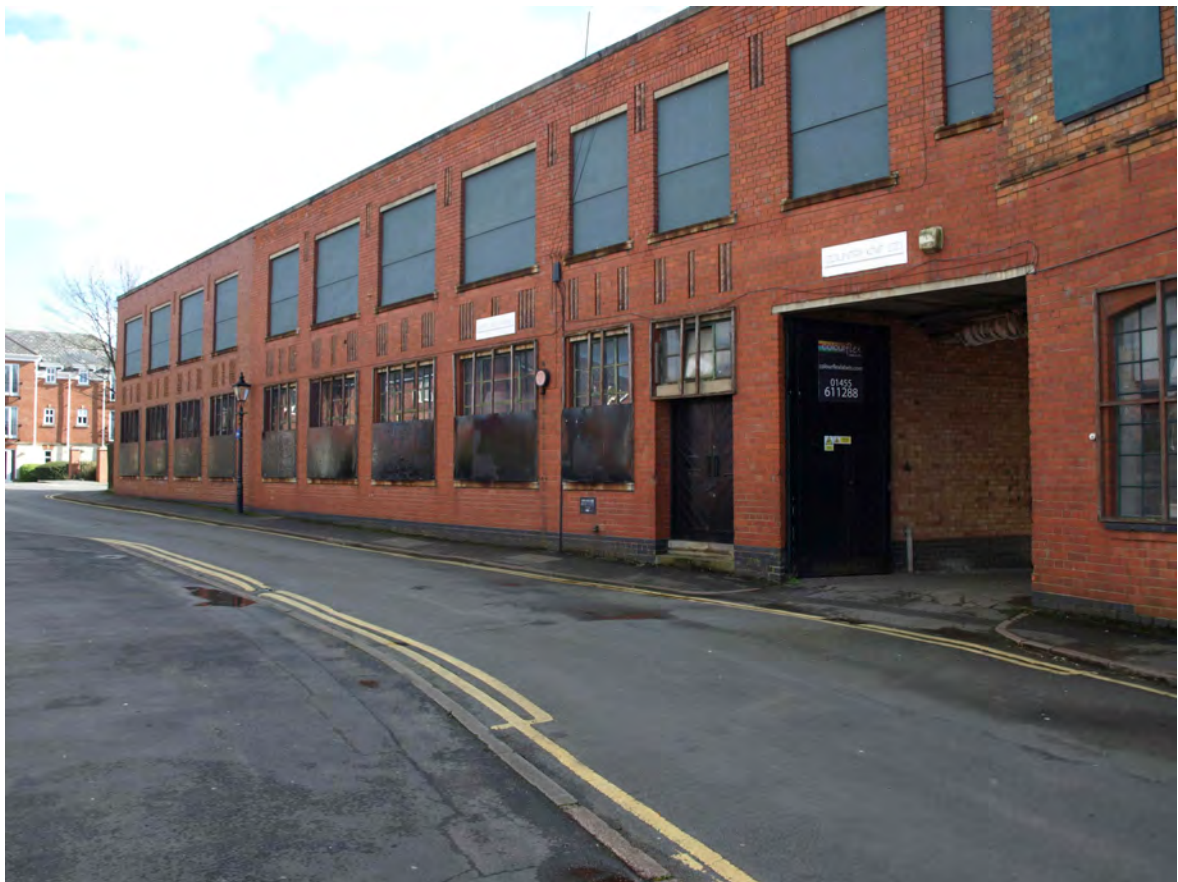
- 6.8 The northern elevation (plate 8) is slightly more decorative with a frieze between floors of panels of semi-circular section brick pilasters with similar panels between the upper windows (plate 9). A door is located in bay one below a shortened window adjacent to the carriageway (plate 10).
- 6.9 The eastern elevation of the extension is angled and consists of four bays (plate 11); the decorative brick pillars are continued onto this elevation but not to the rear.
- 6.10 Plate 12 shows the western side of the carriageway with a door opening into the extension.

*Plate 8: Northern elevation of later extension*

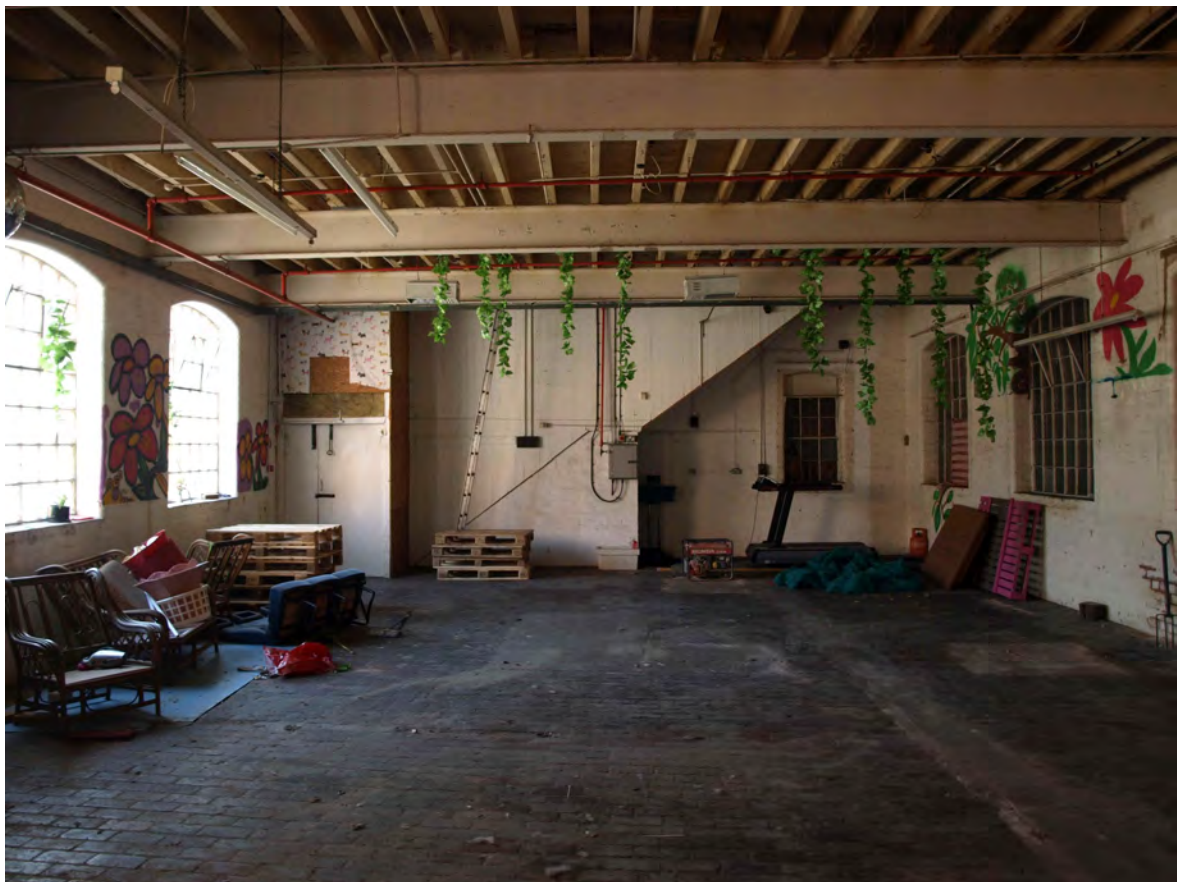
- 6.12 The factory floor is of blue brick, concrete patching is evident as is a concrete repair for a service run crossing the floor. Plate 14 shows the southern wing of the original factory looking towards the stairwell (door to left). The windows are clearly visible, as are the steel I beams supporting the first floor. These are stamped Leeds Steel Works (which began production in 1889). Plate 15 shows the view looking north from the stairs towards the wing fronting Wood Street. Plate 16 shows the western elevation with a door added to allow access to the adjacent jitty.

*Plate 14: Southern wing of original factory looking south*

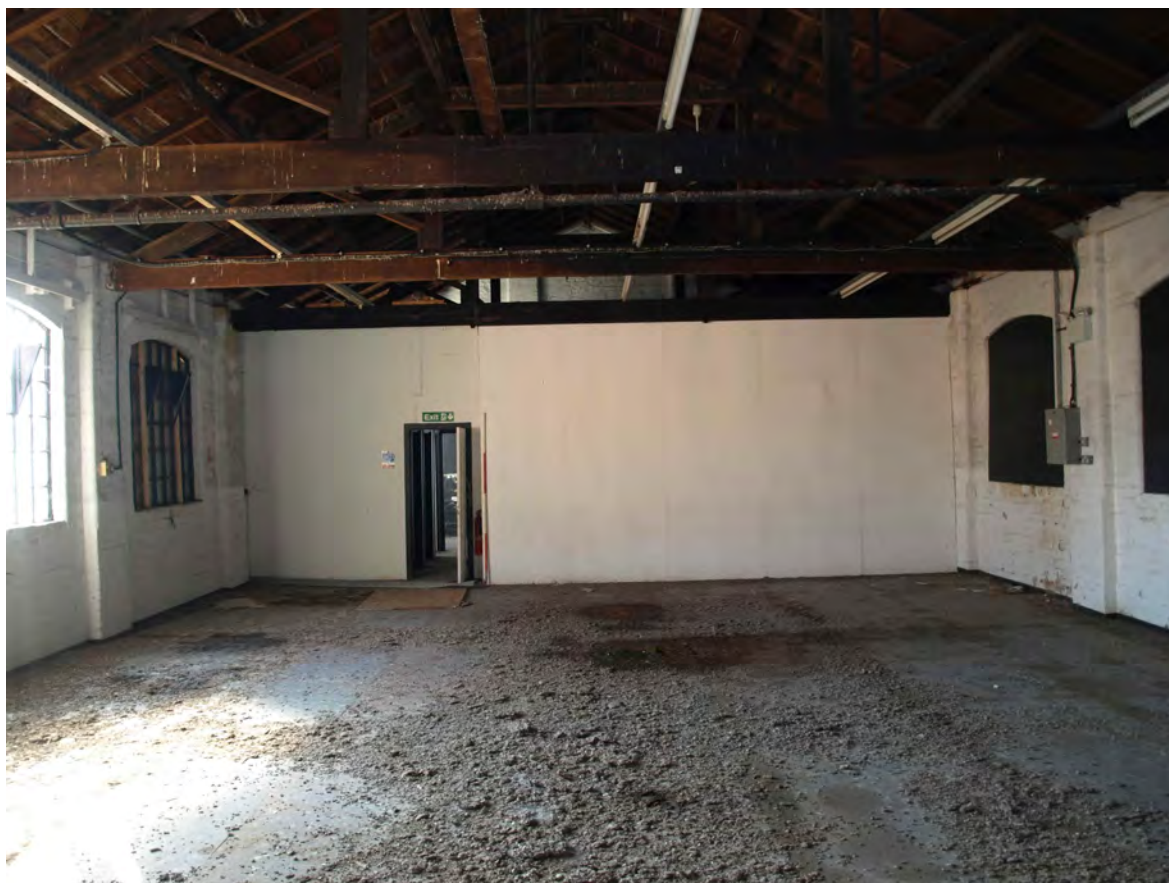
- 6.15 Plate 20 shows the view from the break with the northern wing looking back towards the annexe partition. Note that the first floor is open to the roof space. The floor is planked in oak but is heavily encrusted with pigeon faeces. Plate 21 shows the internal western elevation. These are the four bays up to the break with the northern wing fronting Wood Street. Plate 22 shows detail of the roof construction.

*Plate 20: View of southern wing looking south showing later partitioning*

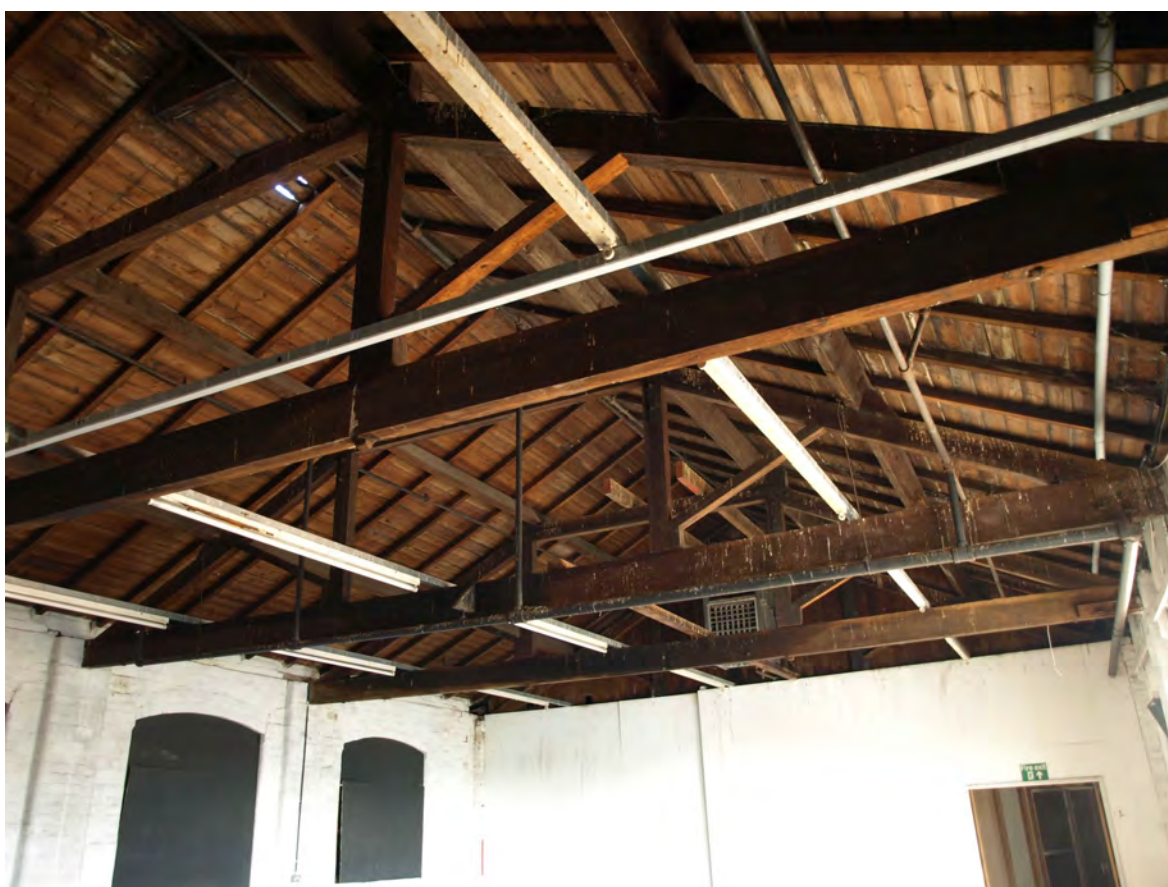
*Plate 22: Detail of roof structure*

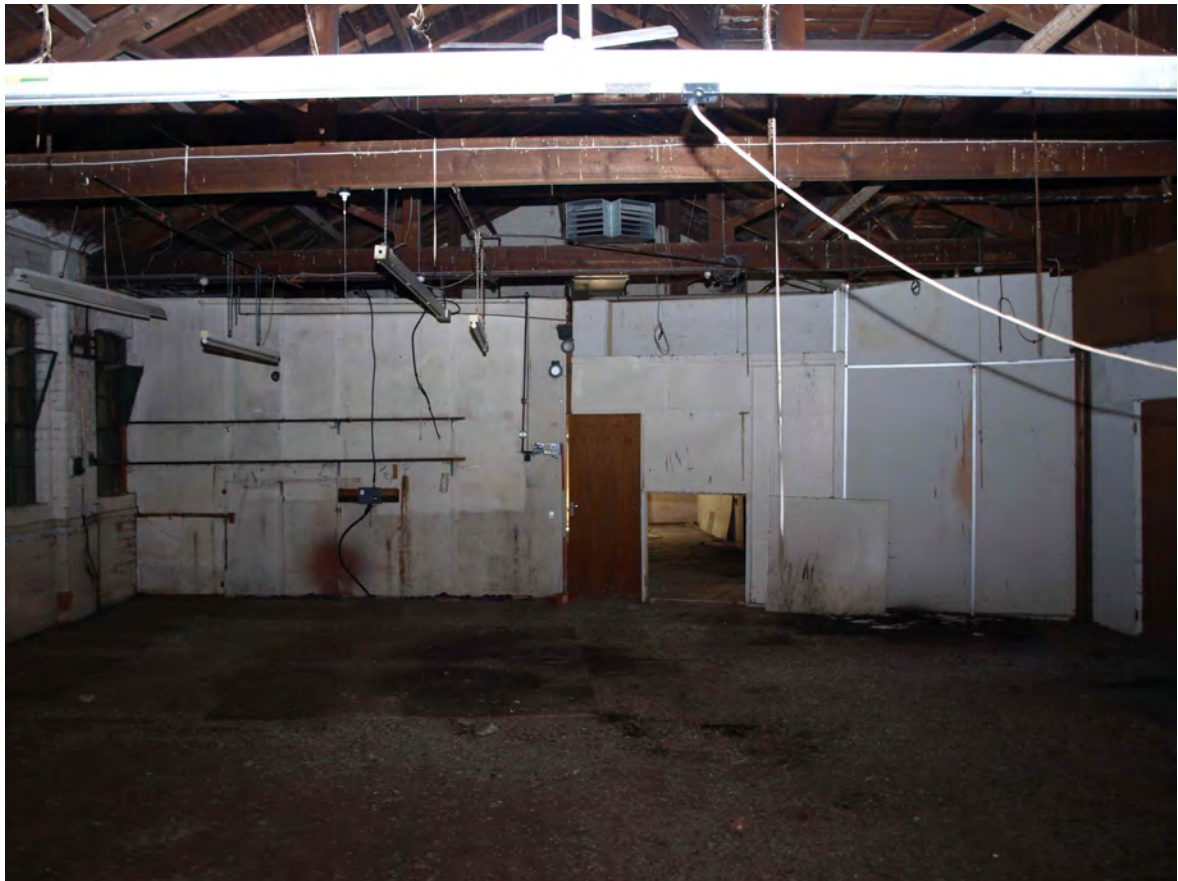
- 6.16 The northern wing has been sub divided by a crude plywood partition (plate 23) which has created a large room that covers approximately two thirds of the original open space (plate 24). A further sub division (plate 25) has created a probable office (plate 26). This marked the point where the original factory ended. However, the 1930s extension removed the upper half of the gable wall so that the factory would flow through on the first floor. During the construction phase in the 1930's a lift was installed. It was positioned in the corner of the northern wing of the old factory, opening to both east and west on the first floor and opening into the carriageway on the ground floor. Plate 27 shows a view of the lift looking east from the original factory, plate 28 shows the opposite side of the lift looking from the later extension (Note the concertina doors) Plate 29 shows the maintenance access to the lift machinery in the roof space above the lift shaft.

*Plate 23: Crude plywood partition dividing up northern wing of original factory*

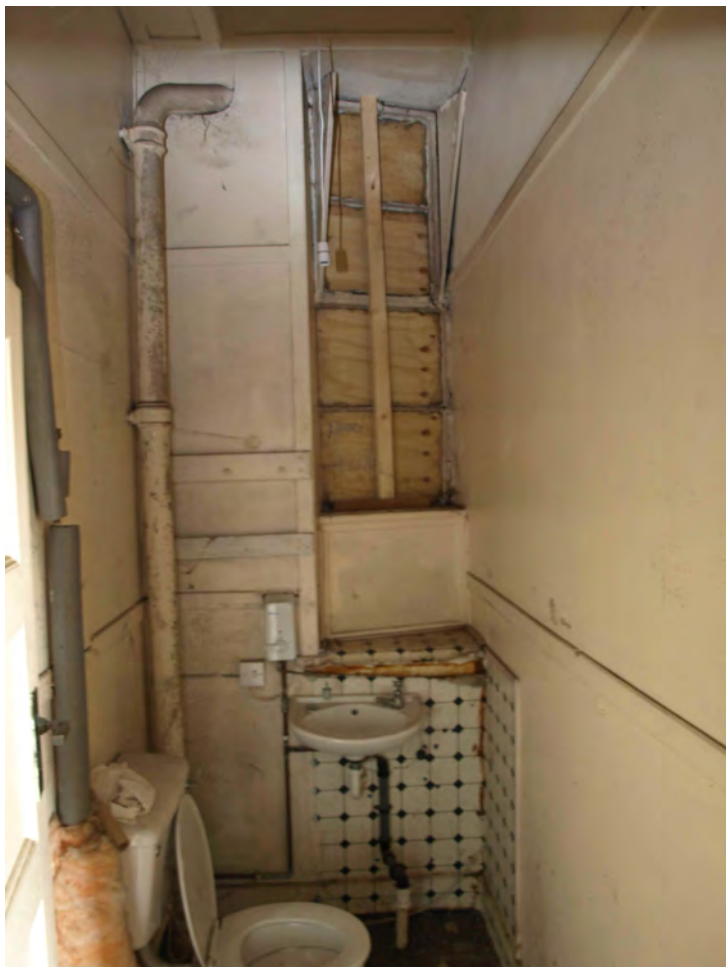
- 6.17 The interface between the old and new build is on an angle and sits over the carriageway below. This area was utilised to provide a toilet (plate 30) and a further probable office (plate 31).

*Plate 30: Toilet built into angle over carriageway*

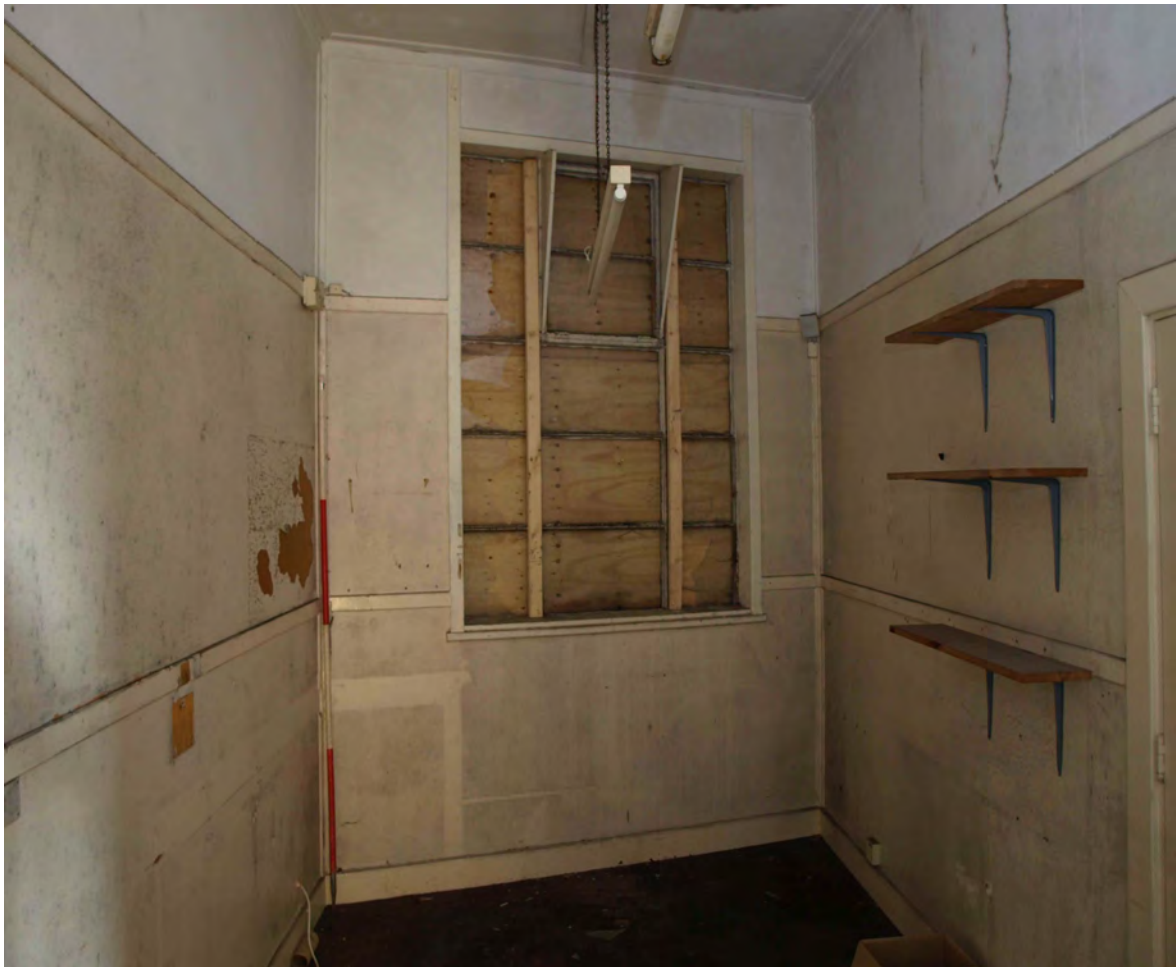
*Plate 31: Office created above carriageway*

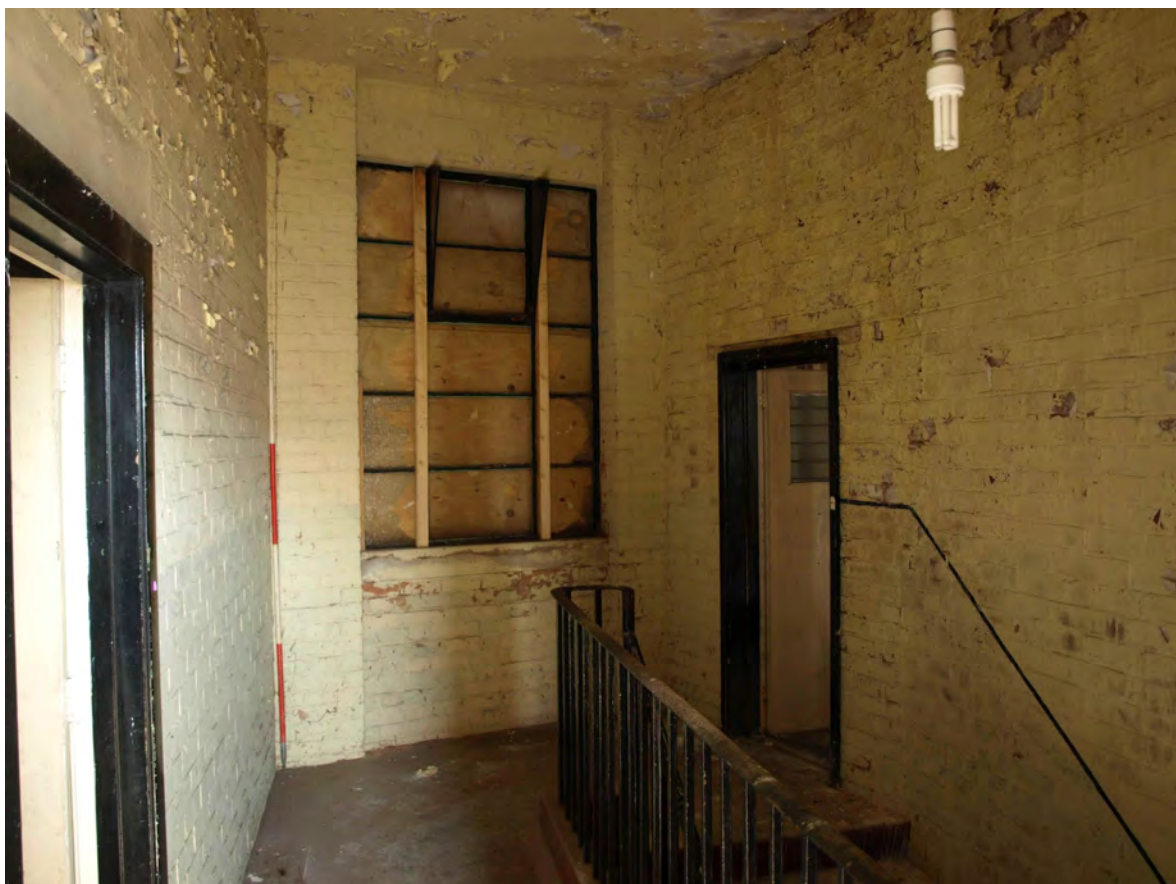
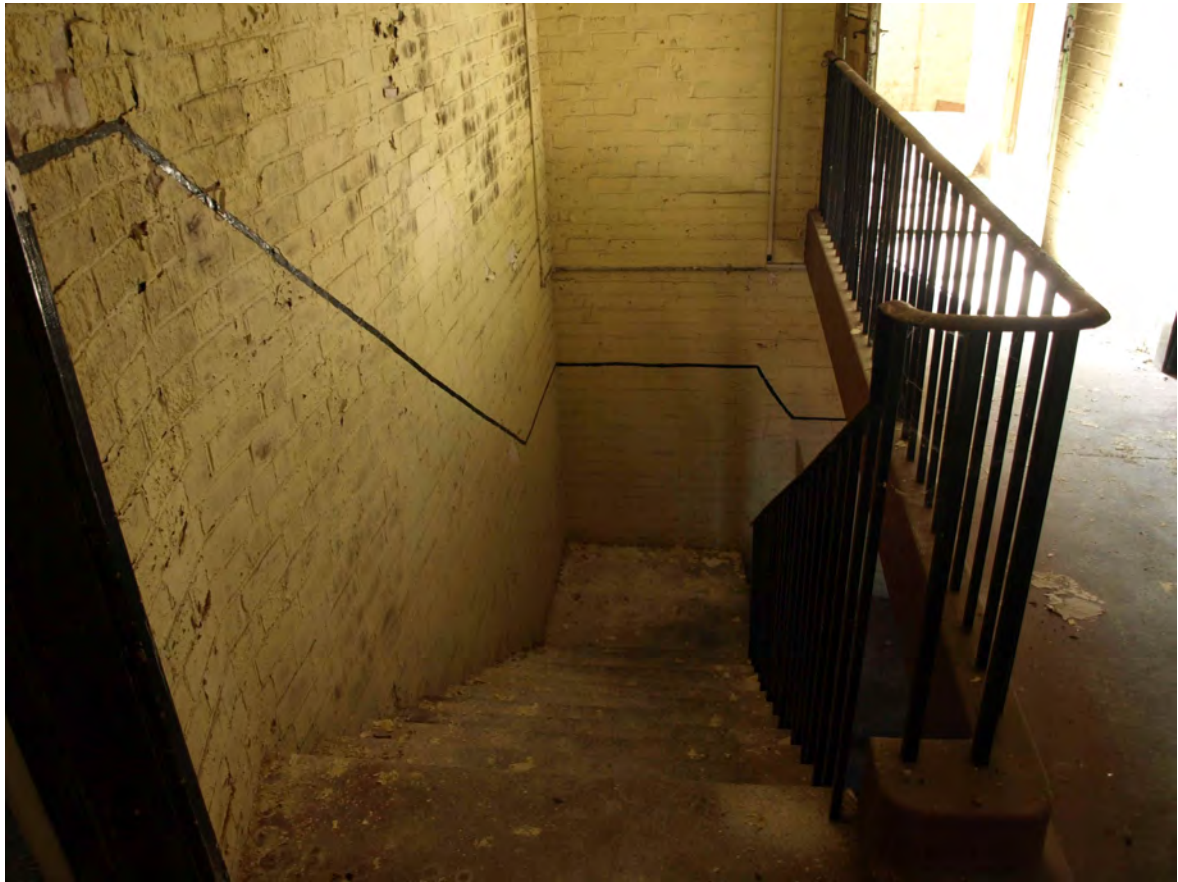
- 6.18 Continuing along the upper floor, a stairwell is present (plate 32 and 33) which is located to the immediate right of the carriageway. This stairwell provided access to the upper floor with double doors leading onto the corridor (plate 34) and a further door opening east into a probable supervisor's office and a door on the west side leading into the office above the carriageway.

*Plate 32: Stairwell looking north on first floor*

*Plate 33: Stairwell looking south*

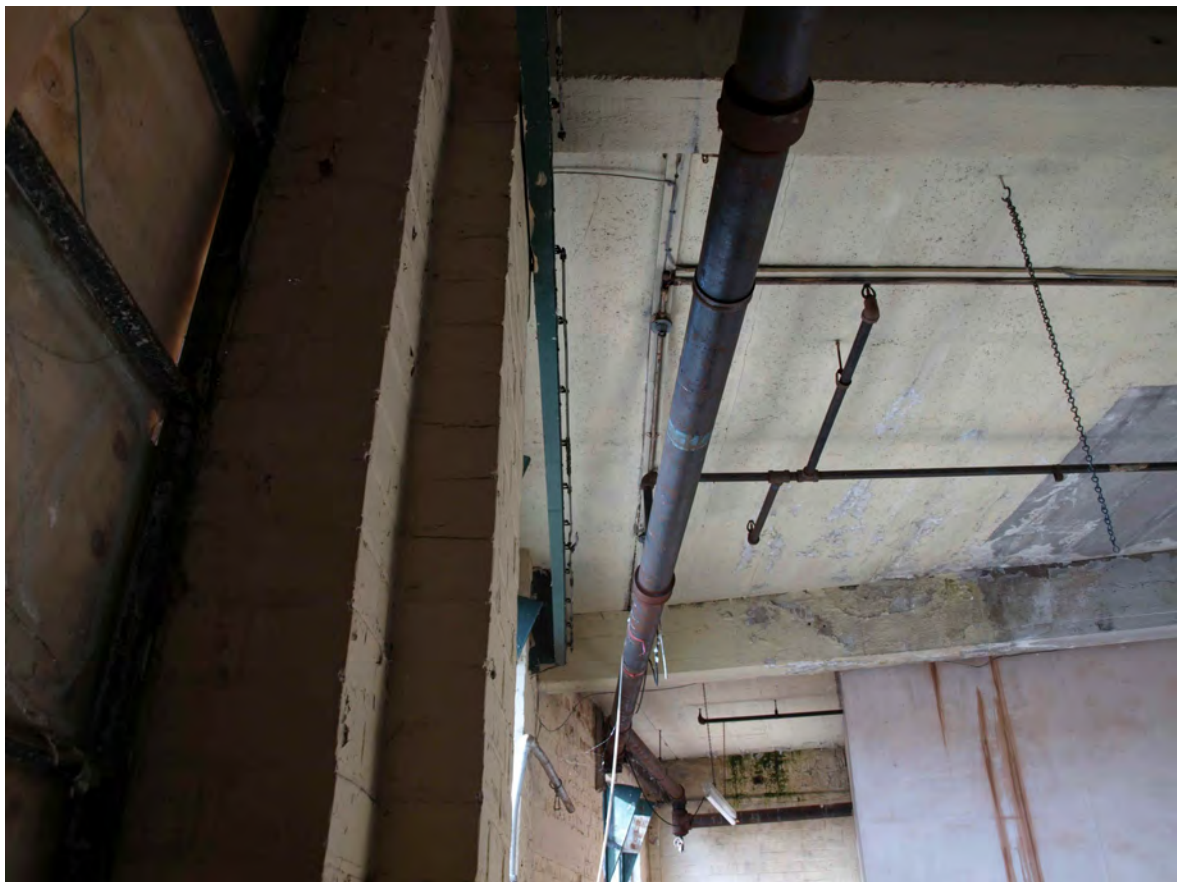
- 6.19 The upper floor of the extension is largely open plan with two probable supervisors' offices constructed in timber located in the north-east corner adjacent to the stairwell (plate 35 and 36). Plates 37 and 38 show the open plan nature of the space with the steel I beams supporting the concrete roof slab. Fluorescent lighting tracks are present throughout the length of this space with a gas fired heating system located half way down on the south side. A fire escape is located in bay 5 (plate 39) while curtain rails were provided along the southern elevation. Plate 40 shows the curtain rail in detail with the sprinkler system visible to the right.

*Plate 40: Detail of curtain rails to left with sprinkler system shown to right*

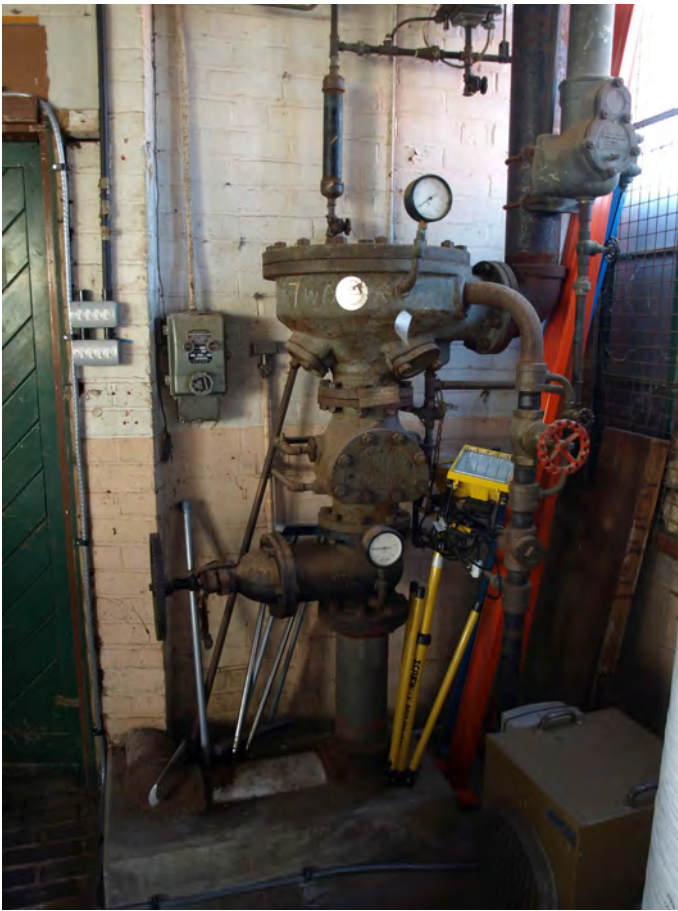
*Plate 41: Mather and Platt Sprinkler system*

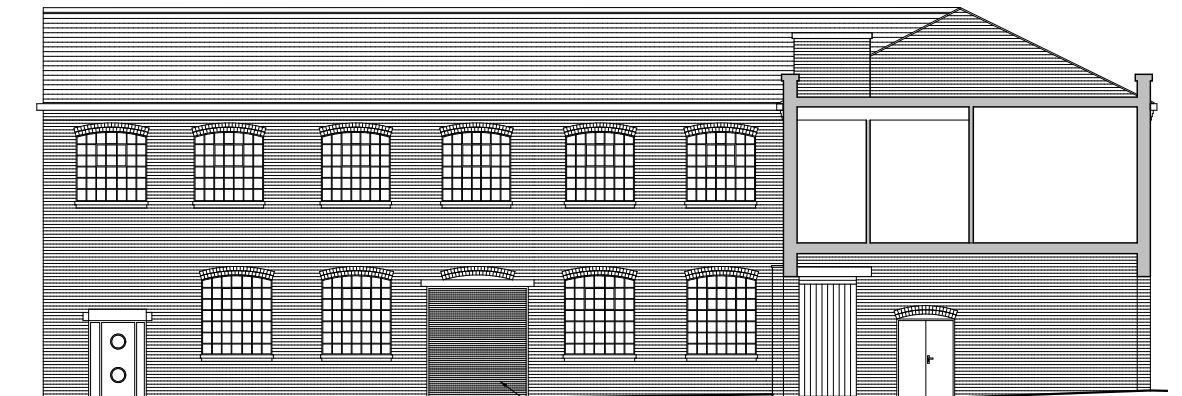
Figure 12: Existing elevations of surviving buildings

roller shutter door shown thus
