**Tree Survey  
and  
Arboricultural Method Statement  
for  
The Old Rectory  
19 Church Road  
Witherley**

**18<sup>th</sup> March 2024**

AT2 was instructed by Mrs Alison Prentice to prepare a tree report with reference to plans to erect a garage at The Old Rectory in Witherley. This report describes the methods to be deployed to ensure minimum impact to the trees.

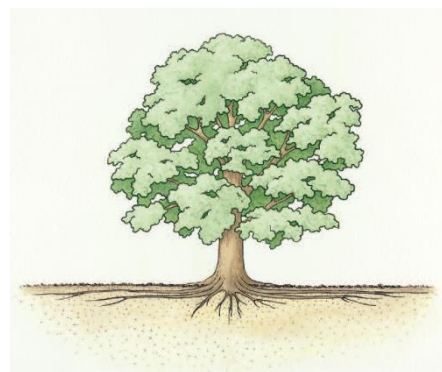
**Trees have relatively shallow but wide spreading roots<sup>6</sup>.**

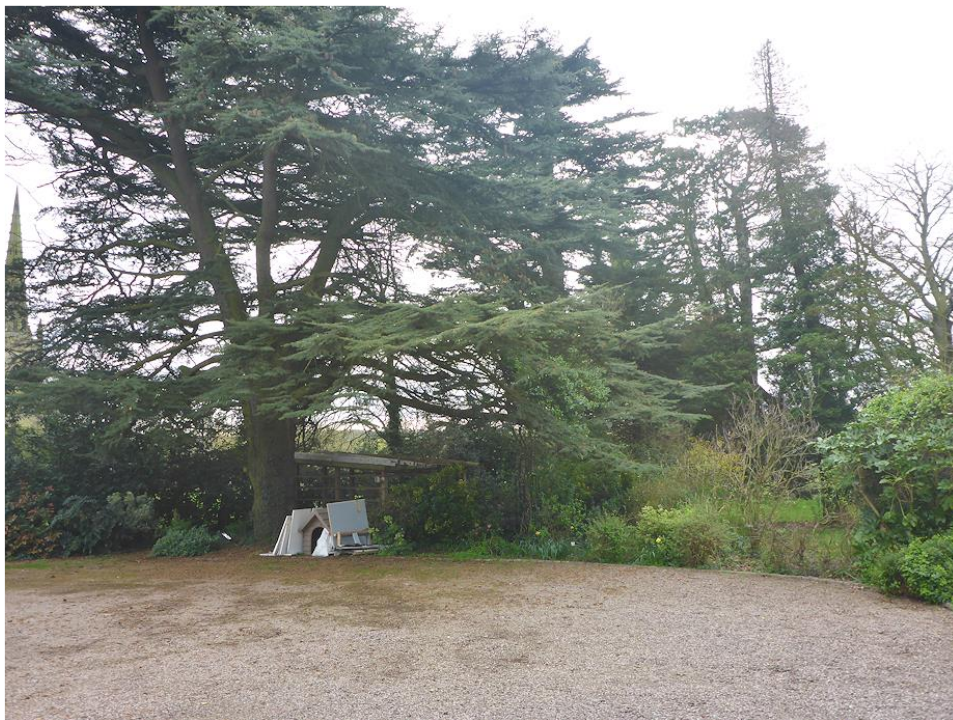
**Cedar looking southwest from the driveway.**

The Old Rectory is a detached property with a large garden between Church Road to the east and the River Anker to the west. The Hinkley and Bosworth website shows that the property is within a conservation area but there are no tree preservation orders. A tree plan is included on page 11 showing canopies shaded in accordance with their BS5837 categories and their root protection areas coloured magenta. At the time of the visit the weather was fine and bright.

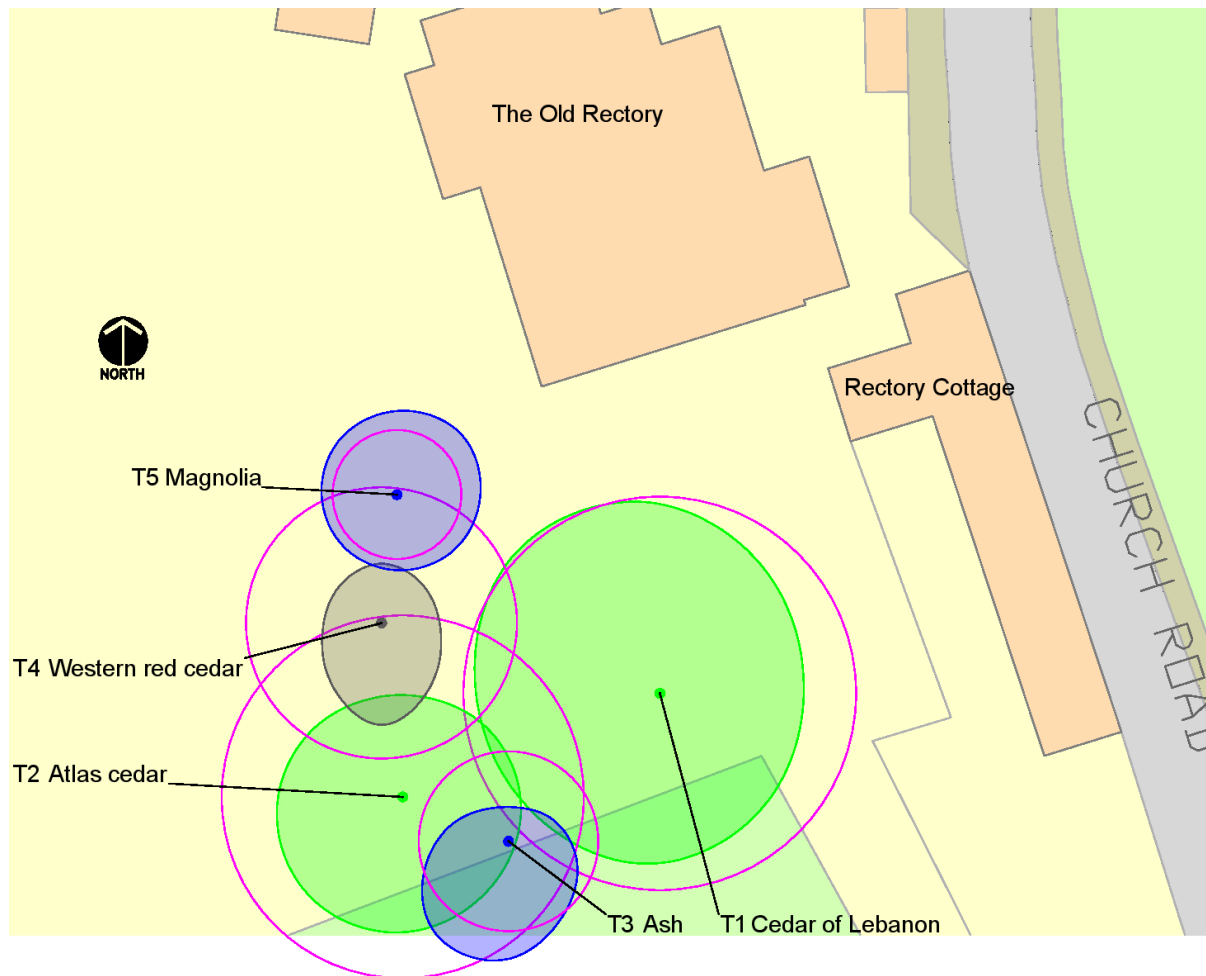
## Tree Survey Plan

Shaded outline shows tree canopy graded in accordance with BS5837; RPA shown in **magenta**. The position of the trees is not intended to infer ownership which should be clarified before any tree work is carried out.

This tree plan is also supplied as an AutoCAD dwg file, XREFerenced to the topographical model. The tree geometry including the canopy and RPA are stored as layers that can be easily imported and overlaid onto a design layout to produce a tree constraints plan. Note: the CAD drawing units are metres.

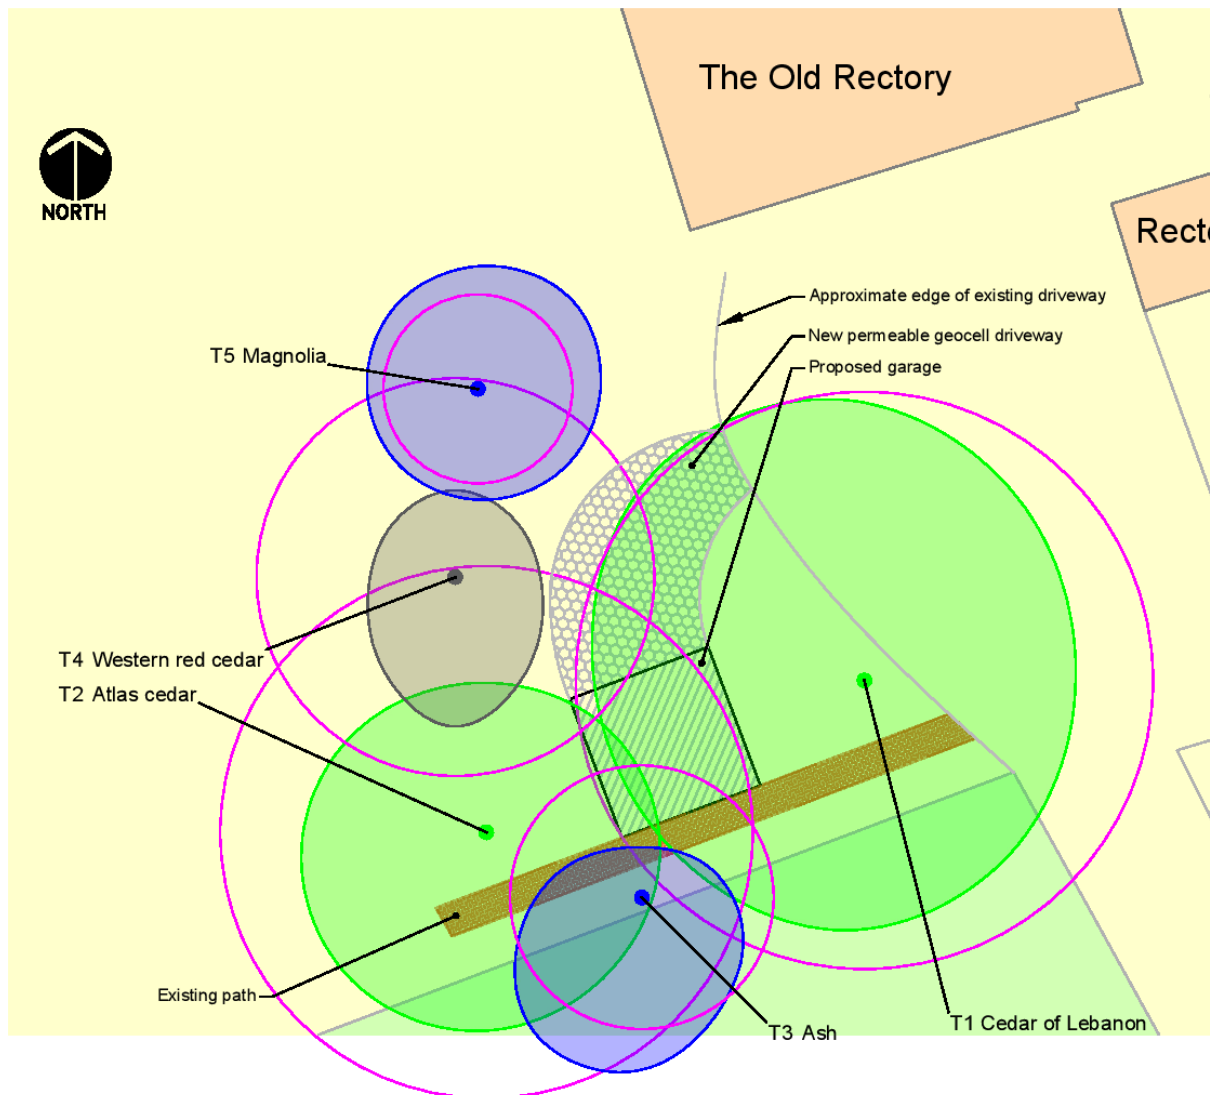
It will not be necessary to remove any trees to accommodate the proposed garage as shown in the plan below.

**Root protection areas shown in magenta. Proposed garage and surfacing hatched grey.**

The two cedars will require minor crown lifting of secondary branches to provide 4 clearance over the driveway and garage.

To minimise the impact on roots, foundations will be constructed using specially engineered screw pile and beam.

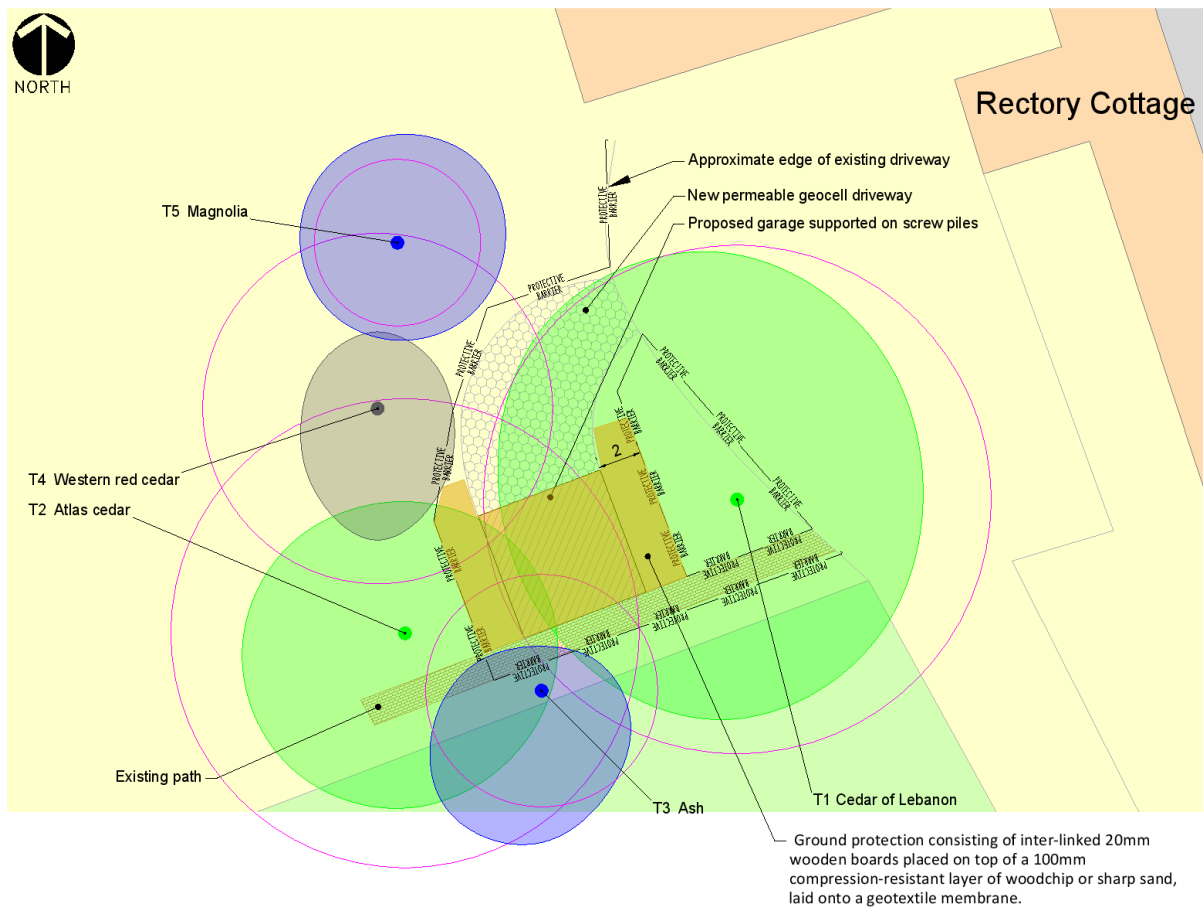
Extract from the tree protection plan showing siting of protective fencing.

Ground protection will be installed between the protective fence and the foundation line and within the garage footprint as shown in the tree protection plan extract above. Boards will be placed 20cm from the face of the wall. Ground protection will consist of inter-linked 20mm wooden boards or scaffolding boards placed on top of a 100mm compression-resistant layer of woodchip or sharp sand, laid onto a geotextile membrane. Builders' sand will not be used because of its high salt content, which is toxic to tree roots.

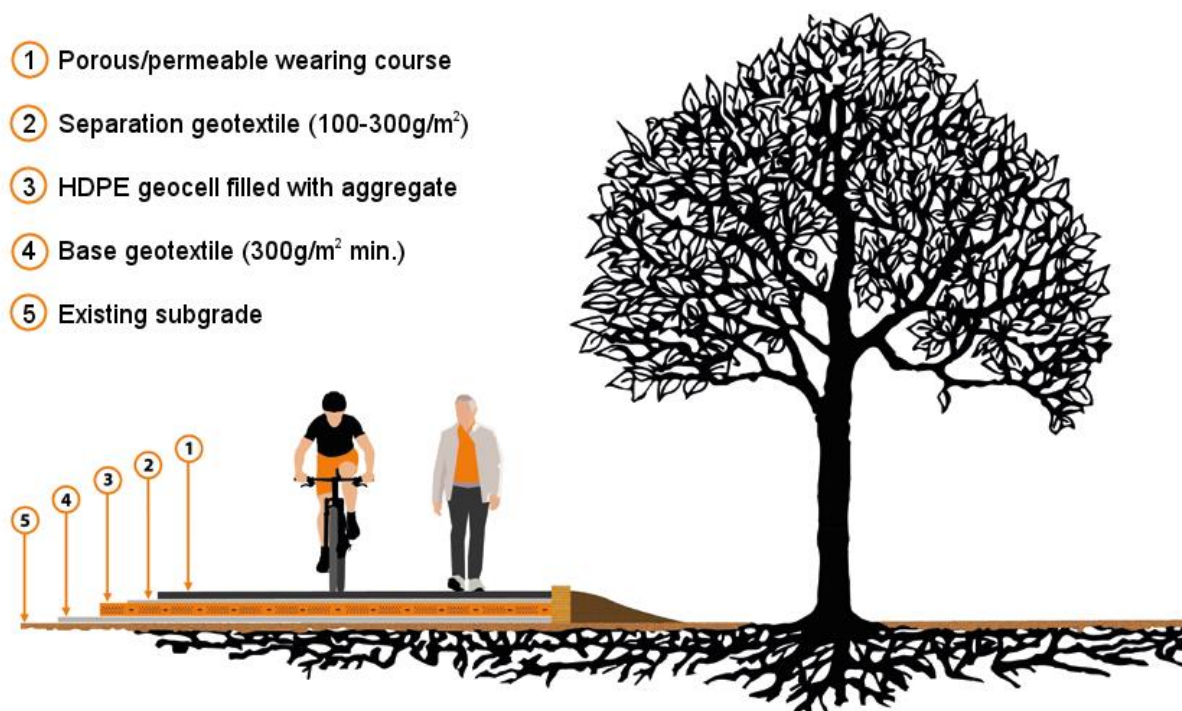
A cellular confinement system is a series of geocells arranged in a honeycomb-like formation that is combined with an underlying geotextile and angular stone to spread loads in such a way as to minimise compaction of underlying soil. Wearing surface options include porous asphalt, permeable block paving and loose or resin-bound gravel.

When cellular confinement systems or 'geocells' are used to protect tree root zones the central concept is that they are installed above ground and this normally results in a surface that is around 150mm above the existing ground level for footpaths, and in excess of 300mm above for roads and driveways. Careful consideration may need to be given to matching the raised level with existing surfaces and a sectional drawing can be useful.

## **The basic approach to using cellular confinement systems for ground protection near trees<sup>8</sup>.**

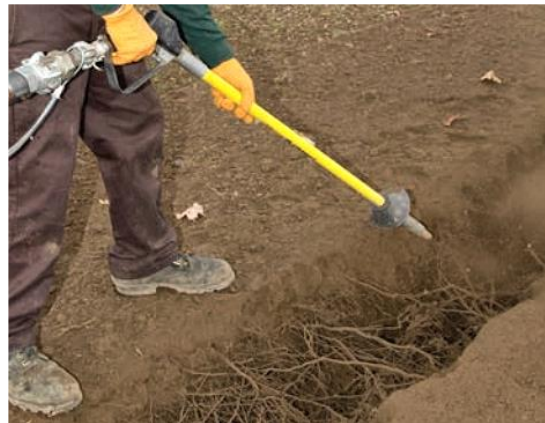
Once the new driveway hard surfacing and the ground protection have been installed, excavations will be dug using an air-spade along the proposed piling line to establish the size, position and depth of roots. These works will be carried out under the supervision of a qualified arboriculturalist. Screw piles will be positioned in-between the roots and no roots of more than 20mm in diameter will be severed. If a piling rig is required, to avoid compaction, it will be restricted to the area covered by the ground protection. The floor will be suspended to create a vented void with no further loading of the oversite.

**Air-spade trenching.**
