# Bat Emergence and Re-Entry Survey

**16 Tower Road, Earl Shilton,  
Leicestershire  
LE9 7EG**

**This report is prepared to inform a planning application for the proposal described as the erection of a rear single and two-storey extension.**

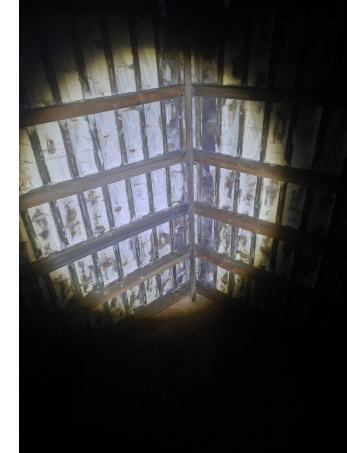
**Figure 1a:** B1 loft space (looking north end)

No bats or evidence of bats was identified in B1. However, due to the presence of a low number of external roosting features suitable for crevice dwelling species, and potential access points into the building suitable for void dwelling bats, B1 is assessed as low habitat value.

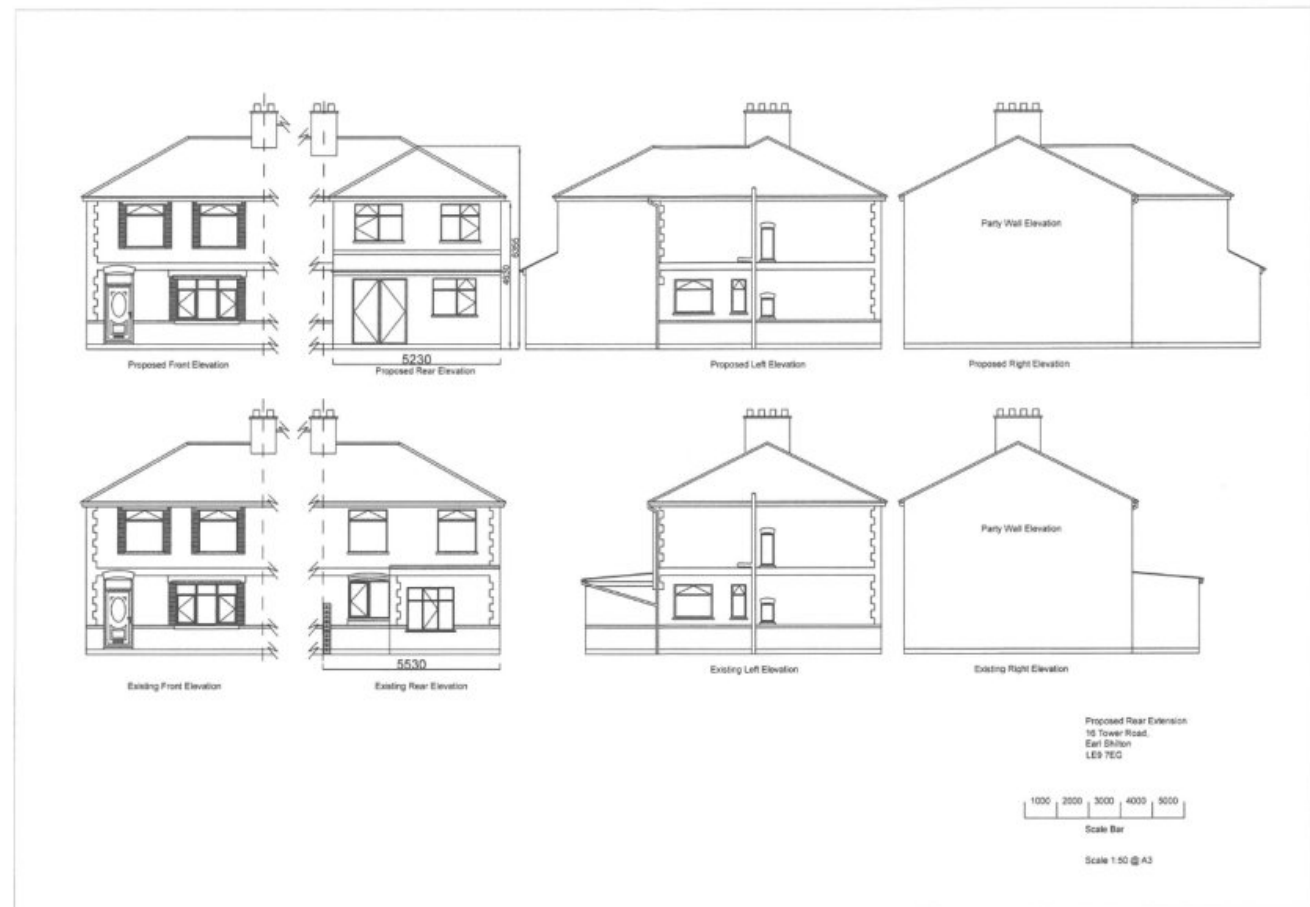
Figure 2: The proposed plans

The proposed works comprise the demolition of the existing single storey extension to facilitate the construction of a new rear single and two storey extension to the rear.

The installation of one bat box at the site will provide additional roosting habitat for bats. The bat box will be integrated within the new build extension. Bat boxes should be positioned 3-5m above ground level (at the eaves of buildings), facing in a south or south-westerly direction, with a clear flight path to and from the entrance, away from and unlit by artificial light, and not above any windows. The bat boxes will be a specification suitable for crevice dwelling species.

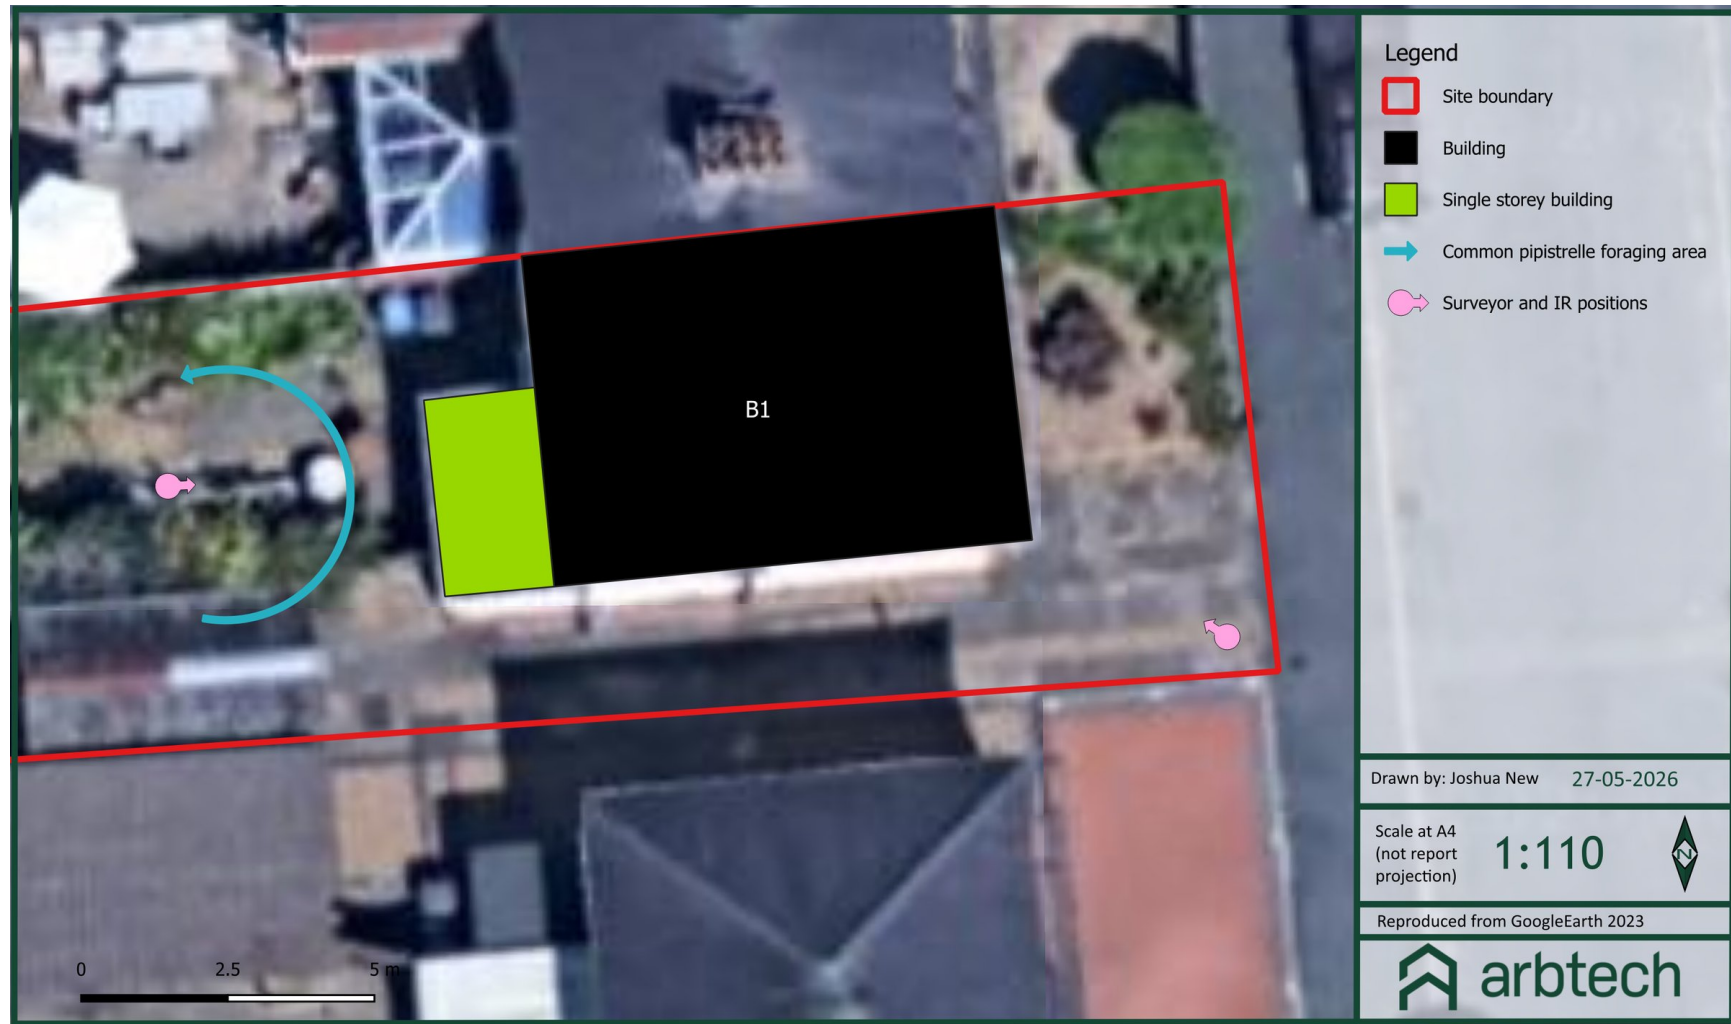
## Appendix 1: BERS plan

A diagram of the positions on site can be found in Appendix 1 along with the position images.

| Position | Elevation | Visit 1 |
| B1-1 | Western | Rabia Gull (LS) |
| B1-2 | Eastern | James Brack |

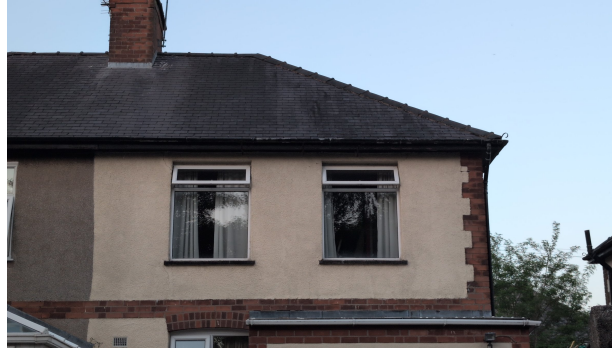
V1 B1-2 surveyor photo

Intermittent security light from neighbouring property. The lighting was intermittent and/or localised. Surveyors adjusted positioning to maintain clear views of potential access features, and NVAs compensated for variations in ambient light levels. General bat activity was still readily detectable both visually and acoustically. As such, this represents a minor constraint to a portion of one survey and does not affect the robustness of the overall dataset or conclusions.
