# Desk Study Report

Richborough Estates

Brascote Lane, Newbold Verdon

Ref: PJSG21-47-RT-01-A

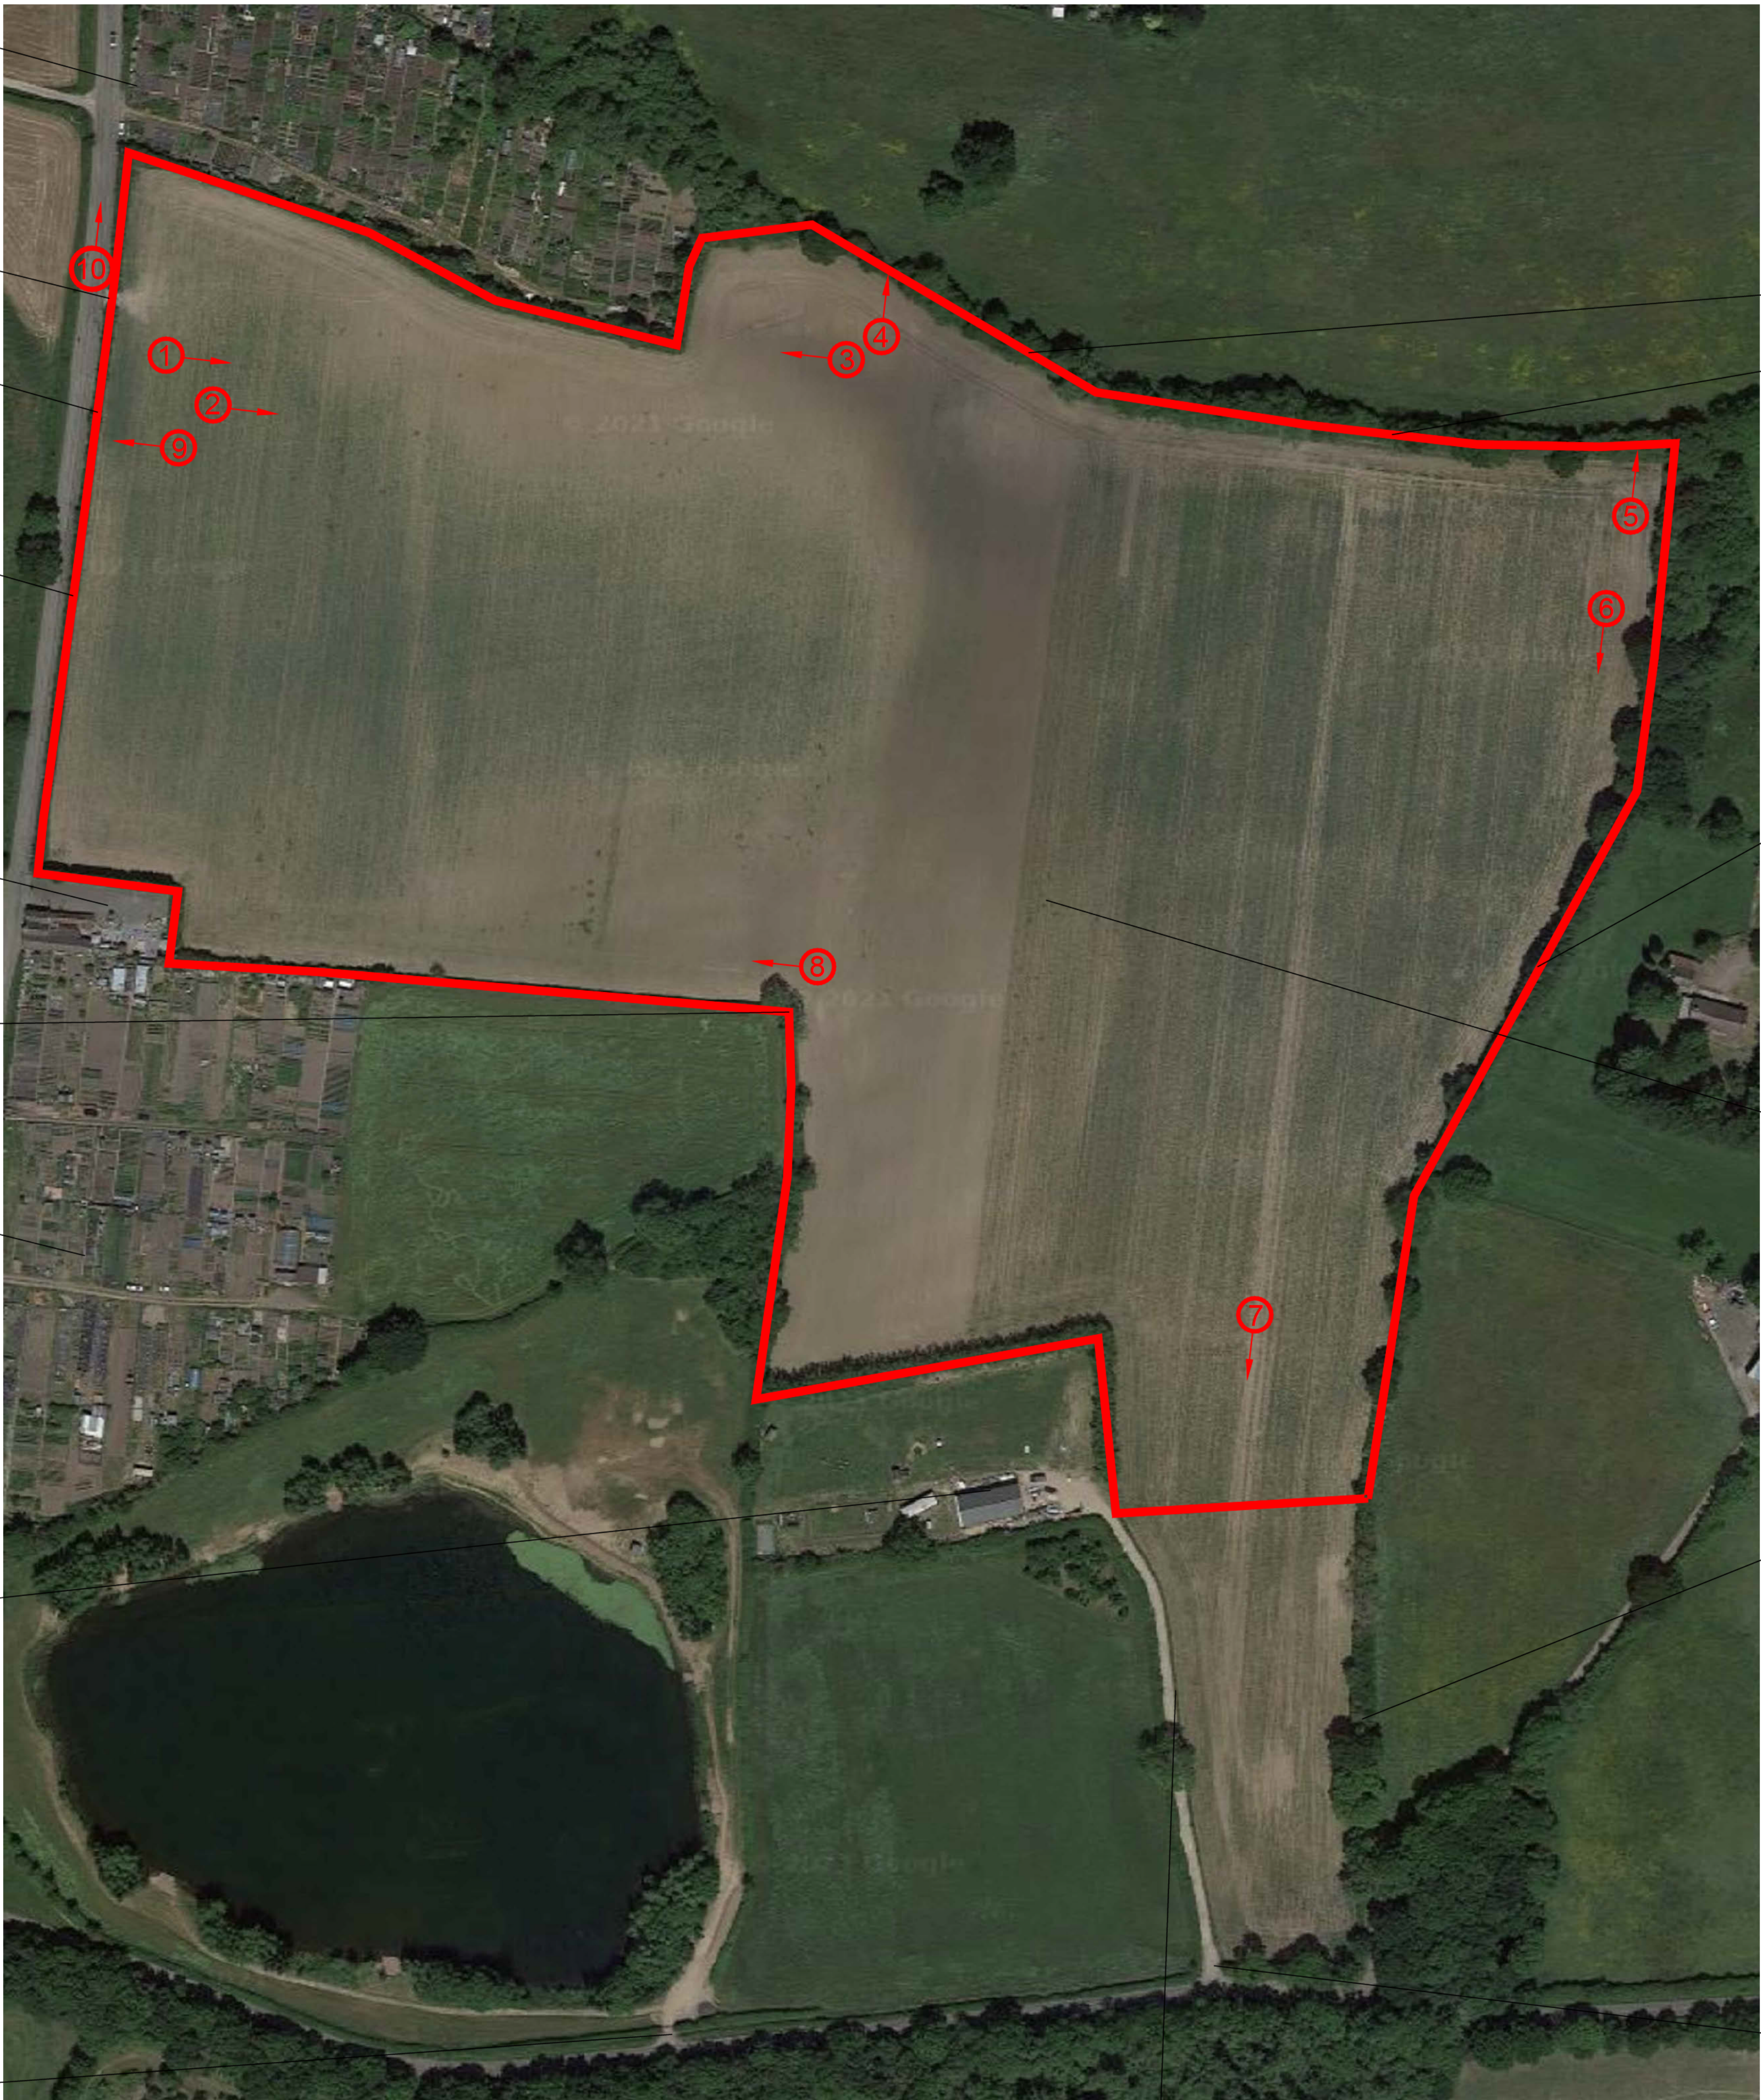
| PJSG21-47 | DR-002 | A | | |

Allotment gardens.

Access to field via open field boundary

Open water lake. Signage suggested  
areas of running and quick sands were  
present.

Boundary formed of wooden post and rail fencing.

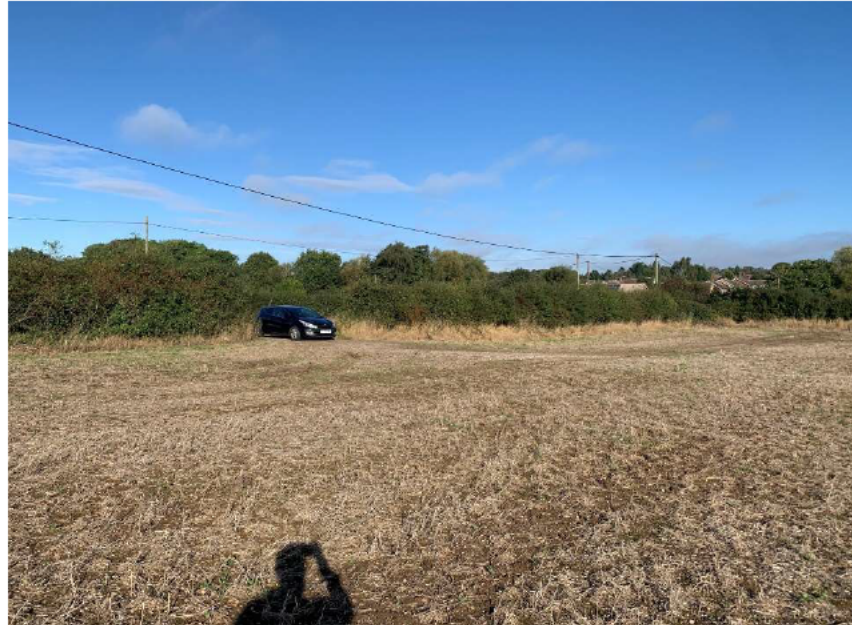
Photograph of the northern access point from within the site.

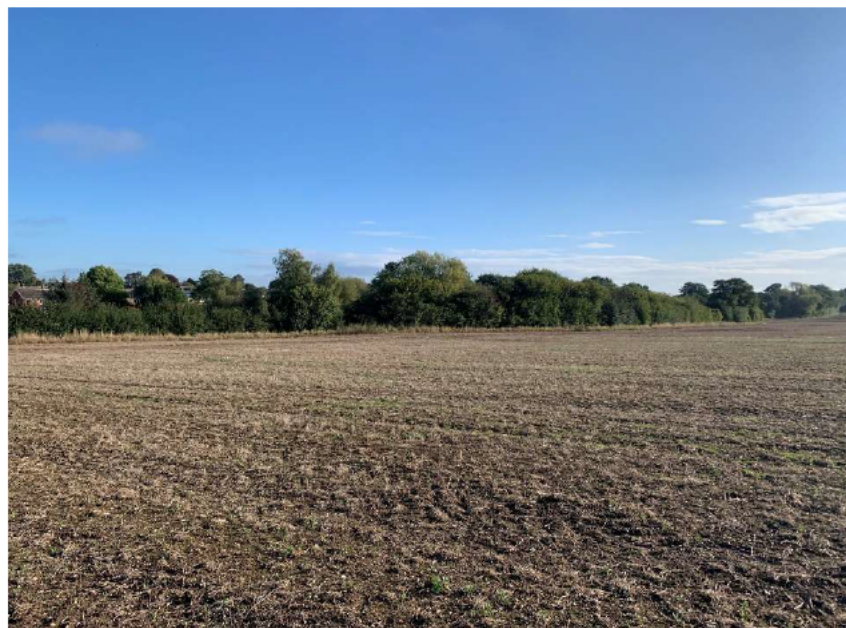
Photograph of the northern boundary looking north from the northern access point.

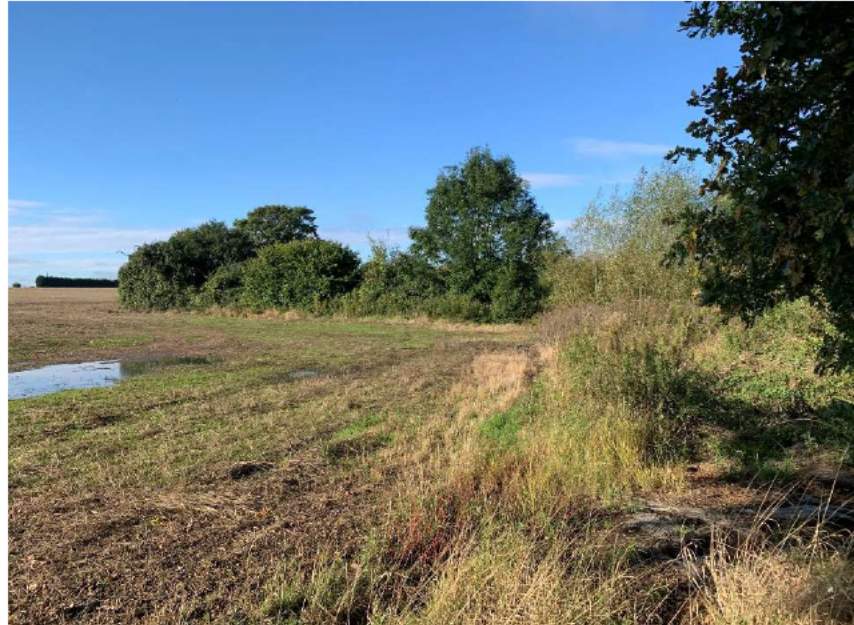
Photograph of the northern boundary looking west towards the boundary with the allotment gardens.
