Old Rectory  
Market Bosworth  
Archaeological Monitoring and Recording  
July 2024

Archaeological Monitoring and Recording

Old Rectory, Market Bosworth

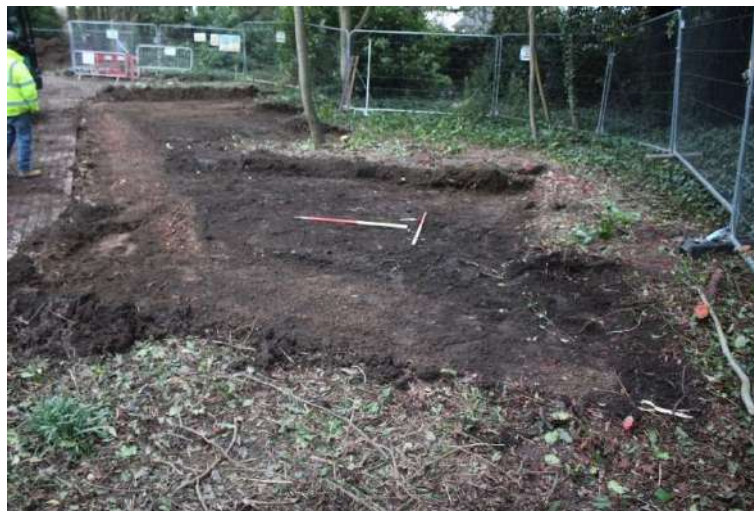
- 6.1.1 Monitoring comprised the excavation of parking spaces to a depth of 0.18m and one trench for a new water main to the site running north-south to the west of the property to a maximum depth of 1.20m (Figure 2, Figure 3). Ground conditions throughout were dry.
- 6.1.2 Natural geology comprising mid-yellow to brown clayey silt (108) was observed at a depth of 0.60m BGL (131.24m aOD). This was sealed by a deposit comprising mid-grey to brown clayey silt subsoil (111) which ranged in thickness from 0.45m in the north to 0.35m in the south. The sequence was completed by topsoil (100) measuring up to 0.20m in thickness.
- 6.1.3 In the north of the area, this sequence was cut by the foundation of the modern paved path. Cut [104] was linear in plan and filled by a mid-pink to grey gravel (103).

*Plate 1. Area 1, north section looking west (2x1m scales)*

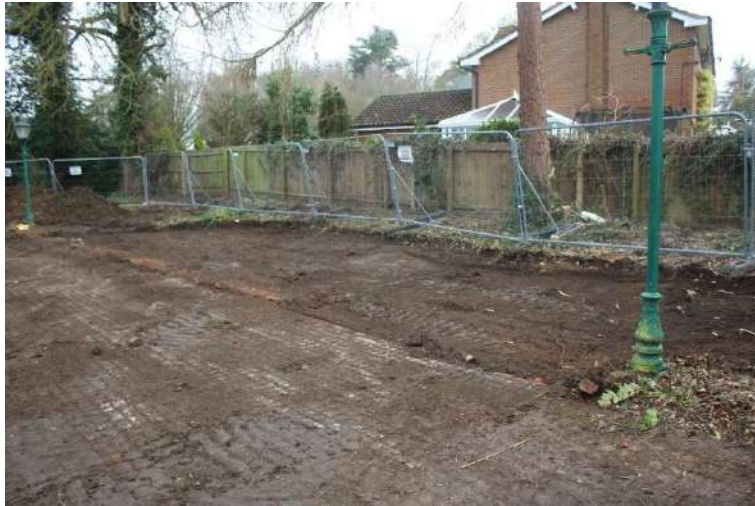
- 6.1.4 In the east of Area 1, a similar sequence of deposits was visible, with path cut [106] filled by (105) a mid-pink to grey gravel.
- 6.1.5 In the southeast of Area 1, made ground (107) was present, comprising firm mid-yellow to grey clayey silt with clay lenses (Plate 3).

*Plate 2. Area 1, west section looking northeast (no scale)*

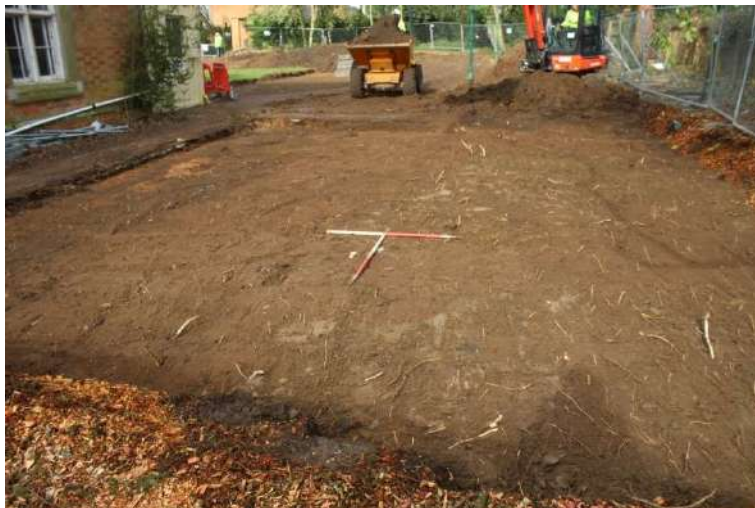
*Plate 3. Area 1, west section with made ground (107), looking north (2x1m scales)*

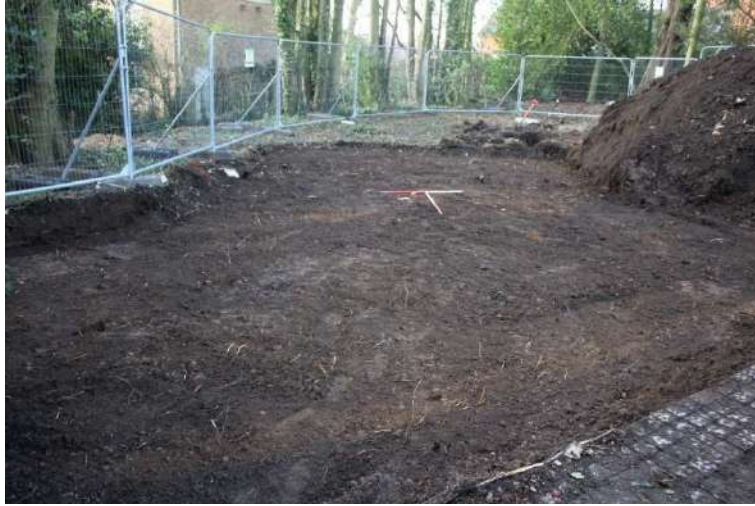
- 6.1.6 A large area was stripped (Plate 4), and a trench running north-south was excavated in the western area. In the southwest of this area, subsoil (111) was cut the construction cut for the paved path, measuring 15m long, 0.60m wide (excavated) and 0.24m thick. The northern side of the cut [110] was visible, comprising a gradual break of slope at the top, vertical sides and a flat base. Fill (109) consisted of a mid-grey brown clayey silt with occasional frogged bricks and frequent small subangular stones.

*Plate 4. Area 1, western area, looking northwest (2x1m scales)*

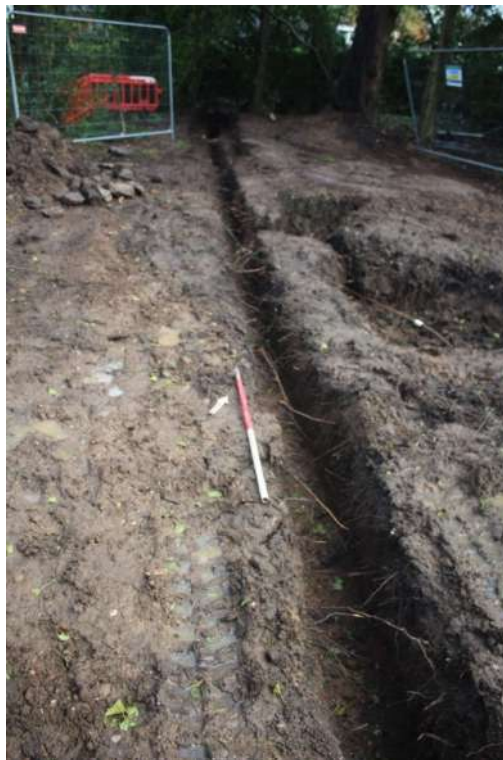
*Plate 5. Trench for new water main excavated in Area 1, looking north (1m scale)*

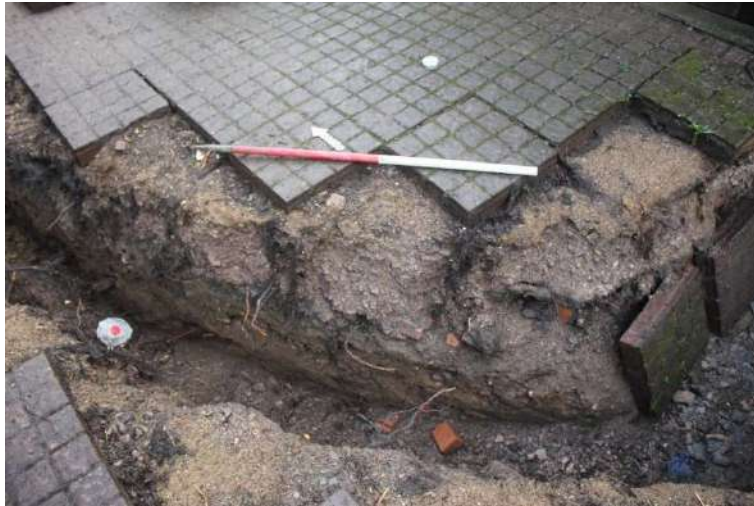
*Plate 6. Southwest section of western trench for new water main, showing (109), looking northeast (1m scale)*

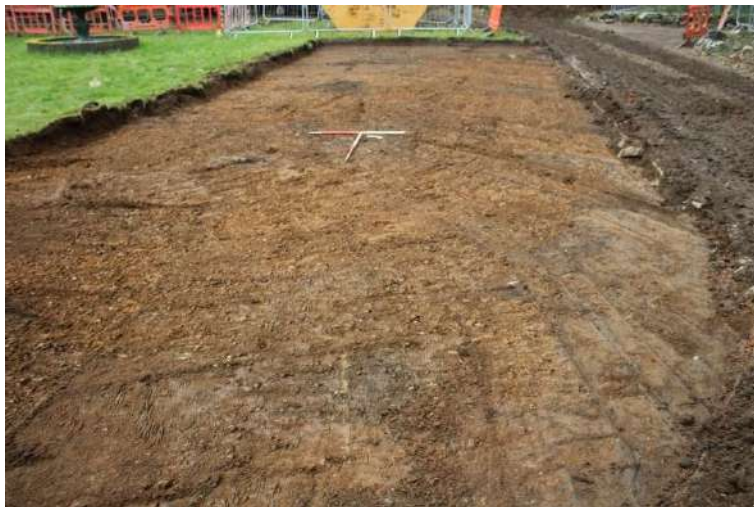
- 6.1.7 To the north of the central area was a modern deposit consisting of redeposited natural geology (101), a mid-yellow to brown clayey silt, with frequent subangular stones, occasional modern pottery and frequent modern glass (not retained) (Plate 7). This was sealed by topsoil (100). Cutting into (101) were a number of tree-throws, which were investigated but were not recorded as the regularity of their spacing (1.40m exactly on a northeast-southwest alignment) and the inclusions found within suggested a very modern date.

*Plate 7. Area 1, northern part of parking area showing deposit (101), looking west (2x1m scales)*

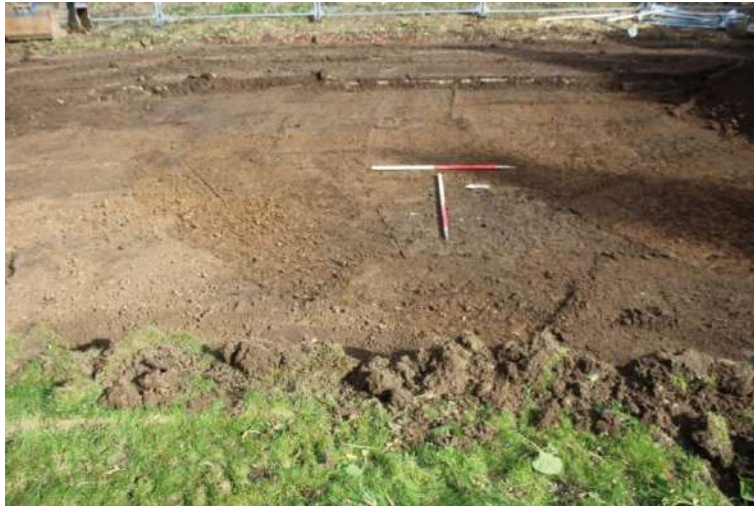
- 6.1.8 To the south of the central area, made ground (102) comprising a mid grey to brown sandy silt with occasional modern pottery (not retained), and frequent small subangular stones was observed under topsoil (100). The relationship between (101) and (102) was unclear (Plate 8).
- 6.1.9 Services, including gas and electricity were observed to the south. All were on a northwest-southeast alignment leading to the existing building.

*Plate 8. Area 1, parking area showing intersection between (101) and (102), looking east (2x1m scales)*

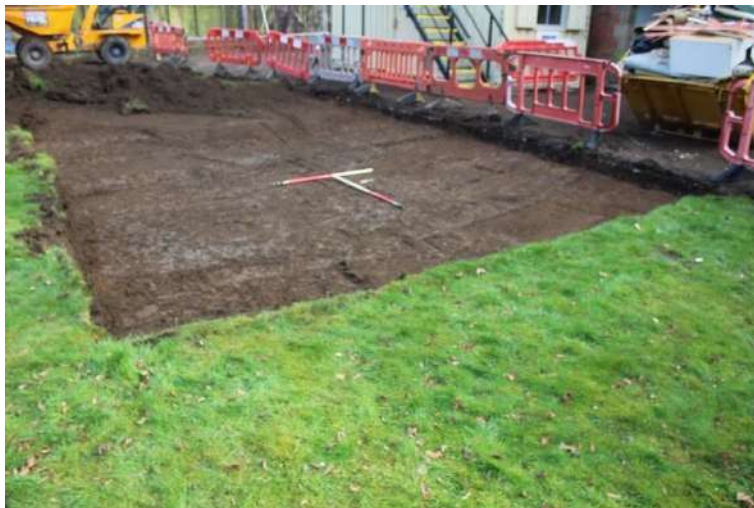
*Plate 9. Area 1, southern part of parking area showing deposit (102), looking southeast (2x1m scales)*

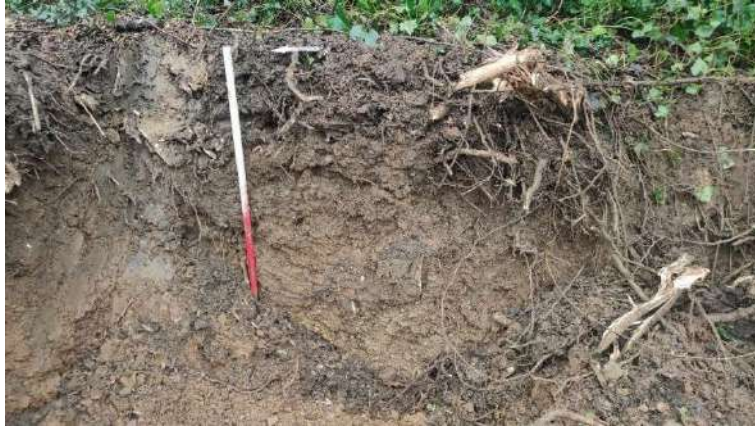
- 6.2.3 To the east of the property, deposit (202) was sealed by a dark orange to brown clayey silt (201), possibly associated with the rooting system of the removed stumps. This was sealed by topsoil (200) measuring up to 0.28m in thickness.

*Plate 10. Area 2, west-facing section of tree stump 3 (1m scale)*

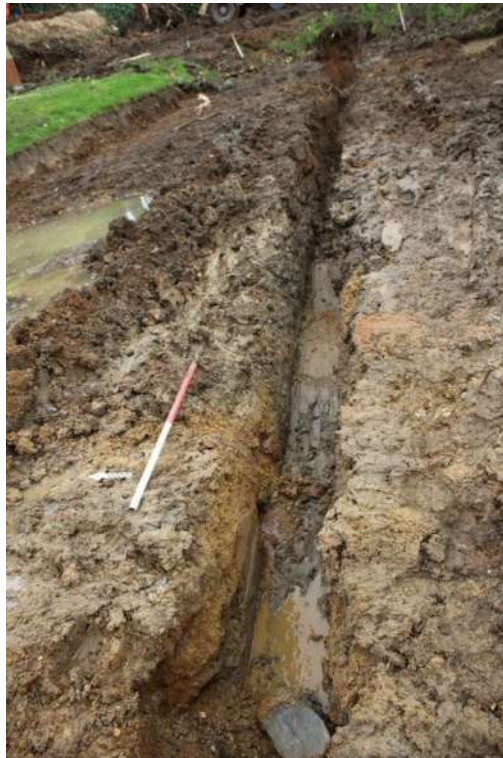
- 6.2.4 In the centre of Area 2, deposit (202) was truncated by a large cut, 25m in length, 13m in width and 0.45 in depth (Figure 6). The cut [206] was rectangular, with a sharp break of slope at the top, concave sides, and a flat base. This was filled by primary fill (205) 0.23m thick, comprised of a mix of mid-blue to grey silty clay and mid-red to brown silty, with occasional small subangular stones, and secondary fill (204), a mid-grey to yellow silty clay measuring 0.18m thick.

*Plate 11. Area 2, Drain 1 [206] (205) (204), looking southeast (1m scale)*

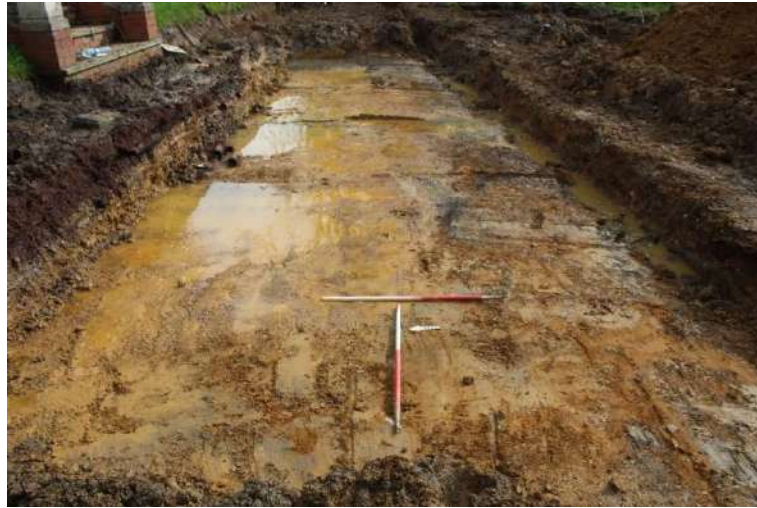
*Plate 12. Area 2, north of tank location showing deposits (206) (205), looking east (2x1m scales)*

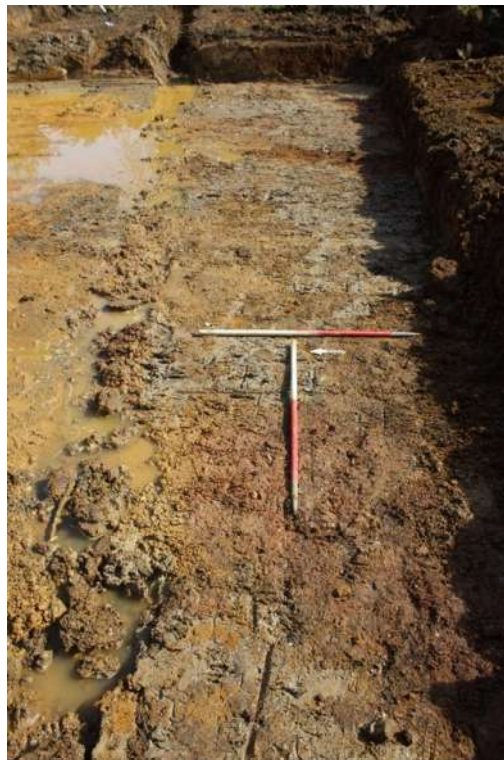
*Plate 13. Area 2, south of tank location showing (205), looking east (2x1m scales)*

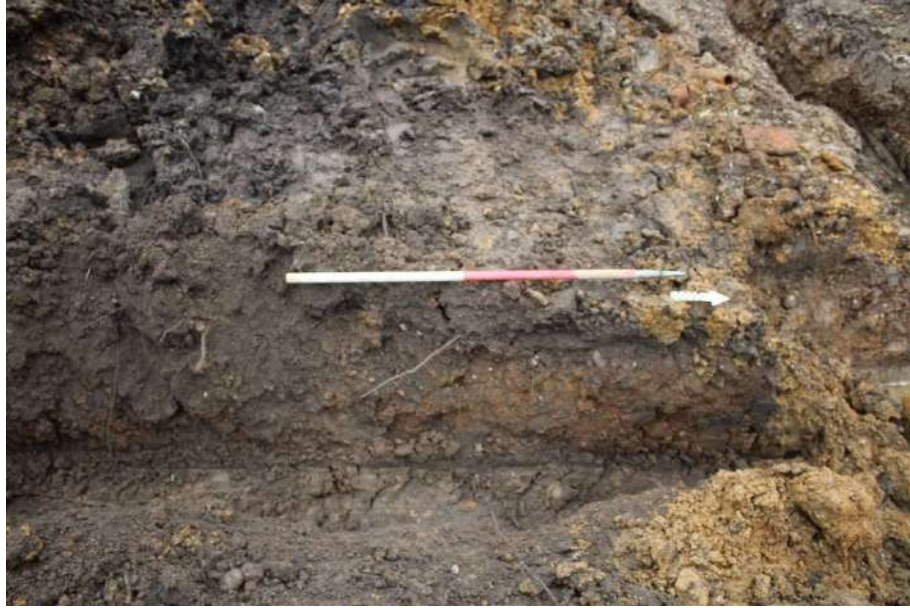
*Plate 14. Area 2, east-facing section of Drain 7 (1m scale)*

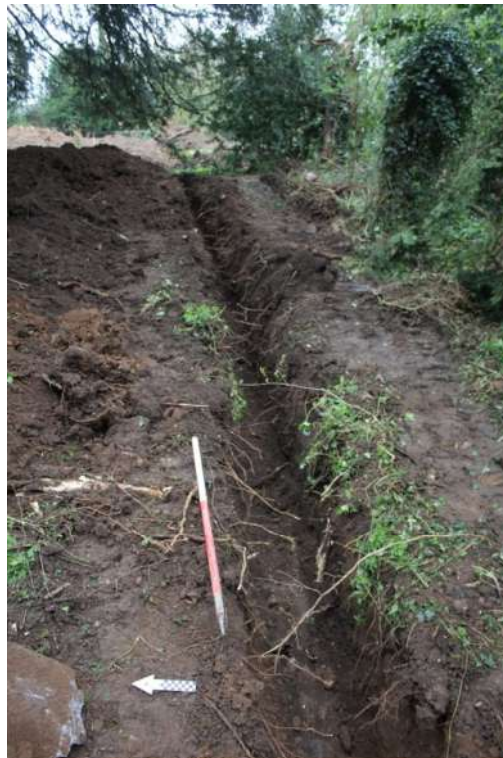
- 6.2.5 Deposit (202) was also cut by a possible cess pit [214], measuring 50m long, 0.60m wide (excavated) and 0.60m deep. Cut [214] was only visible at the southern end of Drain 2 and was filled by (213), a mid-yellow to brown silty clay with occasional small subrounded stones, and modern glass bottles (not retained).

*Plate 15. Area 2, Drain 3b showing (200) and fill (213), looking west (1m scale)*

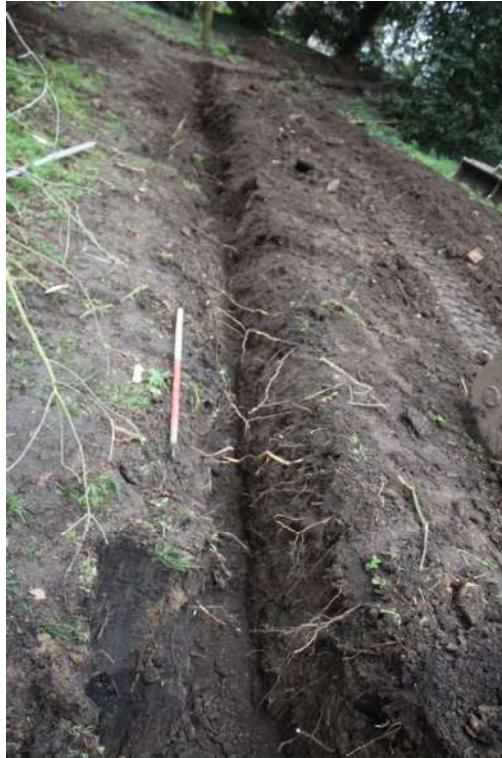
- 6.2.6 Fill (213) was cut by another cess pit [217], measuring 35m long, 0.60m wide (excavated), and 0.50m deep. This cut was only visible on one side, within Drain 3,

with concave sides and a flat base. It was filled by (216), a dark grey to brown clayey silt with occasional animal bones (cattle), glass bottles, slate, and modern plastic (not retained).

*Plate 16. Area 2, Drain 3b showing (216), looking north-northwest (1m scale)*

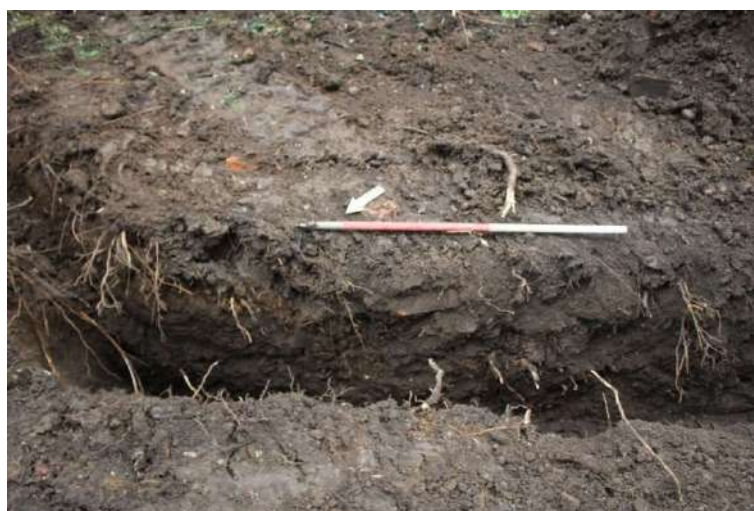
*Plate 17. Northwest facing section of the corner of Drain 3b showing (200) (216) - Looking southeast (1m scale)*

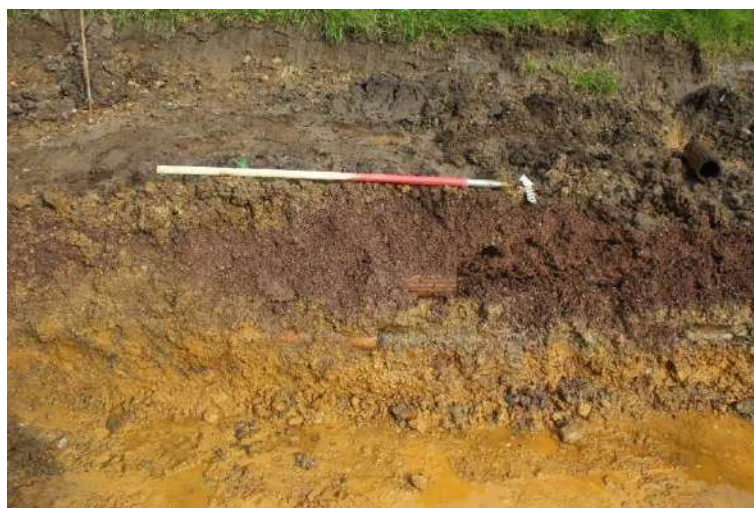
6.2.8 Several post-medieval drains were observed in Area 2 (Figure 3). Most were on a north-south alignment leading to the existing building. Two ran east to west.

*Plate 18. Area 2, post-medieval drain running east-west in south facing section of tank excavation (1m scale)*
