**Bat and Nesting Bird Method Statement for,  
Mr. and Mrs. Taylor.  
Building at,  
Dovecott Barn,  
Ravenstone Farm,  
Main Street,  
HIGHAM ON THE HILL,  
Leicestershire,  
CV13 6AH.**

**Map Ref SP 3814 9541  
2<sup>nd</sup> March 2026.**

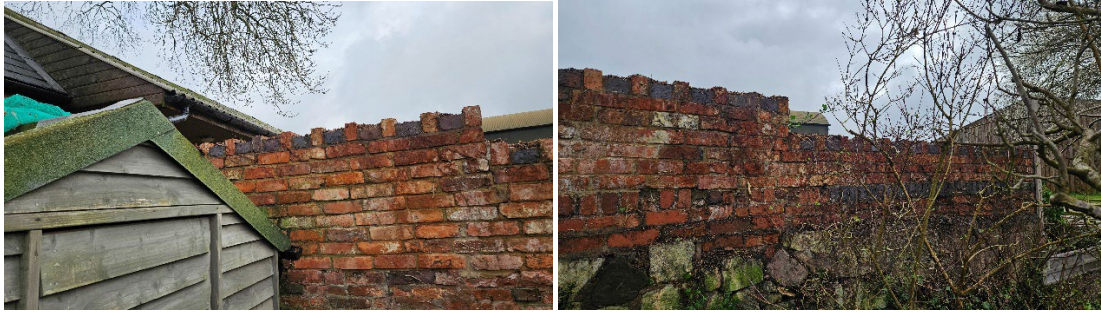
At the rear of the area where the new kitchen is to be built was an area of hedge with the neighbouring property. This was removed before the end of February 2026 to ensure that birds do not begin nesting in the hedge. The digging of foundations close to the boundary would have been likely to disturb birds if they had begun nesting in this area. The removal of this area of hedge removes this likelihood..
