## Technical Note - Infiltration Assessment

| Project: | Stoke Road, Hinckley | Project Ref: | M224-138 |
| Doc Ref: | M224-138 SRH-AJP-XX-XX-R-G-0001 | Revision: | P01 |

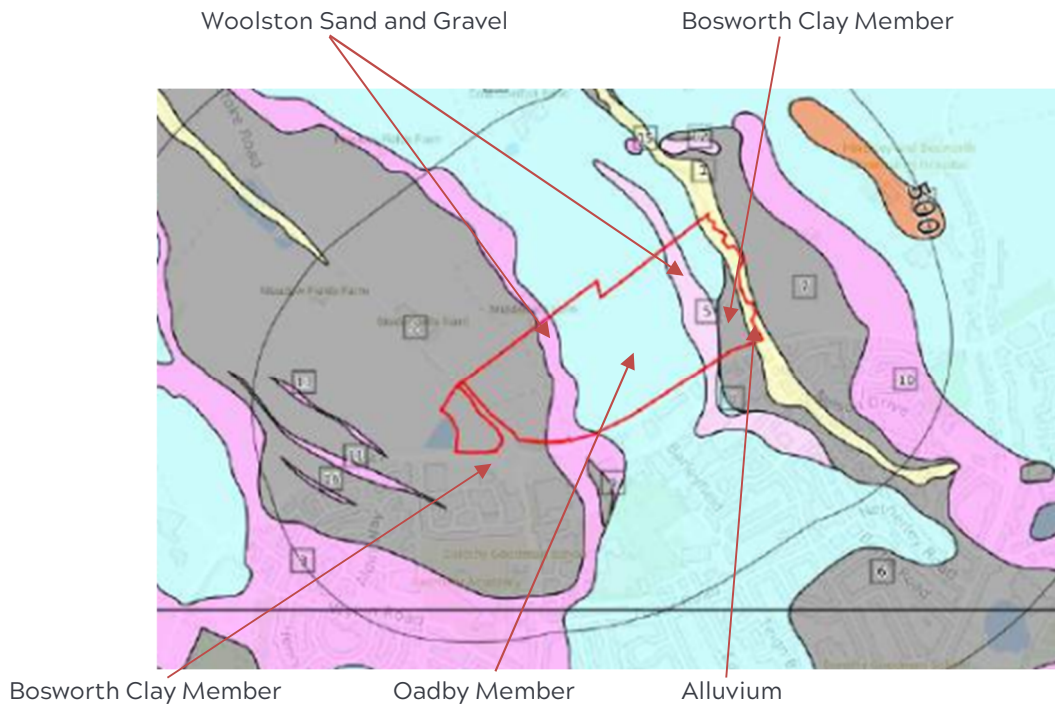
Information published by the BGS indicates that the site is directly underlain by the Bosworth Clay Member (clay and silt); Wolston Sand and Gravel; Oadby Member (Diamicton) and Alluvium (clay, silt, sand and gravel) superficial deposits, overlying Mercia Mudstone Group bedrock. Topsoil is present across the site.

The spatial distribution of the recorded superficial geology is illustrated below:

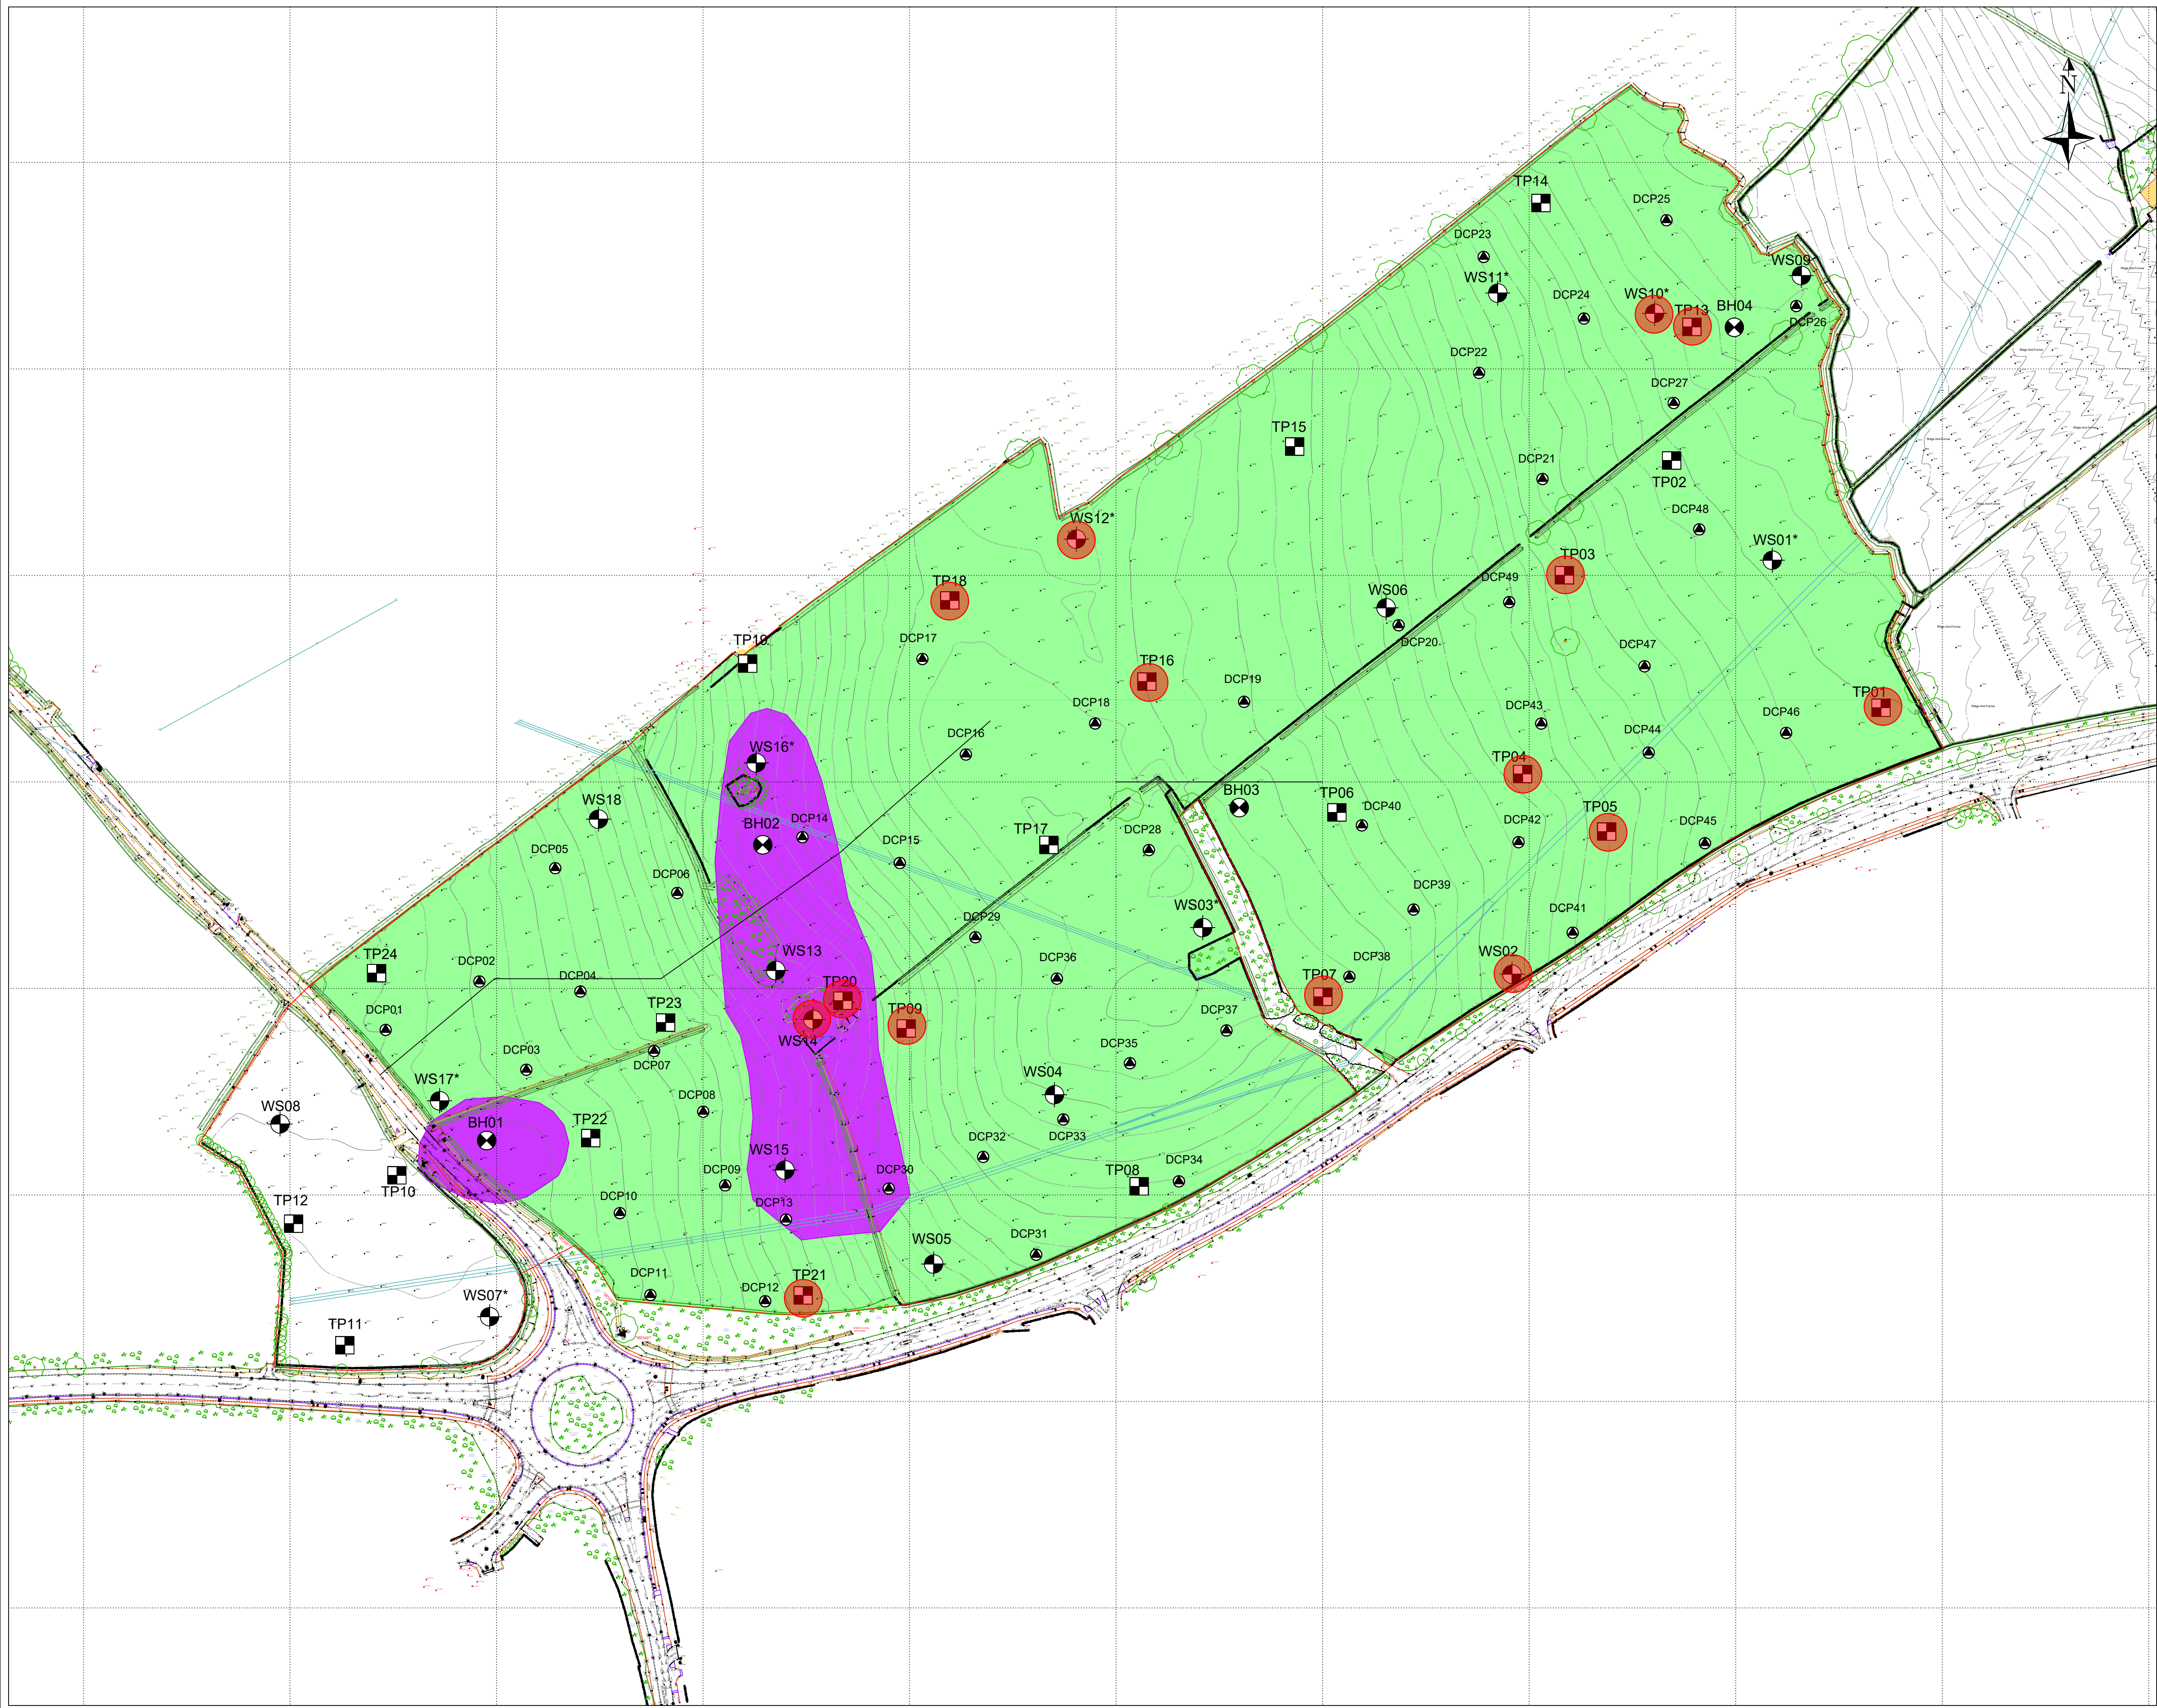
The above table does not include sand lenses <0.5m thick. The above locations are highlighted red on the MEC hole location plan presented in Appendix A.

## MEX Exploratory Hole Location Plan and Logs

AJP have reviewed the logs and the locations where granular deposits are present are detailed below:

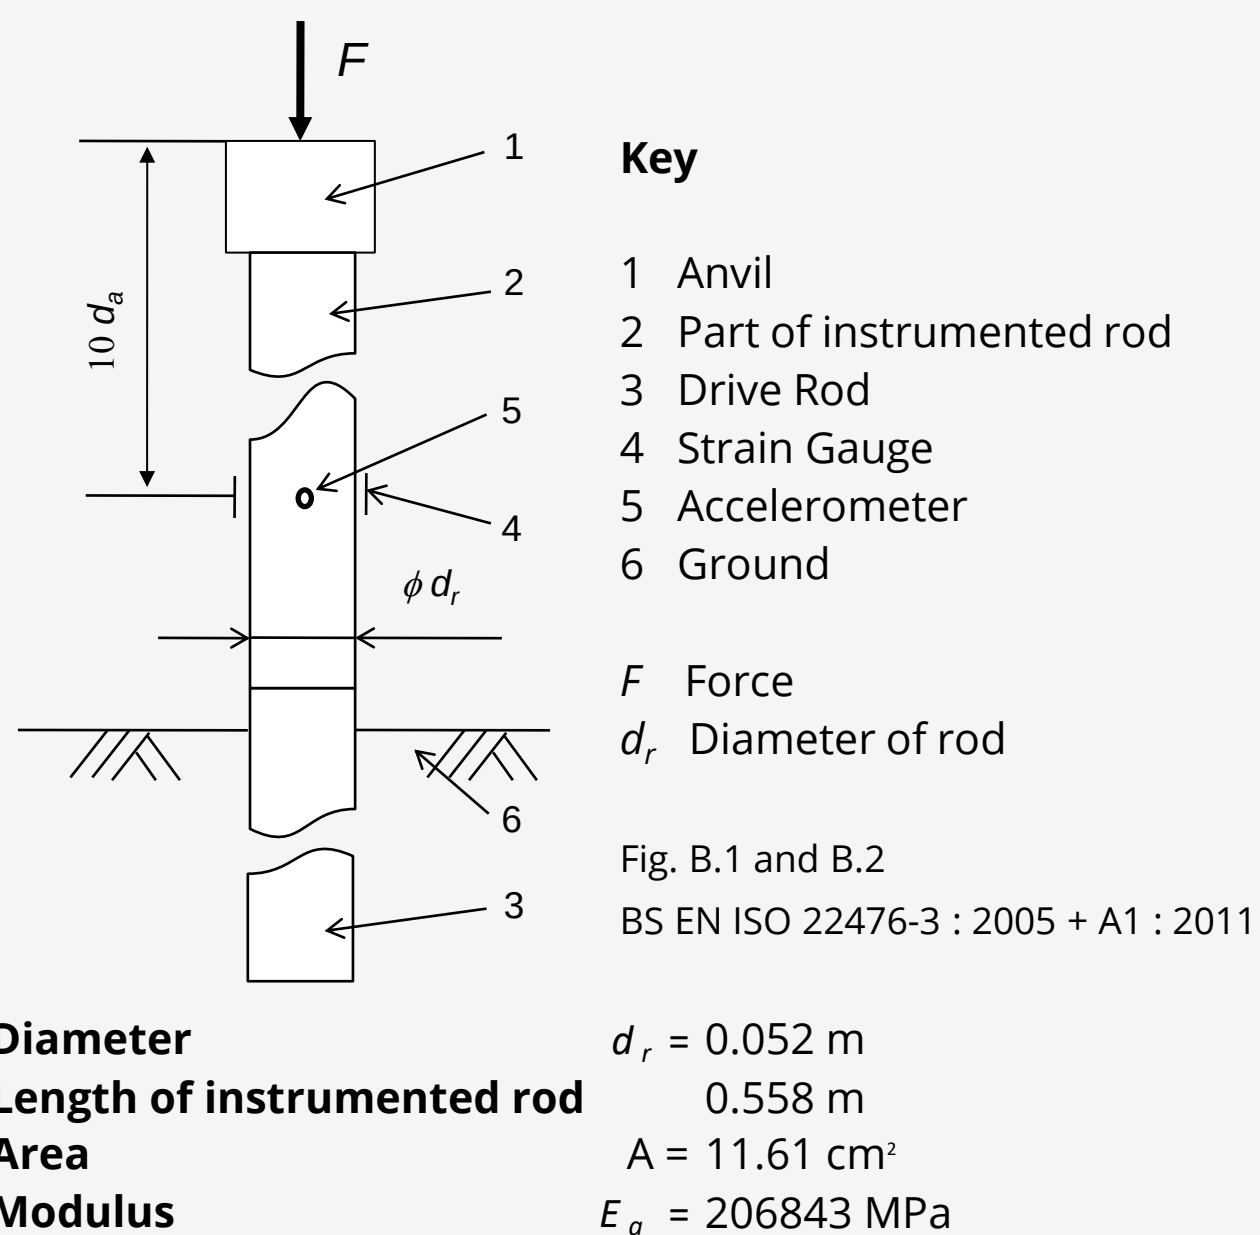
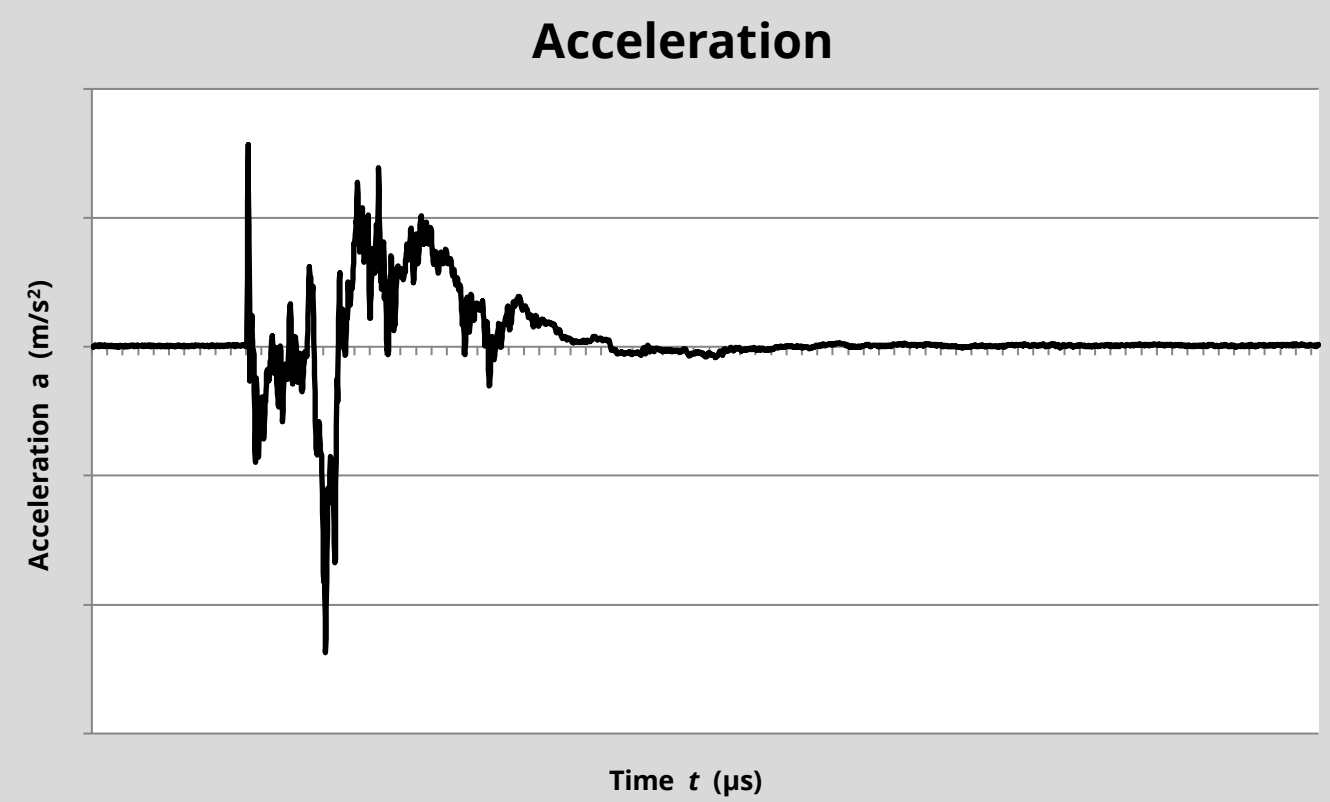
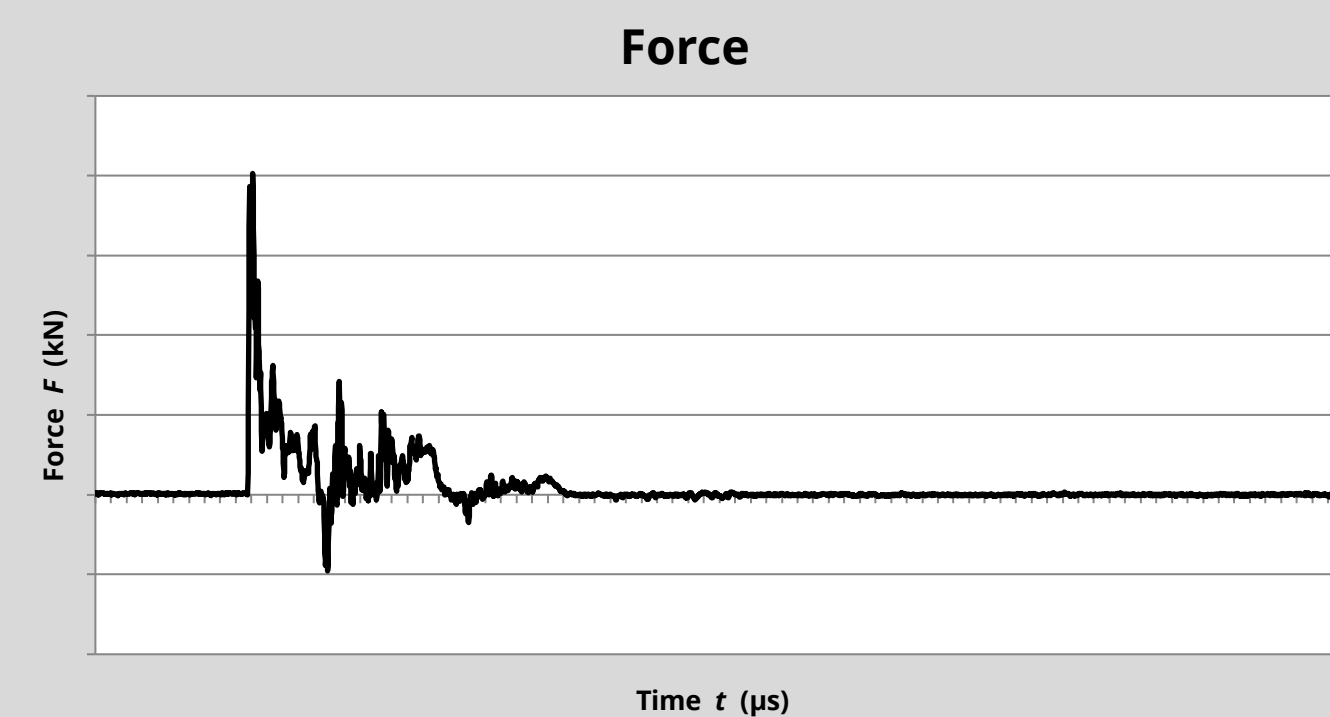
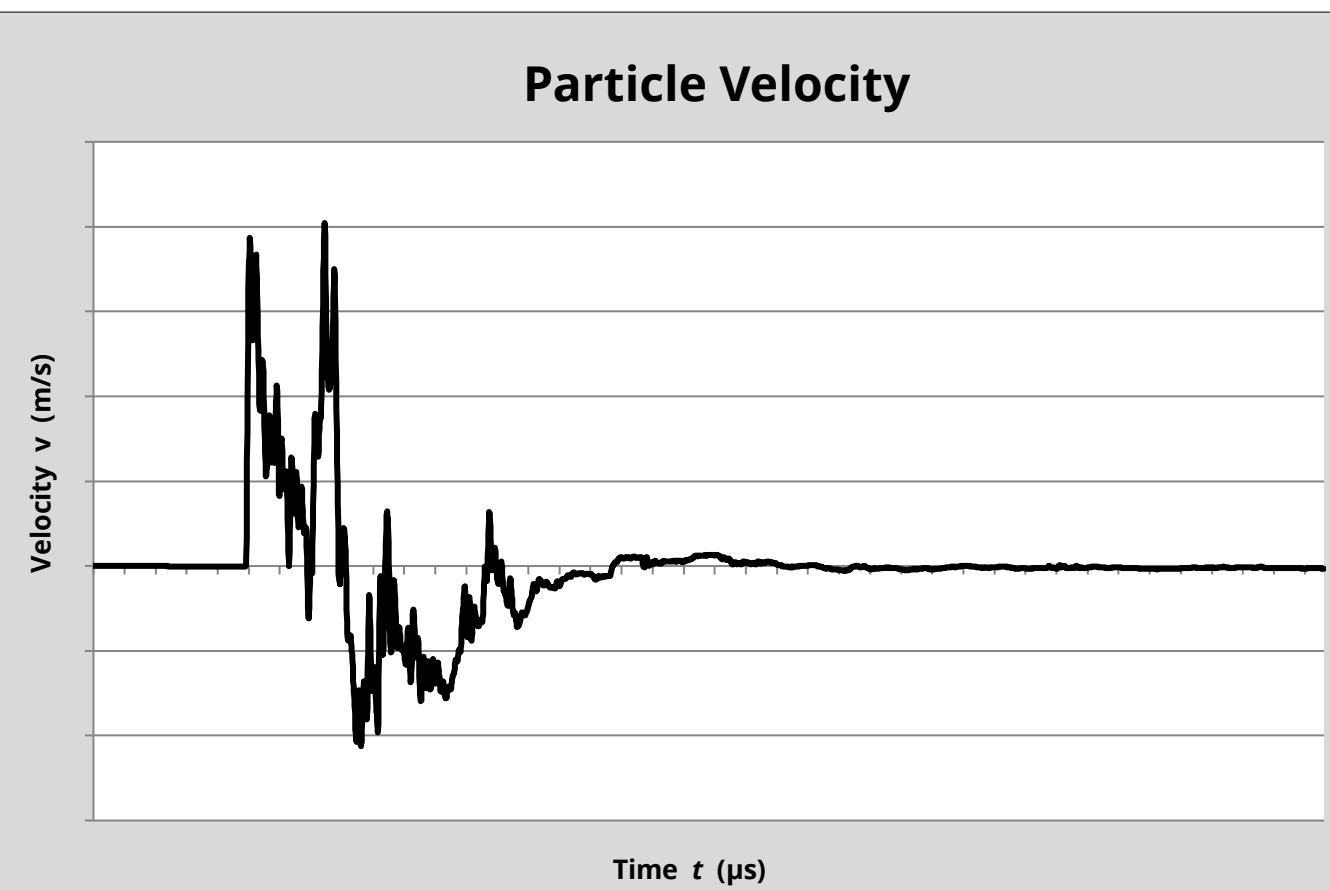
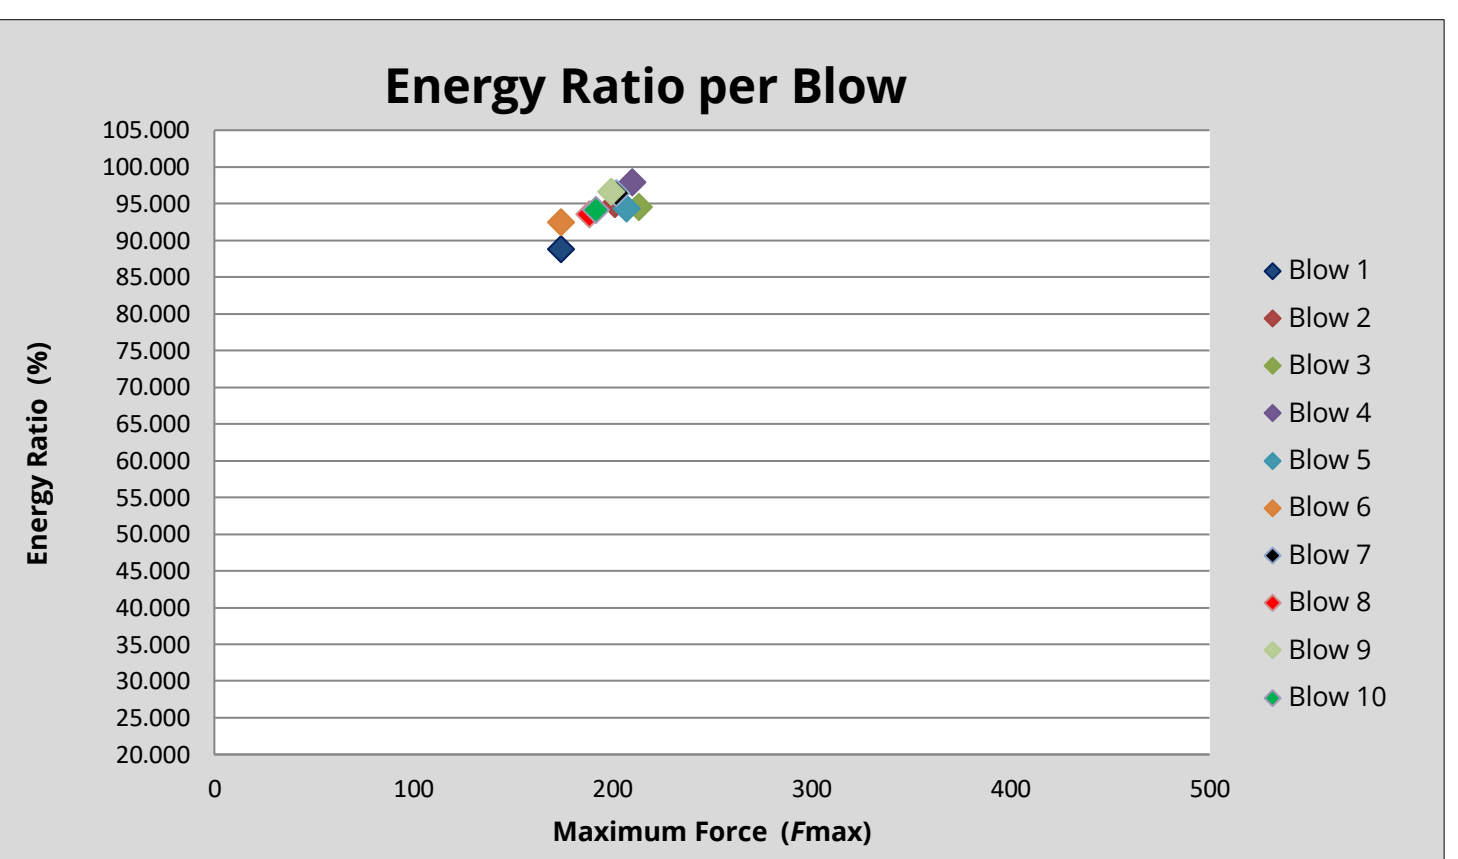
## SPT Calibration Report

Test Depth (m) 9.70  
Mass of hammer  $m = 63.5\text{kg}$   
Falling height  $h = 0.76\text{m}$   
 $E_{\text{theor}} = m \times g \times h = 473\text{J}$

Energy Ratio (Er) =  $\frac{E_{\text{meas}}}{E_{\text{theor}}}$

93.16%  
© COPYRIGHT 2023
