**Internal /External Bat Survey**

**4 Vilia Close**

**Client: Chris Bedford**

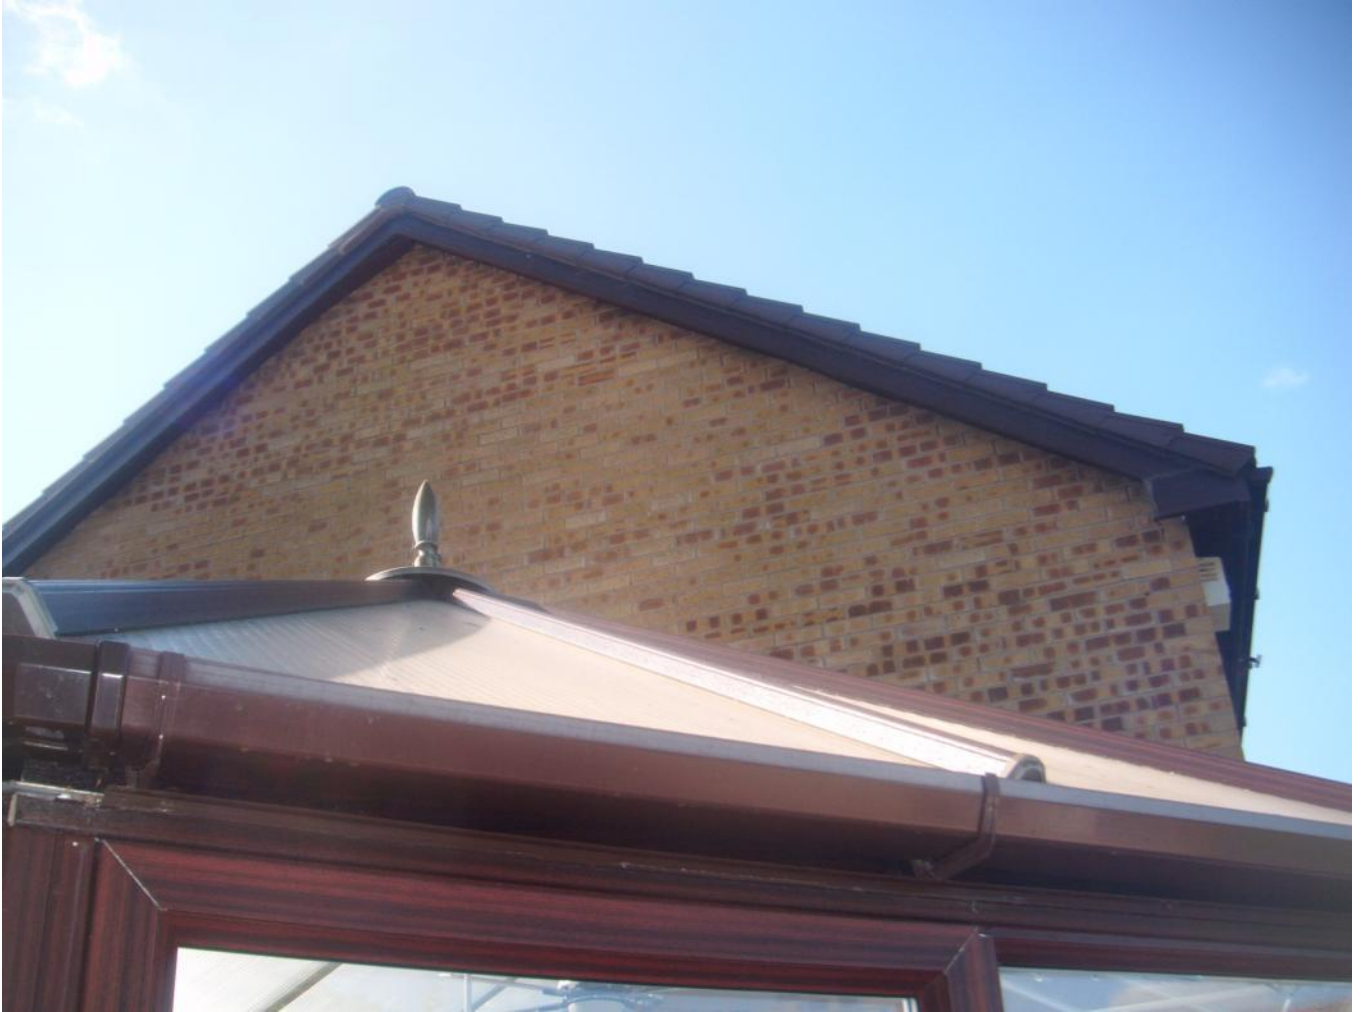
All of the brickwork and render is generally very intact throughout. Windows, doors and soffits (where exist) intact, with the exception of a single location where the soffit has a gap at gable end: this was inspected with binoculars: no signs of bat usage such as staining, scratching or droppings.

Gable end

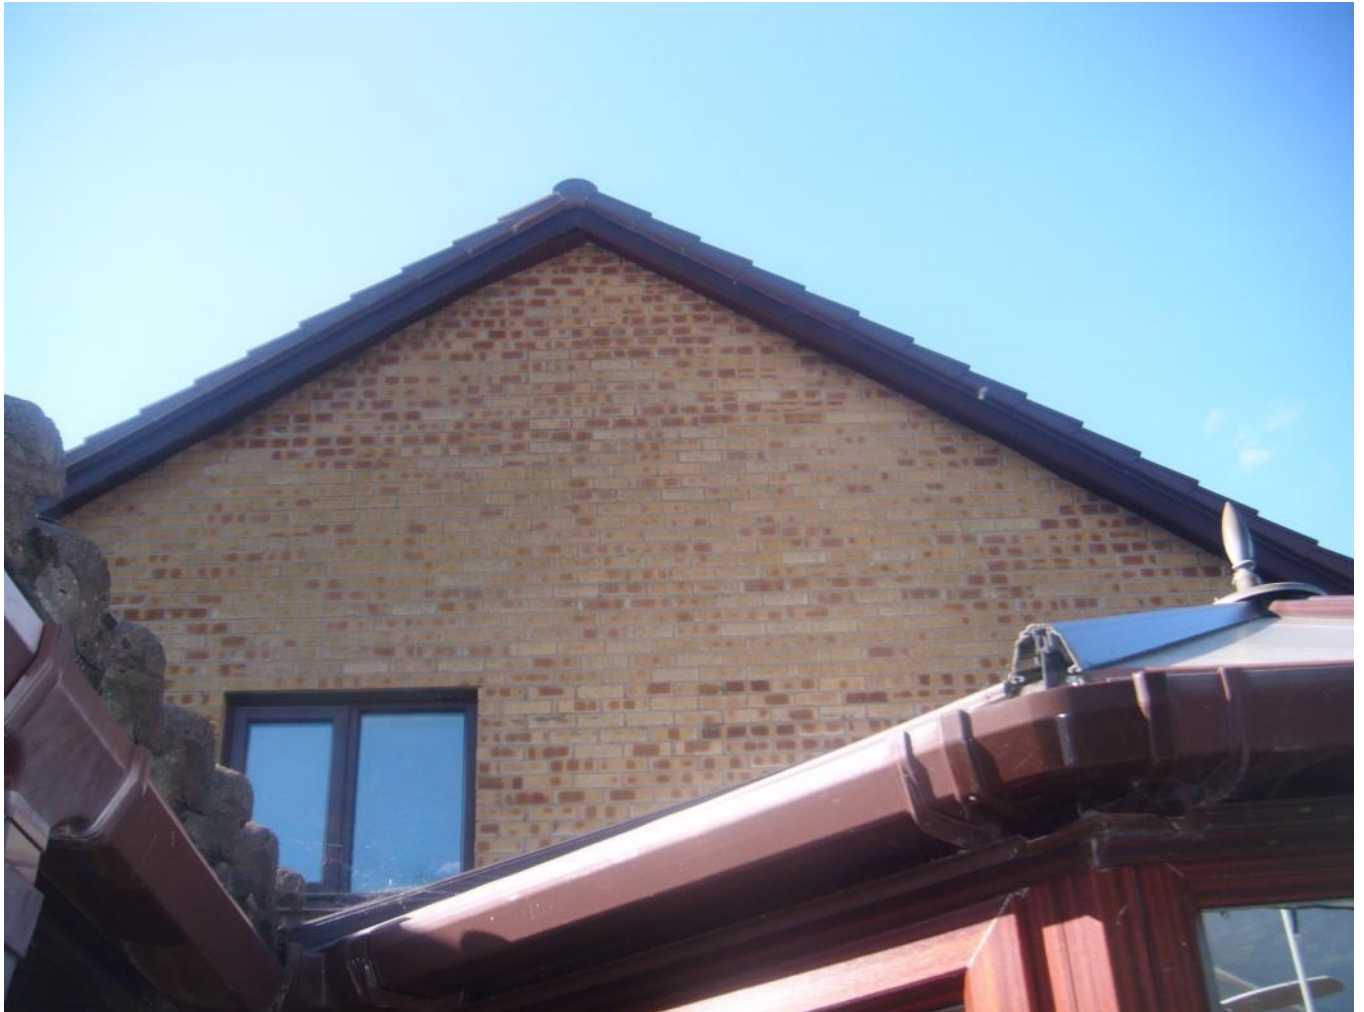
Gable end

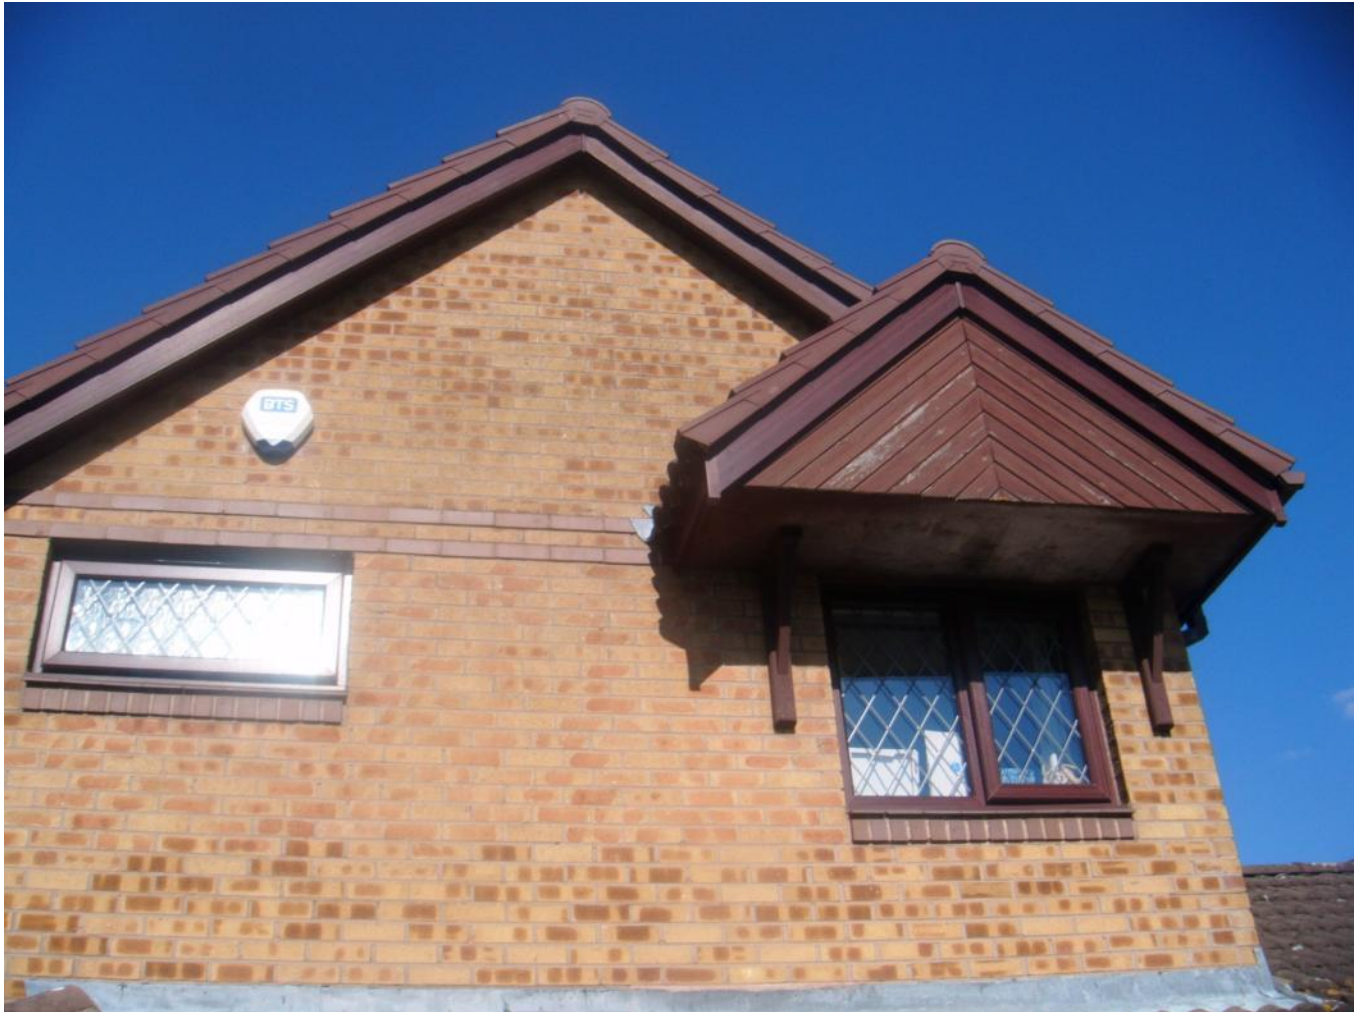
- Evidence of bird access with droppings on small over-window feature to frontage, no evidence of current use for bird breeding.

Front feature over window: note whitewash

In relation to the National Planning Framework (2023) there will be no requirement for Mitigation/ Compensation measures for bats, no further surveys required. As previous bird use is recorded in one area, works to this area must avoid the peak bird breeding season of March to end August. Mitigation in the form of a NE facing bird box (House sparrow terrace) and Bat box (S facing; Beaumaris bat box midi) will be required to compensate for any loss of bird breeding/bat roosting potential and as a site enhancement. In addition, external lighting should be restricted and should conform with BCT guidelines, 'Bats and External lighting, BCT, 2018', updated in 2023 should be followed.

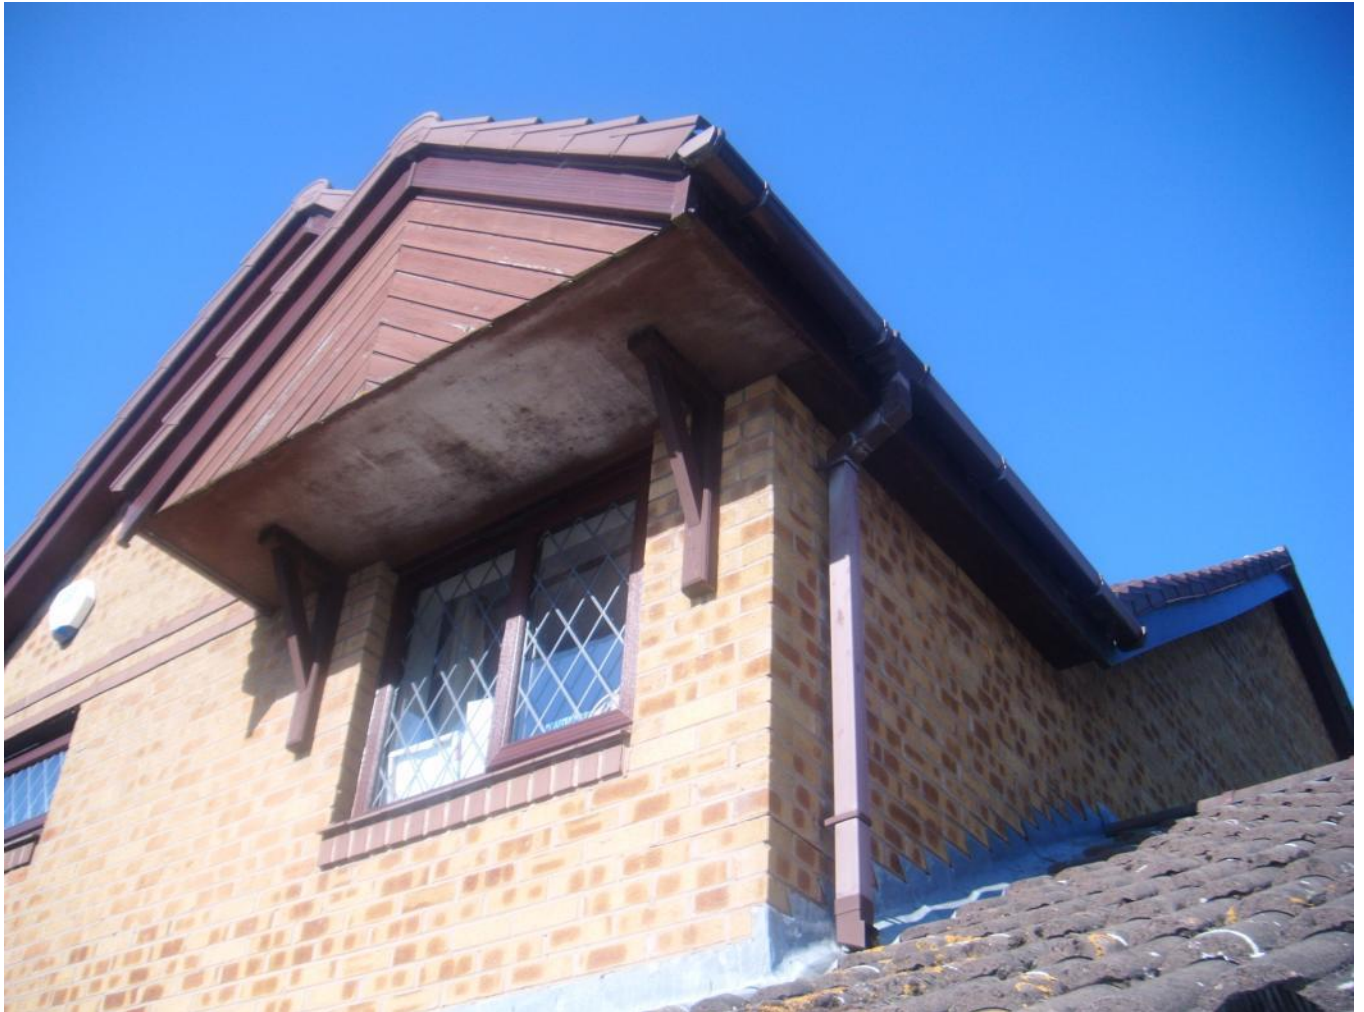
Feature over window

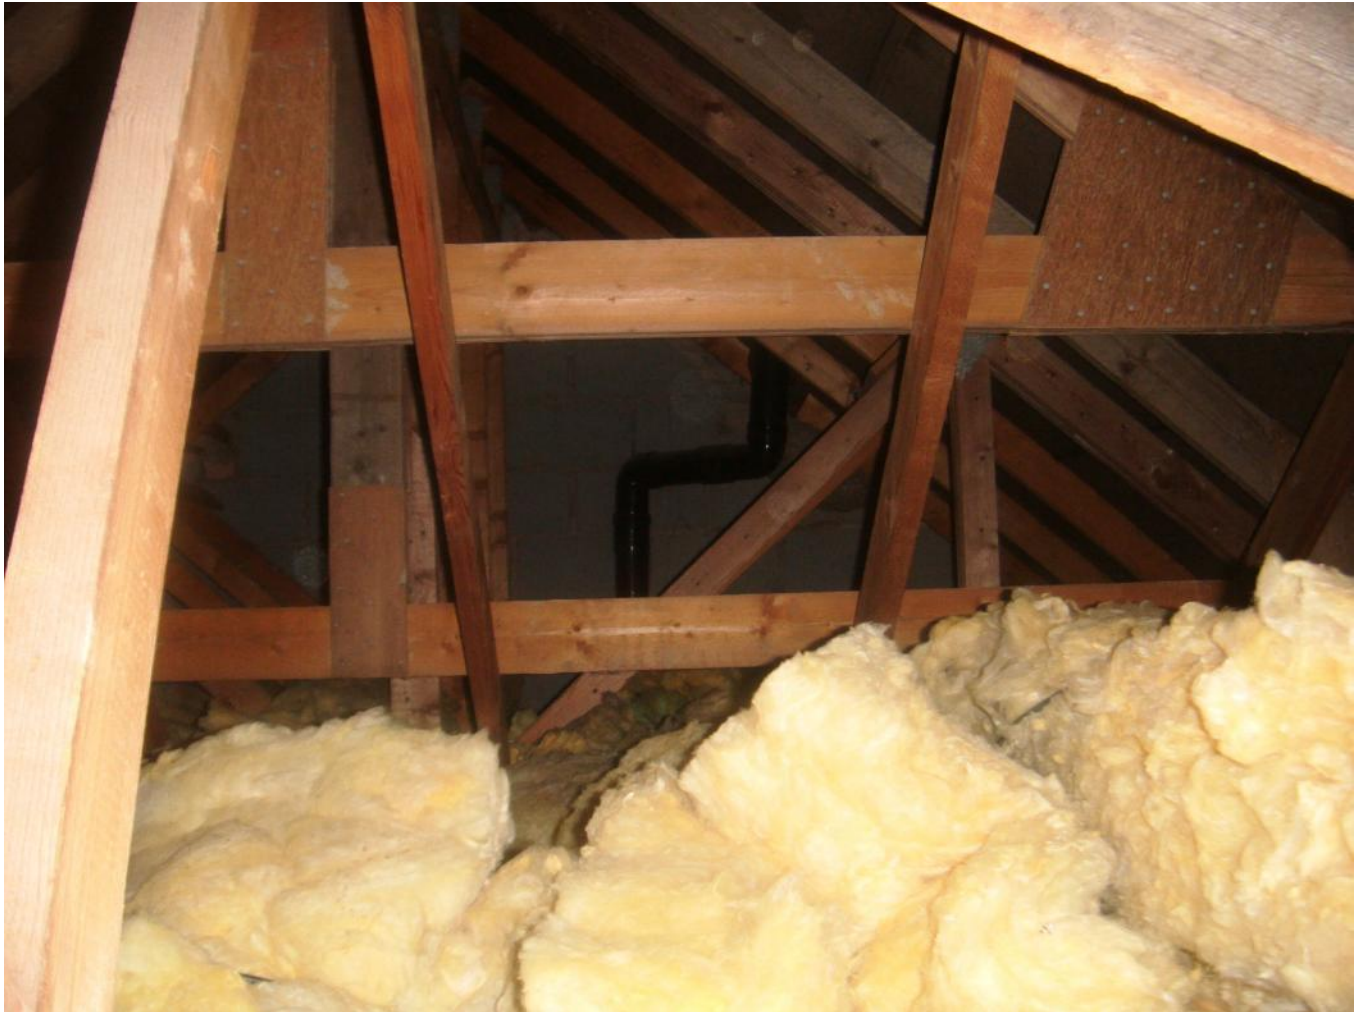
An internal visual assessment of the roof space were carried out on the same date. Access to all interior roof spaces was possible, rockwool at lower level. There were no signs of bat presence such as droppings, staining or scratch marks. The internal roof space is with a bitumen felt lining, appearing intact with no obvious access points in evidence. The building was classified as negligible in terms of bat roost potential.

Loft space

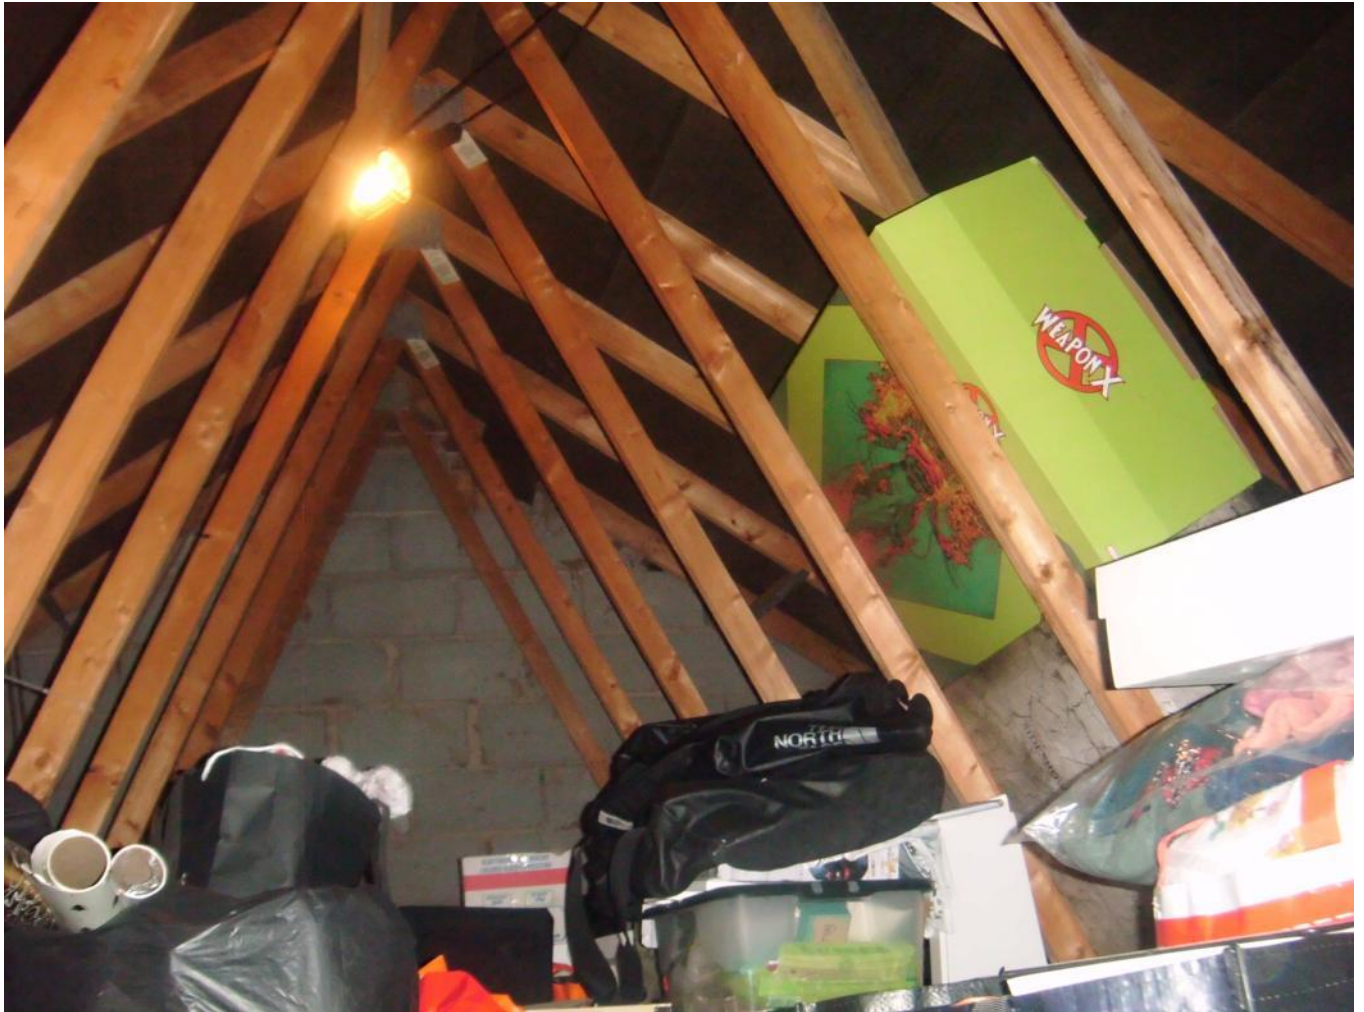
Loft space
