**Proposed Commercial Unit at  
MIRA North Plot 8, MIRA Technology Park  
Watling Street, Nuneaton**

**Combined Phase I Desk Study &  
Phase II Exploratory Investigation Report  
For  
MTP 3 Limited**

| Project No: 45296 | | Date: 15 May 2026 | |

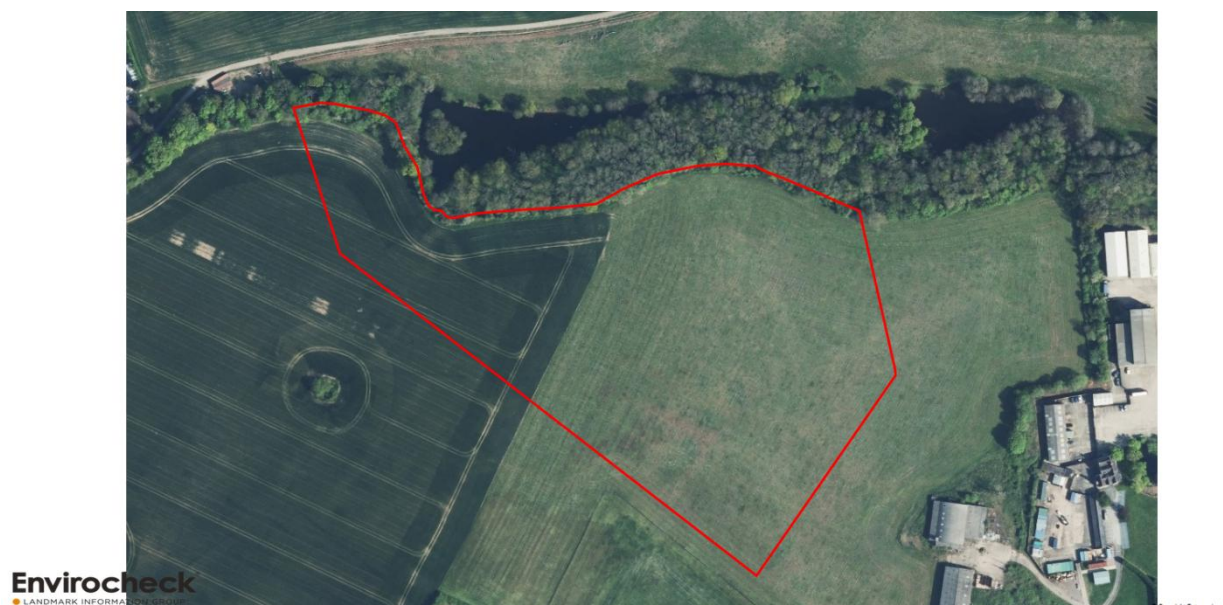
**Figure 1: Aerial photograph of the site. Site boundary demarcated in red outline.**

An aerial photograph of the site, obtained from the Landmark Analysis tool commissioned as part of our works, is included in Figure 1. We would note that the aerial photograph obtained from the landmark viewer appears to be older than freely available imagery elsewhere and is not representative of the site as observed during the walkover.

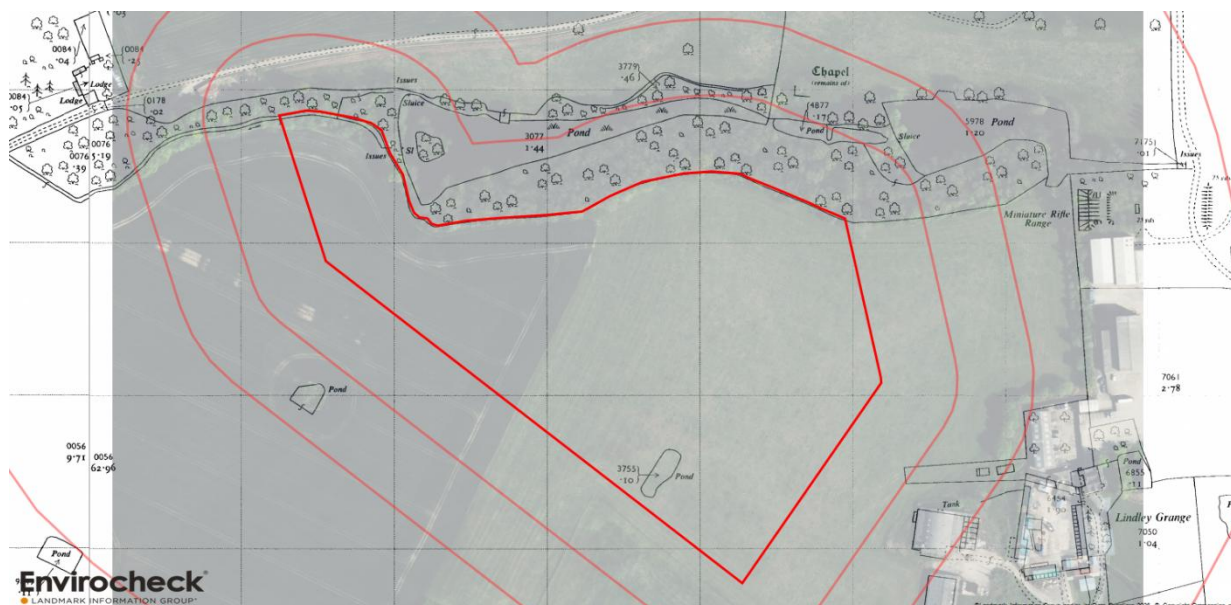
**Figure 3: Modern Aerial Photo Overlain with 1963 1:2,500 Historical Map Data**

Figure 3 shows a modern aerial photograph of the site overlain with the 1963 historical map, showing the field boundaries no longer present, additional buildings to the southeast of the site and the pond to the southeast no longer mapped.

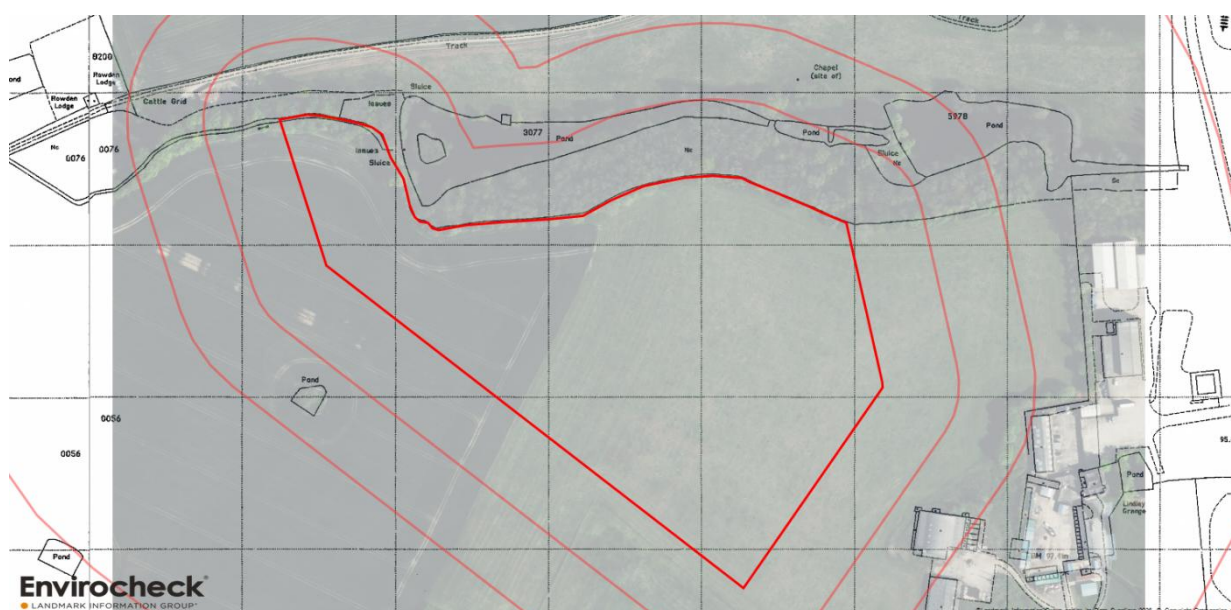
**Figure 4: Modern Aerial Photo Overlain with 1994 1:2,500 Historical Map Data**

Figure 4 shows a modern aerial photograph of the site overlain with the 1994 historical map, showing minimal changes to the site and only minor changes within its environs.
