## Phase 2: Site Investigation

Former Leisure Centre, Hinckley

## PHASE 2 SITE INVESTIGATION REPORT

### FORMER LEISURE CENTRE, HINCKLEY

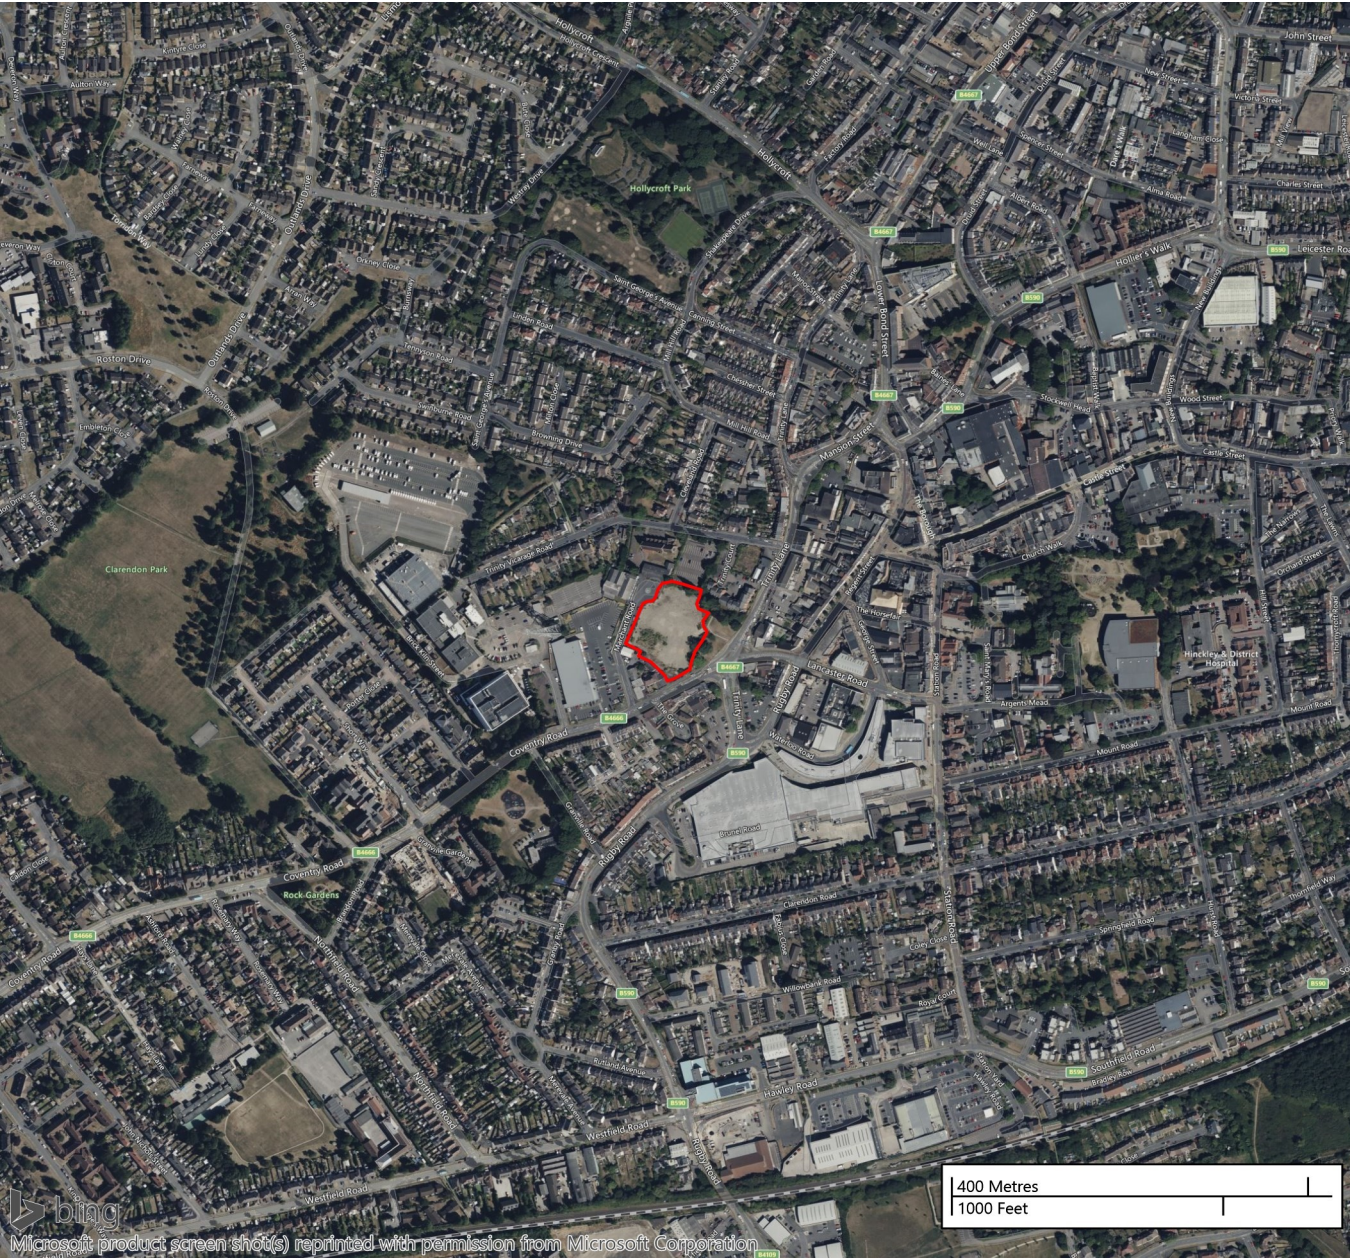
The site investigation described in this report was carried out by Solmek to the instructions of Green4Planning on The Former Hinckley Leisure Centre LE10 0BY (Figure 1).
