PROTECTED SPECIES (BAT) SURVEYS

11 REDMOOR CLOSE  
MARKET BOSWORTH

| Report Title: | Protected Species Surveys of 11 Redmoor Close, Market Bosworth |

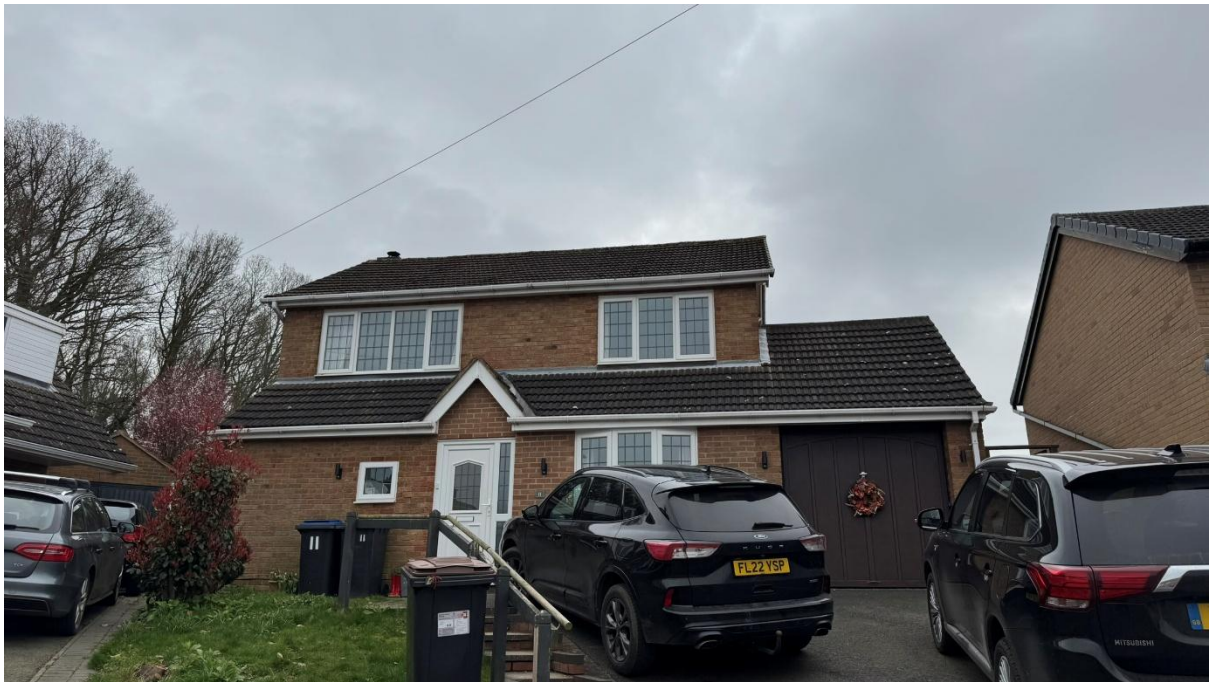
Photograph 1: The dwelling, taken from the north, showing the two-storey height with single storey front extension and garage on the west, with interlocking tile roof covering.

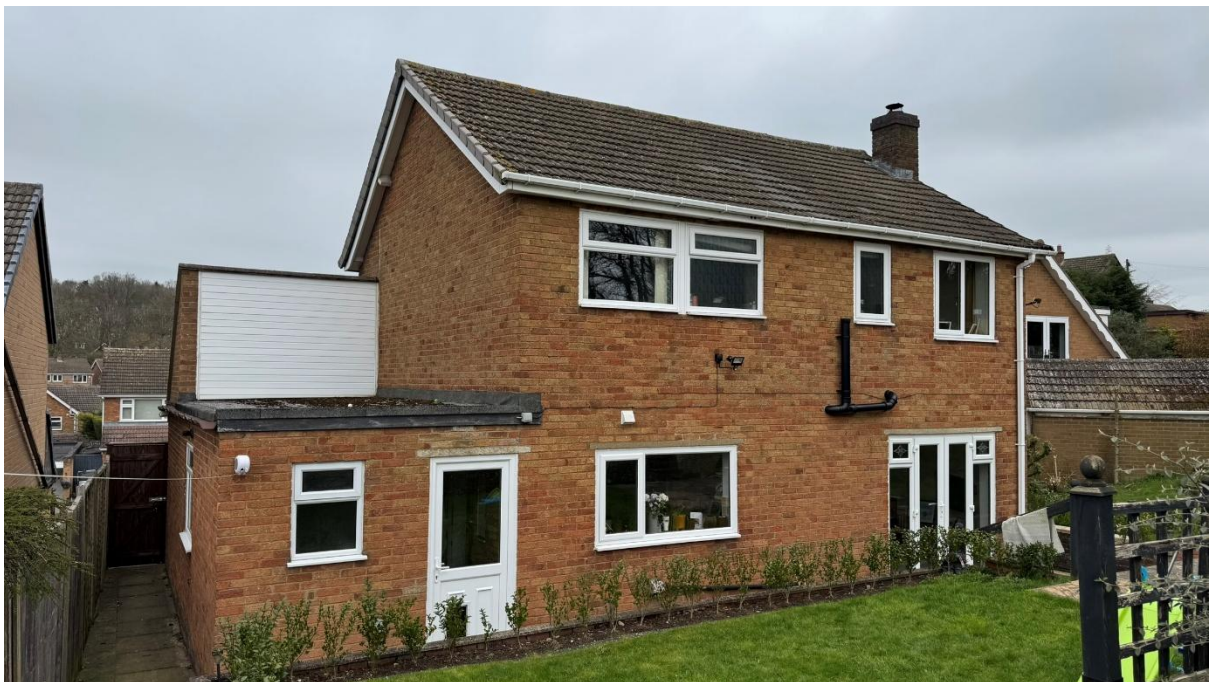
Photograph 2: The dwelling, taken from the south-west, showing the uPVC weatherboarding on the rear of the roof covering over the garage.

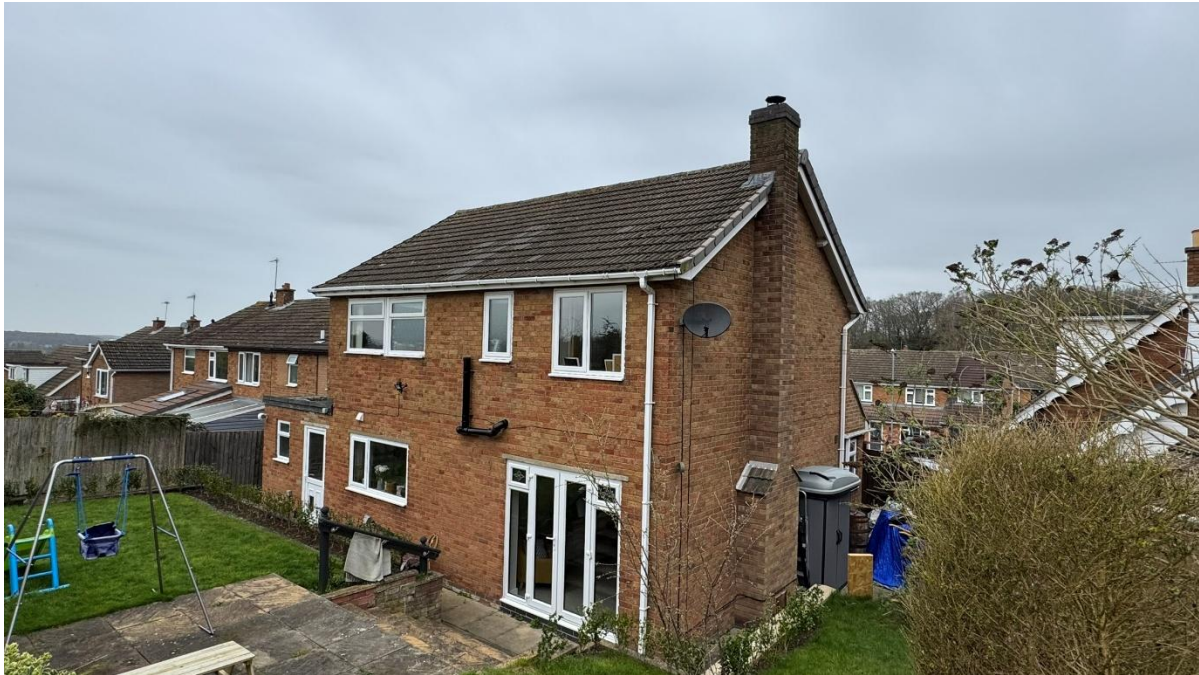
Photograph 3: The dwelling taken from the south-east, showing the chimney on the eastern gable.

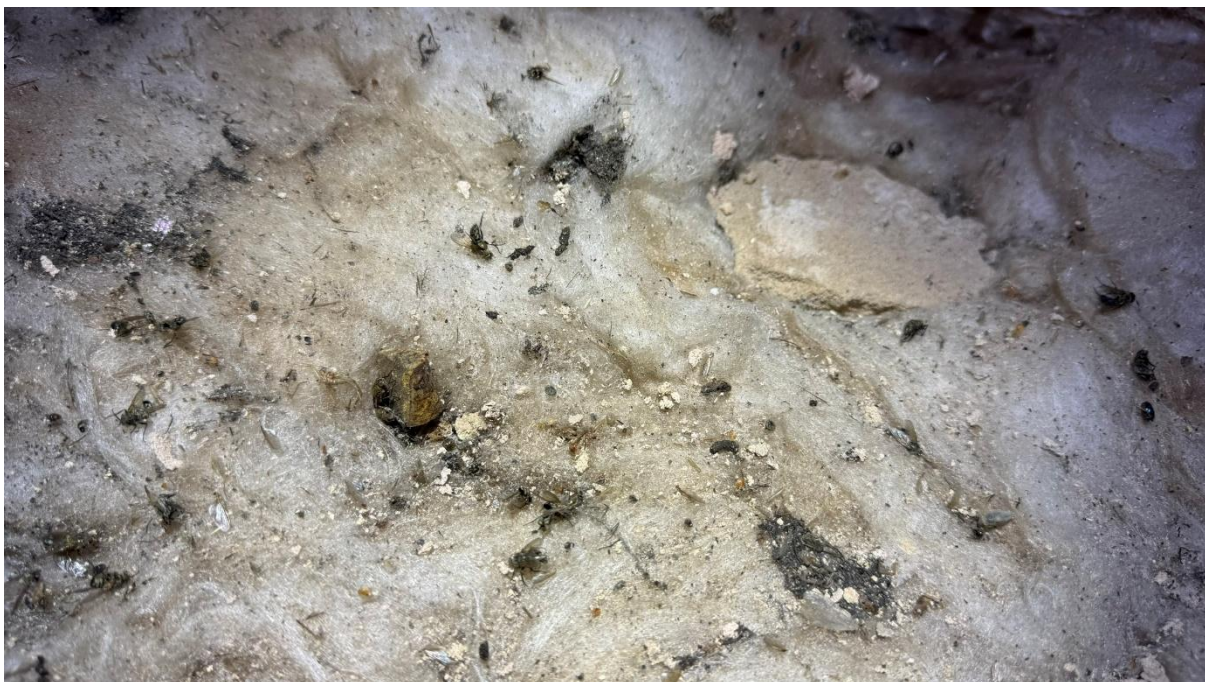
Evidence of bat roosting was identified within the roof void, in the form of dropping evidence typical of those voided by Long-eared (*Plecotus sp.*) bats. The surveyor identified a small aggregation at the eastern end of the void, and a small scattering within the space. There was then a small aggregation identified within a hole in the blockwork on the internal gable, below a roost crevice.

Photograph 4: The small aggregation of droppings located at the eastern end of the roof void, below the ridge.

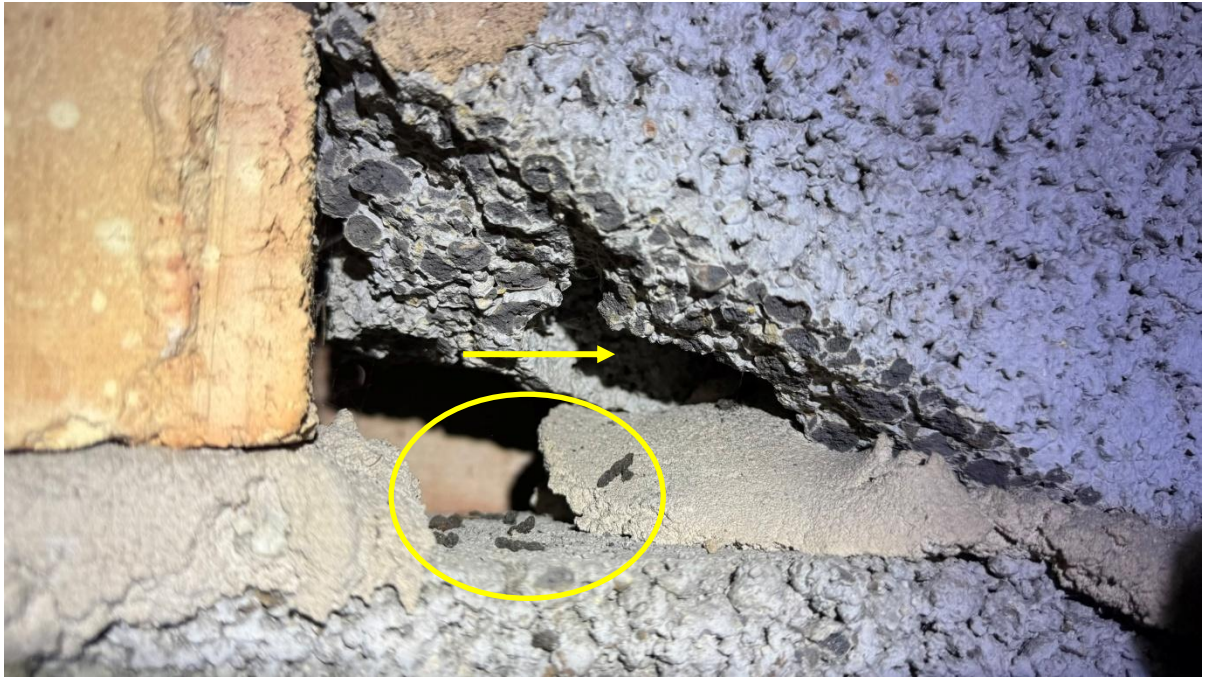
**Photograph 5:** The small aggregation below a hole in the blockwork, indicating a roost location at least within recent history.

Evidence of bat roosting was identified within the roof void, in the form of droppings located in a small aggregation, and below a roosting crevice within the blockwork. The feature of primary focus as being the access feature for the bat roost, was located at the eastern end of the dwelling.

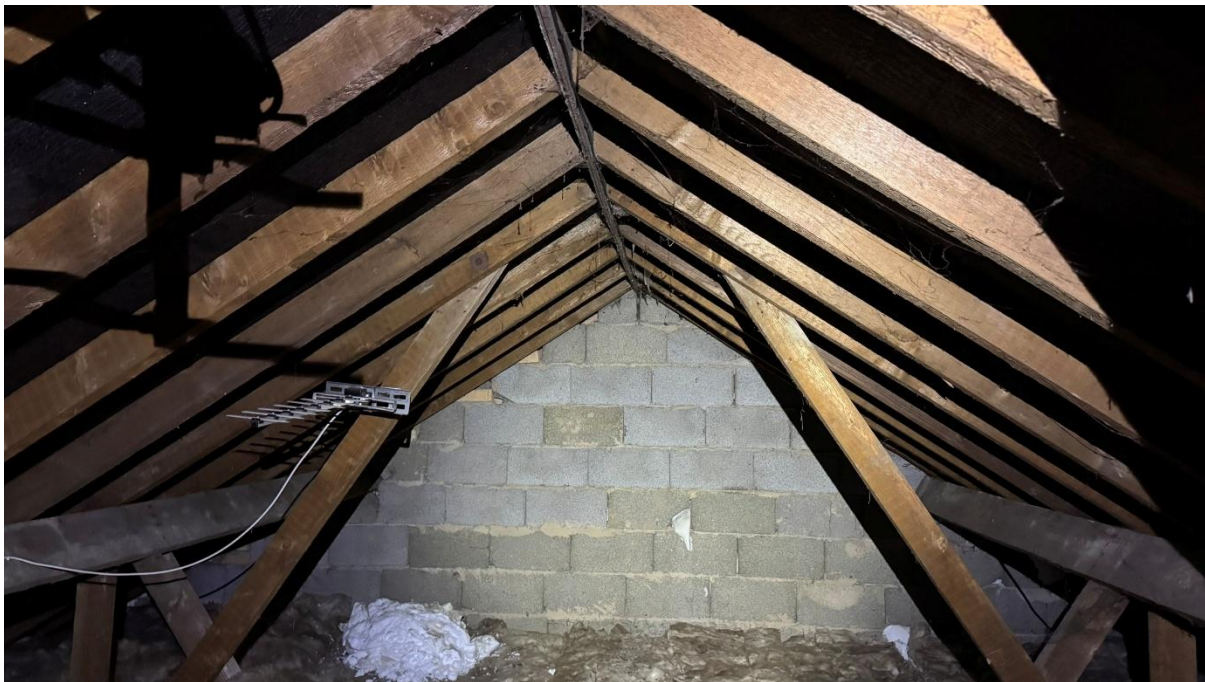
The attic is an open void with space to undertake pre-emergence flight, but the surveyor did not identify evidence of natural light ingress, indicating the roof covering is well sealed. Potential roost features included for perching against the timber ridge board, and the gaps around and above the internal gable walls.

**Photograph 6:** The internal void of the dwelling, showing the open and uncluttered space.

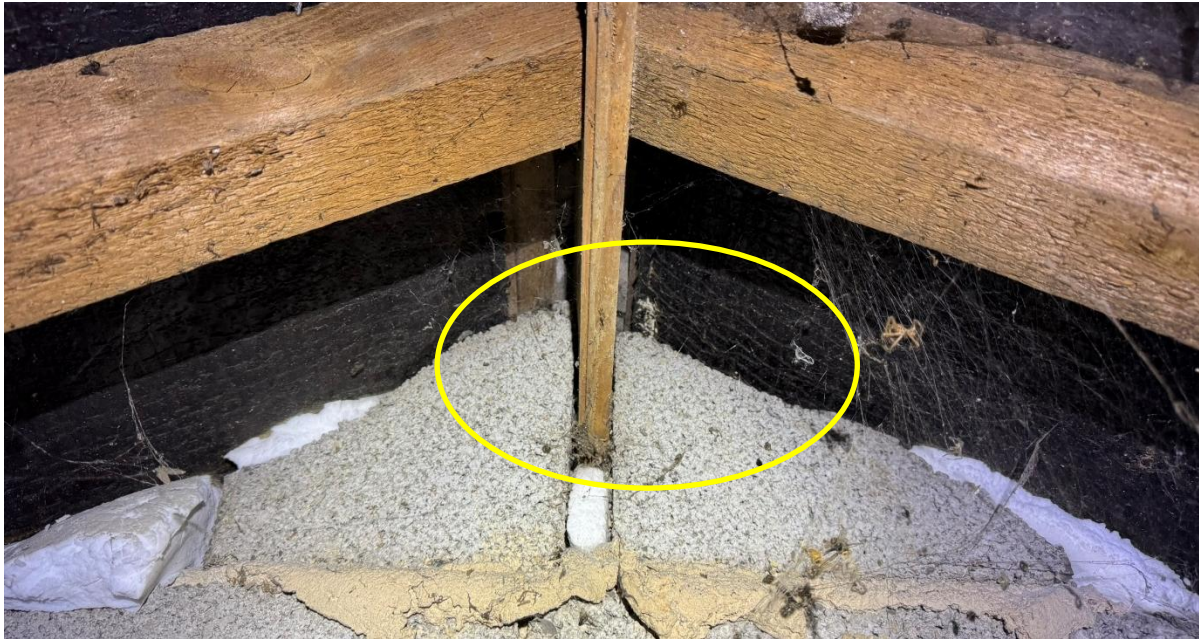
Photograph 7: The small gaps over the internal gable which may provide an access point for bats.

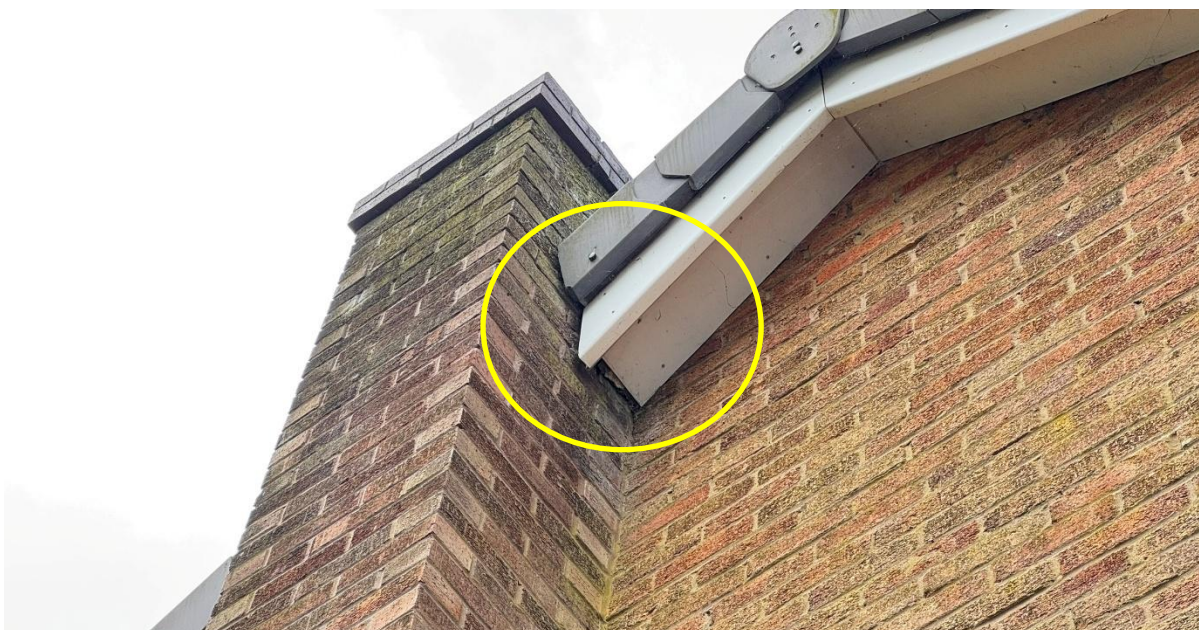
The surveyor observed a limited number of potential roost features associated with the external fabric, including for gaps behind the verge capping, from the top, and a large gap in the soffit on the eastern gable, where it joins the chimney brickwork.

Photograph 8: The gap behind the soffit box, adjacent to the chimney, which is the primary roost feature/access feature.

Droppings have been identified within the roof void, and the likely access feature is associated with the eastern gable. It is therefore imperative that works do not impact this gable end, in order to prevent a breach of legislation.

Any development or repair works that include impact to the eastern verges and soffits, that are not undertaken after further survey and advice from an ecologist and a potential licence, will constitute a probable breach of the law

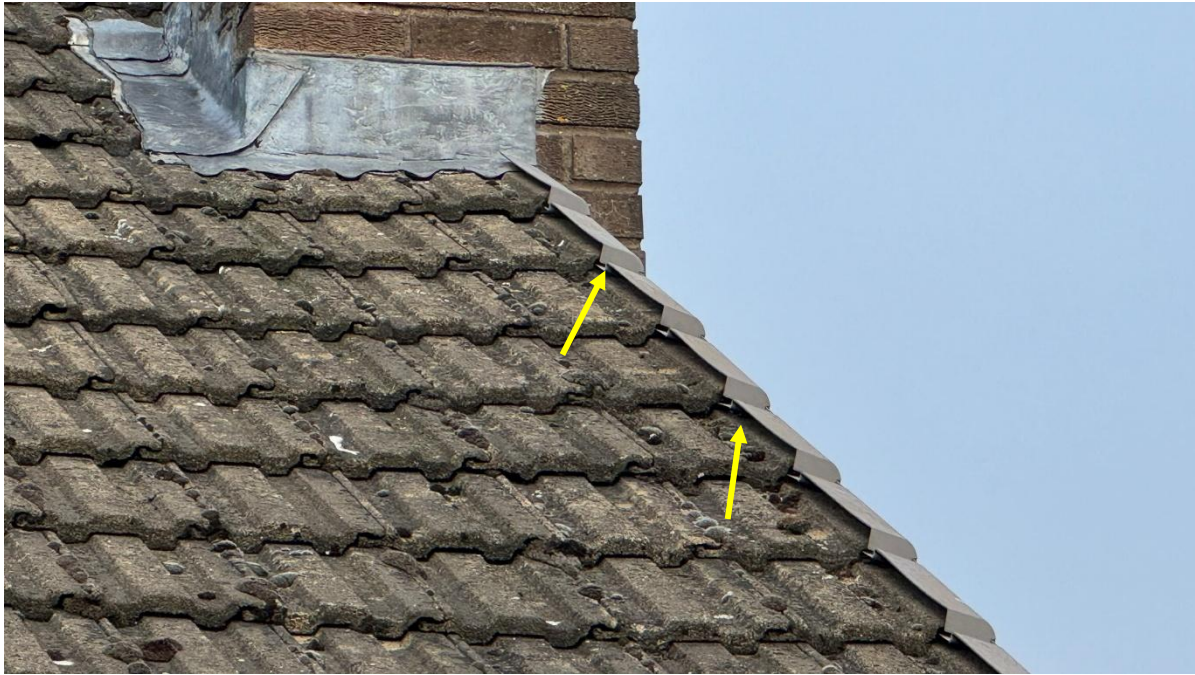
**Photograph 9: Evidence of the gaps behind the verge capping.**

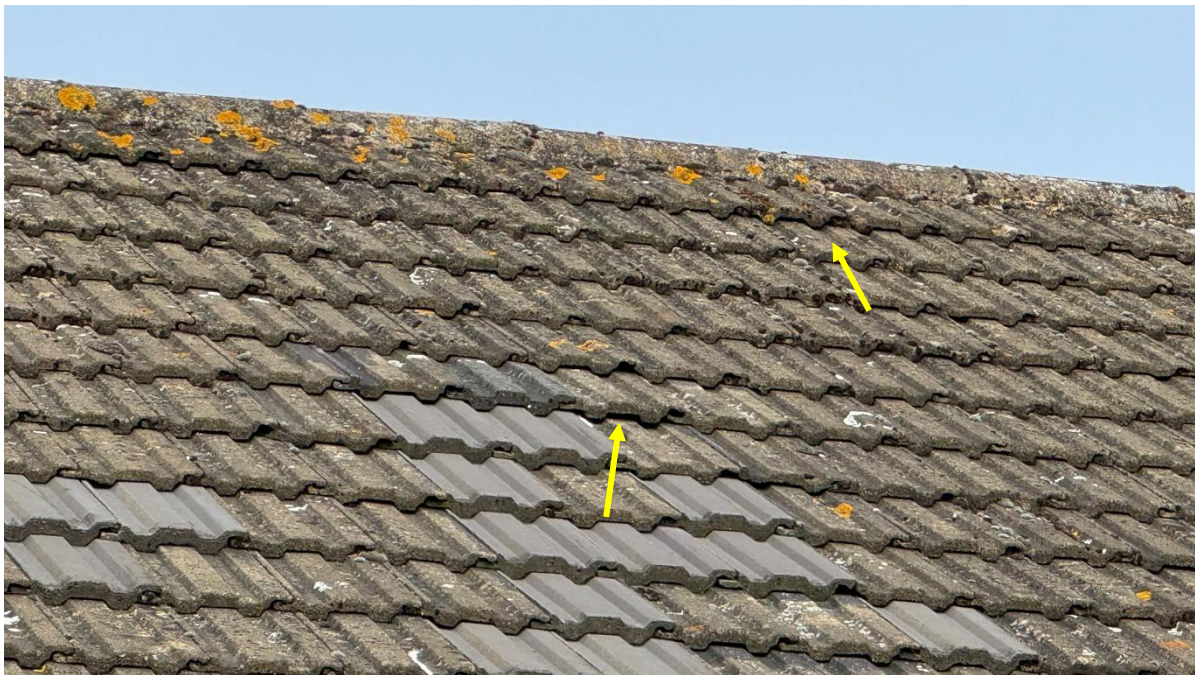
There was some roof tiles on the rear pitch which had a slight lift to them, that could potentially provide a small crevice suitable for *Pipistrellus* bats. The surveyor noted that some tiles have been historically replaced, but it is not known when this was done. The bitumen felt below is intact, so it is highly unlikely that this has prevented access internally.

**Photograph 10: The slightly lifted roof ties, which are otherwise well fitted, including sections of replaced tiles.**

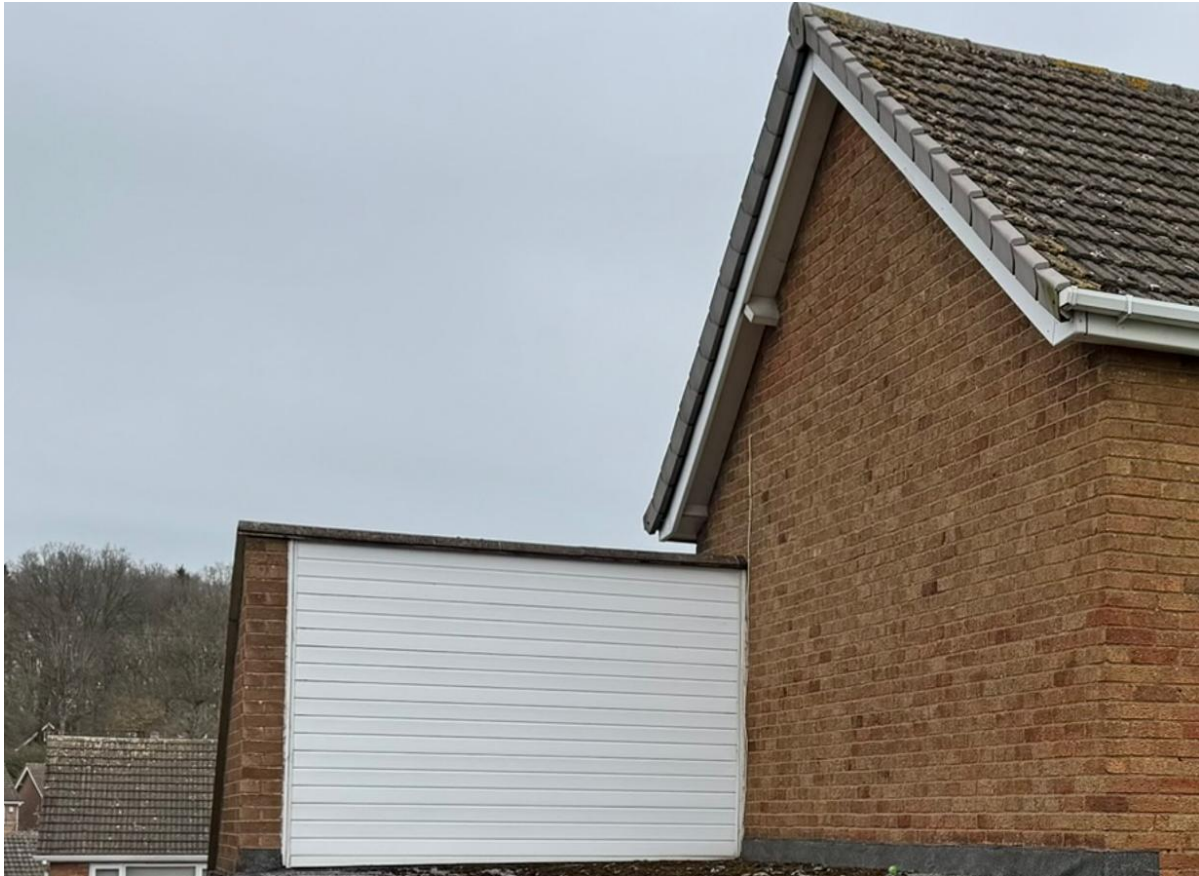
**Photograph 11:** The well fitted uPVC weatherboard and soffit box on the western end, where development works are planned.

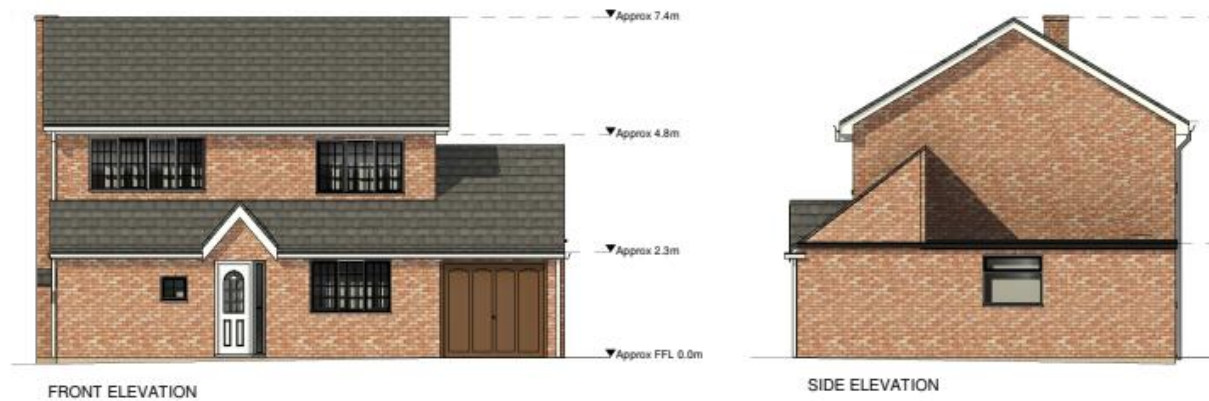
Figure 4: The existing front and side (West) elevations of 11 Redmoor Close.

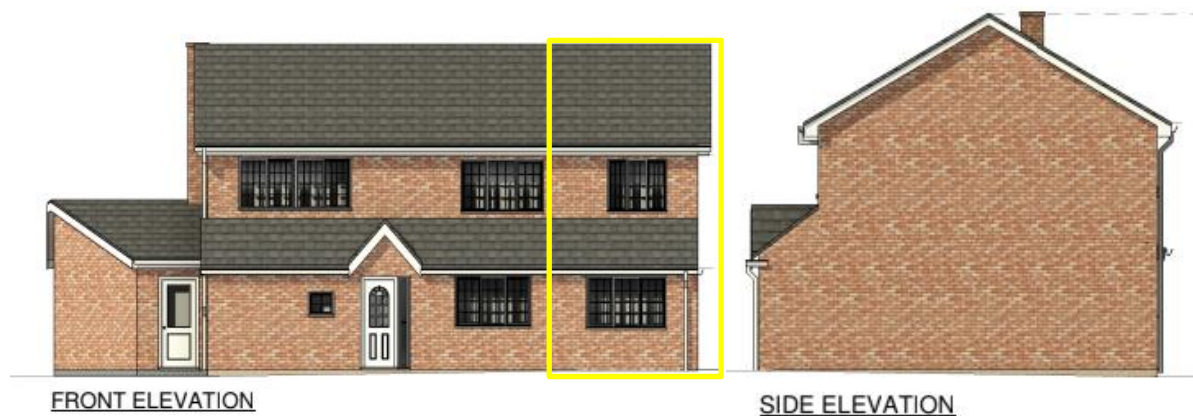
The development proposals include for an extension on the western end, which will impact the soffit box (which is well fitted at this end) and a small number of tiles along the ridge to tie in the extension, as well as impact on the single-storey roof covering, that is again well sealed.

Figure 5: The proposed elevations for the two-storey side extension on the western elevation, the small store extension to the east may be completed but will not impact upon potential bat roost features.
