## **Technical Note: Response to Comments from Planning Ecology Officer Karley Khan Regarding Planning Application 26/00235/OUT**

The below comments were received from Northwest Leicestershire District Council Planning Ecology Officer Karley Khan regarding a planning application located at 121 Station Road, Bagworth, Coalville, Leicestershire LE67 1BJ (planning ref 26/00235/OUT). This document provides clarification for each comment individually.

## Appendix 1: Additional Photos of Building

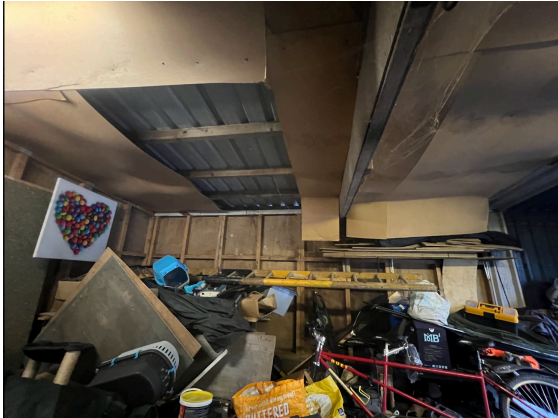
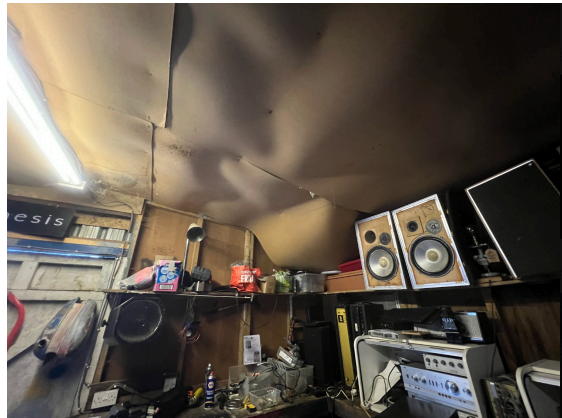
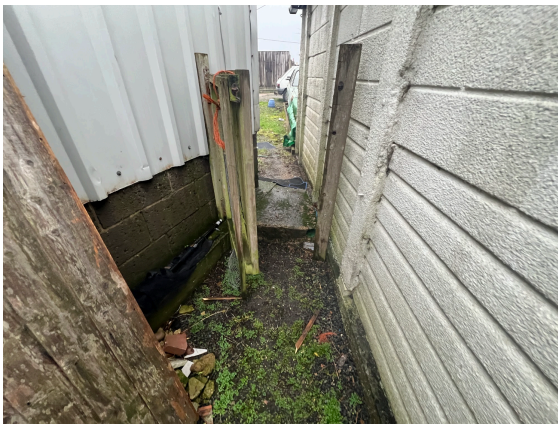
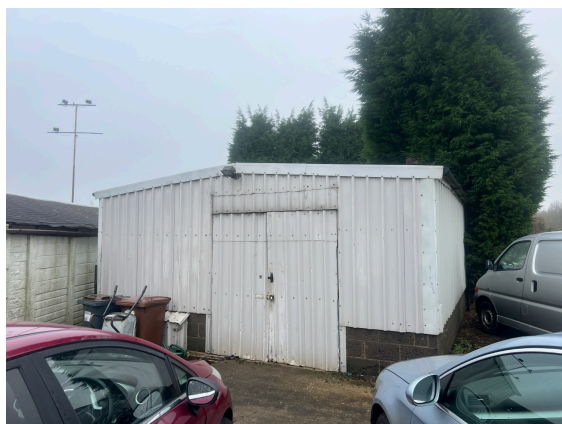
The walls of the surveyed building were formed of breezeblocks in the lower portion and wooden boarding above, with corrugated sheet metal cladding which was attached around the entirety of the building which was tight to the wooden boarding. The thin metal cladding was considered unsuitable to support roosting bats due to the material's low thermal stability. Aside from lacking thermal stability, any access gaps at the base of the corrugated metal cladding were very low to the ground and access for bats was therefore suboptimal. Furthermore, the building was surrounded by large amounts of rubbish / clutter / vehicles which further limited flight lines / entry points for bats on many aspects.

The roof of the building was also formed of corrugated sheet metal, which was backed internally by thin wooden sheets which were damaged. Internal and external gaps were inspected for the presence of bats / bat droppings and no evidence of bats was recorded during the search. Again,

due to the low thermal stability of the corrugated metal roof, any areas between the roof and the thin wooden sheets were considered unsuitable to support roosting bats. In light of the above, the building was considered to be of negligible bat roost potential. This is in accordance with page 44 of the relevant guidance<sup>1</sup>, which states:
