## Preliminary bat roost assessment

| Site Location | 7 Stapleton Lane, Kirkby Mallory, Leics. LE9 7OJ |
| Document reference | CE4390 |

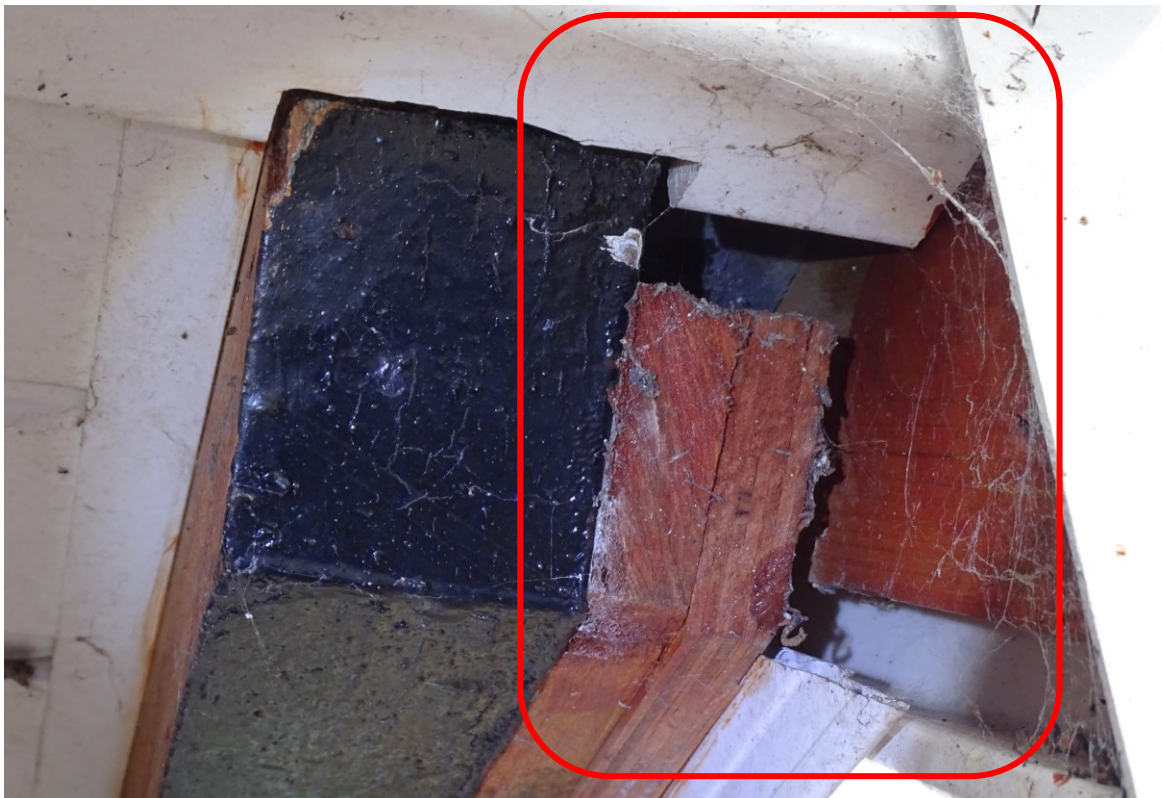
Image 2 – Gaps of adequate proportions to offer shelter/access opportunities for bats observed within the front eaves coverings of the property

| External | Features of value to bats | Notes |
|---|---|---|
| Eaves coverings | Yes | <p>A gaps within the front eaves coverings of adequate proportions to offer likely shelter/ access opportunities for bats was observed.</p> <p>Such feature may offer a likely enclosed roosting habitat commonly used by crevice dwelling species of bats.</p> |

- 6.5** In line with best practice survey guidelines, a further single emergence or re-entry survey will be required to rule out or confirm activity from bats. This survey should be carried out within the recommended survey season from May to August.

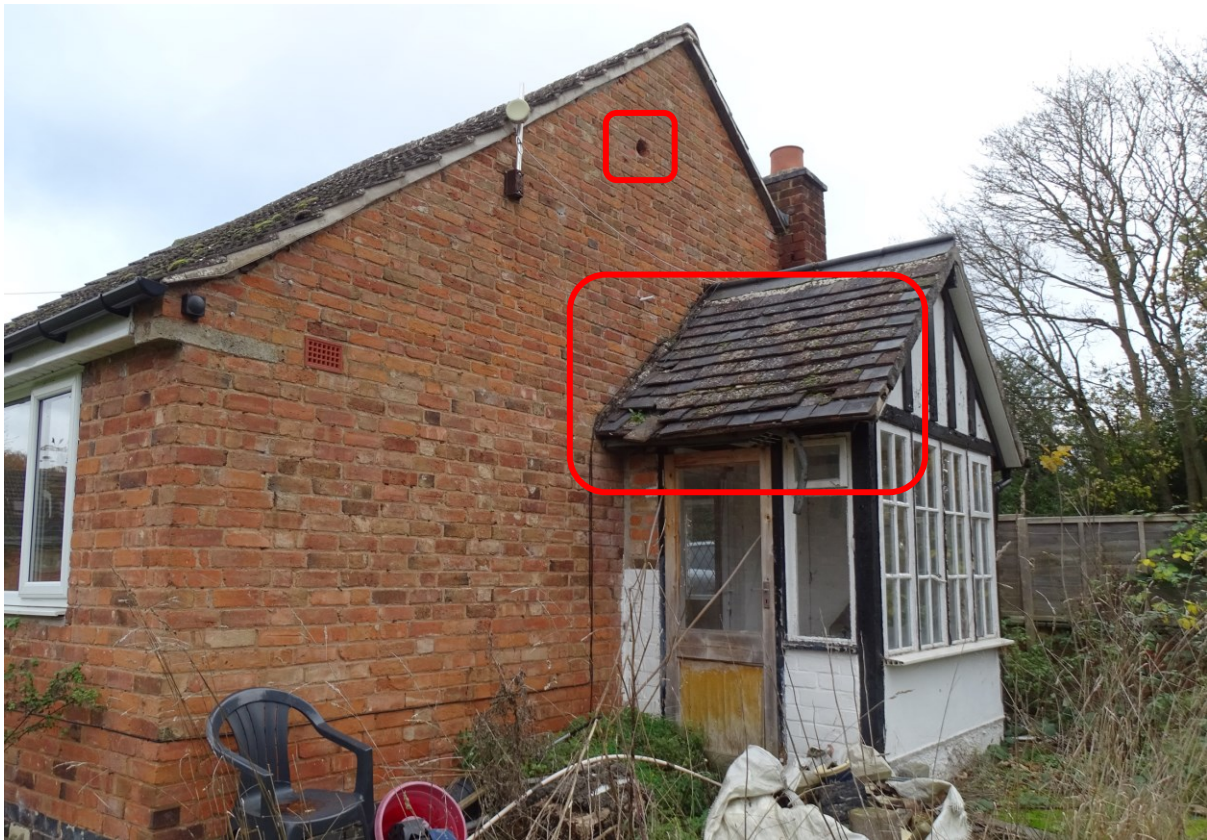
Image 3 – South facing elevation offering further gaps within the lower roof coverings and brickworks with likely access/shelter opportunities for bats

| External | Features of value to bats | Notes |
|---|---|---|
| External Stonework | Yes | The brickworks to the structure have demonstrated a fair level of condition with a single gaps within the South gable from a previous pipe which now offers access to bats and nesting birds internally. |
| Roof coverings | Yes | <p>The roof coverings have demonstrated a fair level of condition with a small number of slipped tiles within the lower roof coverings.</p> <p>These coverings were inspected further with the use of an inspection camera where no further evidence from bats was observed.</p> <p>A small gap between the roof coverings and brickworks to the North gable has demonstrated likely access/shelter opportunities for bats.</p> |

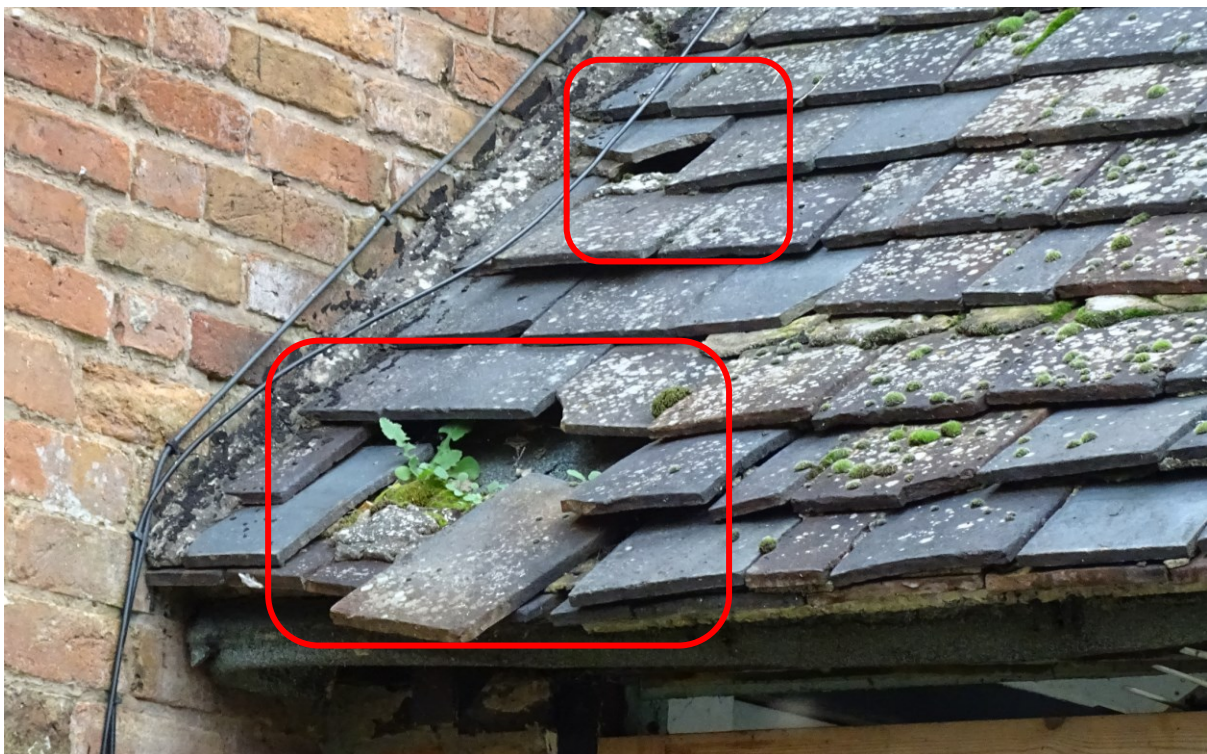
Image 4 – As per image three above

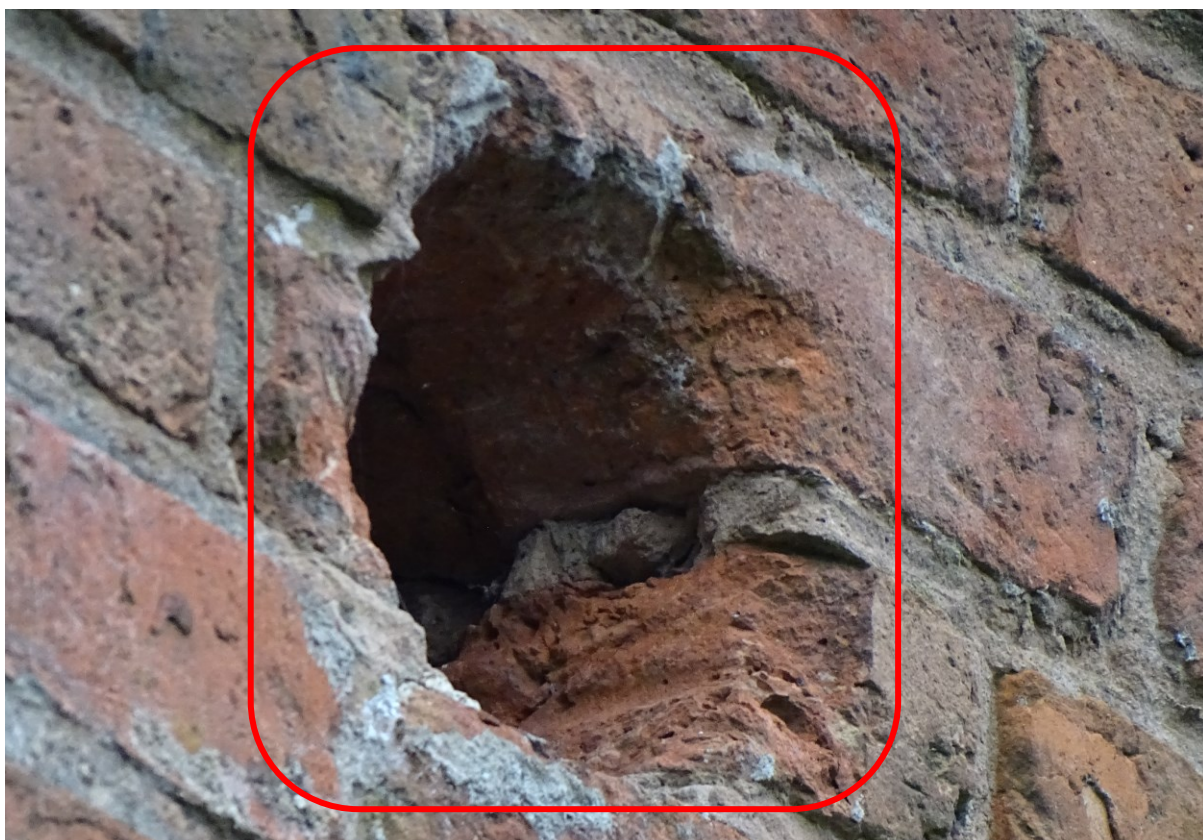
Image 5 – As per image three on the previous page

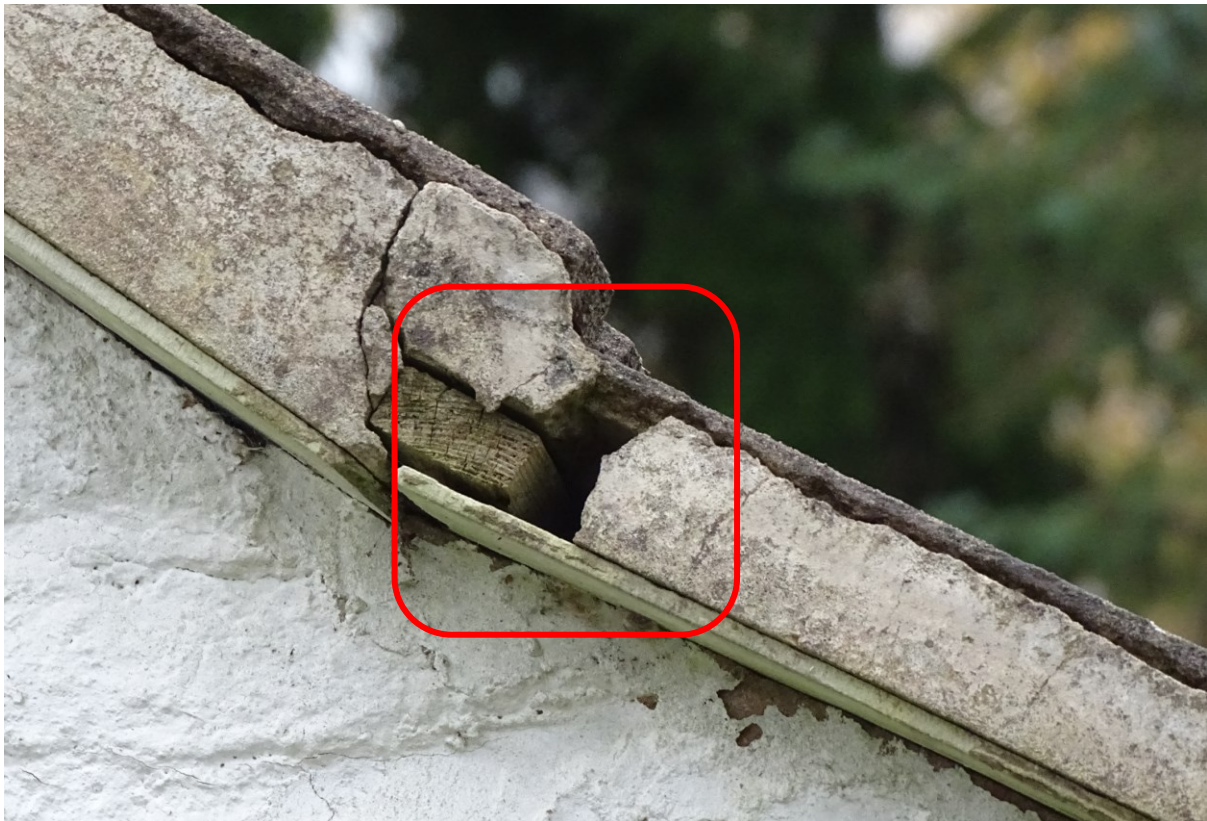
Image 7 – Gap within the North facing roof coverings of adequate proportions to offer likely shelter/access opportunities for bats within

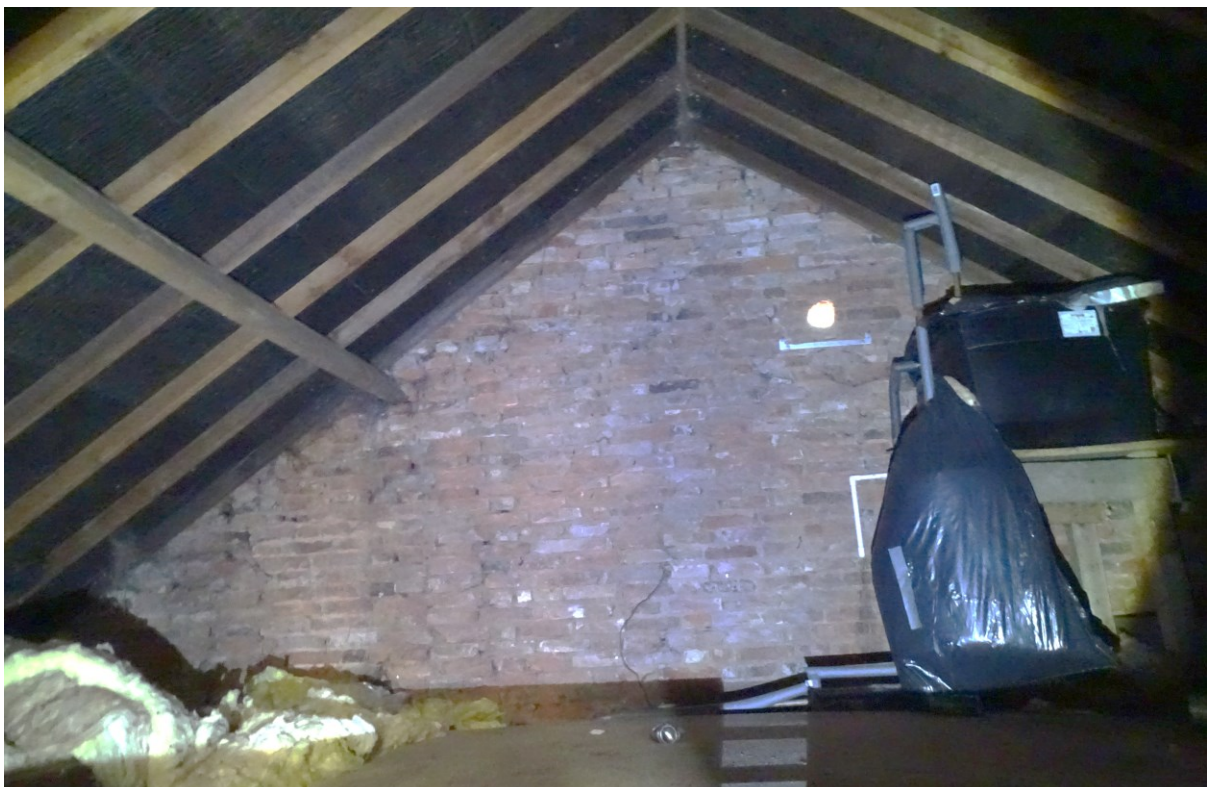
Image 8 – Internal view from within the main roof void spaces of the property

| Internal | Features of value to bats | Notes |
|---|---|---|
| Membrane coverings | Yes | An intact felt membrane coverings was observed within the main roof void spaces of the property.<br><br>Such coverings would offer further opportunities for bats with likely roosting habitats between the membrane and roof tiles where external gaps may provide access. |
| Evidence from bats | No | No internal evidence of bats was identified within the roof void areas; however, we are unable to rule out or confirm any roosting evidence within the spaces between the roof coverings/eaves and felt membrane below where evidence such as droppings wouldn't always be visible when enclosed between the materials. |

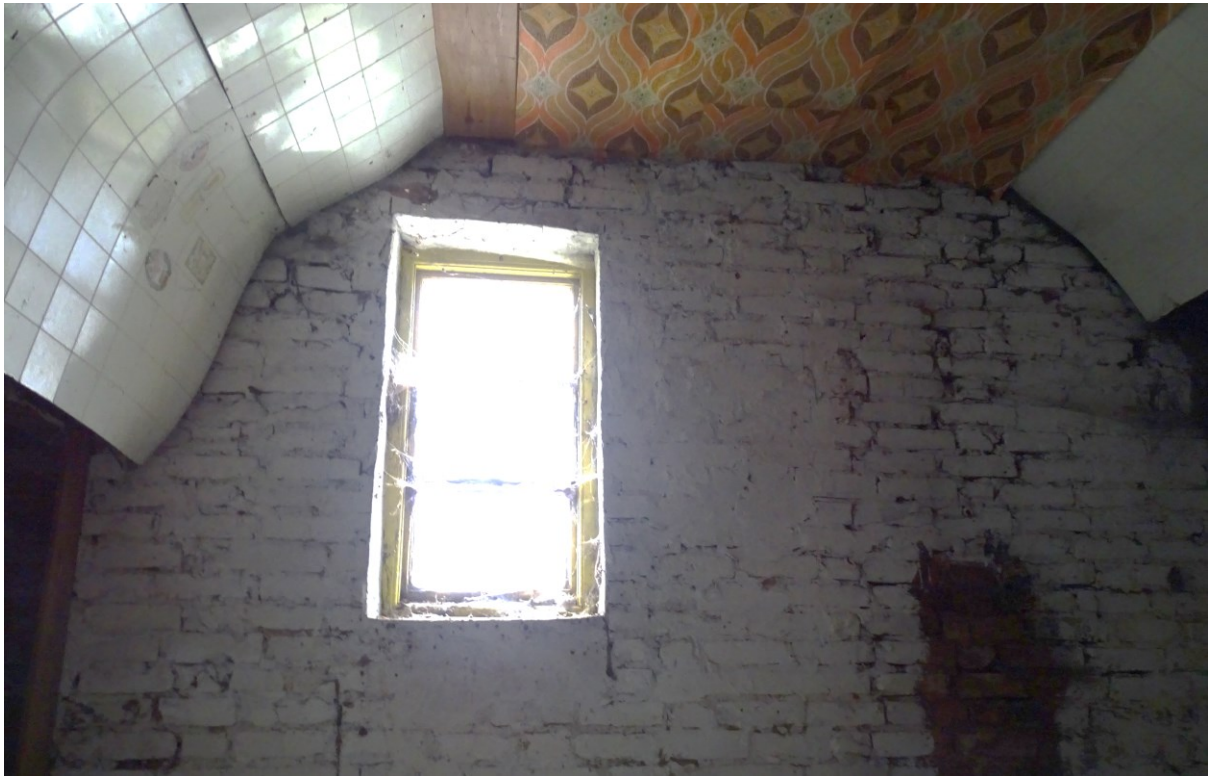
Image 9 – Internal view from within the main roof void spaces of the property

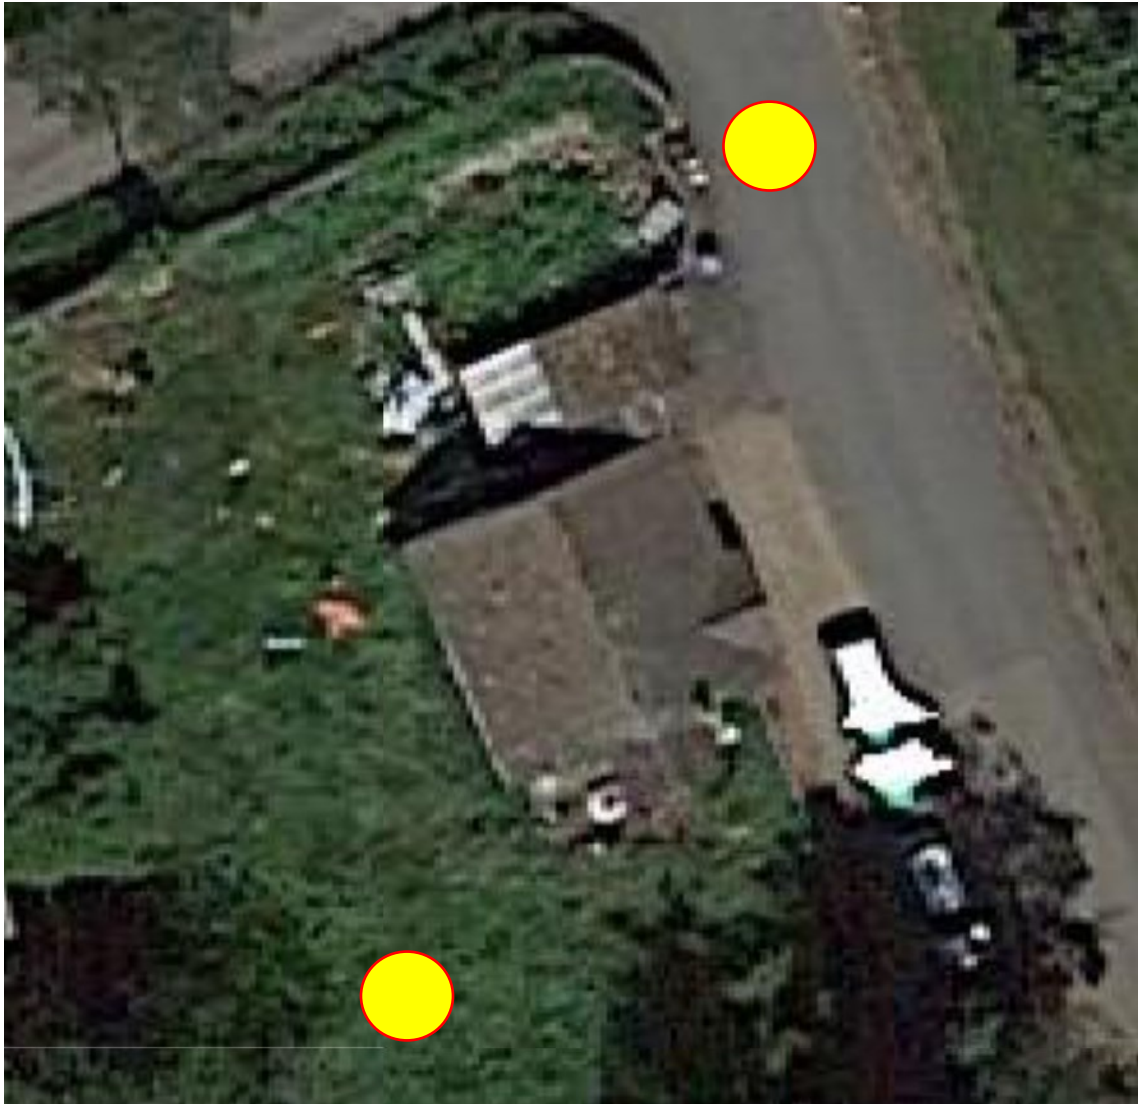
#### Appendix 4: Emergence Survey Location Points

Below site view to show suitable surveyor location points during each emergence survey to maintain visibility of the property.

In line with best practice survey guidelines, a total of two surveyors will be required to visually cover all elevations of the structure during each emergence survey.
