**Archaeological Attendance and Recording  
(Watching Brief) on a Workshop Extension  
at MIRA Drive, Lindley,  
HORIBA MIRA, Nuneaton  
NGR: SP 3622 9535**

**Site Name:** Workshop Extension, MIRA Drive, Lindley, HORIBA MIRA, Nuneaton

**ULAS Job No:** 24-718

**ULAS Report Number:** 2023-116

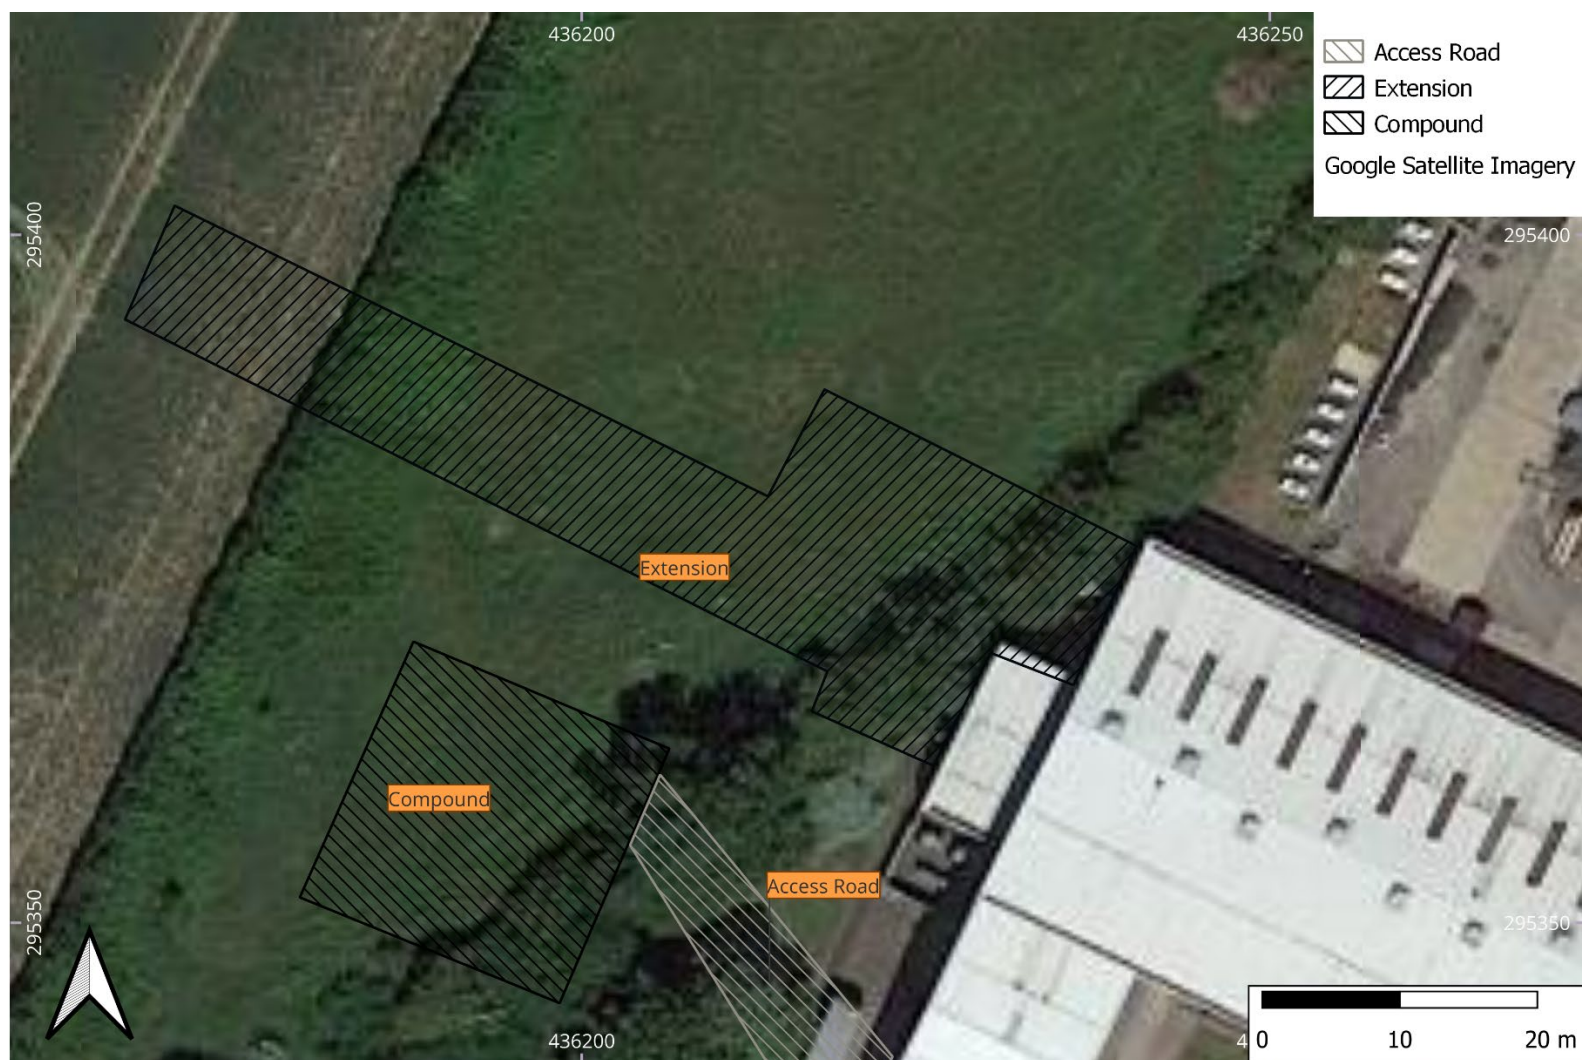
Figure 3: Location of extension, compound and road developments

A soil strip for the works compound was carried out on 27th September 2023 to the south-west of the development area (Figure 3). The topsoil was 0.2m deep on to a subsoil of sandy clay. This subsoil however, was not evident toward the south-west of the area with topsoil directly above natural pink clay geology. No archaeology was observed during this strip and no finds were recovered (Figure 6).

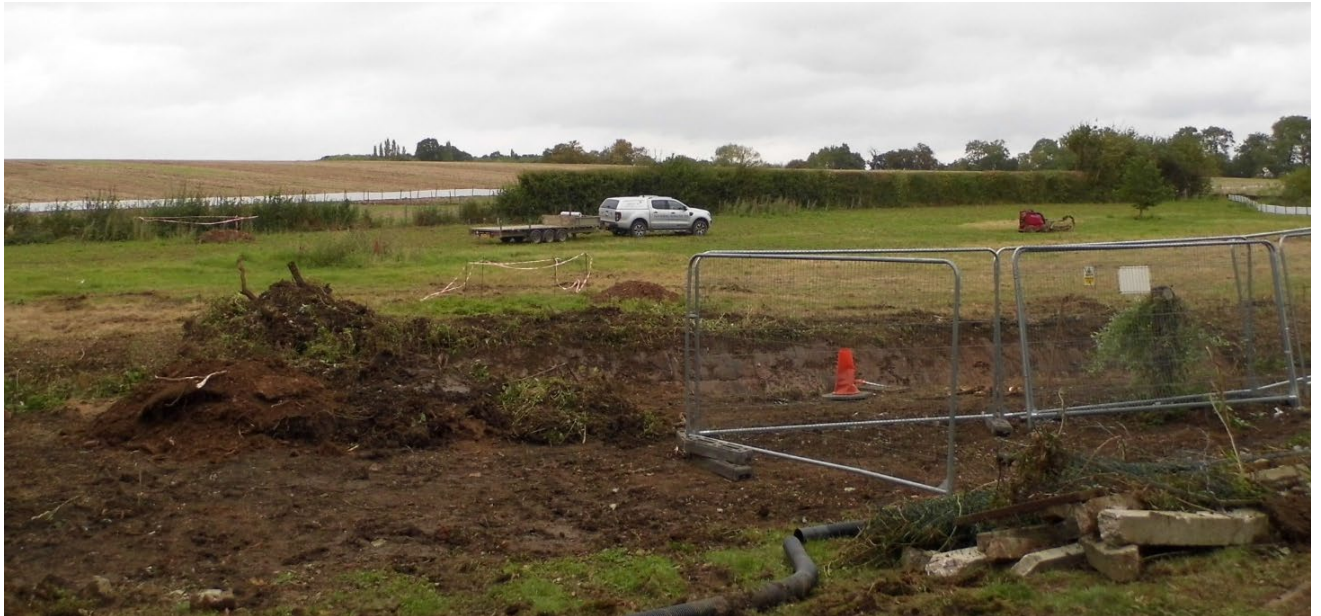
Figure 5: Area prior to stripping looking north-west

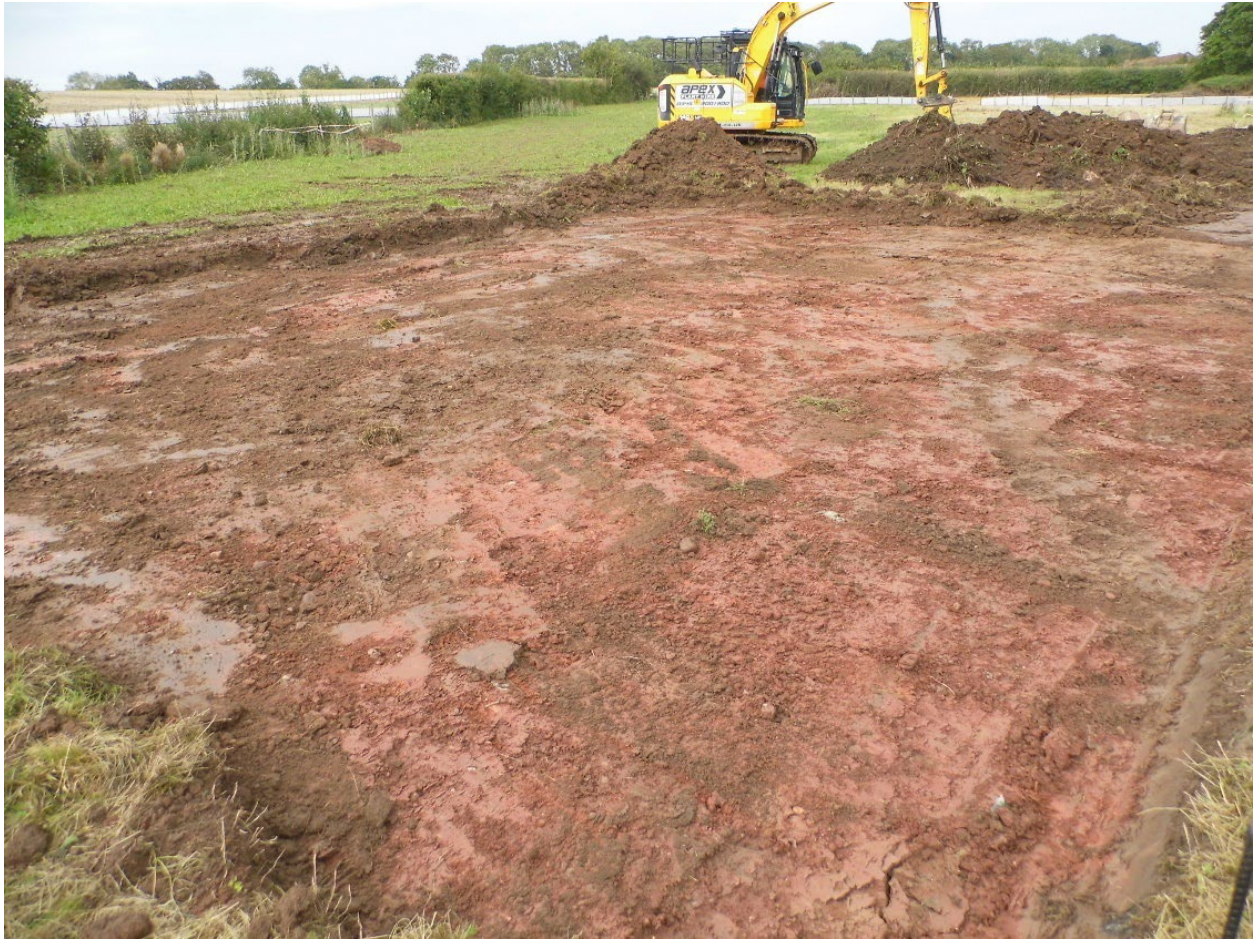
Figure 6: Compound strip looking north

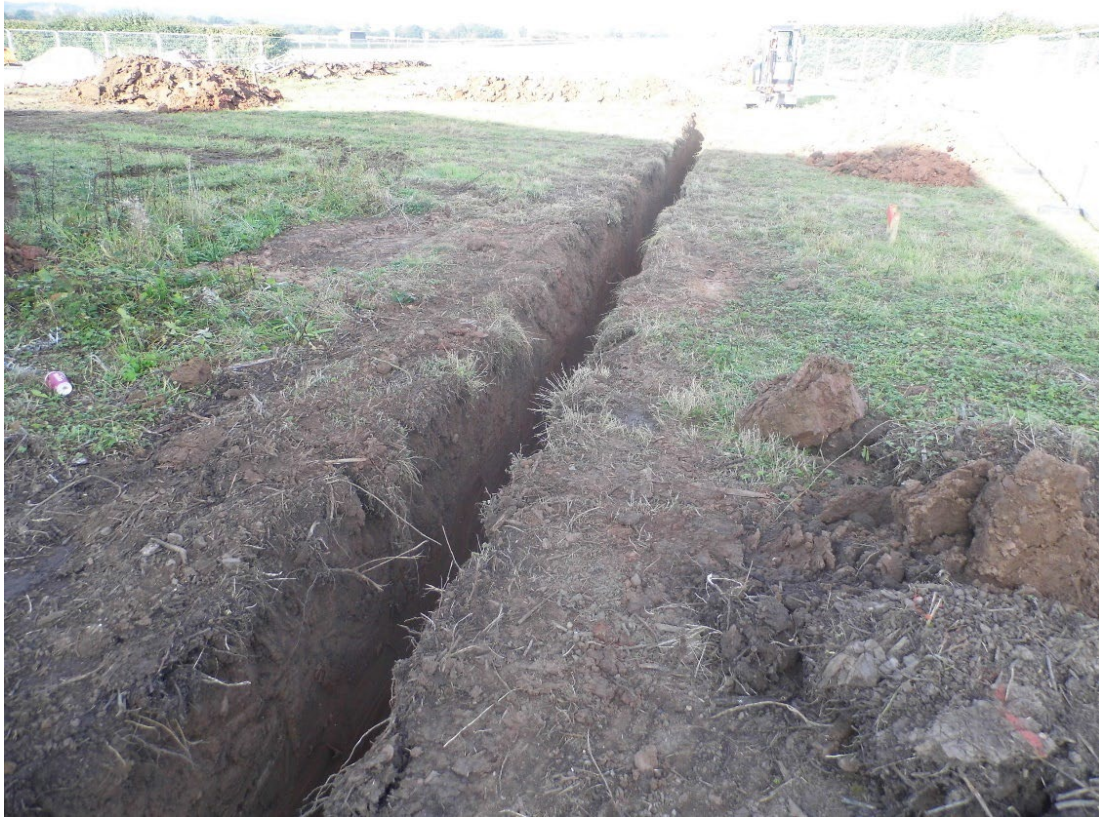
Between 9th-10th October 2023 a series of drain trenches were excavated across the development area. Natural substratum was uncovered at a depth of between 0.25-0.5m. No archaeological remains were observed and no finds recovered (Figure 7).

Figure 7: Excavated drain trench

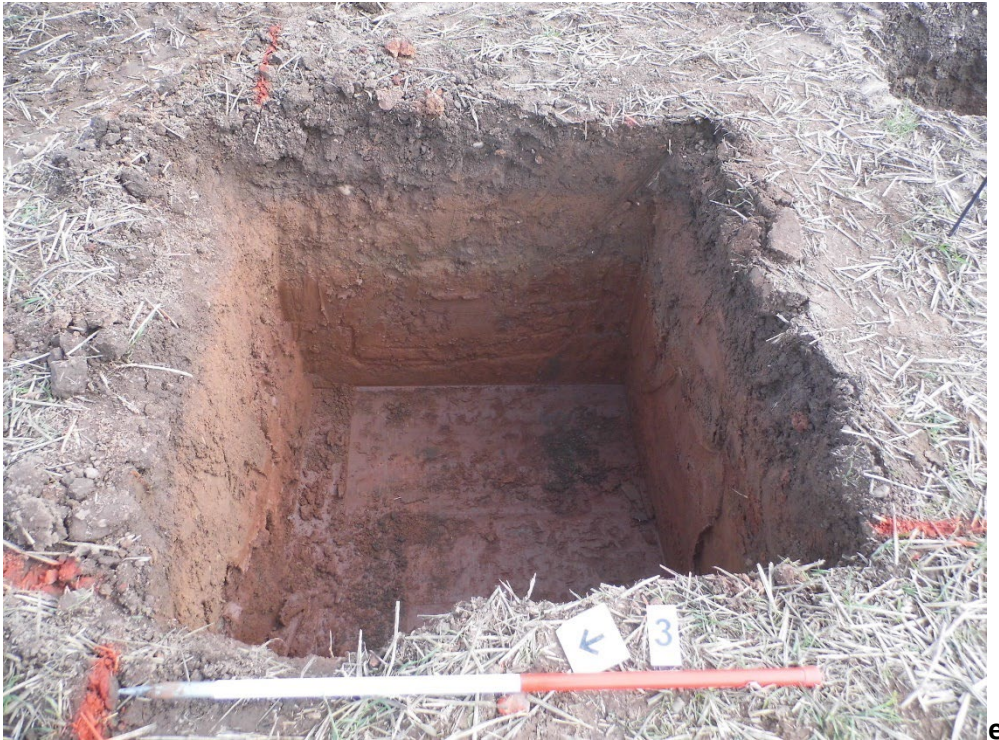
Natural substratum was reached at a depth of between 0.42-0.7m deep. This was overlain by subsoil consisting of orange brown or mid grey silty clay of depths between 0.10 and 0.24m. The subsoil was overlain by a layer of mixed pink clay of varying between 0.04 and 0.3m in thickness. The clay layer was overlain by topsoil which was 0.27m thick on average (Figure 8).

The pink clay overlying subsoil appeared to be redeposited natural, and suggests that some landscaping has taken place in the area.

Figure 8: Excavated pad pit 3 looking south-east

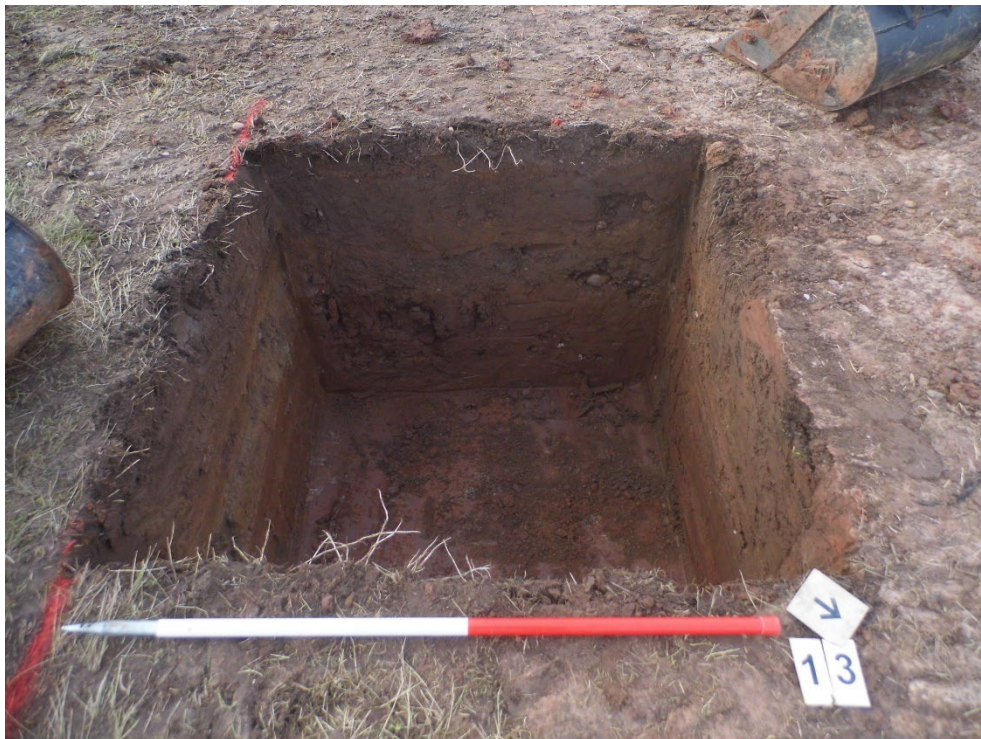
Figure 9: Excavated pad pit 13 looking south-west

substratum. Each foundation trench was observed and the same stratigraphy as the foundation pad pits recorded Figures 8-9). No archaeological features were revealed, and no finds made.

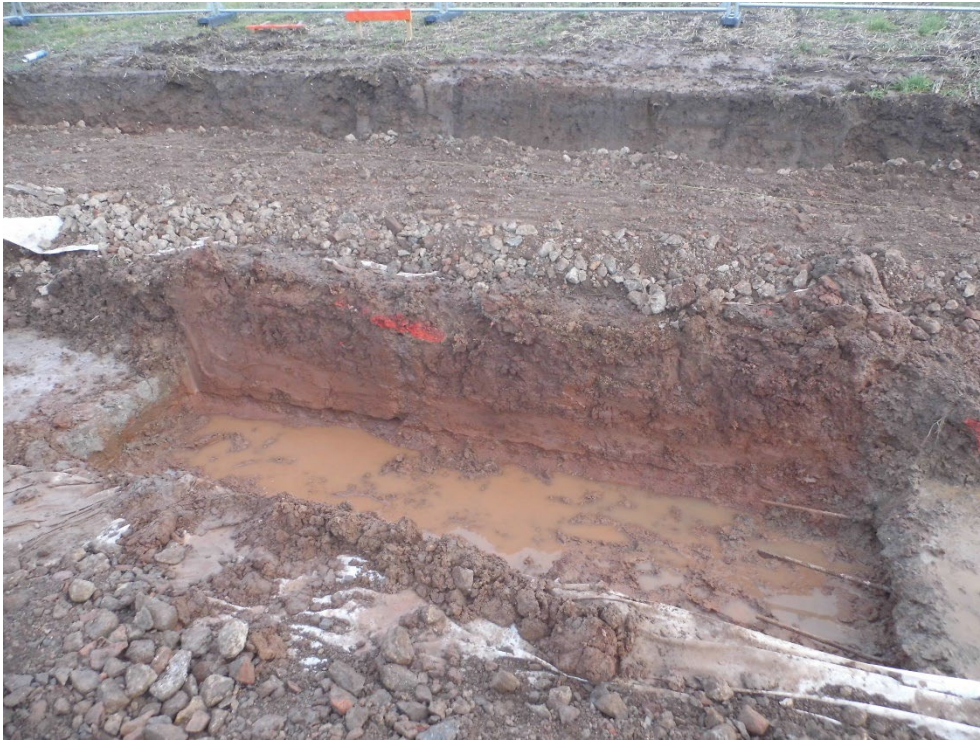
Between 13th-14th November, the northern side of the foundation trenches were excavated (Figure 4, blue lines). A topsoil strip had taken place prior to the excavation of the trench to reduce the overall level. Subsoil was excavated down to formation level in the natural

Figure 10: North-west foundation trench looking north

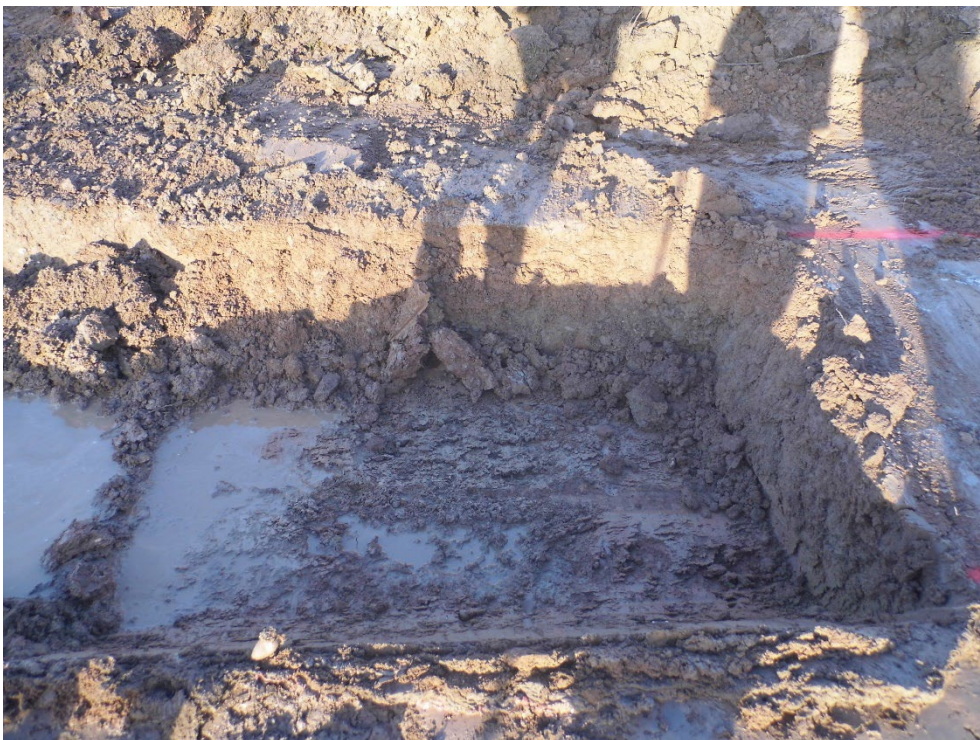
Figure 11: Eastern foundation trench looking north-east

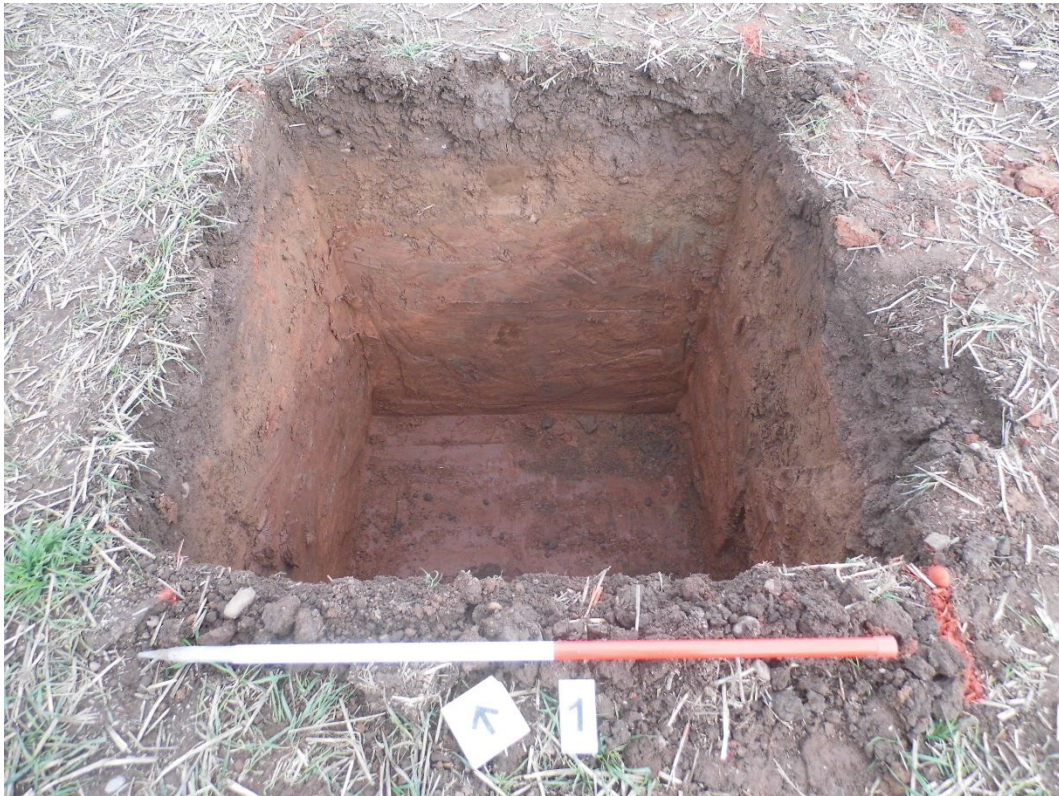
| Pit | Topsoil | Layer | Subsoil |
|---|---|---|---|
| 1 | 0.24 | 0.1 | 0.12 |

Figure 12: Pad pit 1 looking north-east

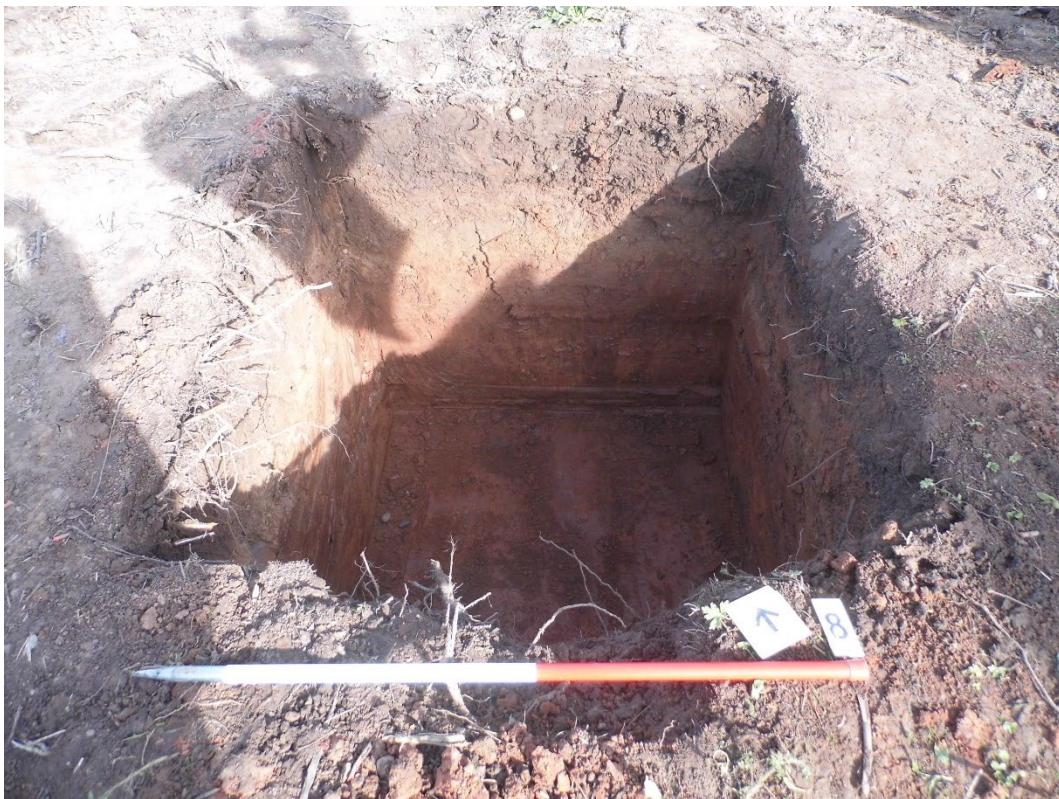
| Pit | Topsoil | Layer | Subsoil |
|---|---|---|---|
| 8 | 0.3 | 0.04 | 0.22 |

Figure 13: Pad pit 8 looking north-east

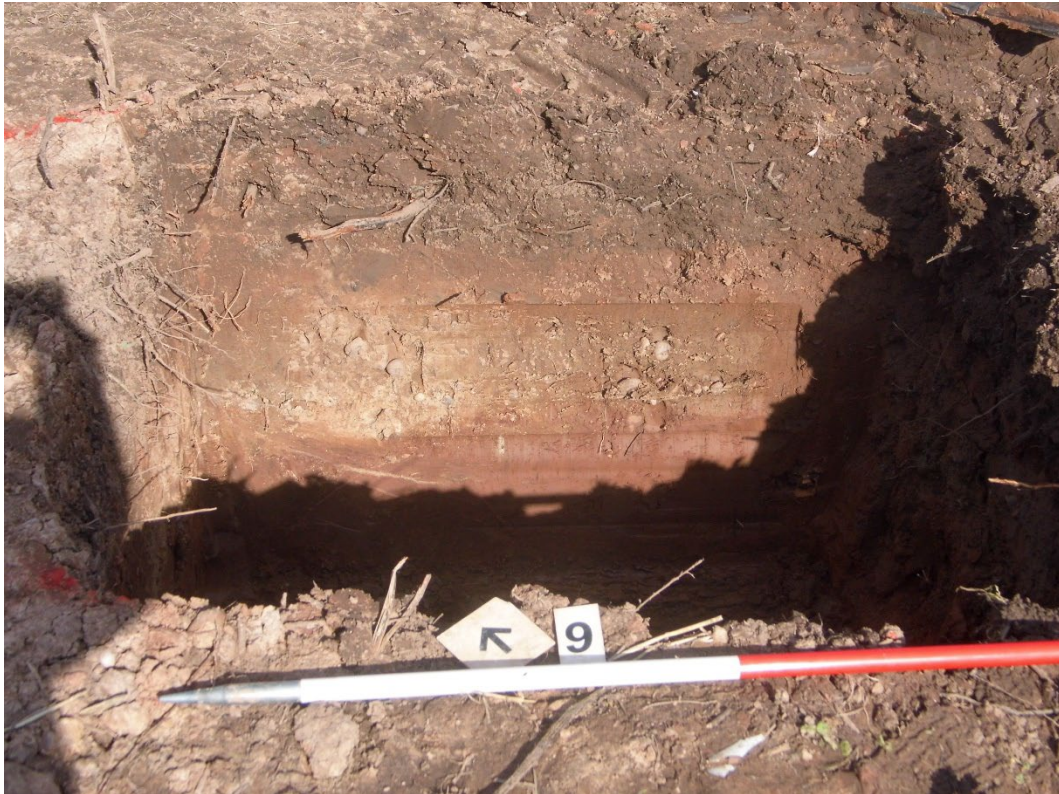
| Pit | Topsoil | Layer | Subsoil |
|---|---|---|---|
| 9 | 0.27 | 0.05 | 0.24 |

Figure 14: Pad pit 9 looking north-east

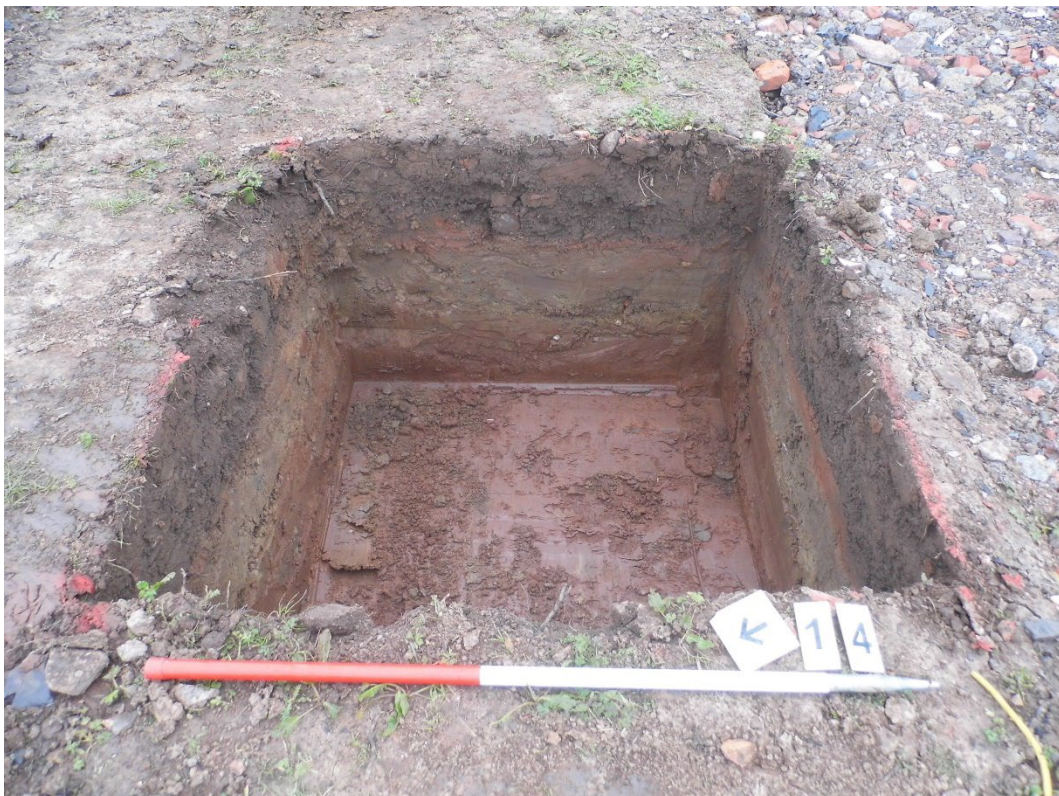
| Pit | Topsoil | Layer | Subsoil |
|---|---|---|---|
| 14 | 0.3 | 0.07 | 0.24 |

Figure 15: Pad pit 14 looking south-east

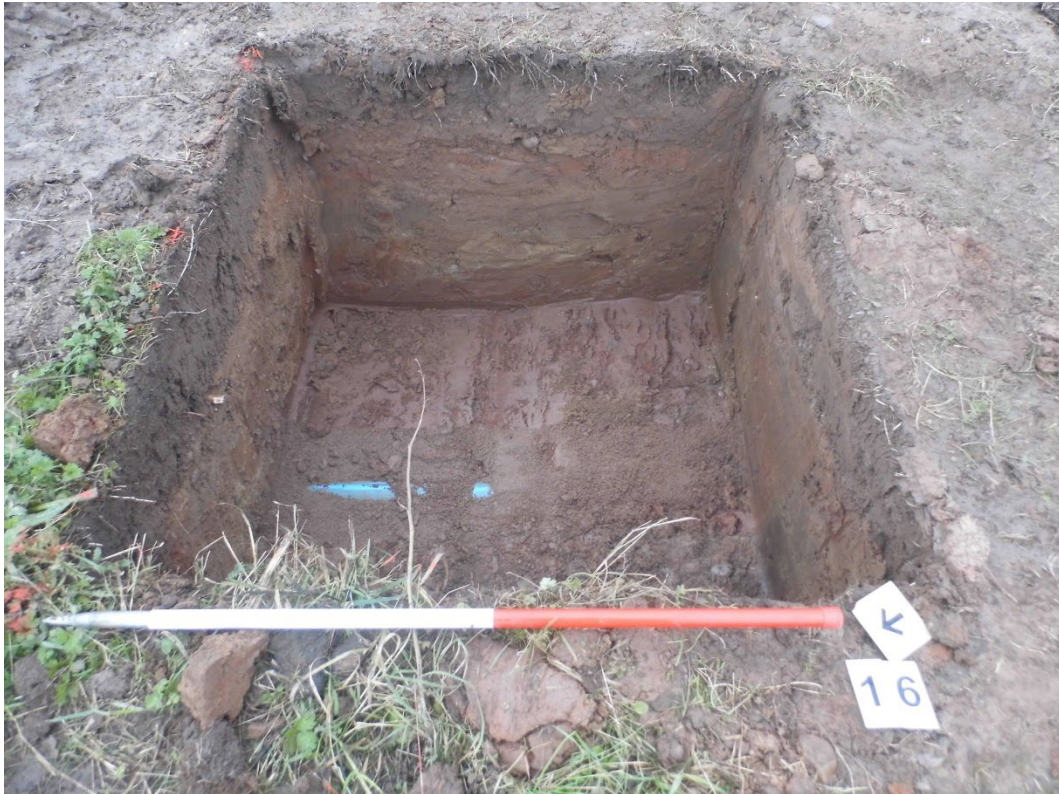
| Pit | Topsoil | Layer | Subsoil |
|---|---|---|---|
| 16 | 0.3 | 0.12 | 0.24 |

Figure 16: Pad pit 16 looking south-east

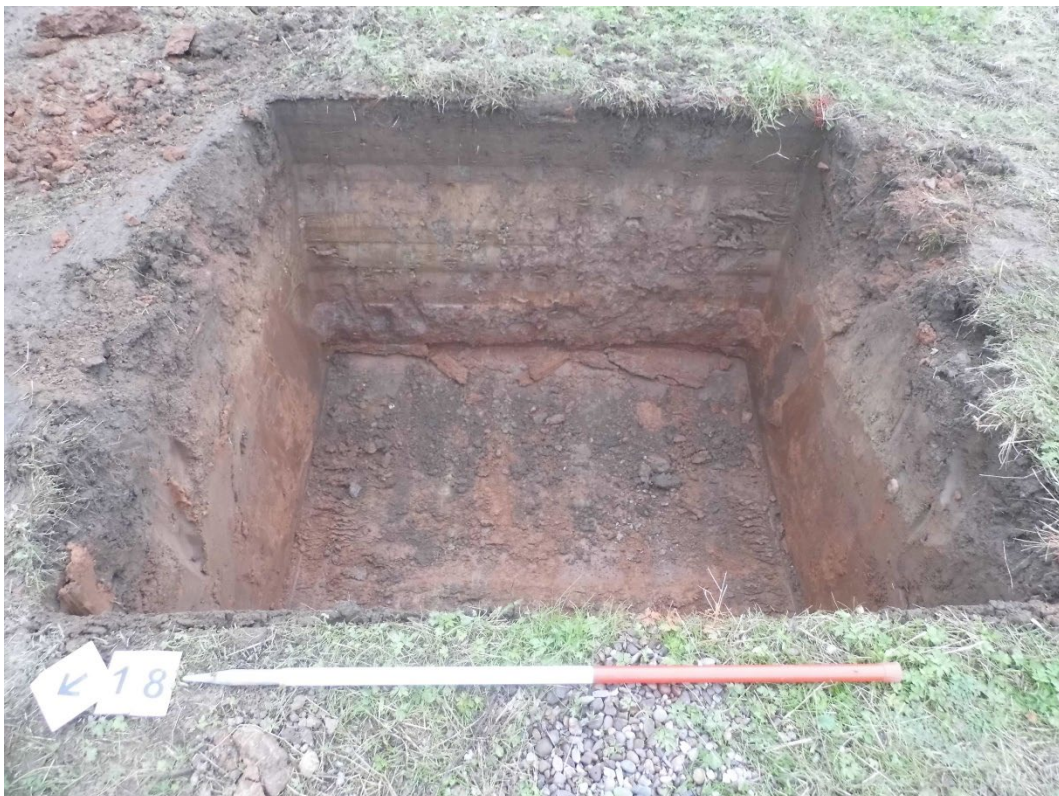
| Pit | Topsoil | Layer | Subsoil |
|---|---|---|---|
| 18 | 0.28 | 0.08 | 0.13 |

Figure 17: Pad pit 18 looking south-east

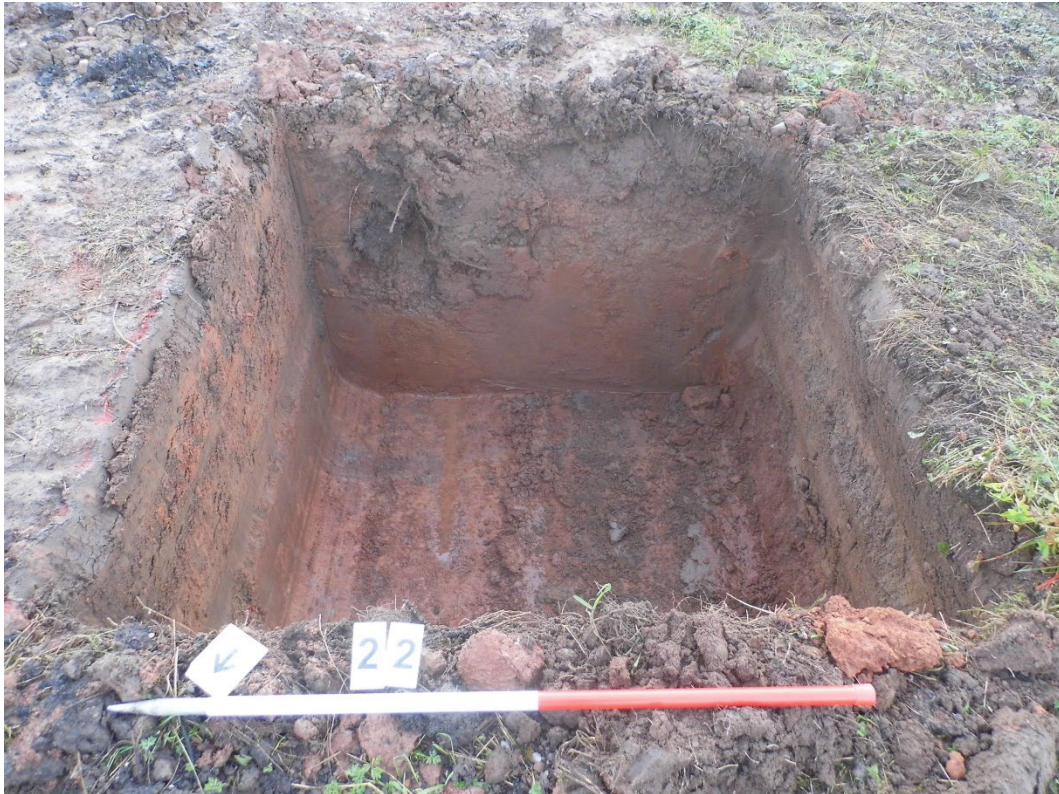
| Pit | Topsoil | Layer | Subsoil |
|---|---|---|---|
| 22 | 0.31 | 0.1 | 0.14 |

Figure 18: Pad pit 22 looking south-east

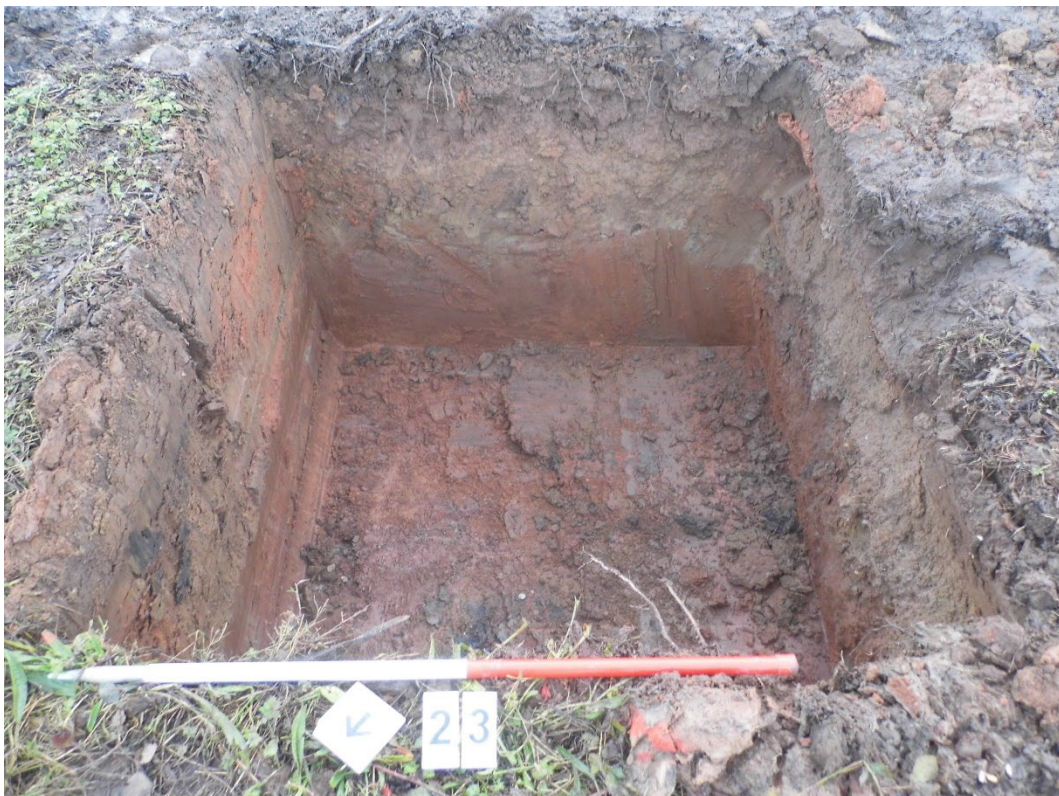
| Pit | Topsoil | Layer | Subsoil |
|---|---|---|---|
| 23 | 0.3 | 0.1 | 0.12 |

Figure 19: Pad pit 23 looking south-east

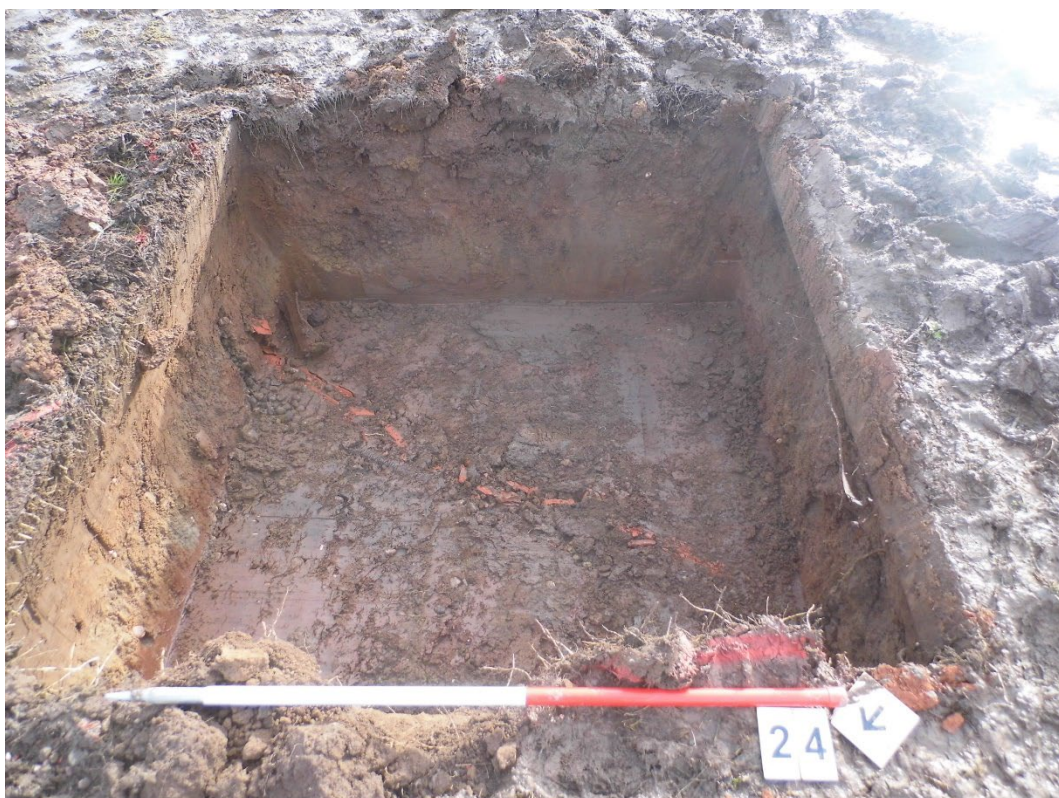
| Pit | Topsoil | Layer | Subsoil |
|---|---|---|---|
| 24 | 0.32 | 0.12 | 0.17 |

Figure 20: Pad pit 24 looking south-east
