## Bat Emergence and Re-Entry Surveys (BERS)

14 Shenton Lane, Dadlington, Nuneaton, Leicestershire, CV13 6JD

This report is prepared to inform a planning application for the proposal described as: The construction of a garage and extension to the rear of the existing building.

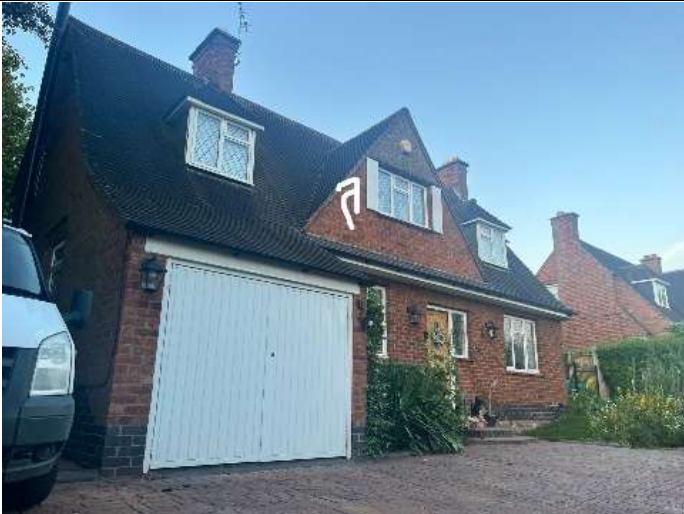
| Surveyor observations | | |
|---|---|---|
| <p><i>Surveyor 1</i></p> | <p><b>Emergences observed -</b></p> <p>Common pipistrelle social calls were heard but not seen at 21:55, following by a common pipistrelle foraging NE to SW at 21:59.</p> <p>A common pipistrelle was observed entering behind the window shutter at 22:04 and emerging from the same access point 7 minutes later.</p> <p>A brown long eared bat was observed flying southeast over the building at 22:54.</p> <p><b><u>Common pipistrelle roost:</u></b></p> <p>Number: 1</p> <p>Time(s): 22:04 (Re-entry, followed by re-emerging 7 minutes afterwards)</p> <p>Location of access point(s): Under window shutter.</p> <p>Direction(s) of travel on emergence: southwest</p> <p>Species ID confirmed on site</p> <p>Summary of general activity:</p> <p>Species – CP, BLE</p> <p>Flight paths – BLE flight path south-east over building.</p> <p>Foraging areas – Constant foraging in the tree line to the west of B1.</p> | |

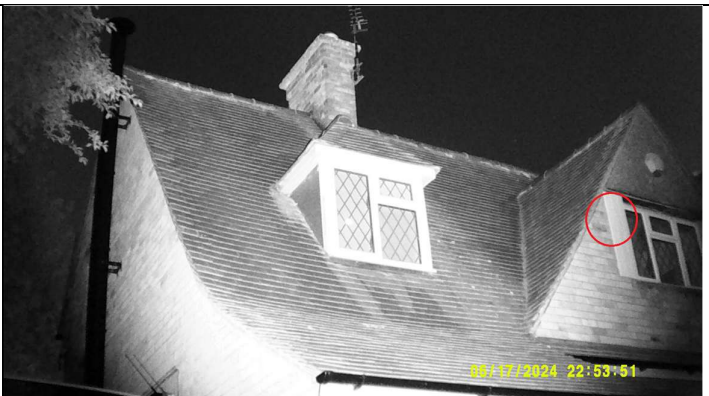
| <i>IR position 1</i><br><i>Nightfox Whisker</i> | <p>Camera position: observing Southwest elevation of B1<br/>Emergences observed: Y</p> <p>No emergences were observed and the footage was in line with the observations of surveyor 1 with no additional activity.</p> <p><b><u>Common pipistrelle roost:</u></b><br/>Number: 1<br/>Time: 22:04 (re-entry followed by emergence 7 minutes later)<br/>Location of access point: Beneath window shutter<br/>Direction of travel on emergence: Southwest<br/>Species ID confirmed on site or by sound analysis post survey.<br/>Surveyor 1 observed the re-entry and emergence.</p> <p>Any other notable bat activity:<br/>Common pipistrelles were seen foraging frequently near the building's elevation on IR review.</p> | |

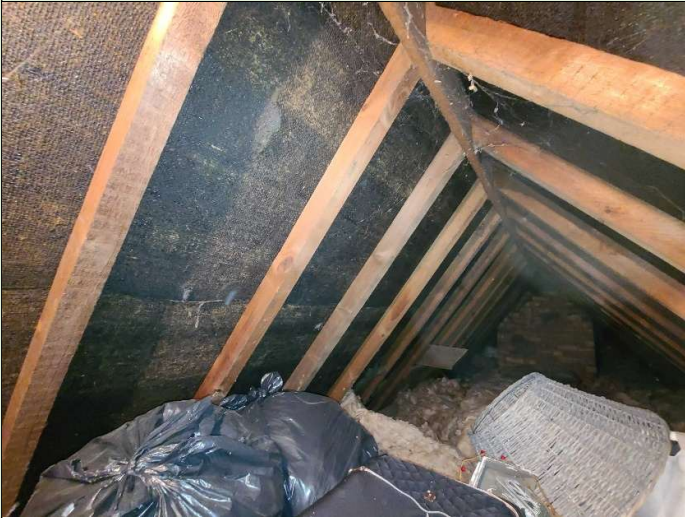
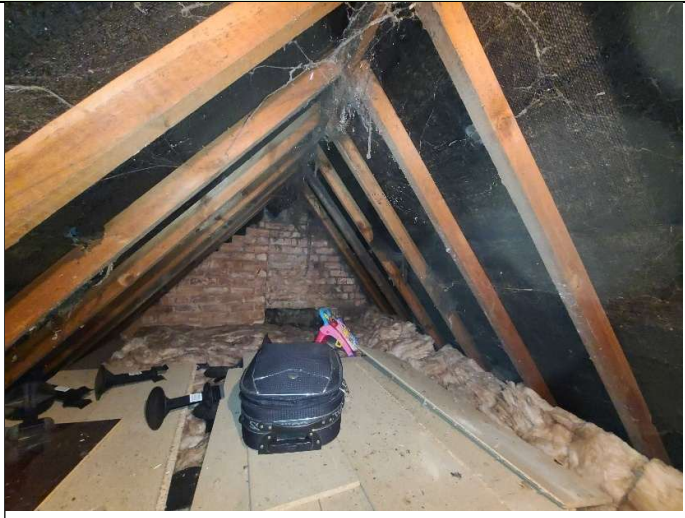
| <i>Building inspection prior to survey</i> | <p>Carried out by: Danielle Olding, Natural England licence: 2019-40541-CL18</p> <p>Structures inspected: Loft void in B1</p> <p>Bat evidence found: None</p> <p>Felt lined apex roof structure along the south elevation of the property. No access was possible within the roof space itself due to lack of walkways and visible support beams. Internal roof felt damaged in several places allowing potential ingress but no evidence of bat occupation, past or present. Area inspected with high powered torch and close focus binoculars. Evidence of rodent damage visible, extensive cobwebs throughout.</p> | |
