**Listed Building Consent Application**  
**Stables and Kennels to Bradgate House**  
**Grade II\* (Listing Number 1361383)**

**Application for the Removal and Storage of the Timber  
Cupola on the Courtyard Tower and Replacement with a  
Temporary Flat Roof**

**Structural Repairs Strategy to  
South Range Tower  
2025 Works Proposal**

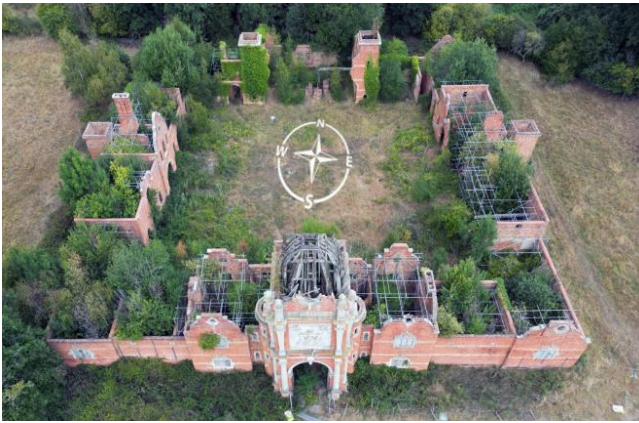
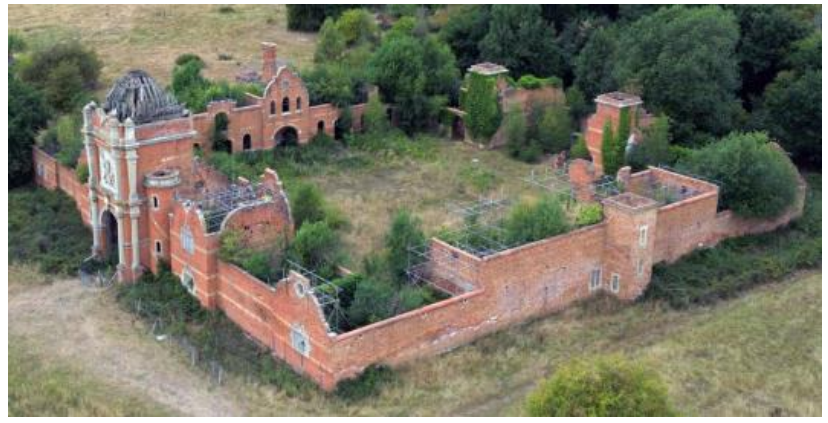
*Drone images showing the Stables before the commencement of the ongoing repairs.*

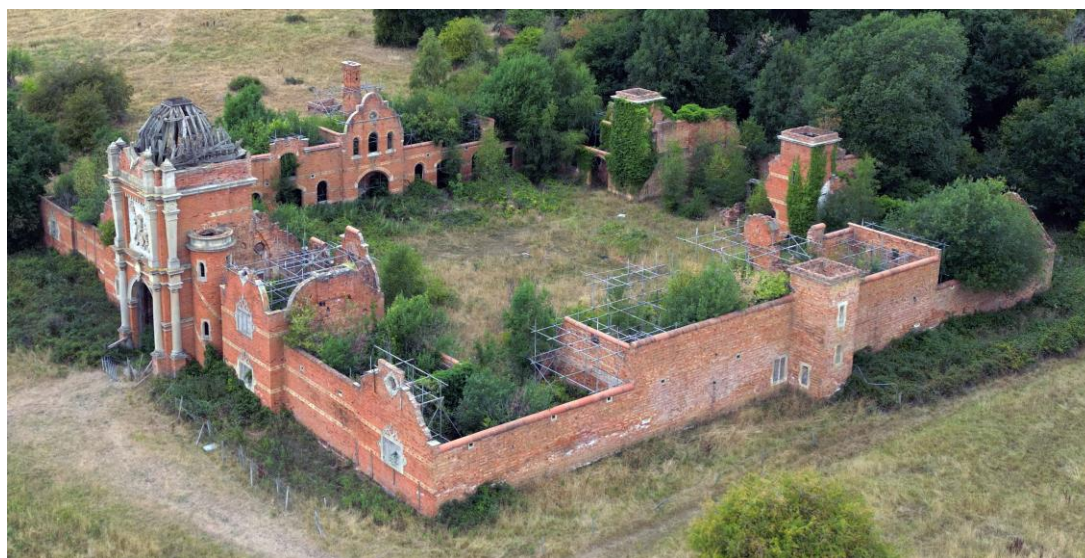
1.02 The image below shows an aerial view of the Bradgate Kennels and Stables buildings taken from the south east. A location plan and site plan are provided in appendices A and B for reference.

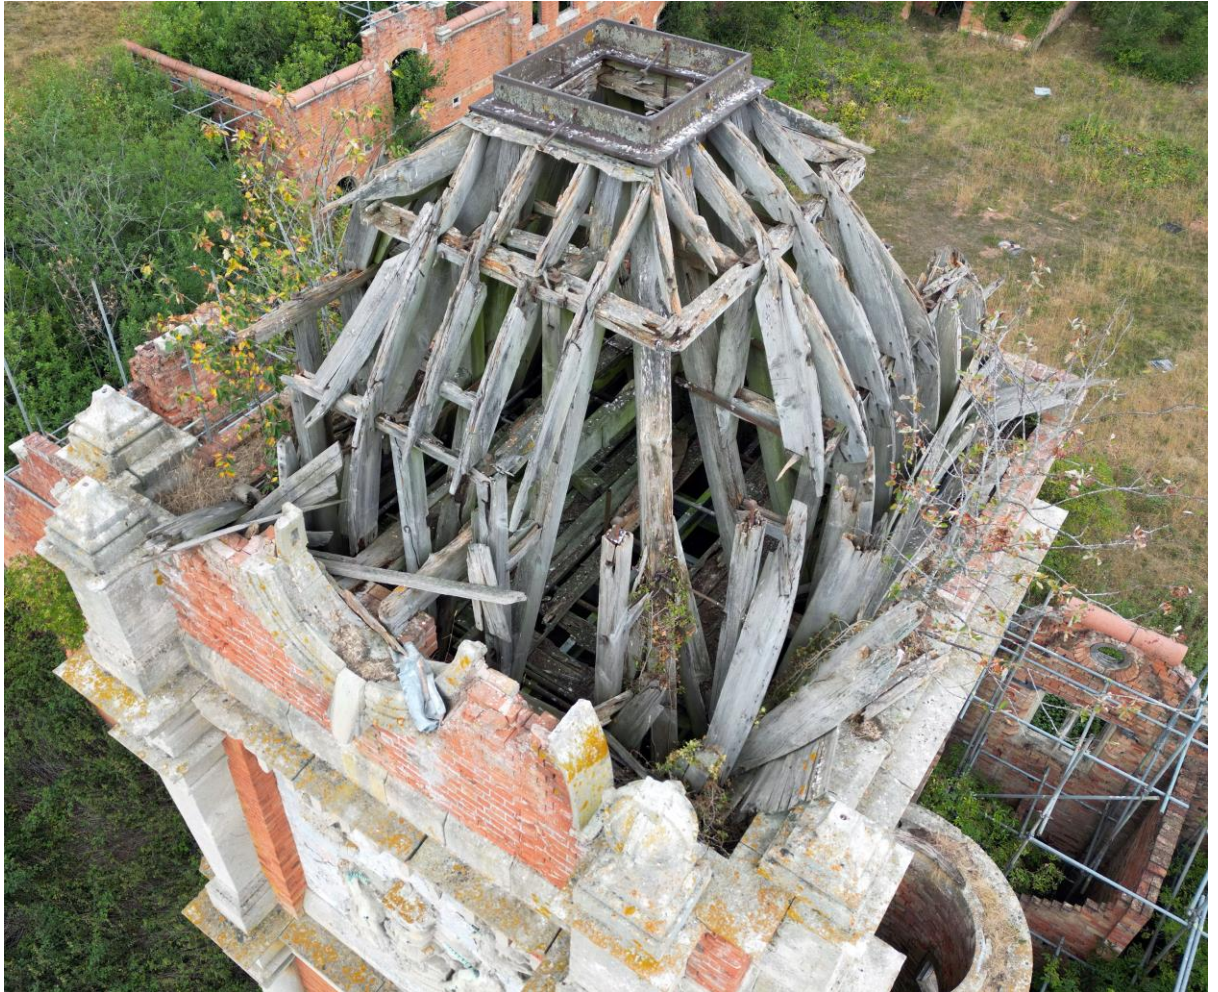
- 2.01 The timber cupola/dome structure is shown in the image below. No finishes remain and the timber skeletal frame is in a precarious and deteriorating state.

- 2.02 An iron capping frame sits on the top of the timber framing with supporting timber in various states of decay. The image illustrates a number of areas of timber failure or loss and concerns exist over the immediate stability. The ability to safely repair the existing timber framing insitu is considered impractical.

- 3.01 To safely progress repairs to the tower it is concluded that the remains of the existing timber cupola/dome structure should be recorded and carefully dismantled. As a protected structure it is noted that a listed building consent would be required for these works and that the removal should include protection, retention and safe storage of recovered structure.

- 3.03 Drawings will be produced to enable dismantled elements to be logged and tagged prior to safe, secure and dry on-site storage.
- 3.04 The approach to safe dismantling will be to use one, and at some stages two, mobile cranes sited externally to the south of the tower. One crane will have personnel basket for safe access above the structure and the second crane, when required will be used for lifting elements to ground level.

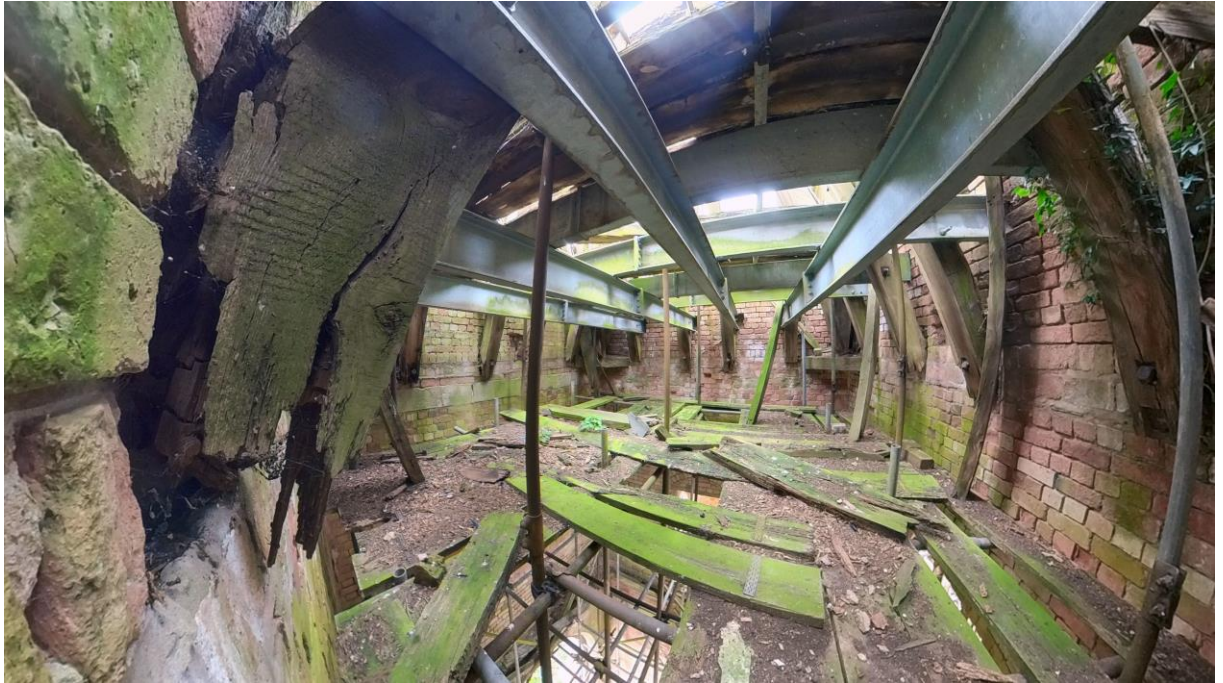
- 2.06 Within the tower head there is evidence of a modern steel frame added to prevent collapse of the timber cupola. The image below shows the steel frame with simple single bolt fixings securing the base of timbers where the bearings have historically decayed. Also visible in the image are several historical phases of scaffolding that are rusting and unsuitable for re-use. These areas require safe access to progress conservation works and this is impractical and unsafe with the high level timber dome in place and collapsing.

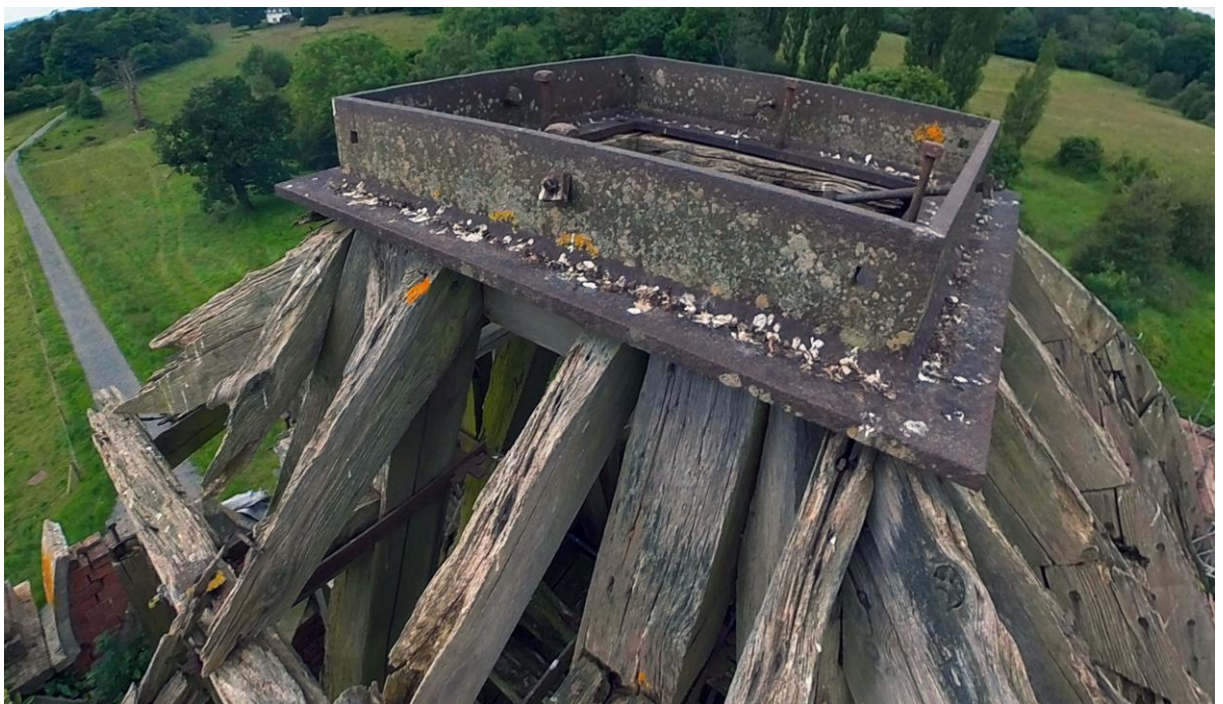
- 2.07 The image below shows the iron head to the cupola that is set precariously on the decaying timber framing. It's safe removal is considered essential to enable the general tower repairs to progress.

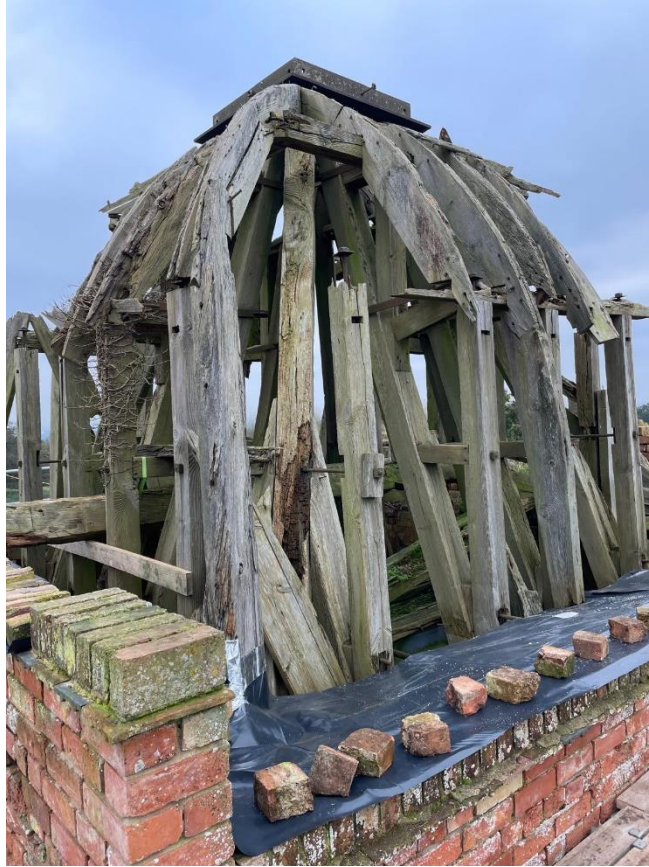
*Image of Timber Cupola*

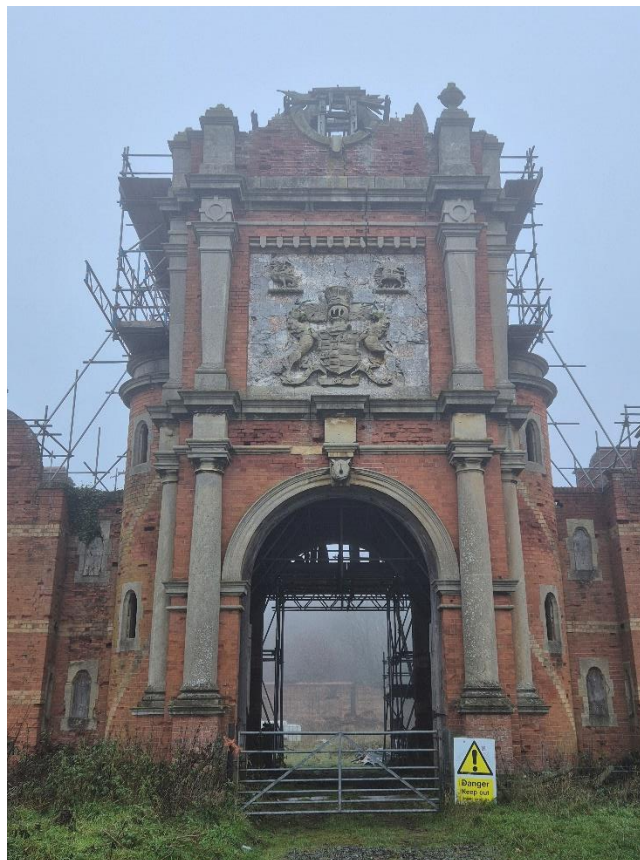
*Courtyard Tower*
