Hinckley Phase 4  
Leicestershire

**Combined Phase I Desk Study and  
Phase II Exploratory Investigation  
For  
Bloor Homes East Midlands**

| Project No: D42153 | | Date: 22 <sup>nd</sup> December 2022 | |

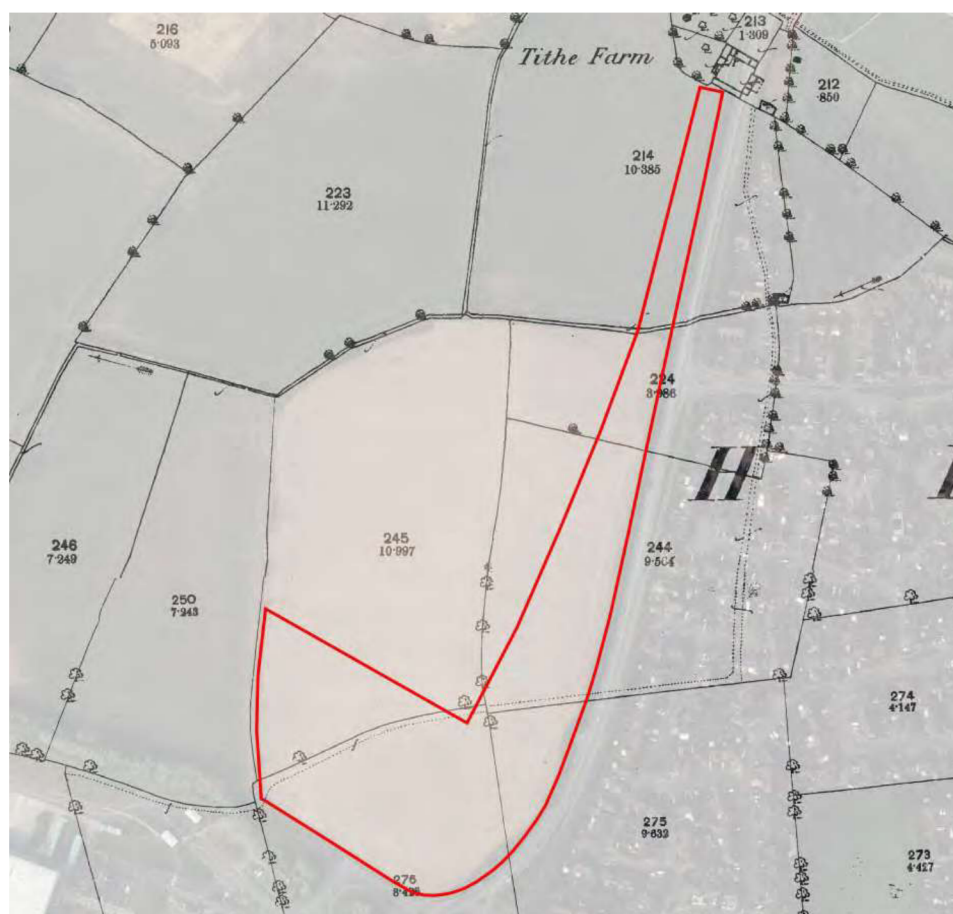
**Figure 3:** Current Aerial Imagery Overlain with 1888 Historical Map Data.

Figure 3 shows the site to essentially comprise undeveloped agricultural fields. The open drain (flowing towards the west) can be seen cutting across the strip of land which forms the northern corner of the site. Tithe Farm is located to the immediate north of the site.

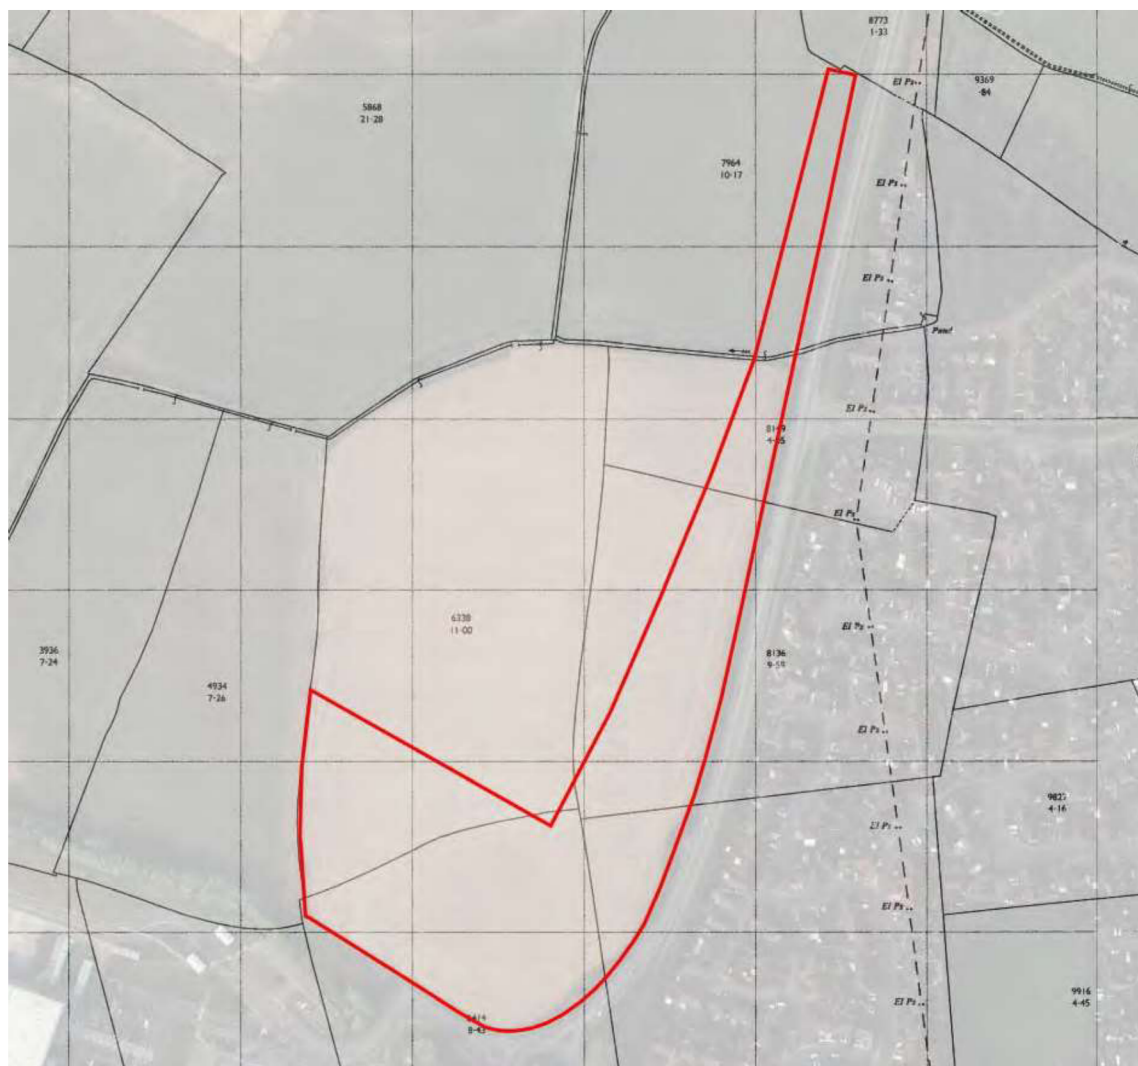
**Figure 4:** Current Aerial Imagery Overlain with 1963 Historical Map Data.

Figure 4 shows the site and its surrounding area to remain essentially unchanged. The cluster of buildings which comprise Tithe Farm are no longer shown to the north of the site.

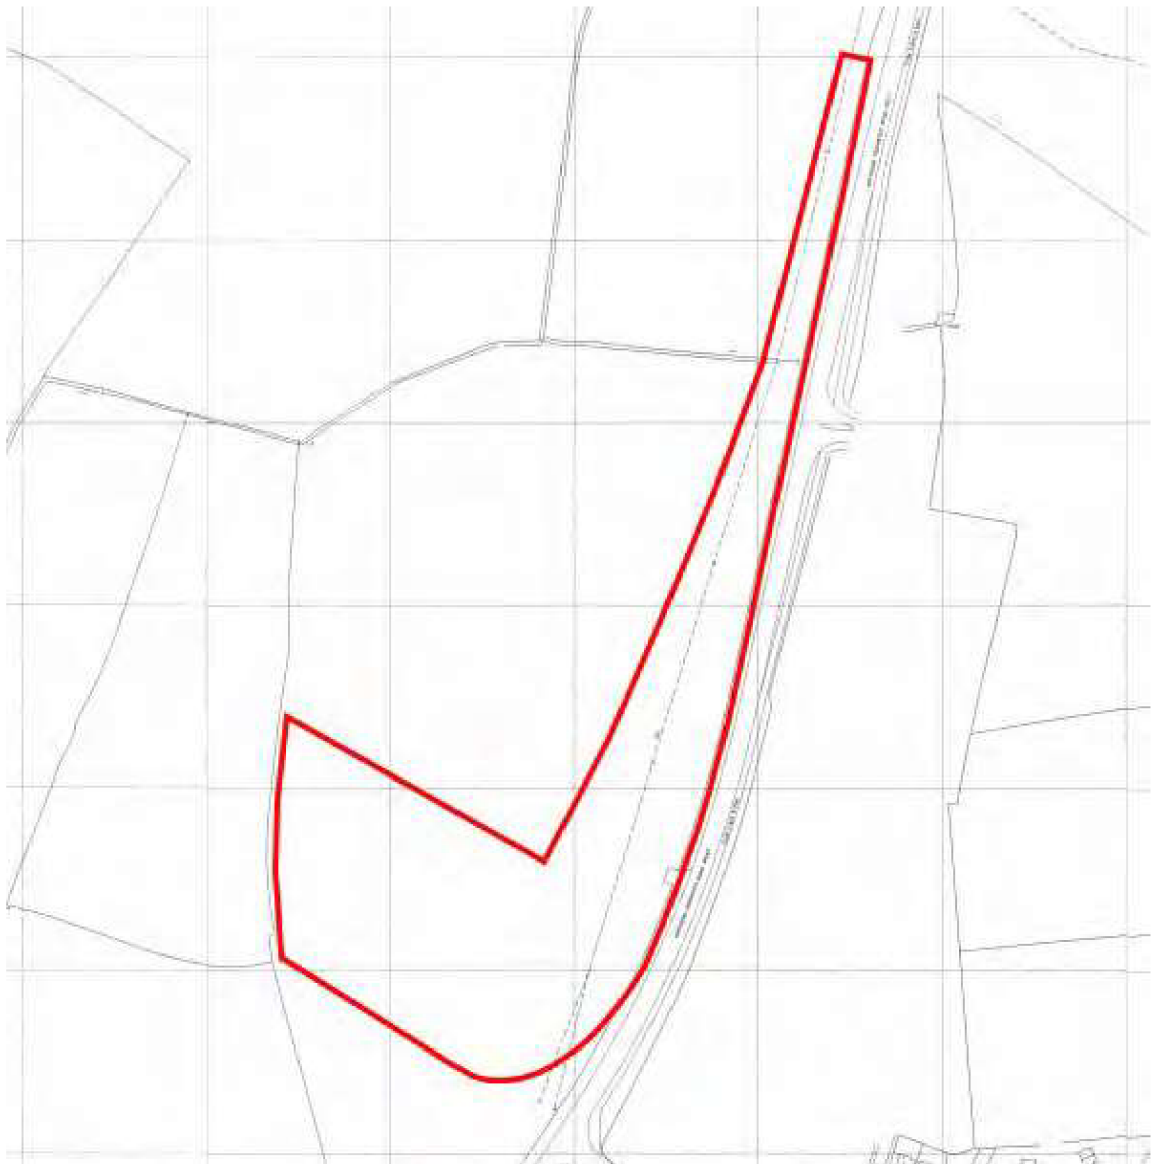
**Figure 5:** Current Aerial Imagery Overlain with 1993 Historical Map Data.

Figure 5 shows the site to remain essentially unchanged, although the majority of the field boundaries appear to have been removed. An overhead electricity cable is shown to run through the east of the site in an approximate north south direction. A road has been constructed to the immediate east of the site, beyond which the housing estate can be seen in the southeastern corner of the image expanding towards the north.

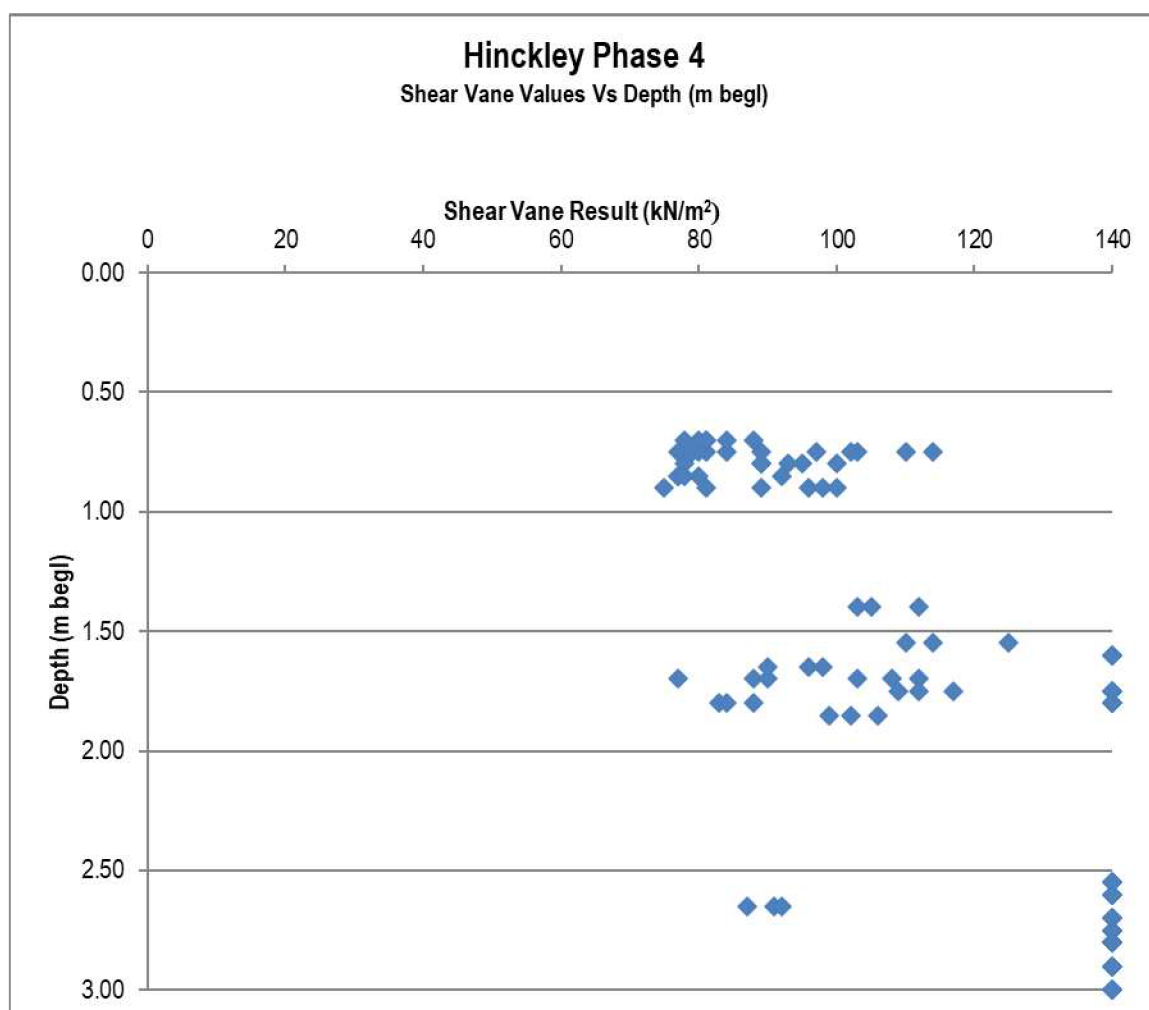
Shear vane testing was undertaken within the visually cohesive natural soils encountered within selected exploratory holes. The results revealed typical soil shear strength values of between 75kN/m<sup>2</sup> and in excess of 140kN/m<sup>2</sup>, at depths of between 0.70m and 3.20m begl. In general, the results also show a typical increase in soil shear strength with increased depth.

It should be noted that shear vane testing undertaken at depths greater than 1.00m was carried out ex-situ for health and safety reasons. The shear vane values are detailed on the logs presented in Appendix VIII. A graph showing shear vane results in relation to depth is presented below.

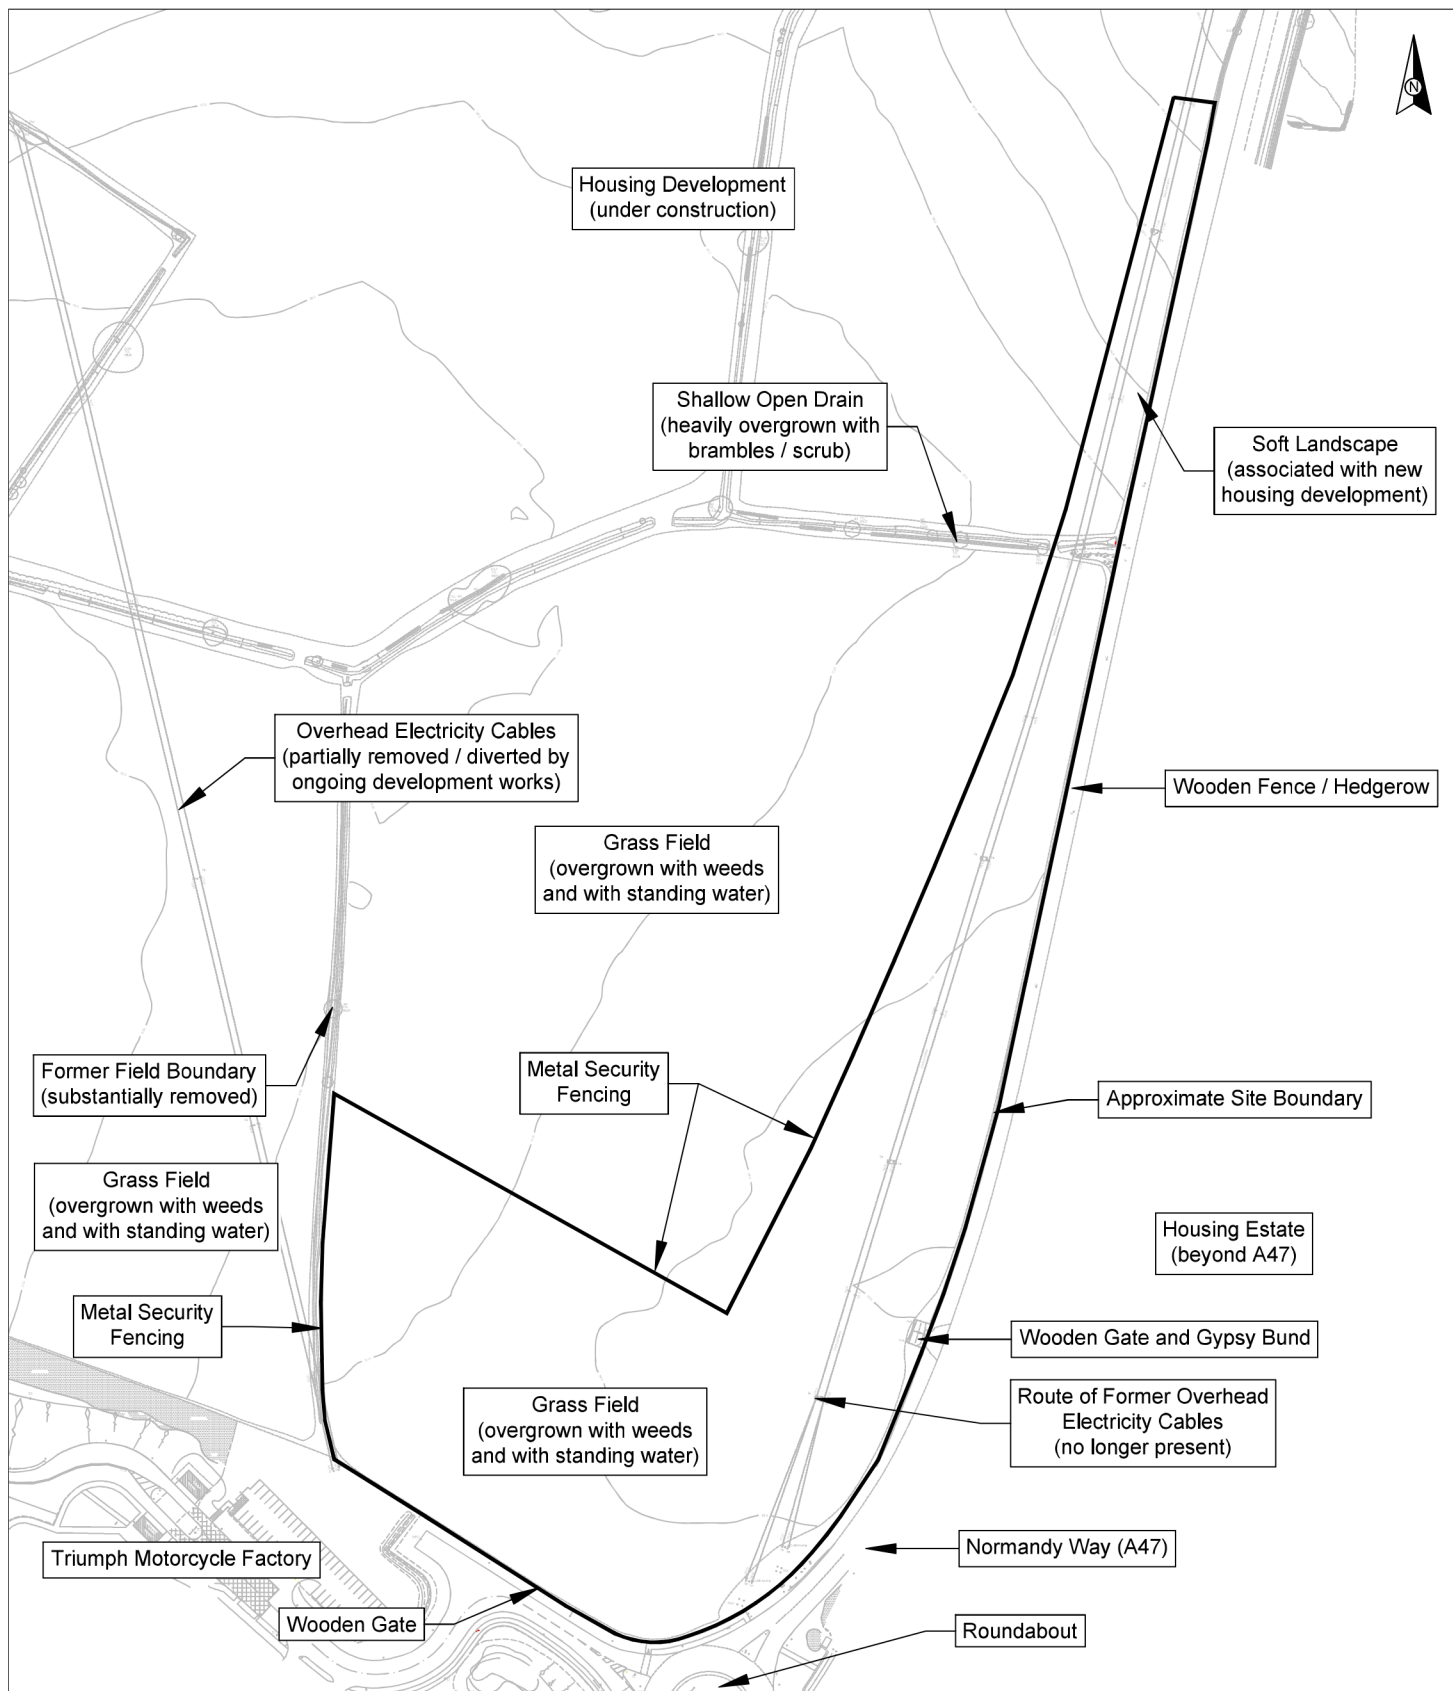
**Annotated Site Plan  
(Figure No. D42153/02)**

Drawing based on Topographical Survey by Greenhatch Group Drawing No.19969 OGL Rev A Dated: March 2014. Used, edited and reproduced with permission of the Client.
