## Updated Ground Gas Risk Assessment

Proposed Residential Development

Hill Top Farm, Earl Shilton

Site: Hill Top Farm, Earl Shilton  
Document Title: Updated Ground Gas Risk Assessment  
Document no.: STW6847-R01-Rev\_A  
Date: December 2024  
Client: Snowdon Homes Ltd  
Issuing office: Soiltechnics Ltd  
Cedar Barn, White Lodge, Walgrave, Northampton. NN6 9PY  
Tel: 01604 781 877 E-mail: [mail@soiltechnics.net](mailto:mail@soiltechnics.net)

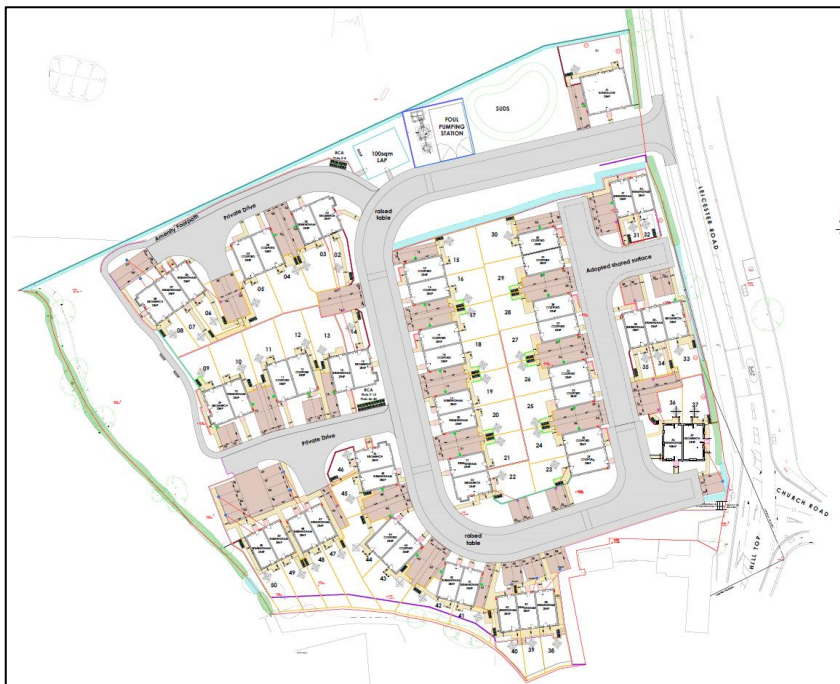
Figure 1: Snapshot of proposed development

1.2.2 A snapshot of the proposed development layout is included below in Figure 1.

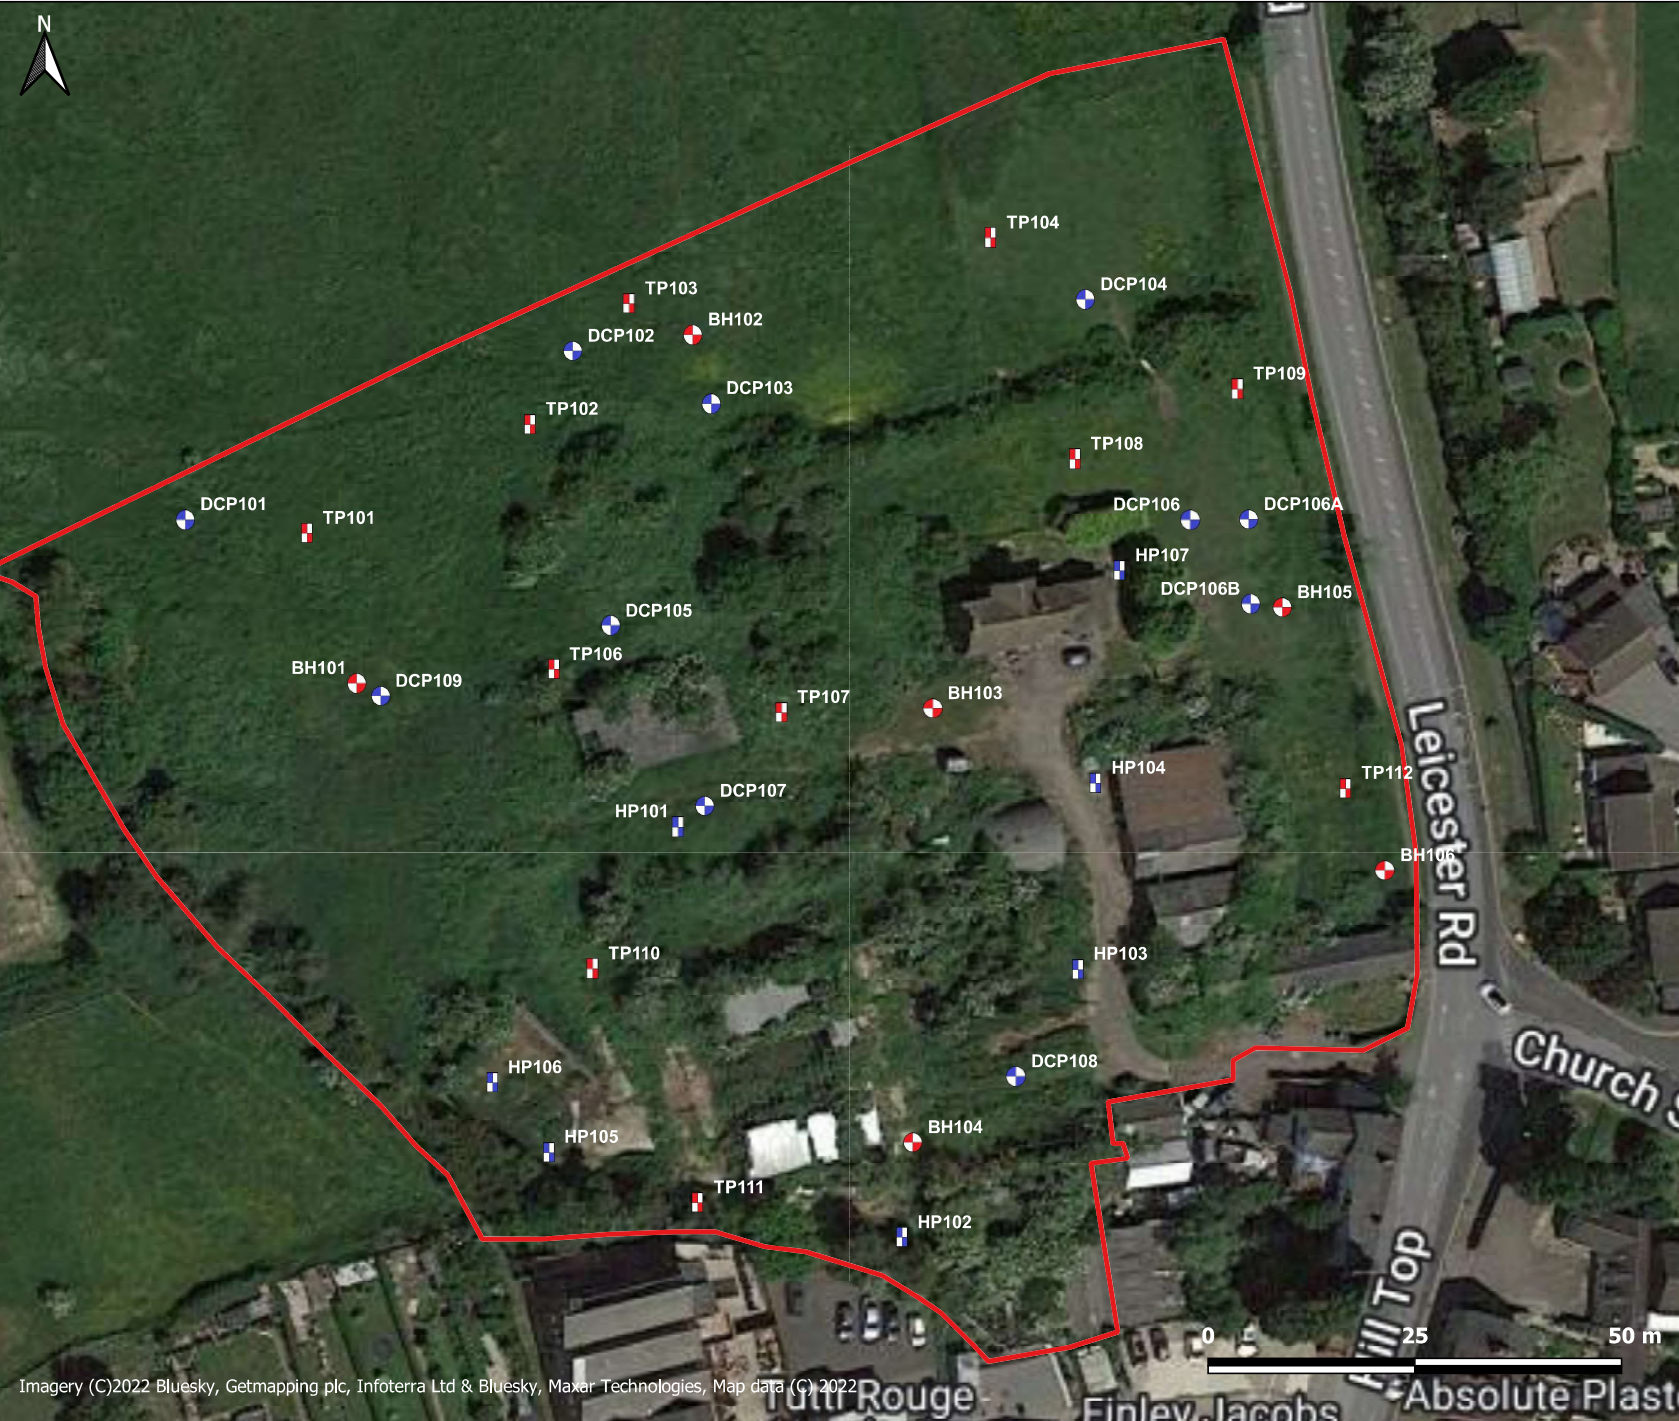
- Site Boundary
- Completed Site Investigation Locations
  - Cable Percussive Borehole
  - Dynamic Cone Penetration Location
  - Hand Excavated Pit
  - Trial Pit

2.3.1 A plan showing the location of exploratory holes and monitoring wells is included in Appendix A, along with the exploratory logs Appendix B.
