Land South of Poplar Terrace  
Congerstone Leicestershire

WRITTEN SCHEME OF  
INVESTIGATION FOR  
ARCHAEOLOGICAL MONITORING  
AND RECORDING

*This report presents the results of archaeological monitoring and recording undertaken in January 2024 on land south of Poplar Terrace, Congerstone, Leicestershire. The work was commissioned by Corporate Architecture Ltd in connection with the erection of an additional dwelling and associated groundworks, approved under planning application 23/00332/FUL.*

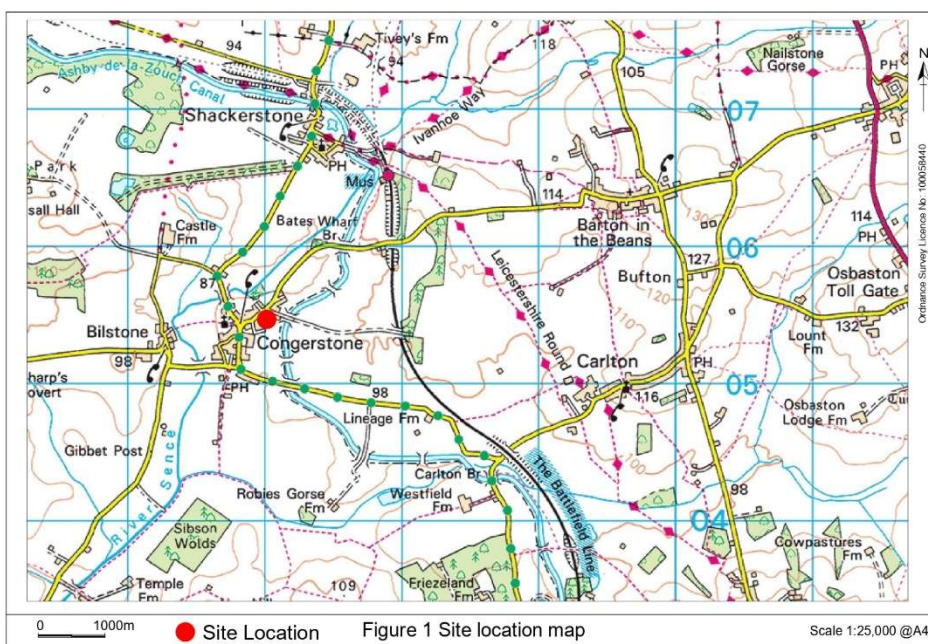
Congerstone is located approximately 4.5km northwest of Market Bosworth, Leicestershire. The site is situated on the eastern edge of the village, to the south of Poplar Terrace and Dovecot Close, at National Grid Reference SK 37015 05555 (Fig. 1).

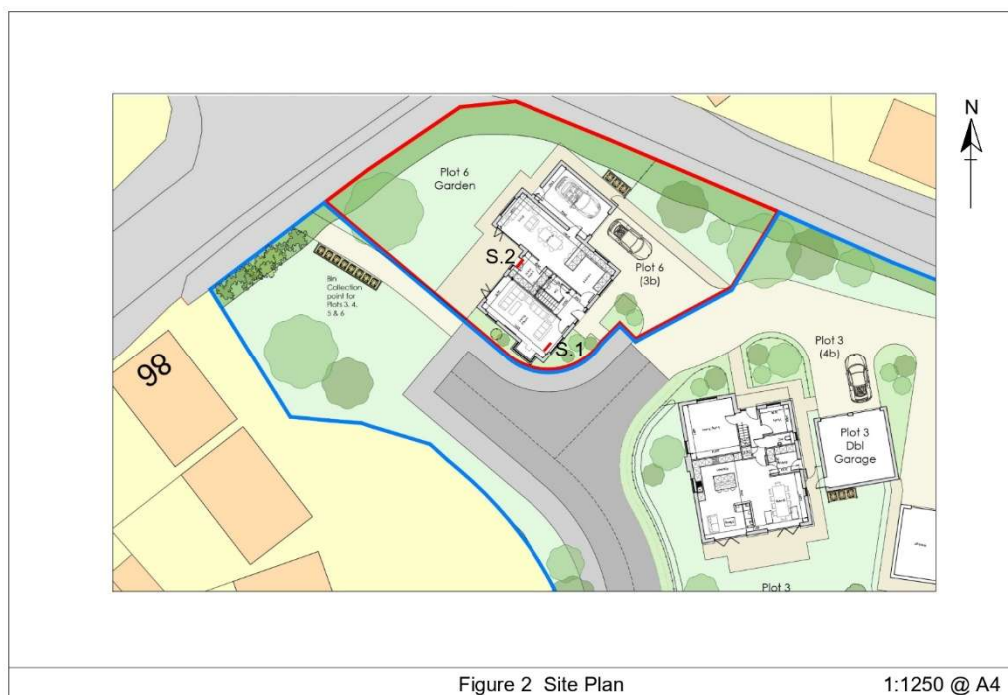
#### **5.0 METHODOLOGY (Fig. 2)**

A single-context recording system was employed. Exposed surfaces and sections were examined for archaeological features and changes in the natural geological deposits. Written descriptions of the deposits encountered were compiled on pro forma recording sheets. Provision was made for sections to be drawn at a scale of 1:10 and any archaeological features exposed in plan at a scale of 1:20.

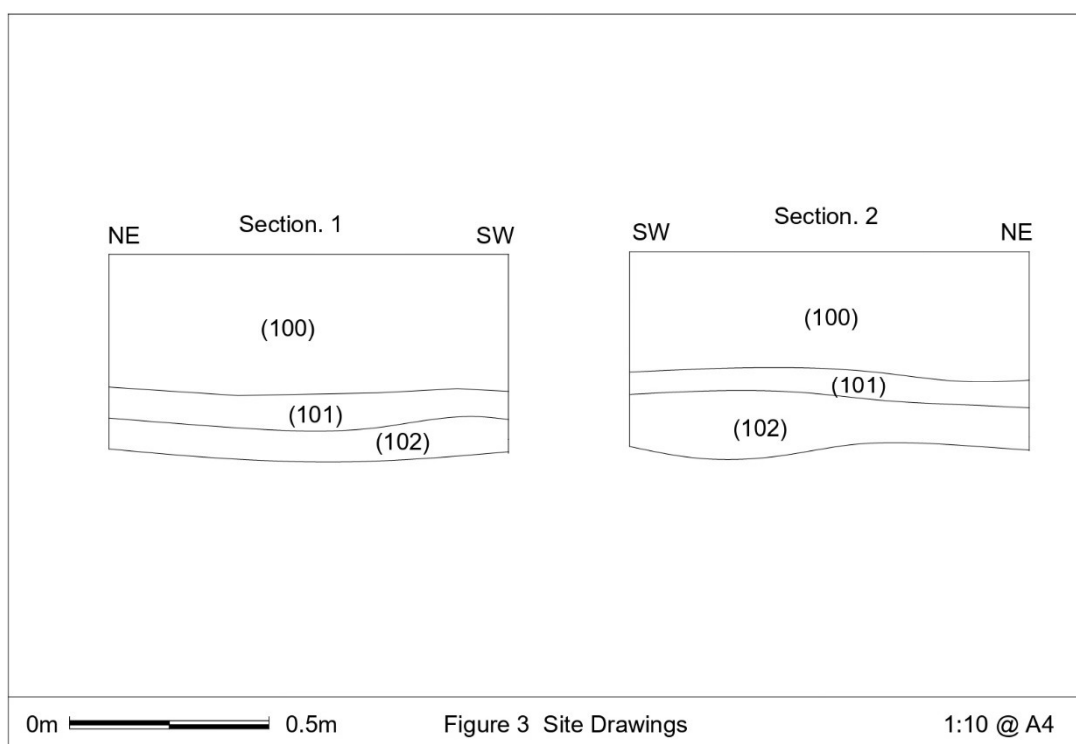
## 6.0 RESULTS (Fig. 3)

Full context descriptions are provided in Appendix A. The monitored groundworks exposed approximately 0.30m of mid-greyish-brown clayey sand topsoil (100), overlying approximately 0.10m of mid-greyish-brown silty clay subsoil (101). This sealed the natural geology (102), comprising mid reddish-orange weathered mudstone with clayey areas.

No archaeological features, deposits, artefacts or ecofacts were identified during the archaeological monitoring. Consequently, no finds were retained and no environmental samples were collected.

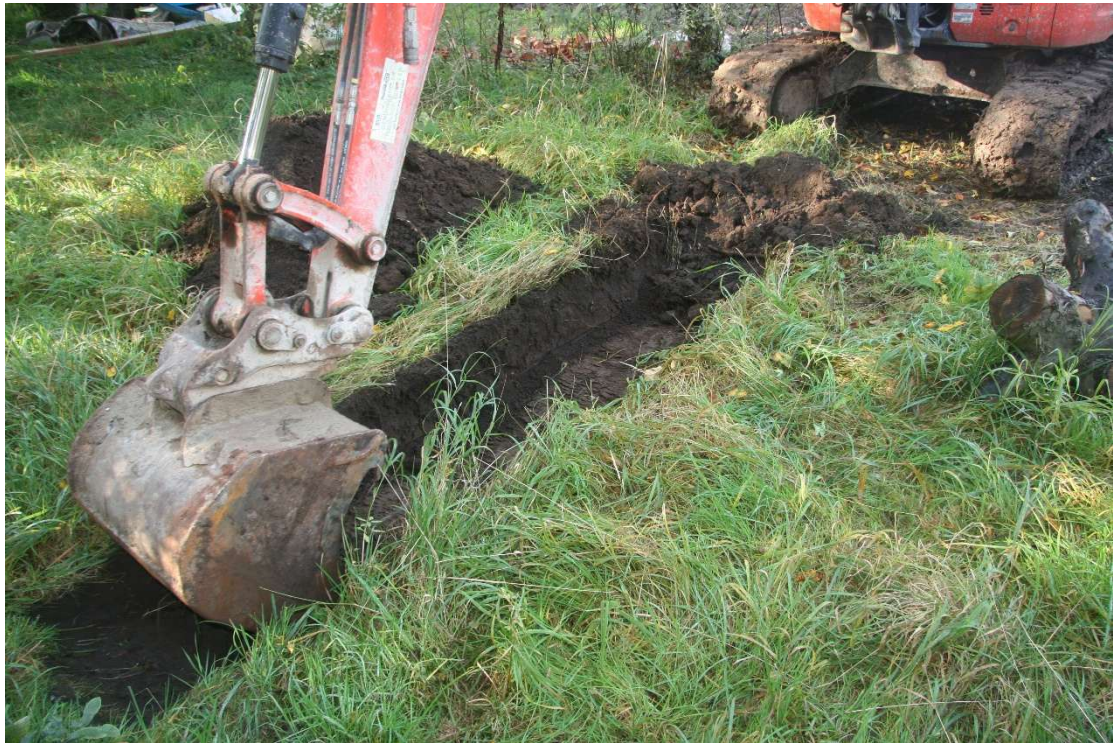
**Plate 1:** Working view of the monitored groundworks, looking North.

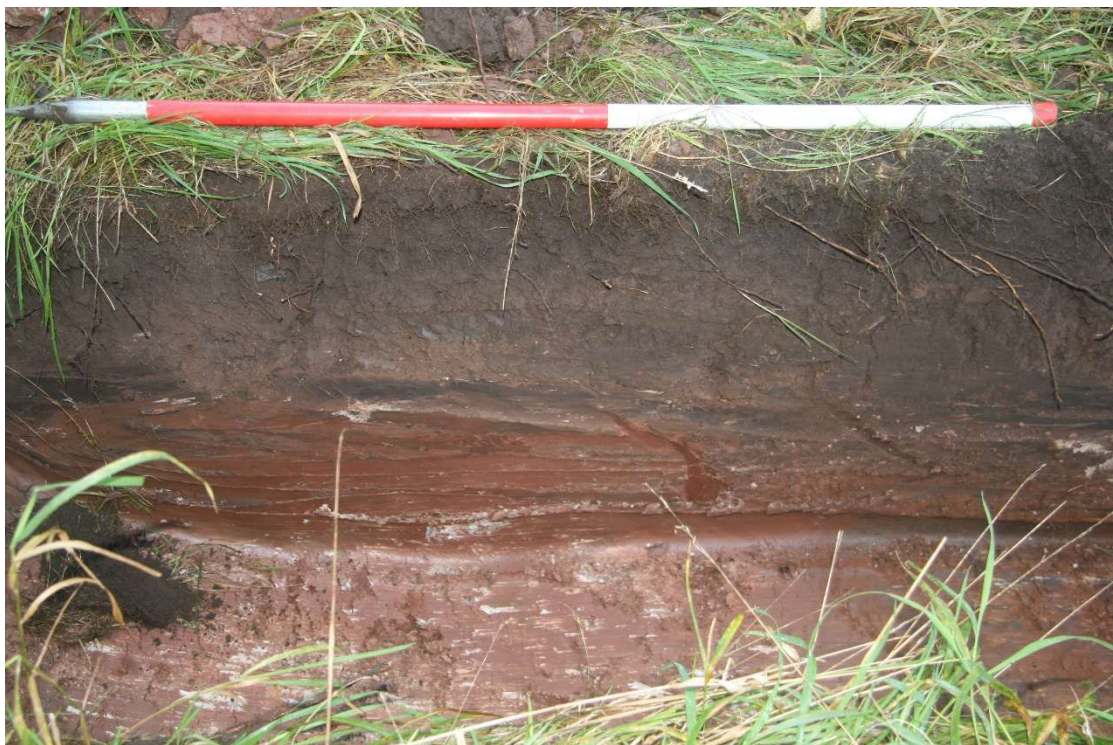
**Plate 2:** Representative section showing topsoil (100), subsoil (101) and natural (102), looking Southeast.

The monitored groundworks exposed topsoil (100) overlying a thin subsoil deposit (101), beneath which was the natural weathered mudstone geology (102). No archaeological features or deposits were identified at the surface of the natural geology.

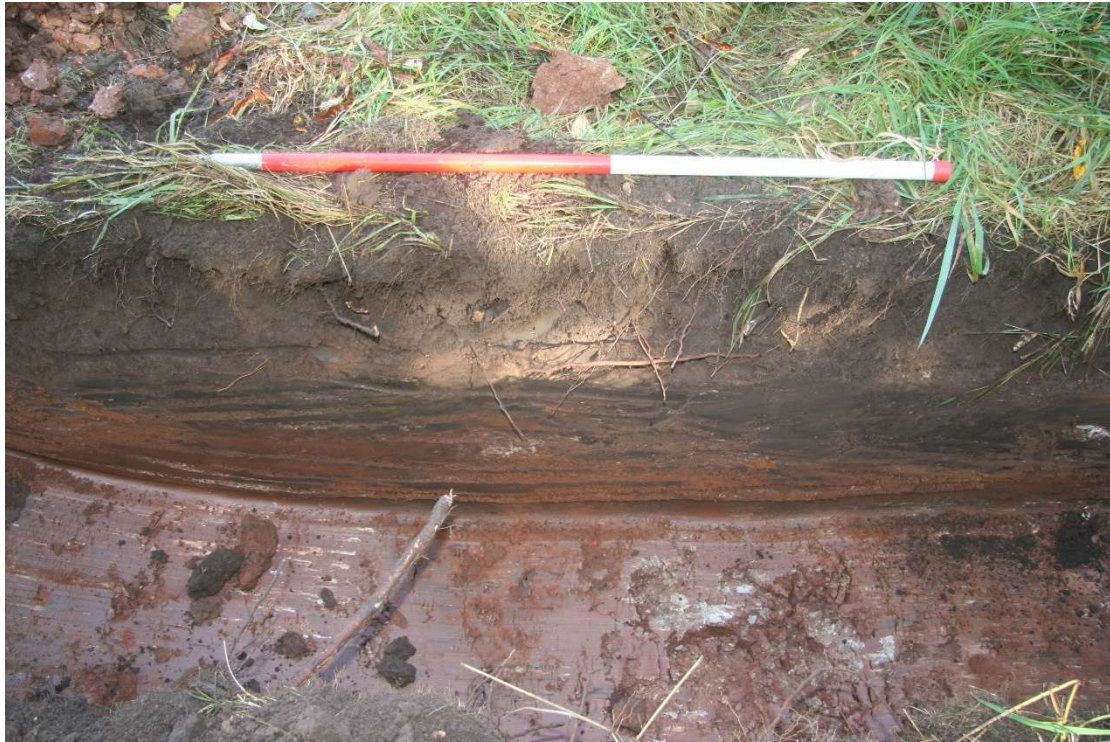
**Plate 3:** Representative section showing topsoil (100), Subsoil (101) and natural (102), facing Northwest.
