# *Former Moore's Arms*

6 Orton Lane, Norton Juxta Twycross, Warwickshire, CV9 3PU.

Archaeological Strip, Map & Sample Excavation.

*9th May 2024*

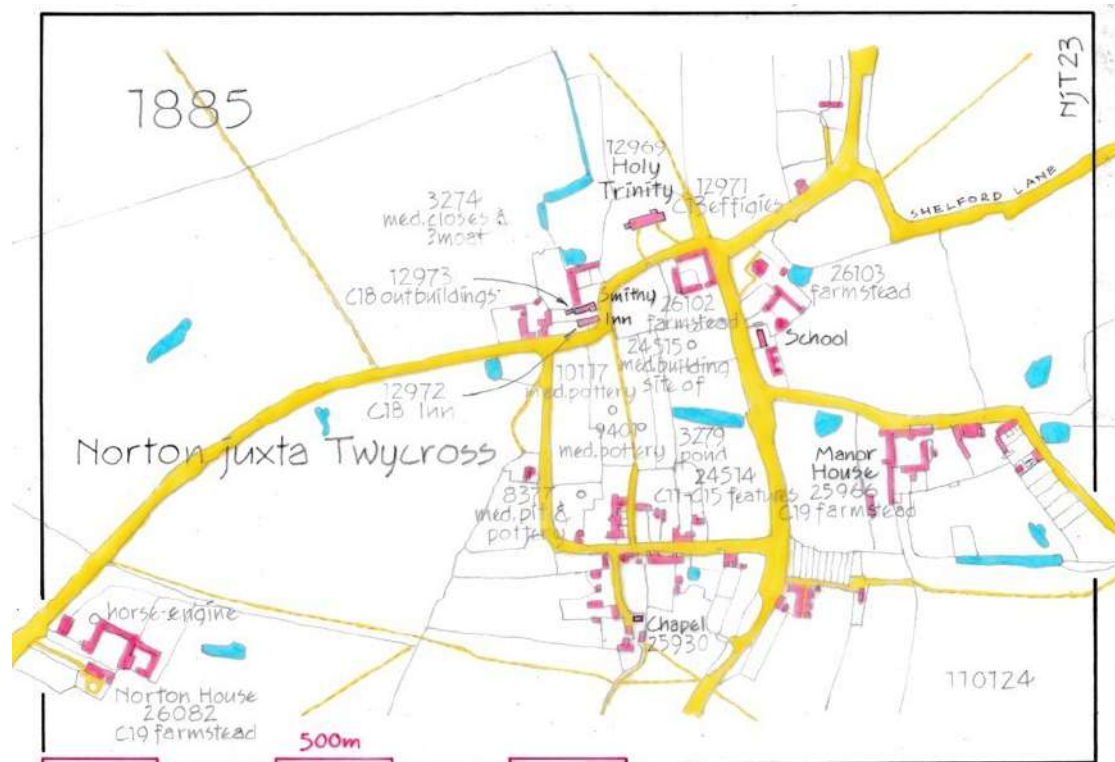
Fig. 3: Sketch plan showing Historic Environment Monument Records.

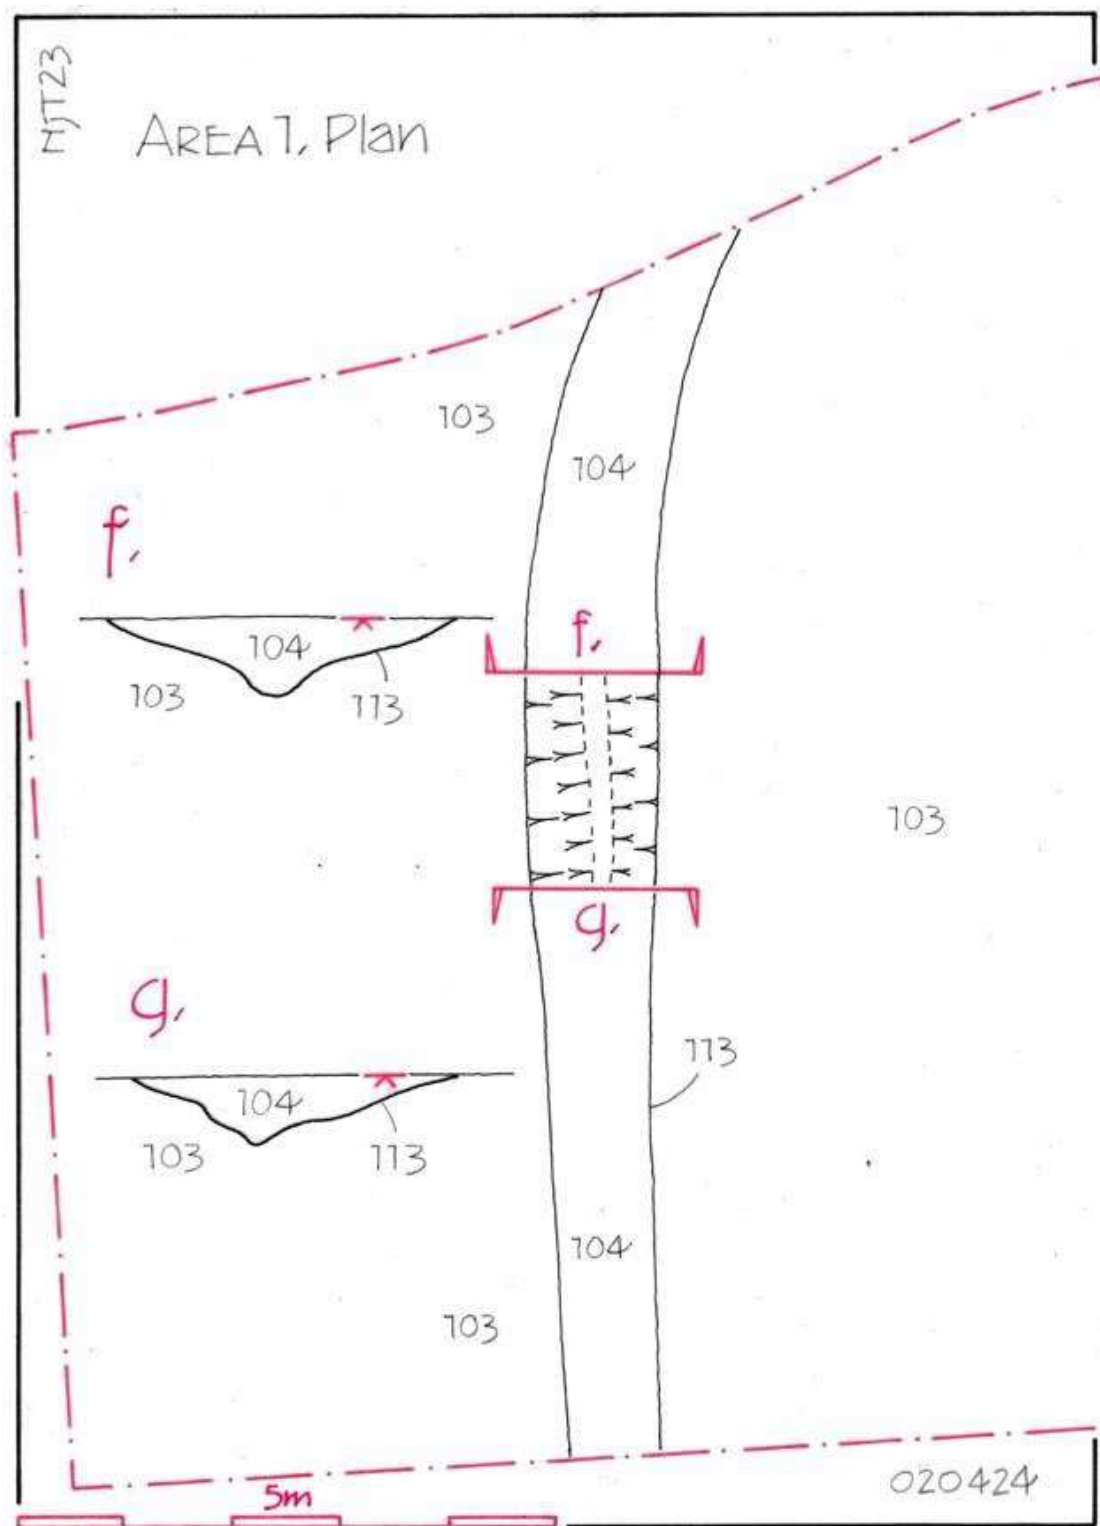
Fig. 5: Area 1, plan of ditch [113] and sections.

The surface of the natural substrate (103), consisting of a stiff light grey/brown clay (103) with the occasional component of small stones, was recorded at a roughly level height of about 107.80m AOD throughout the excavated area. There were the occasional small lenses of reddish-brown gravel intermittent throughout the area. Constructed within the substrate and crossing the excavation from north-south was the ditch [113], previously recorded during the evaluation. Sample excavation showed this to be similarly sized, measuring up to 1.30m wide and 0.30m deep and similarly filled by the deposit (104) although in this instance no finds were recovered during the process. Interestingly, at the northern end of its alignment the feature begins to curve northeast. It is noted that originally the ditch feature is likely to have larger, the current truncated form of the ditch can be attributed to later cultivation associated with the overlying relict subsoil layer (101). The thickness of this deposit ranged from between 0.30-40m across the area, equivalent to that recorded during the earlier evaluation and a single sherd of medieval pottery was recovered from the deposit during the excavation. The evidence would suggest that prior to its truncation the ditch would have probably been in the region of about 2.1-20m wide and 0.70-80m deep, being created from the surface of the contemporary ground level. overlying relict subsoil layer at a time when the ditch had become in-filled and abandoned.

Area 1, placed to the west of the development site, recorded a single linear ditch [113], within the natural clay substrate although it is likely that it was constructed at the surface level of the earlier relict subsoil layer (102) representing the earliest occupation horizon, later truncation to the upper part of the feature is probably linked to subsequent cultivation when the ditch was abandoned. The excavation produced a single sherd of residual medieval pottery from the relict subsoil layer, but no further finds were recovered from the C14 ditch during sample excavation.

The character and alignment of the ditch, perpendicular to Orton Lane, suggests an earlier property boundary, possibly associated with the adjacent cottage which in 1885 formed part of a larger farmstead west of the Moore's Arms and which may have originated in the medieval period. A brook marks the current boundary between the two properties and remains a significant watercourse in the village facilitating the flow of water from the higher ground to the north, however, it may be that the ditch recorded in trench 1 marked an earlier location for the boundary. Interestingly, the alignment of the ditch corresponds with a similarly aligned boundary on the eastern edge of the road opposite, evidence perhaps of a medieval settlement pattern based on a series of small holdings perpendicular to either side of the Orton Road frontage.

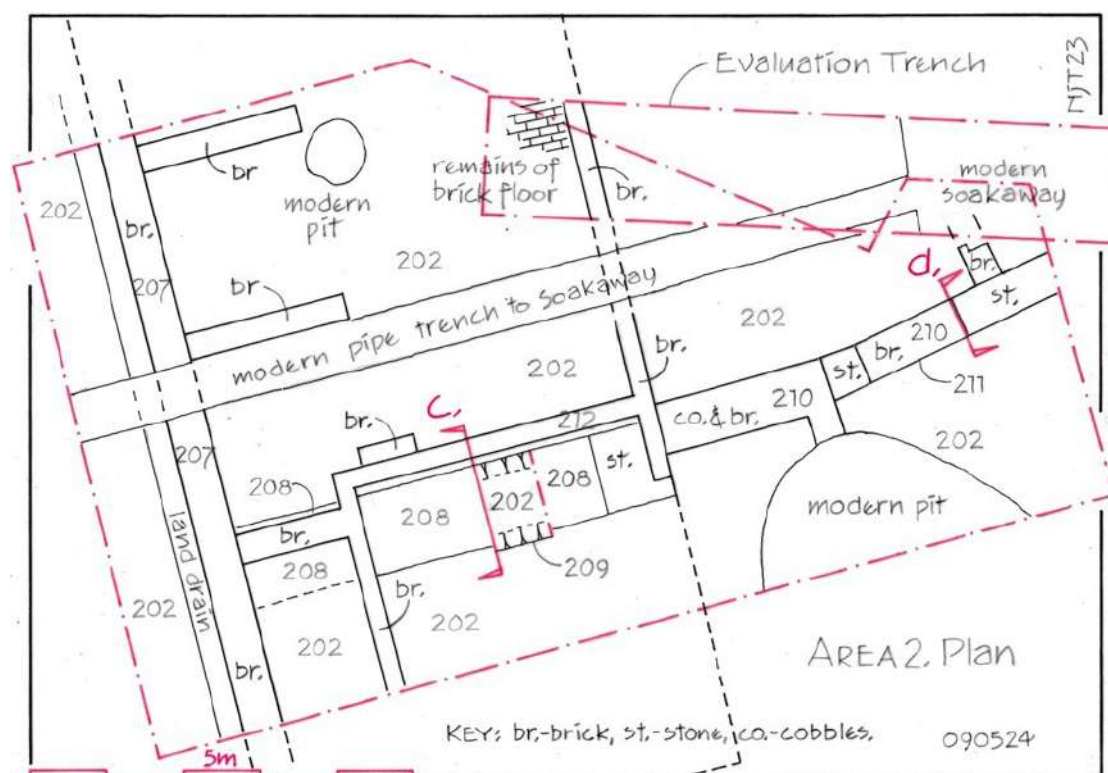
Fig. 6: Area 2, plan showing remains of earlier buildings and features uncovered in Evaluation Trench.

The surface of the natural substrate (202), consisting of a stiff red clay mottled throughout with light grey clay and containing a component of occasional small stones, was recorded at a roughly level height of about 107.25m AOD throughout the area. The earliest deposits recorded within the surface of this clay comprised the foundation remains (208) and (210), of what appears to be two or possibly three former walls each aligned east-west across short lengths of the area, with deposit (208) seemingly abutting (210), although the relationship between the two deposits is lost through the later intrusion caused by the construction of brick wall (207) which in this part of the area is associated with east side of the former C19 barn.

The foundation deposit (208) survives for about 5.50m, albeit truncated at various points and to varying degrees along its length. Sample excavation through an undisturbed area of this deposit revealed a shallow flat-bottomed trench [209], 1.15m wide and about 0.15m deep filled mostly along its length by compacted pebbles and fragments of brick of various sizes within a silty-clay matrix, although at the east end where it appears to have been abutted by wall deposit (210), the foundation trench is filled by stone and half-bricks. No other finds were recovered from this foundation deposit. Although the west end of deposit (208) was truncated by the west wall of the C19 barn, there was no evidence within the section at the west end of Area 1 to indicate that deposit (208) continued westwards beyond the edge of the excavation.

The foundation deposit (210) also survives for about 5.50m, about half-way along its length on the south side and perpendicular to it is a short narrow length of foundation deposit 0.40m wide indicating a possible extension south although this part of the feature was truncated by a large modern pit. Sample excavation through deposit (210) revealed a narrower, shallower and slightly more rounded bottomed trench [211], 0.55m wide and about 0.15m deep similarly filled at various points along its length by either compacted pebbles and fragments of brick of various sizes within a silty-clay matrix or intermittent deposits of stone or whole and half-bricks. No finds were recovered from deposit (210) other than the brick. The relationship between this and deposit (208) is disturbed by the construction of the later brick wall (207) associated with the east side of the 1885 barn, however, its form, slightly offset to the north and noticeably narrower along its length suggests its construction was a separate event. Interestingly, the alignment of the feature can be observed curving slightly northeast towards the eastern edge of the excavation. Another short length of

brick wall aligned north-south adjoining the north side suggests an earlier building, this was also truncated by a modern trench connecting with the large drainage soak-away recorded in the evaluation.

The earlier results from the adjacent evaluation trench suggest deposit (210) terminates between Area 2 and the position of the former trench.

The series of brick walls (207) ~~relate to~~ ~~are connected with~~ the large barn shown on the OS 1885, the larger wall aligned north-south along the western edge of the excavation representing the west side of the former barn, the eastern side marked by a slightly narrower brick wall situated roughly within the central part of Area 1 and was recorded, with part of the internal brick floor in the evaluation trench. Internal divisions comprising bays/stalls are evident in the floor pattern of surviving walling within the former barn.

A modern pipe trench aligned east-west across the excavation and connecting to a large drainage soakaway recorded in the evaluation trench truncates this barn. Constructed along the entire west edge of the barn wall was a large land drain, consisting of a series of short lengths of u-shaped ceramic piping with clay beneath.

The earliest deposits recorded in Area 2, were the foundations remains of two connected walls (108) & (110), each aligned east-west, the narrower more easterly one curving slightly northeast. It remains unclear what type of structure these deposits were related to, perhaps an earlier barn or outbuildings, the presence of brick within its construction indicates a post-medieval date, possibly C18 or early C19.

Truncating these earlier foundation deposits were the walled remains of the former barn shown on the OS 1885 map, its north-south alignment appears to show a re-configuration of the site layout during the period of construction.

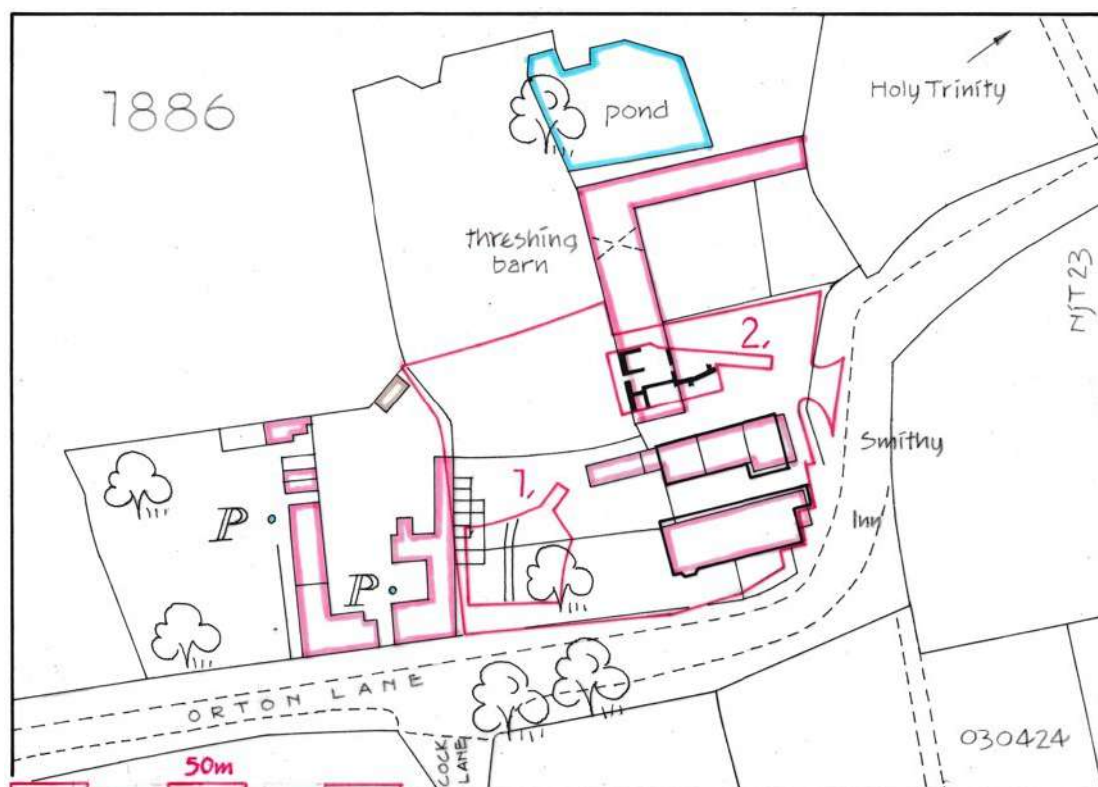
Fig. 7: Site plan with Areas 1 and 2 shown in red and the 1886 setting.

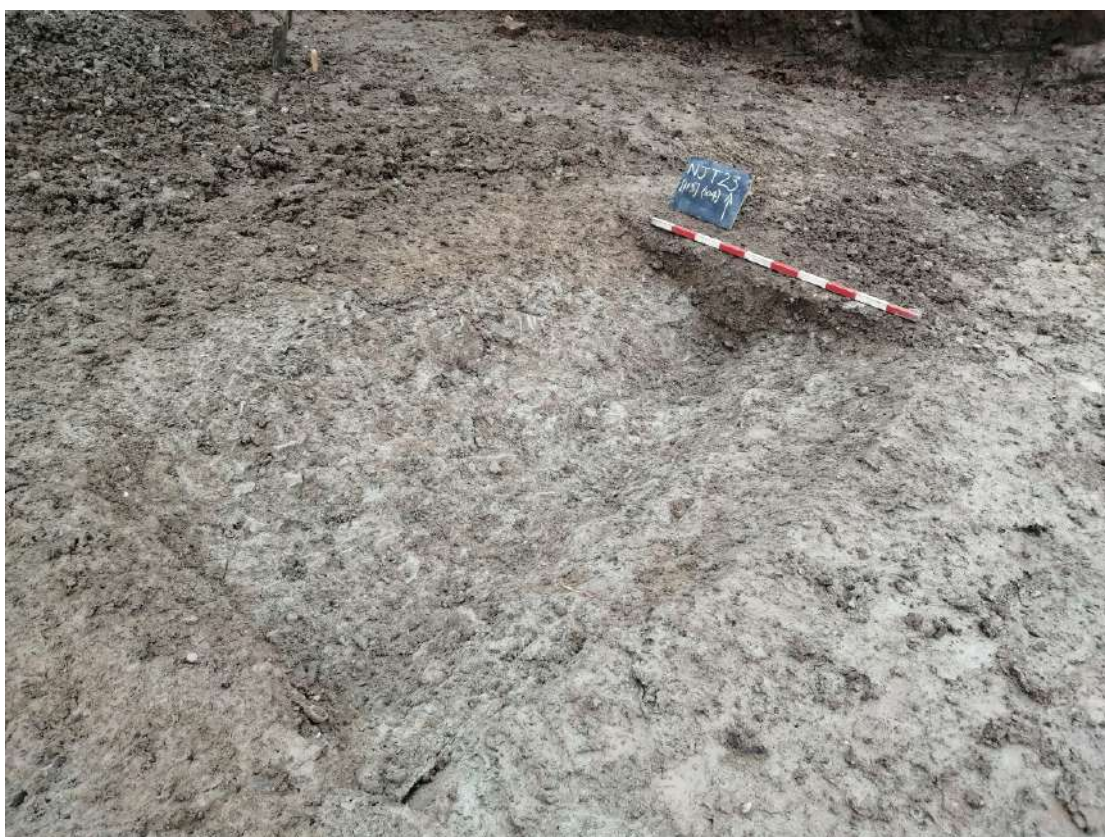
*Plate 4; Ditch 113, view northwest.*

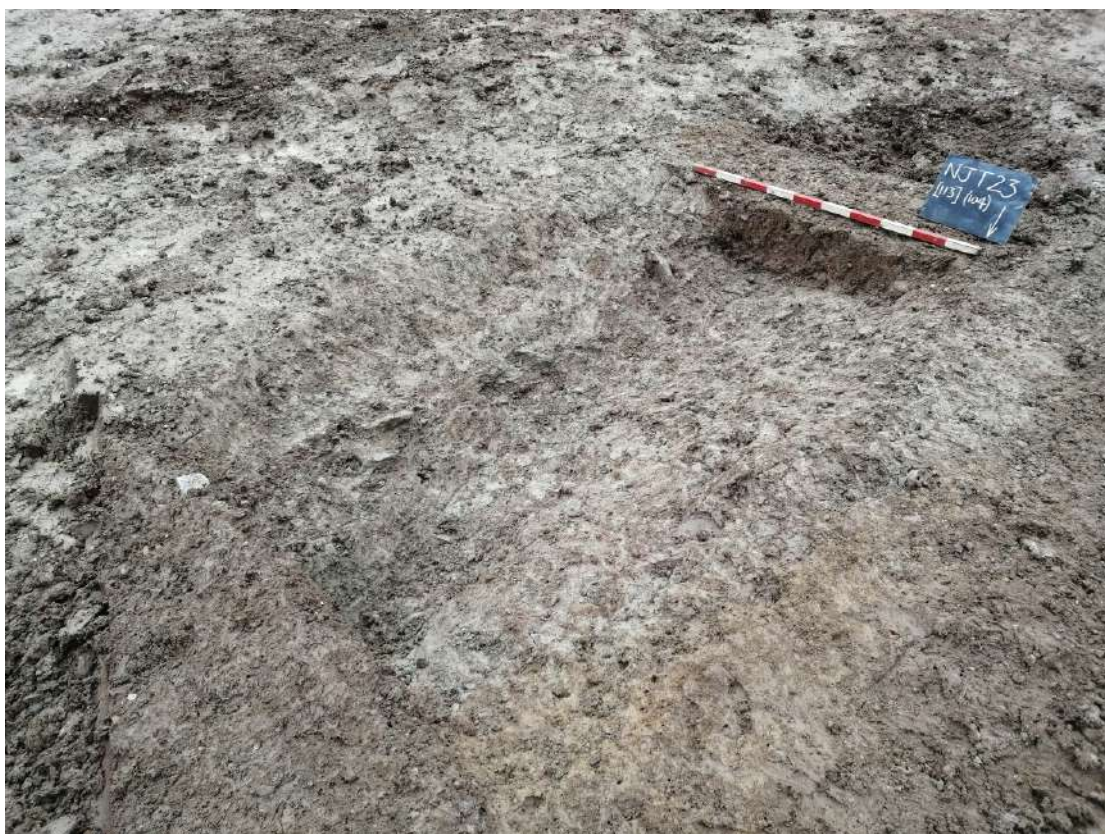
*Plate 5; Ditch 113, view southeast.*

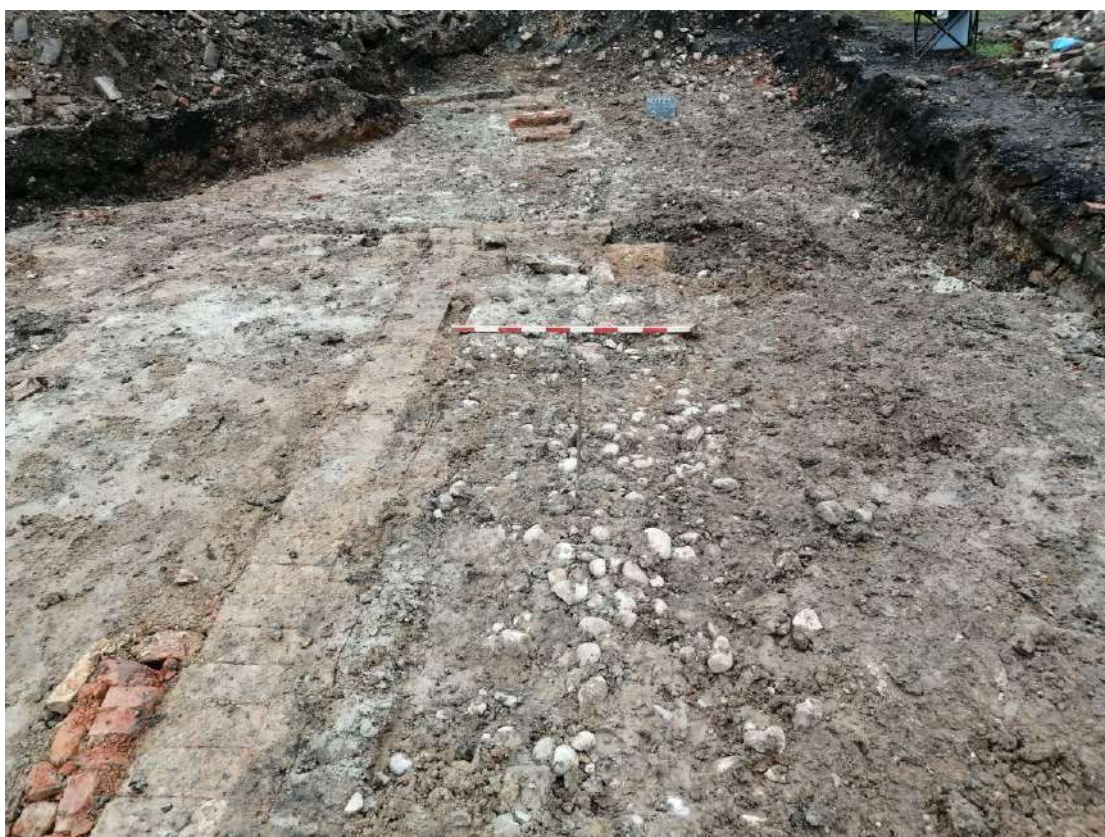
*Plate 12; deposits 208, 210 & 211, view east.*

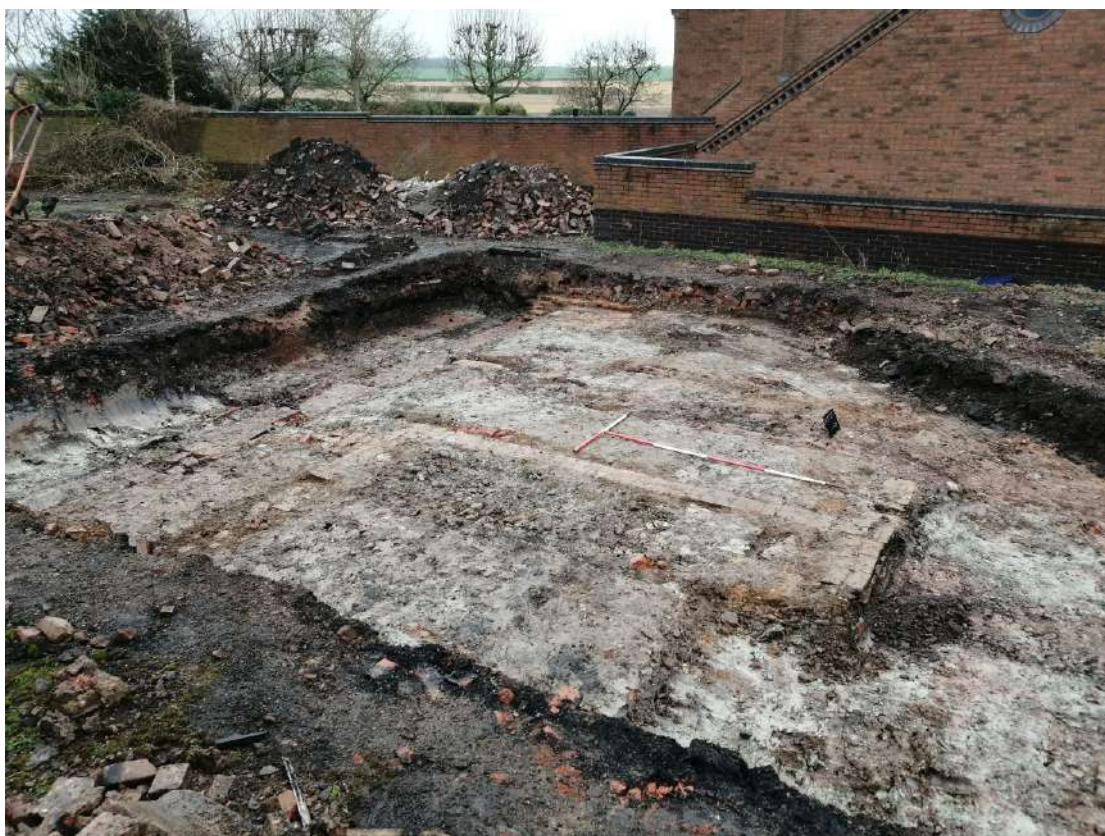
*Plate 13; Deposit 208, view northwest.*

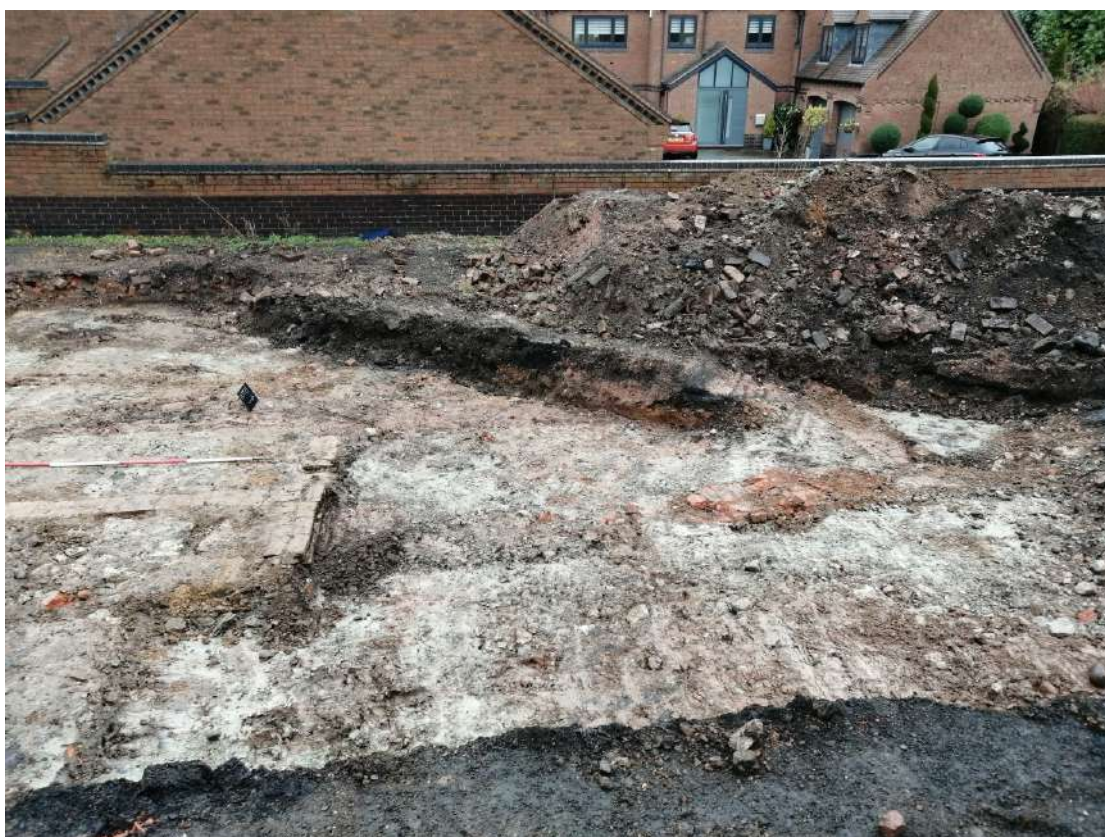
*Plate 14; Deposits 210 & 211, view north.*

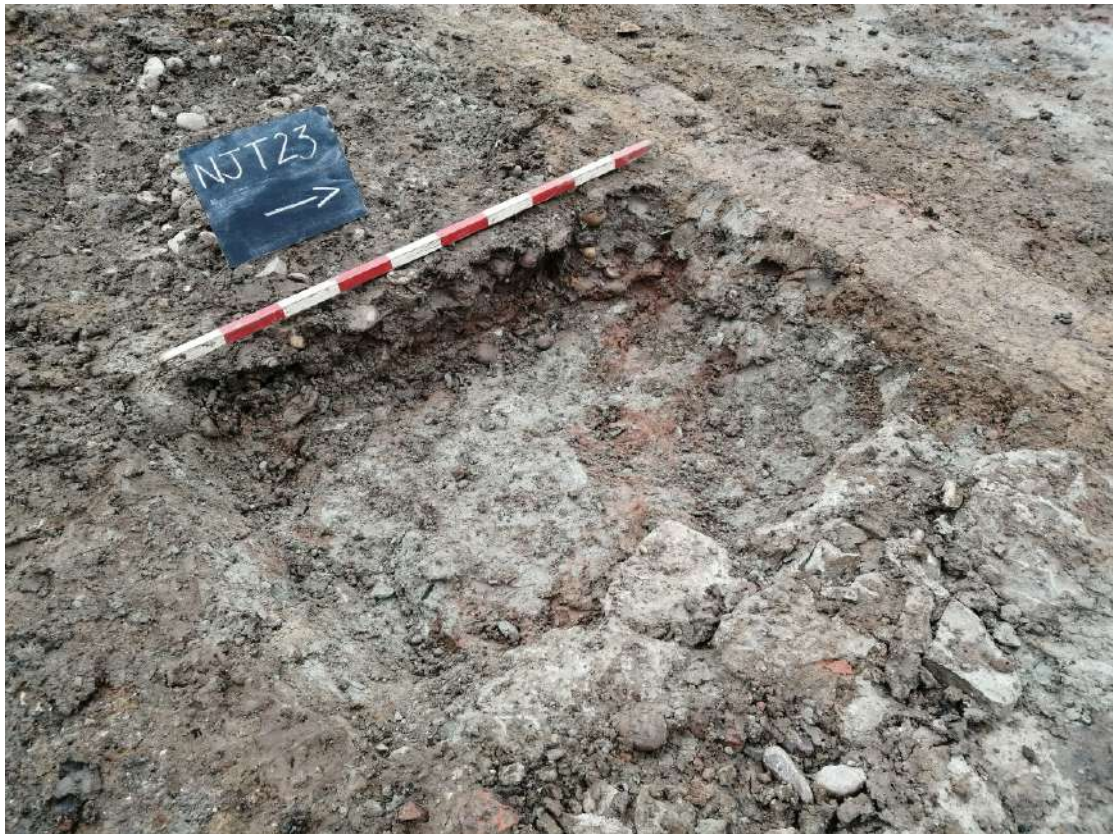
*Plate 15; foundation trench 209 & fill deposit 208, view northwest.*

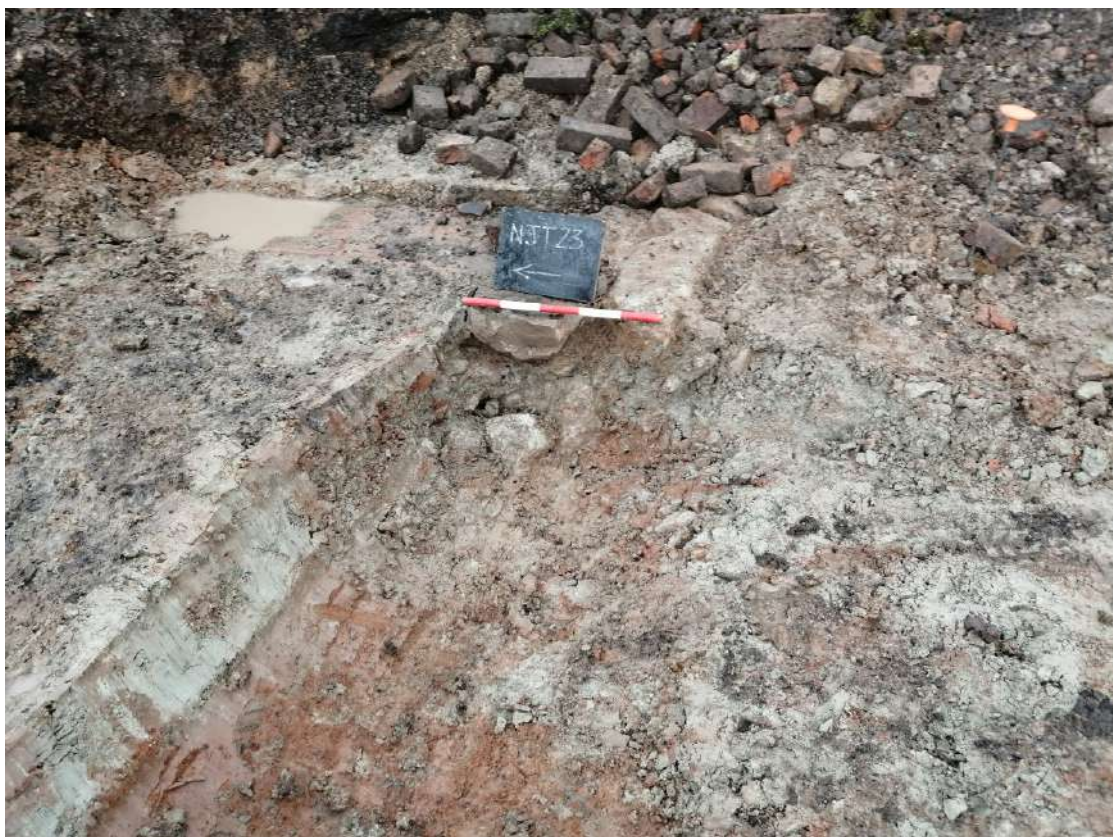
*Plate 16; Deposit 210, section 2d, view northwest.*

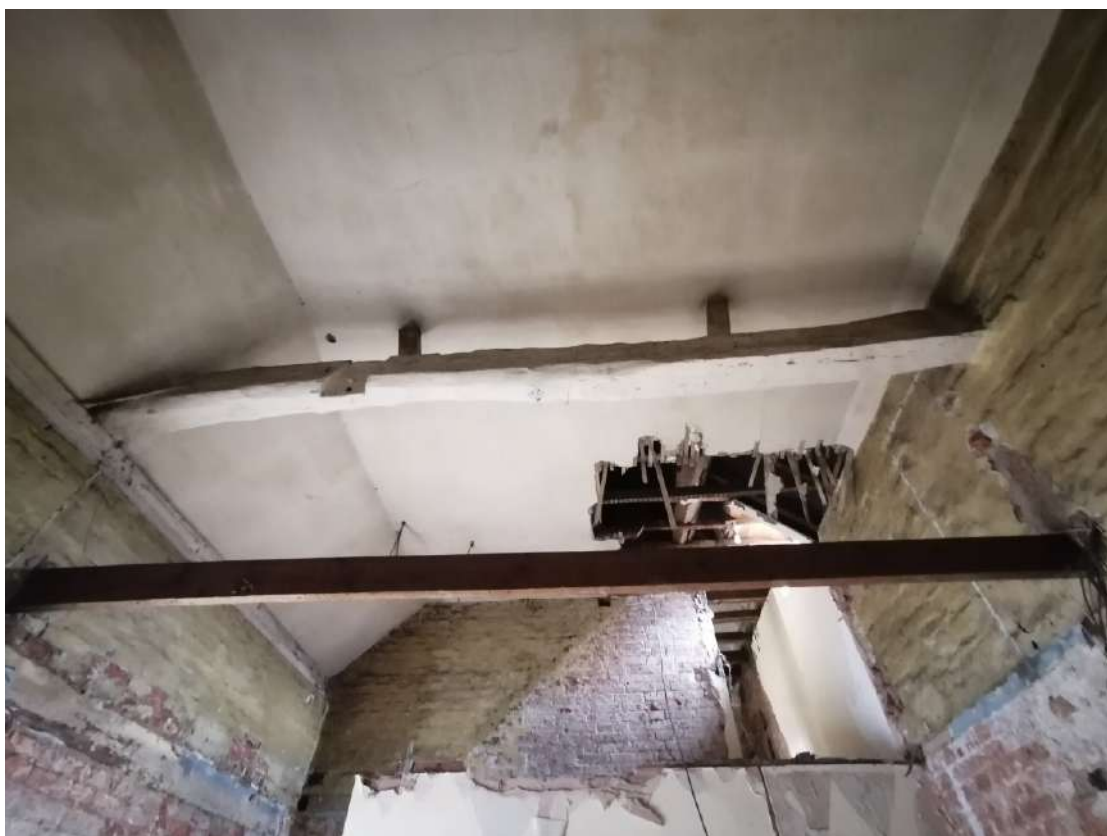
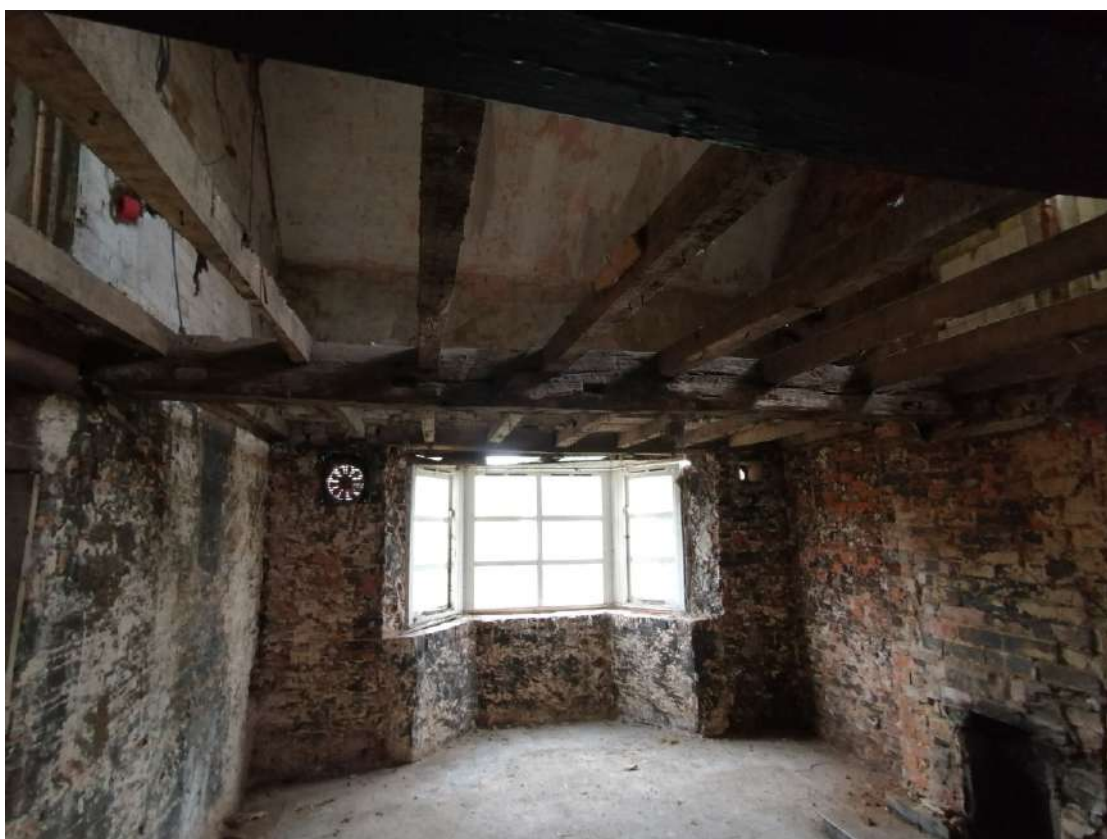
Plate 17; east-wing of re-used timber recorded in the former Moore's Arms showing possible re-used cruck.

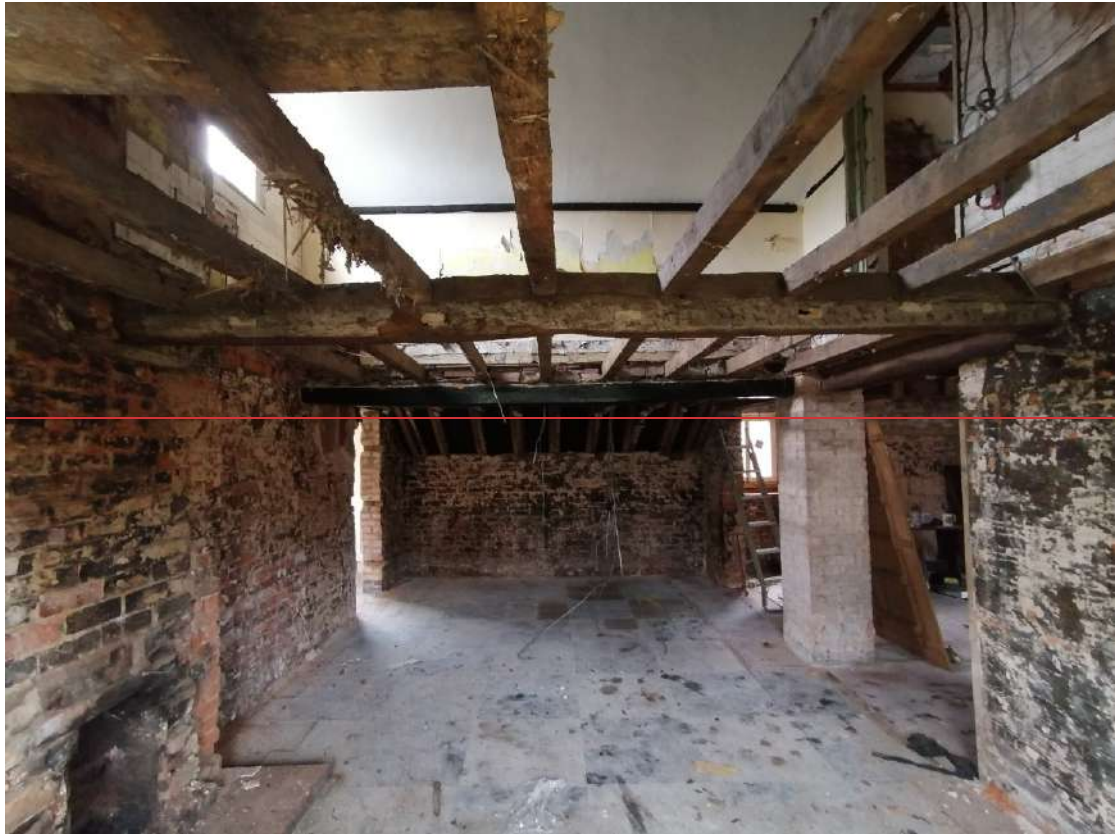
Plate 18; west-wing of re-used timber recorded in the former Moore's Arms showing re-used C17 wall-frame beam with mortices for square-panel framing.
