# Remediation Validation Report v01

| <b>Site Address</b> | Granville Gardens<br>Hinckley,<br>LE10 0JD |
| <b>Our Ref.</b> | P21031 |

Photographic evidence of topsoil and marker layer.

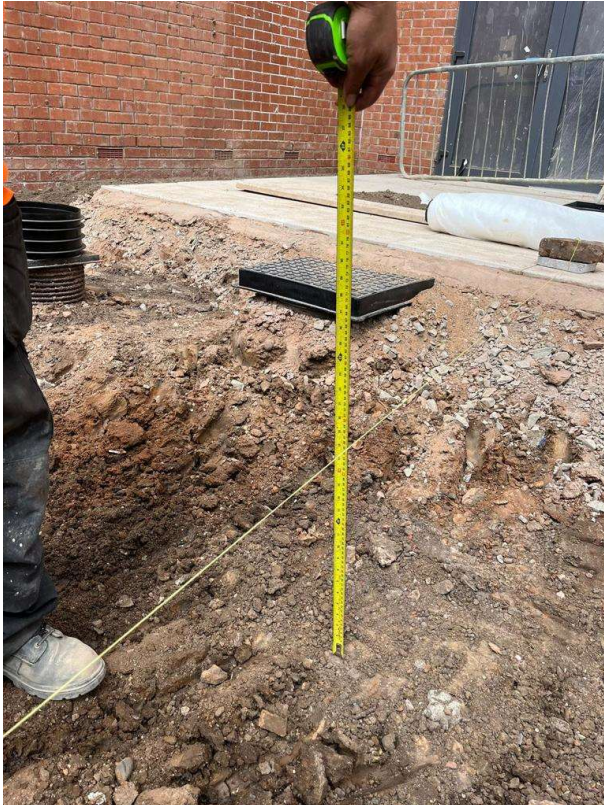
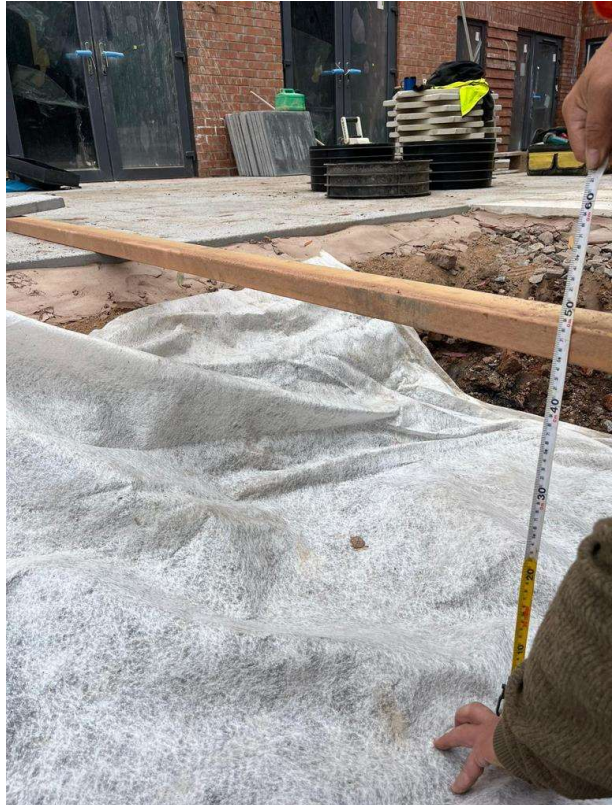
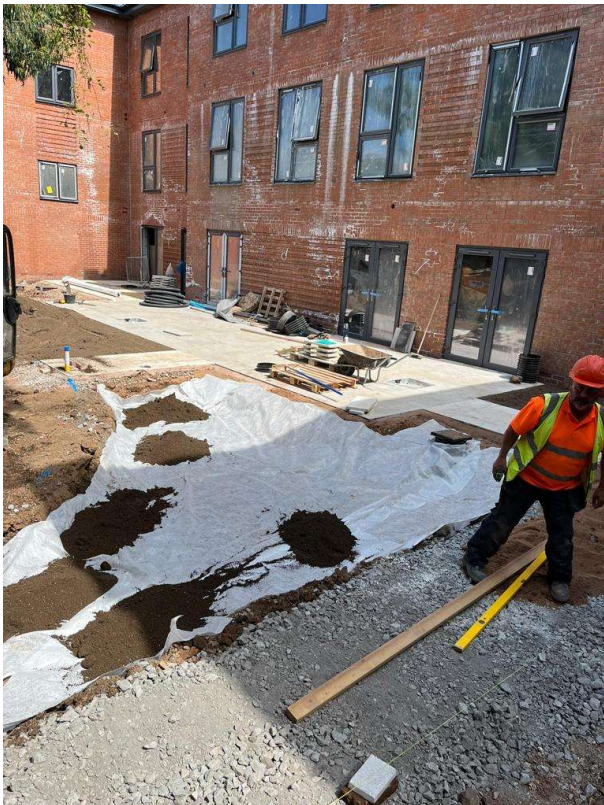
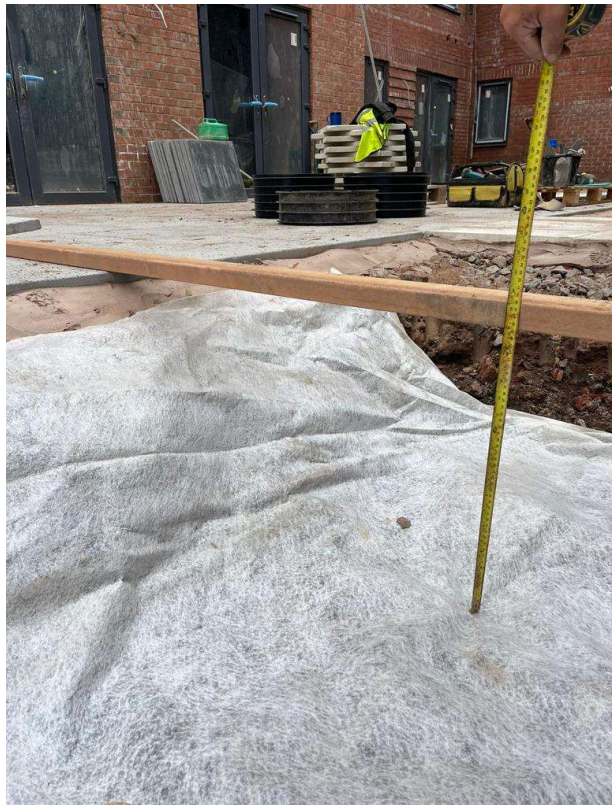
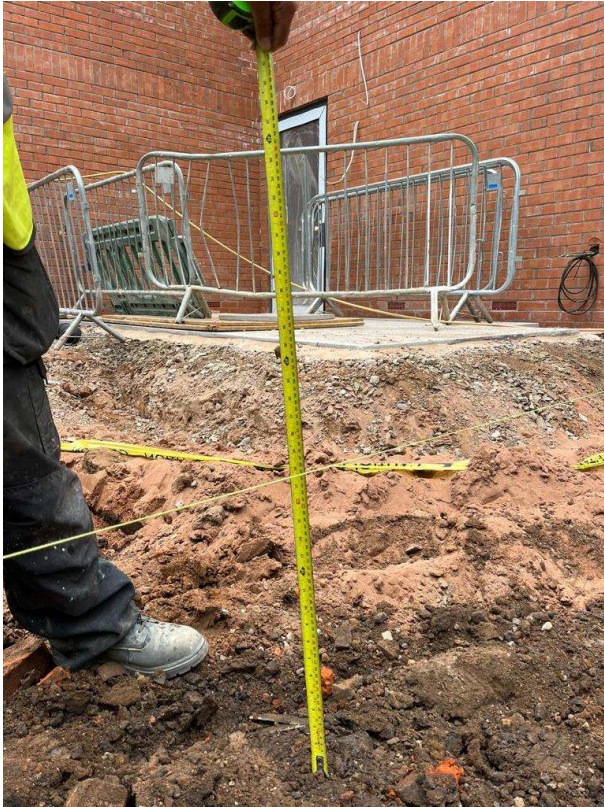
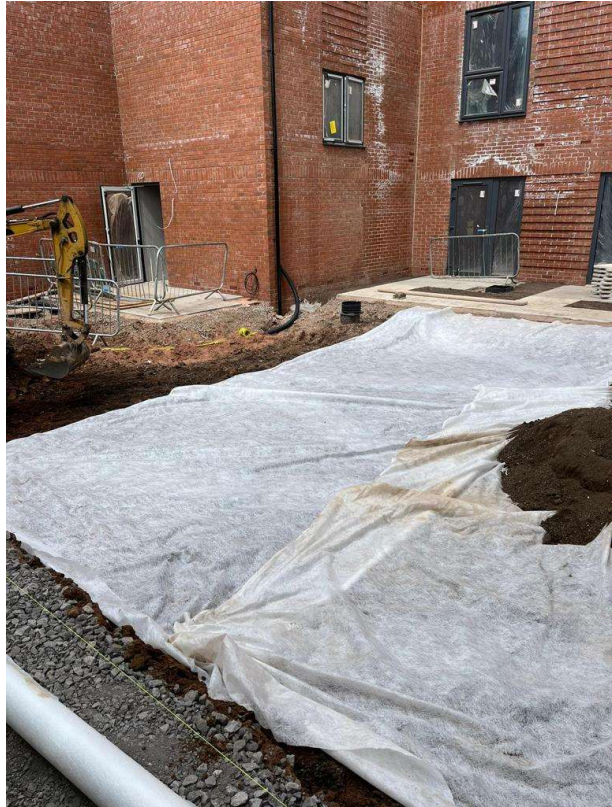
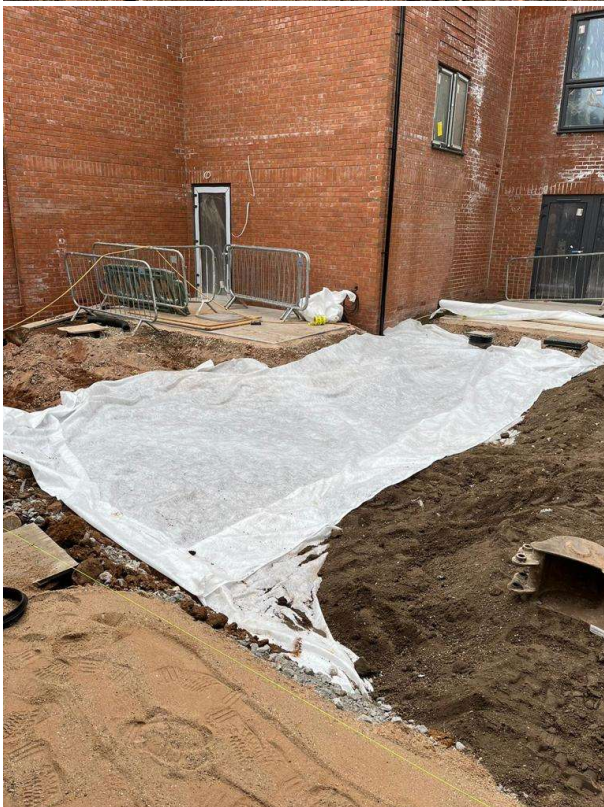
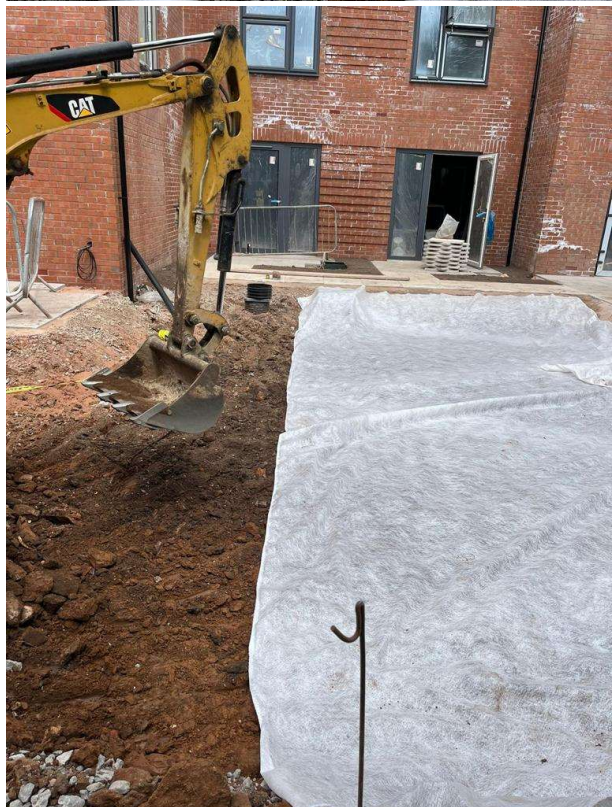
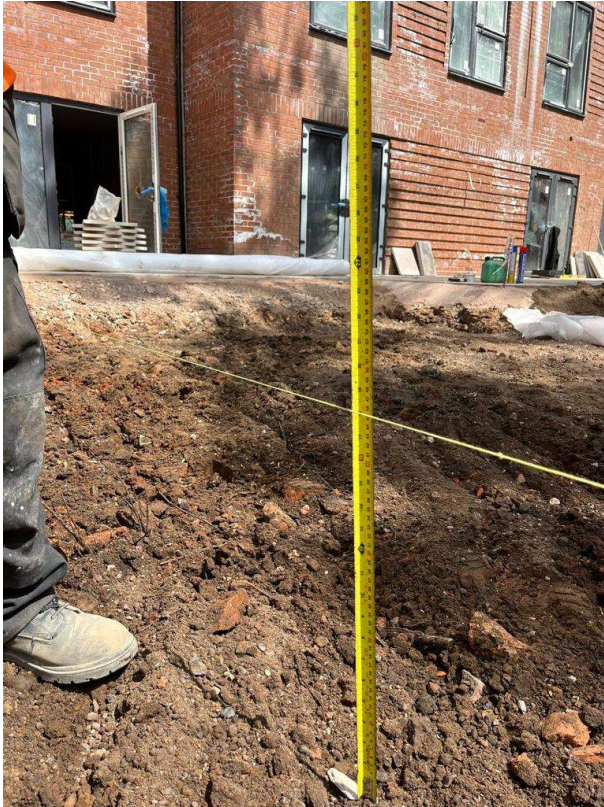
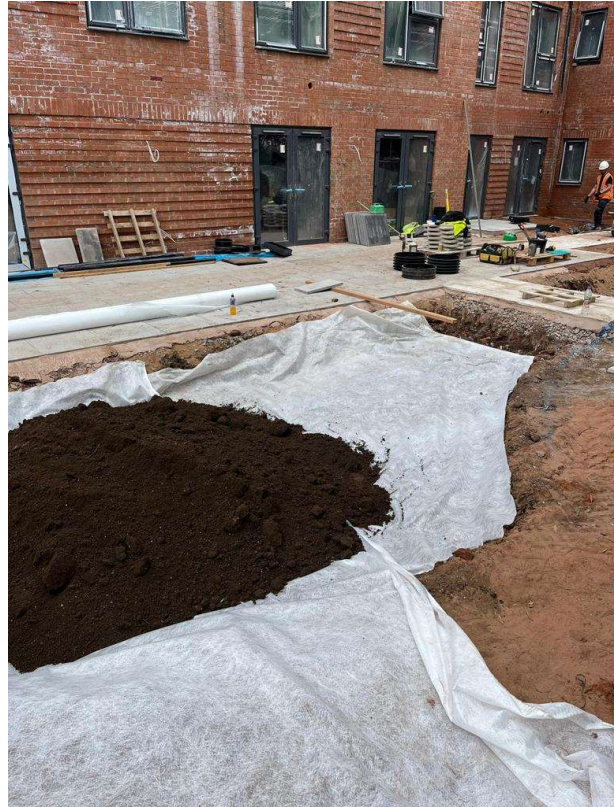
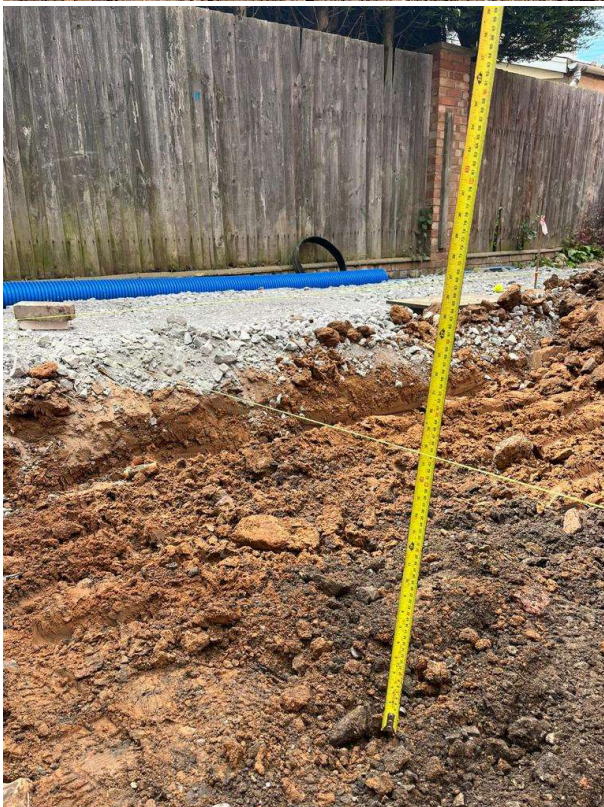
## **Appendix A**

- It has been reported that no Contamination Hotspots were discovered during the groundworks on site.
- The 450mm thick topsoil comprised of the material supplied by Broughton Loam Limited. Please refer to the test data from NRM Laboratories for the contamination testing for this imported topsoil.
- A Terram T1000 Non-Woven Geotextile Membrane was installed to act as the marker layer. Please refer to the photographs in Appendix A.
- Refer to the data included in Appendix A for the photographic evidence of the geotextile and 450mm min depth of topsoil installation.
- Refer to the data included in Appendix B for the soil testing information and delivery tickets.
- No site won material from the site was reused in the soft landscaped areas.

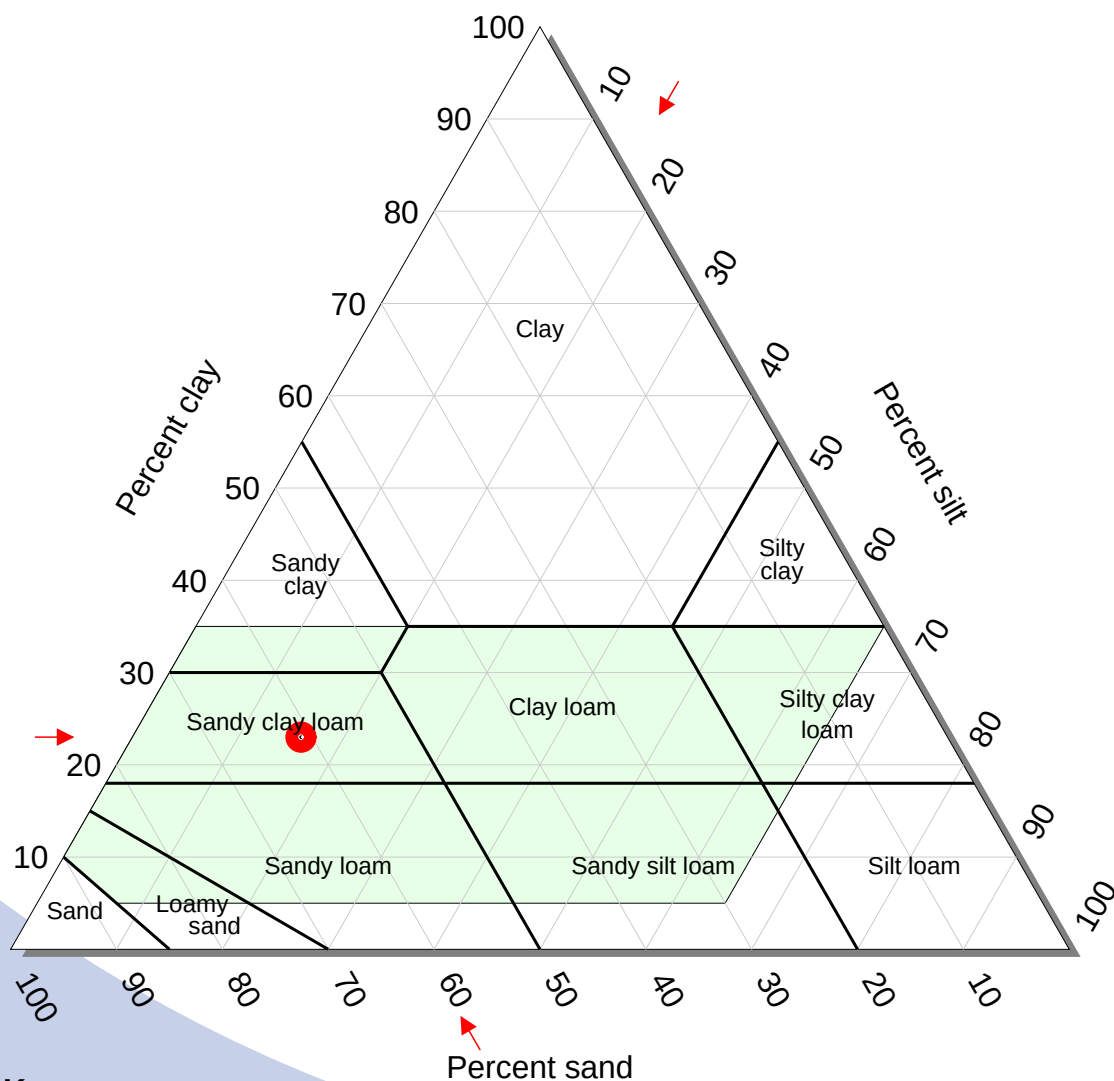
**Fig. 1. Textural Class: Sandy Clay Loam (compliant)**

| | | | | Multi-P | Compliant with range (Y/N) | | | | |
|---|---|---|---|---|---|---|---|---|---|
| | Textural Class | | Sandy Clay Loam | Y | Y | Y | Y | Y | Y |

Area within which texture of topsoil is required to fall.

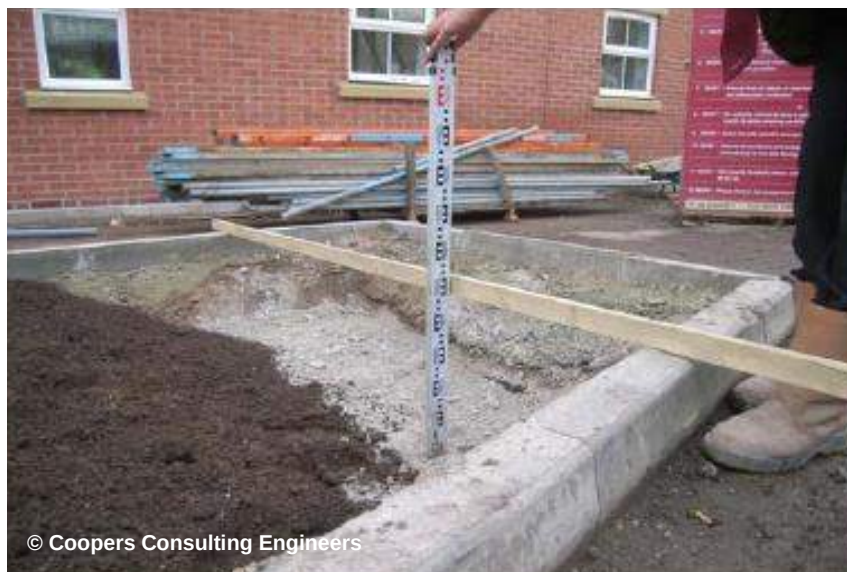
Photograph 1: Depth check of inert cover within area of public open space. Physical break layer and topsoil visible.

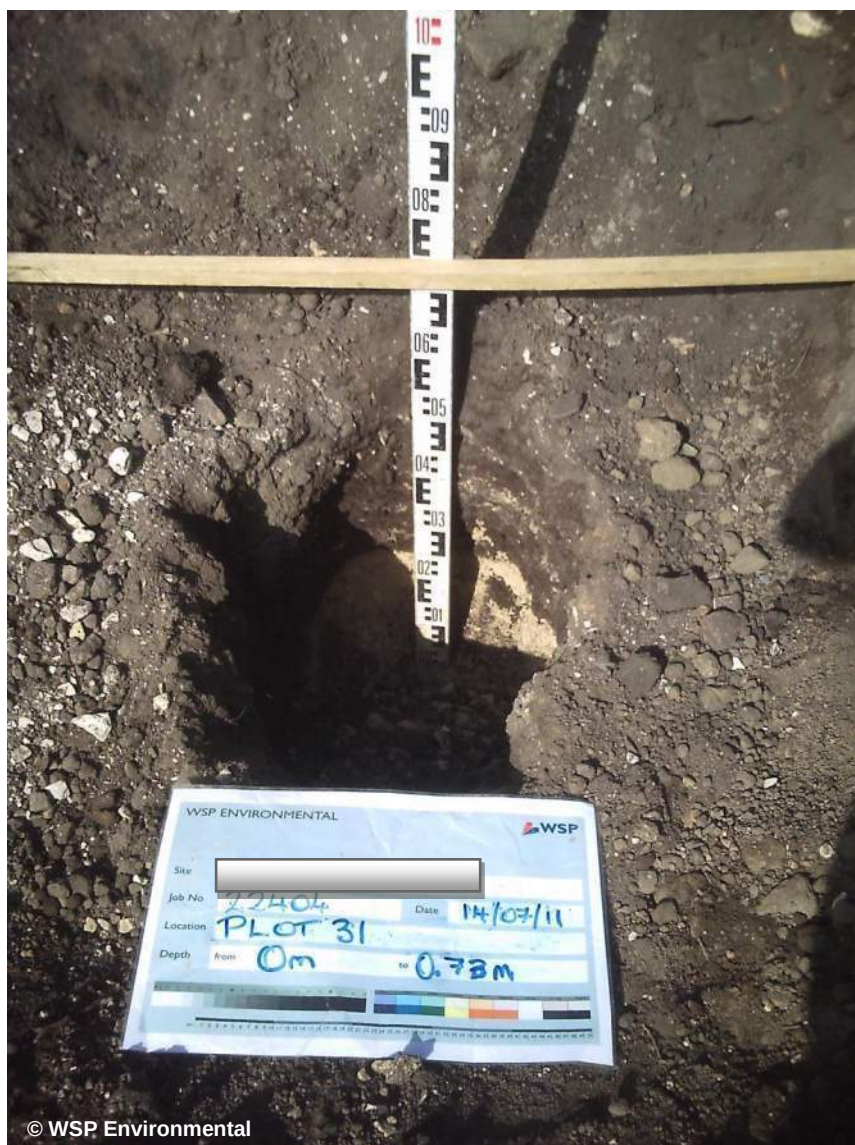
Photograph 2: Depth check of inert cover with Site & Location Information Board.

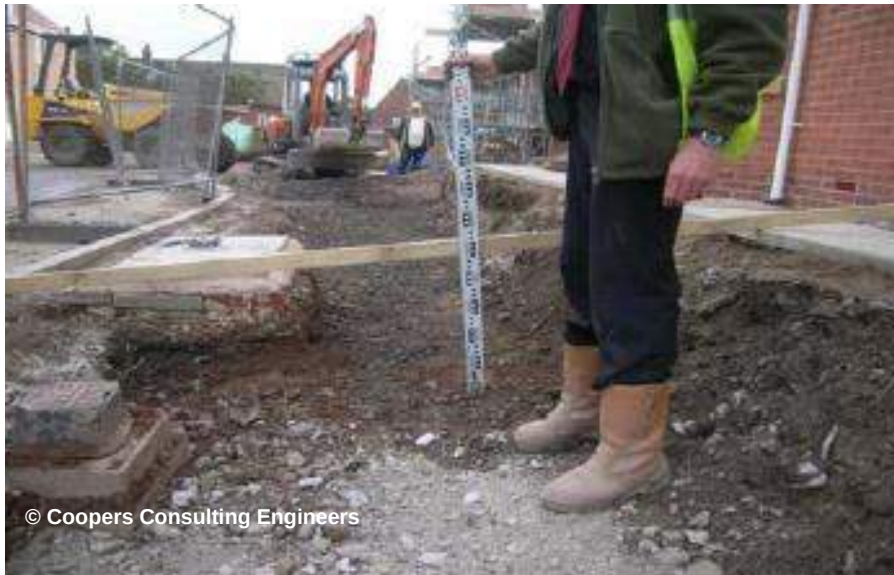
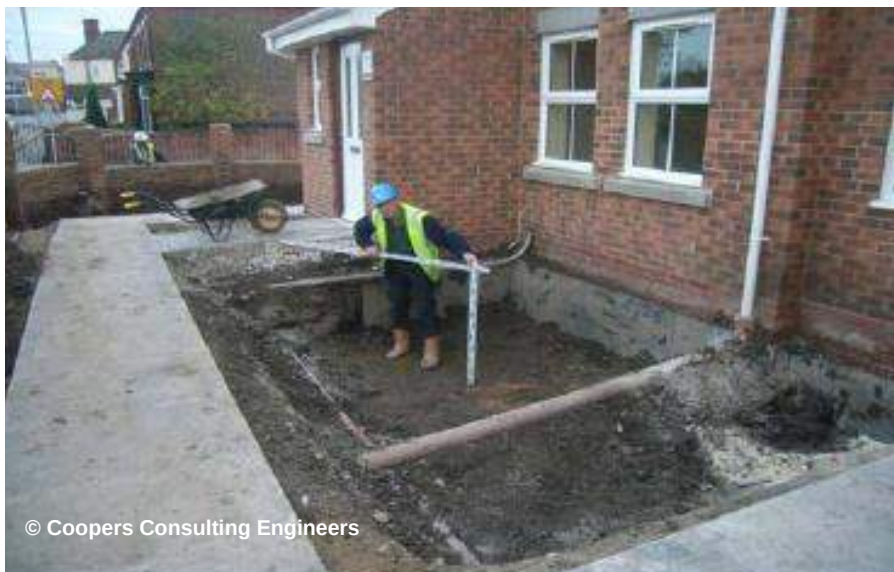
Photographs 3 & 4:  
Depth check of inert  
cover within areas of  
front gardens.

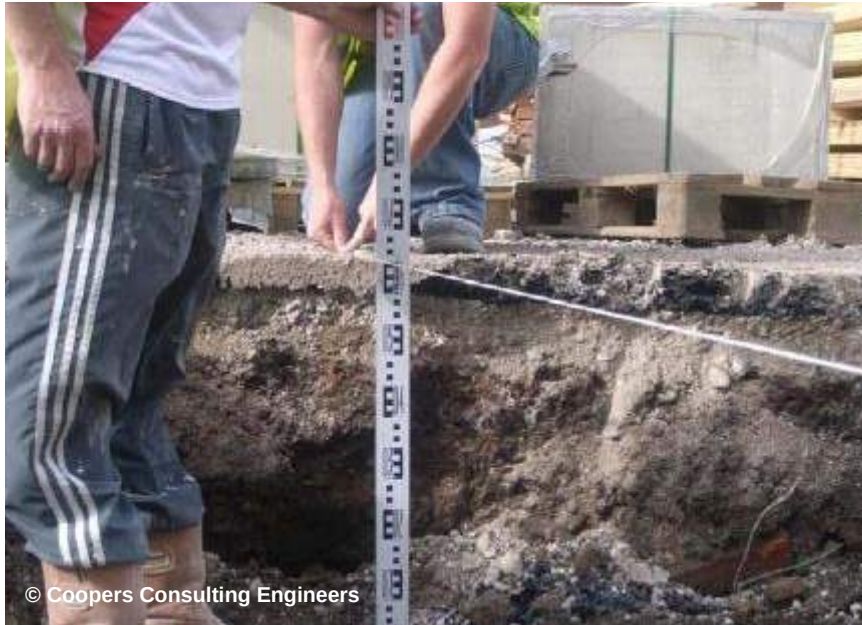
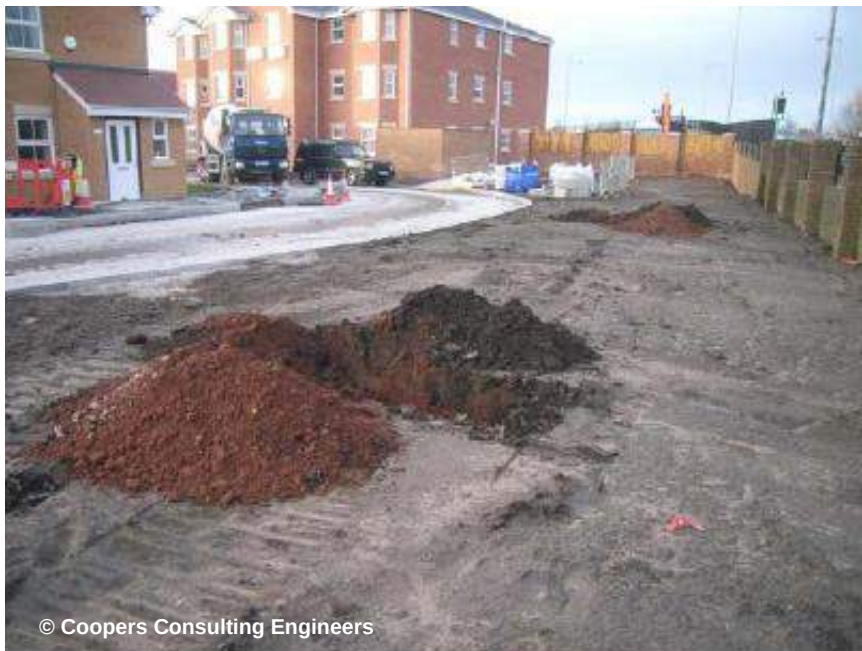
Photographs 5 and 6: Depth check of inert cover within rear gardens. Taut string line spans across excavation.

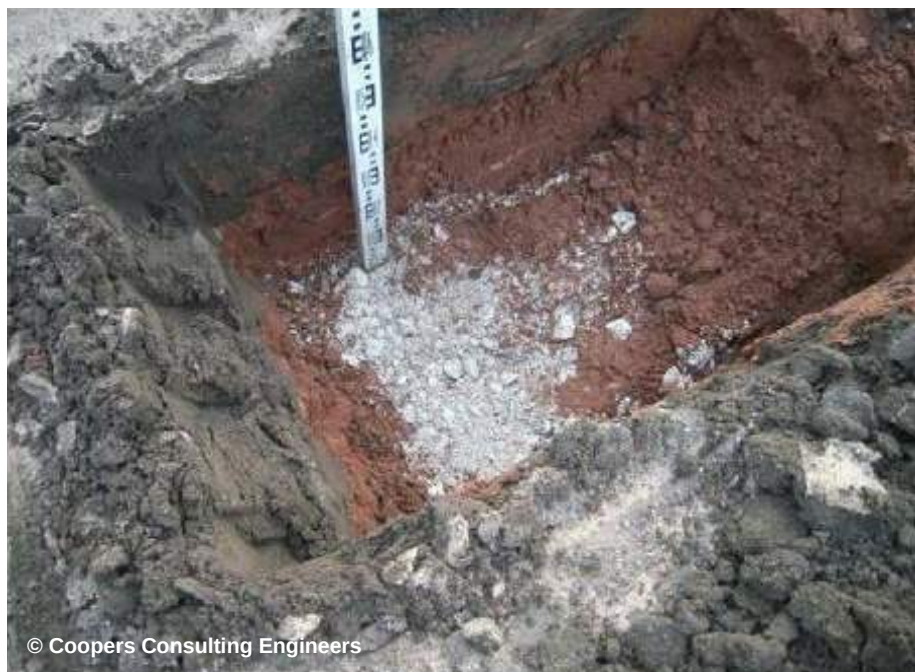
Photograph 7 shows the spatial location of the verification pit.

Photograph 8:  
Excavation within public open space and verification pit showing the presence of a remediation break layer at the base, a crushed sandstone inert fill overlain by topsoil.

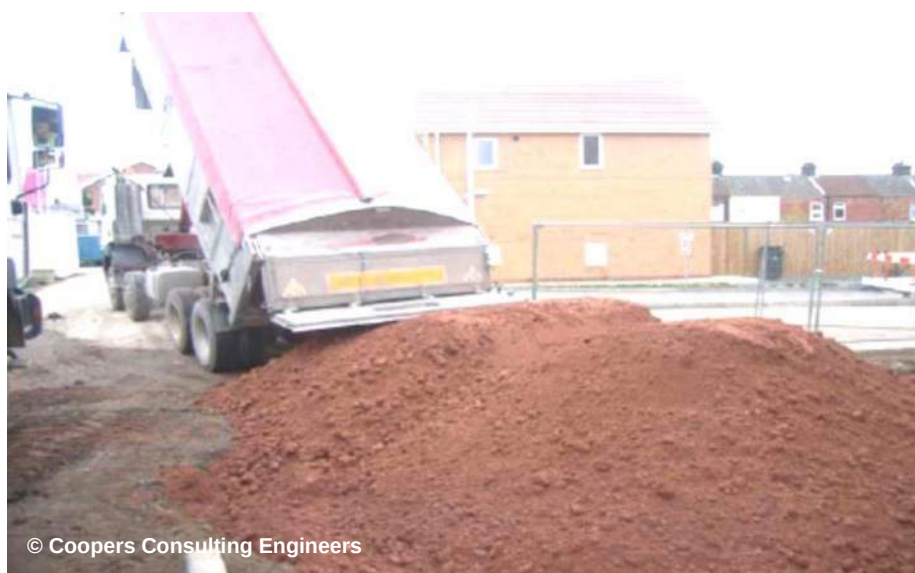
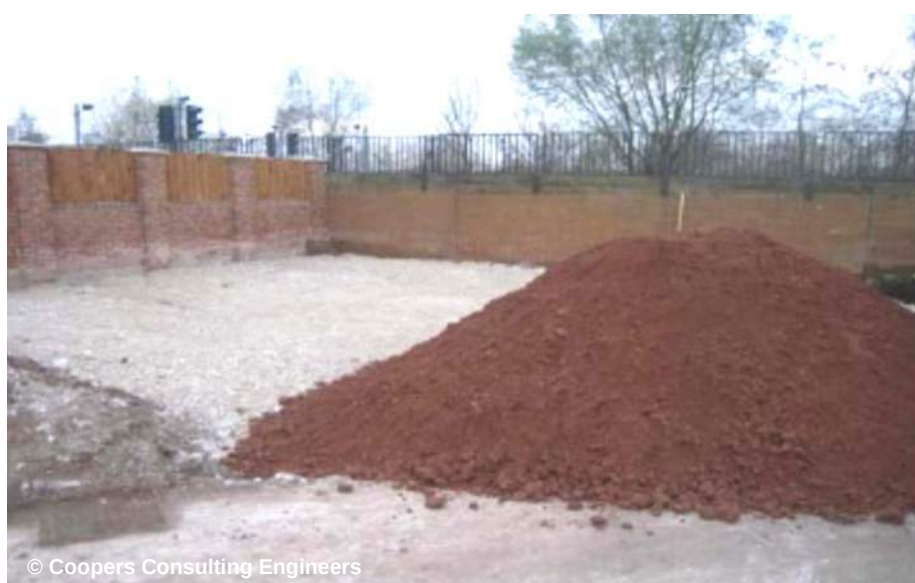
Photographs 9 and 10: Inert crushed sandstone being delivered with remediation break layer visible in Photograph 10. The spatial area of the remediation can be observed from these photographs (old terrace housing in Photograph 9 and traffic lights in photograph 10).

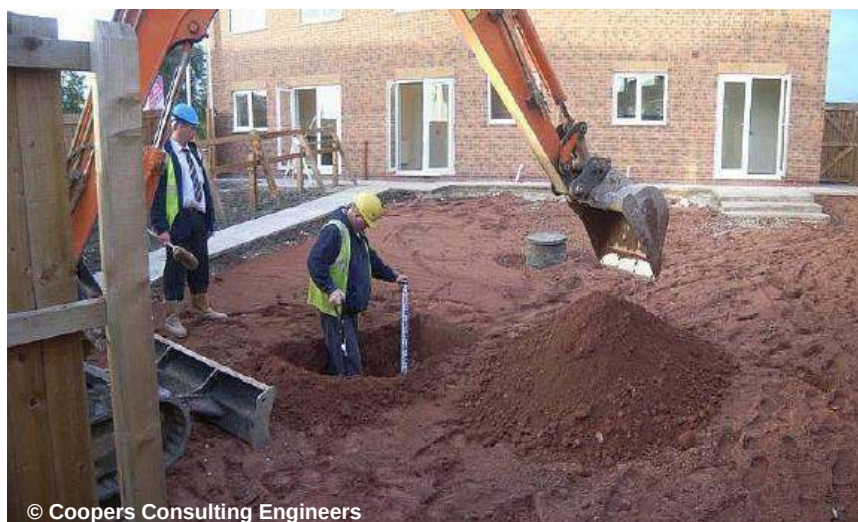
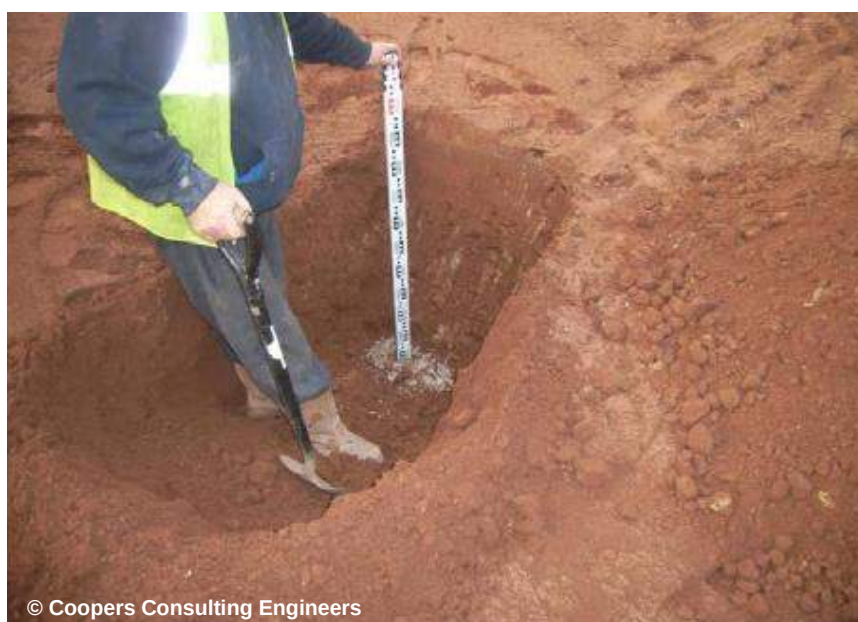
Photographs 11 and 12 show the remediation of the rear garden, with a significant depth (1.0m) of inert cover. Remediation break layer visible at the base of the excavation. Photograph 11 has been stitched to form a panoramic photograph and

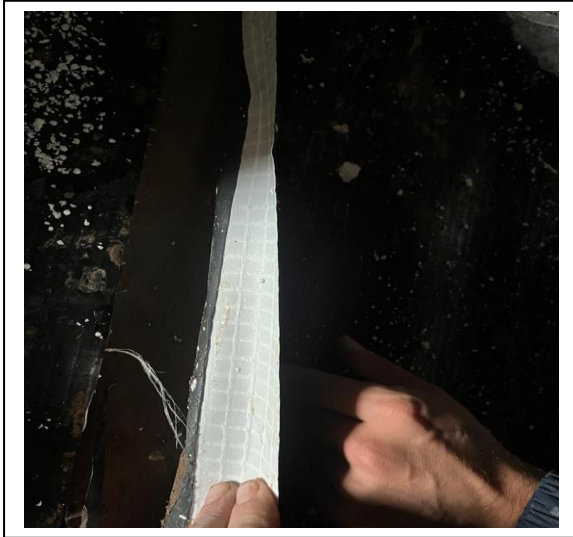
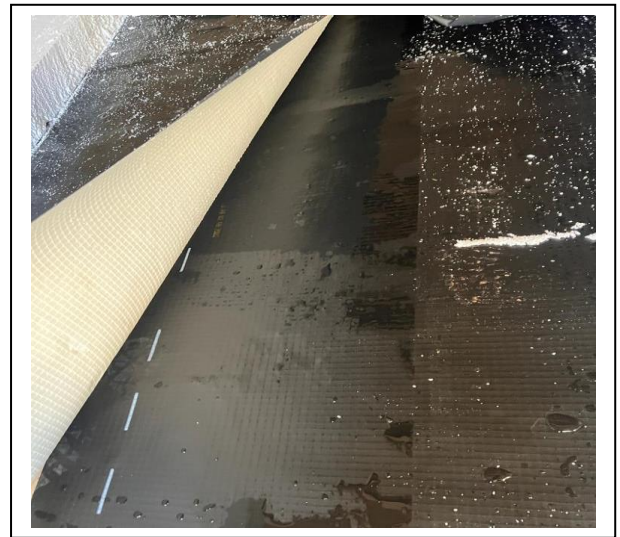
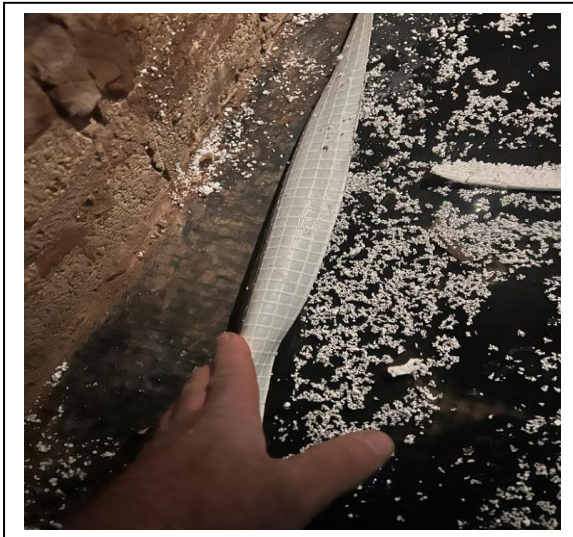
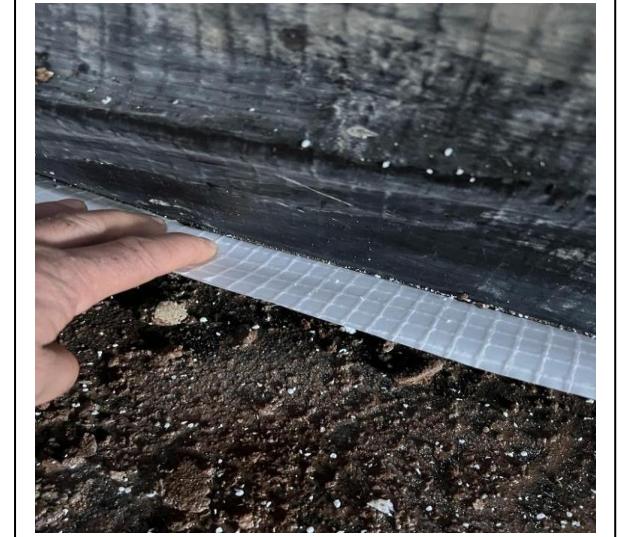
Area: Side Laps

Side Laps – 150mm overlap secured with double sided butyl tape as per manufacturers guidance.

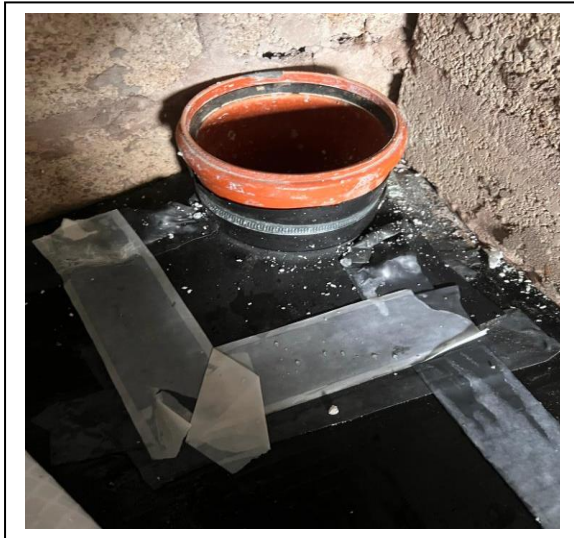
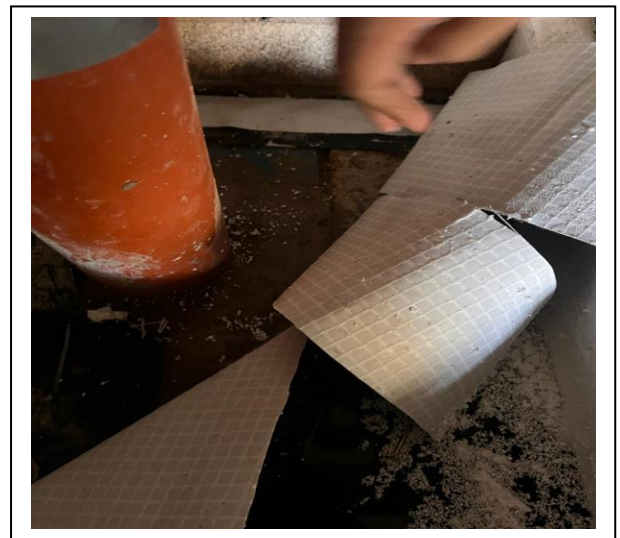
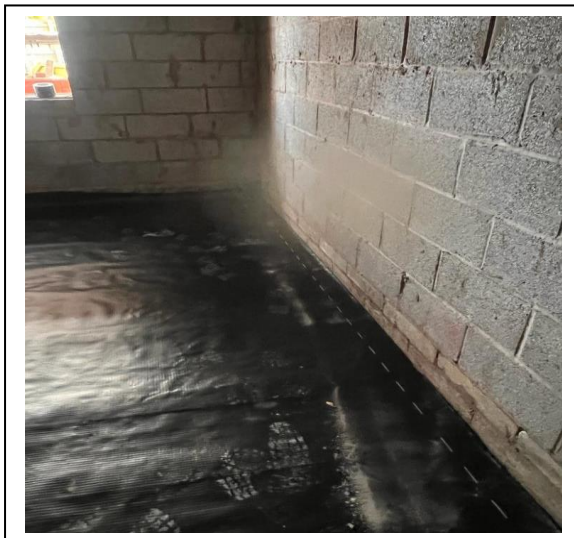
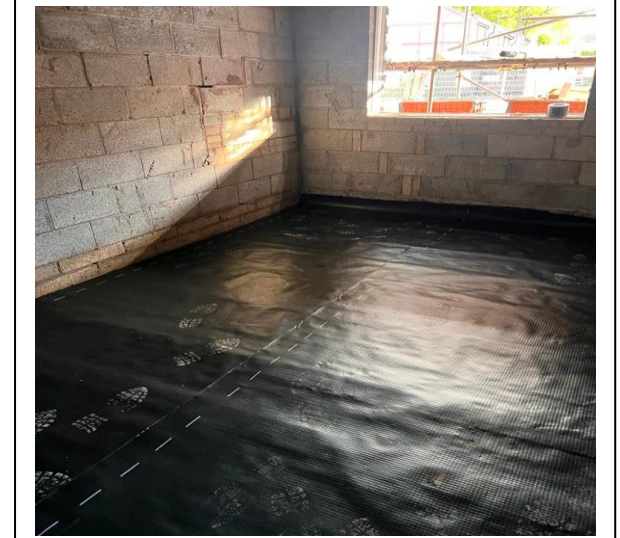
Area: Pipe Penetrations

Pipe Penetrations – Installed with Top Hat & Jubilee clips – Main floor area connected underneath internal walls. Good Level of Installation achieved.
