Phase 2 Ratby, Reserved Matters

Drainage Statement

| <b>Report Ref.</b> | | <b>100032-PEF-ZZ-XX-RP-C-0500_Phase 2 Drainage Statement</b> | | | | |

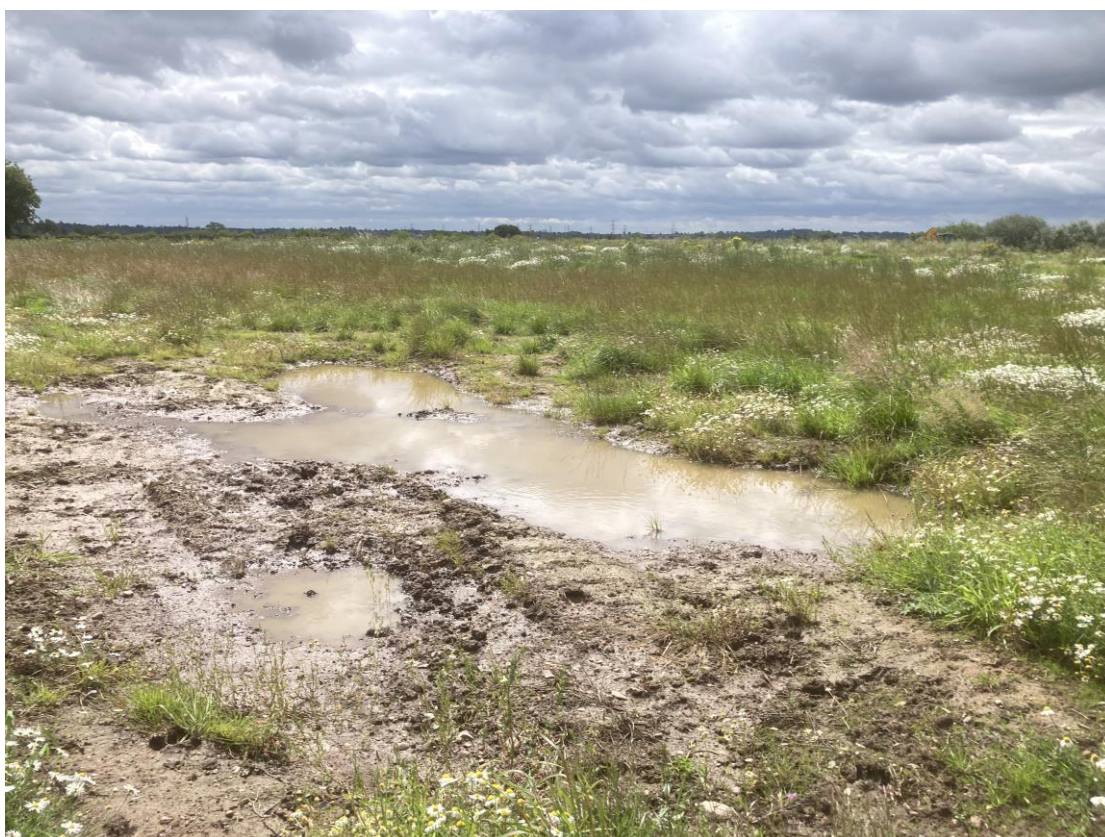
Looking south at an accumulation of surface water near the private access road

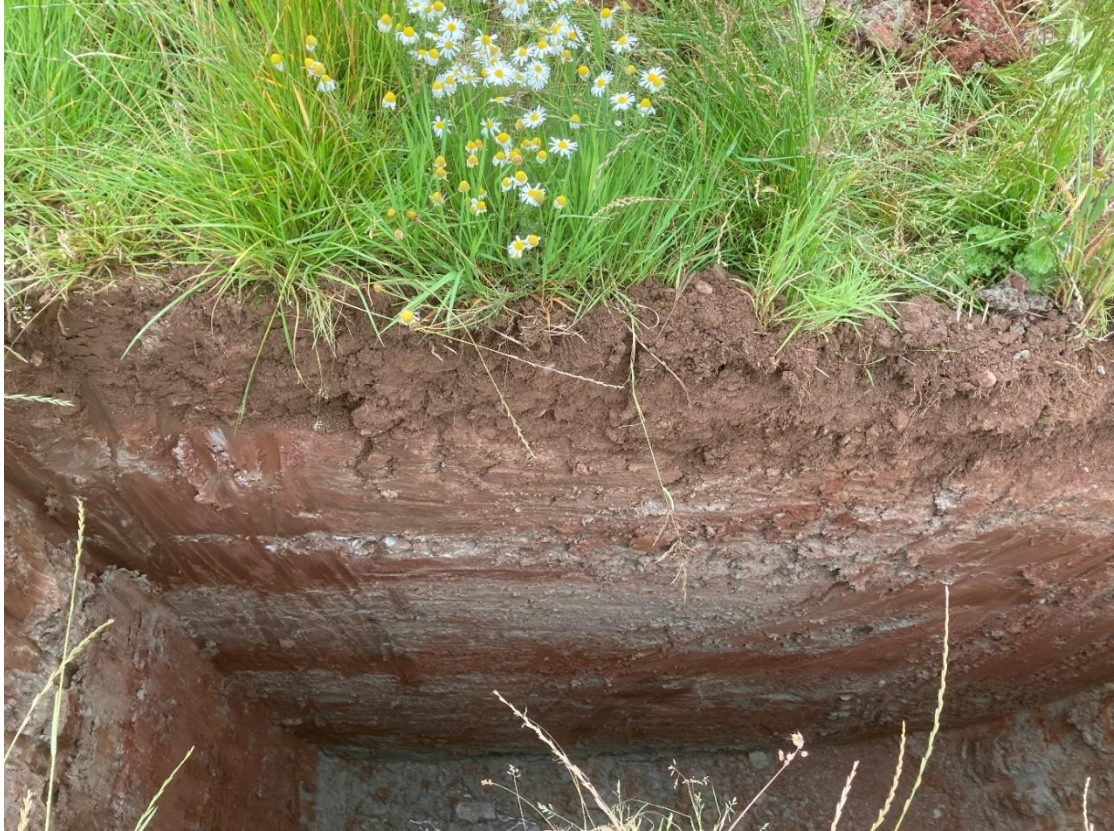
TP01 Trial Pit

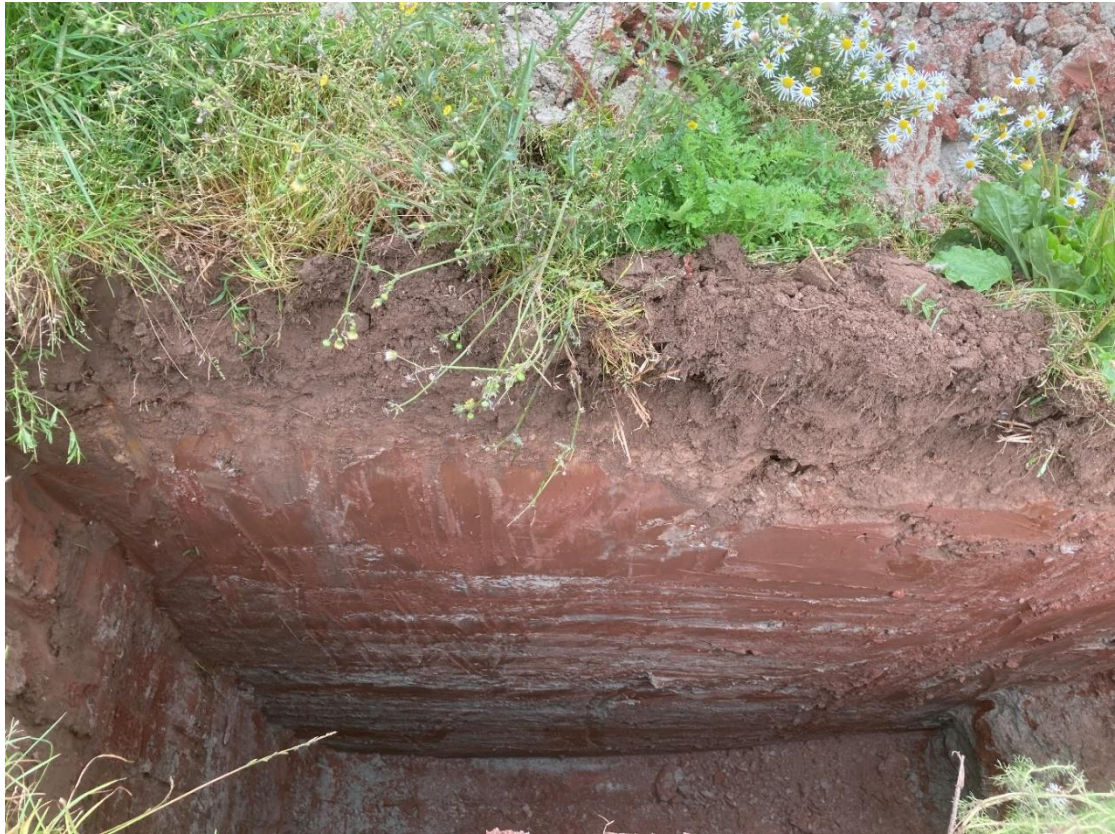
TP02 Trial Pit

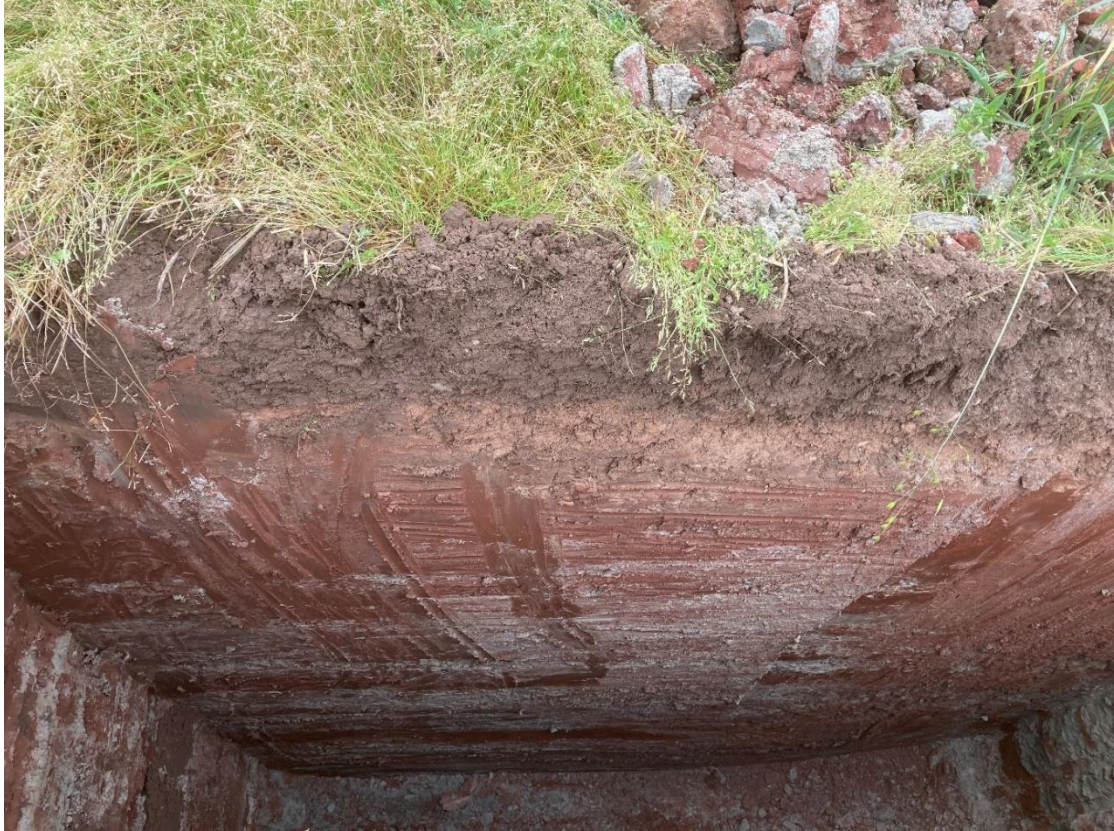
TP03 Trial Pit

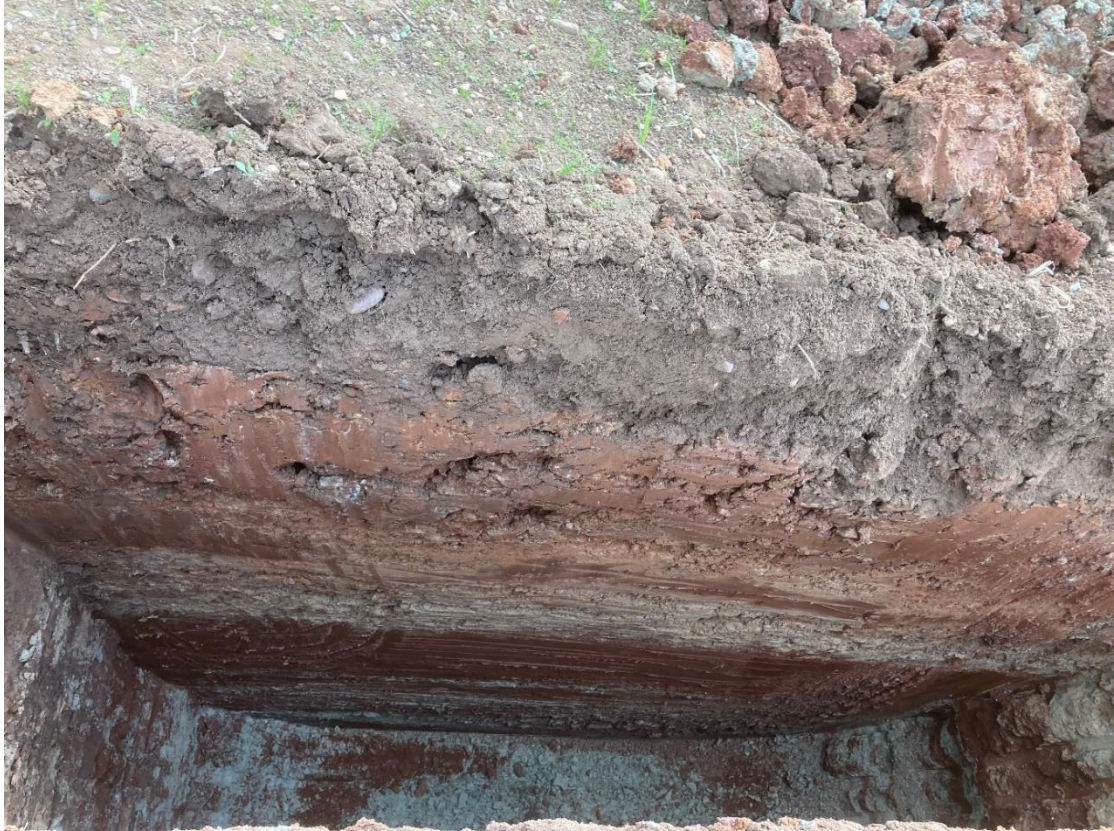
TP04 Trial Pit

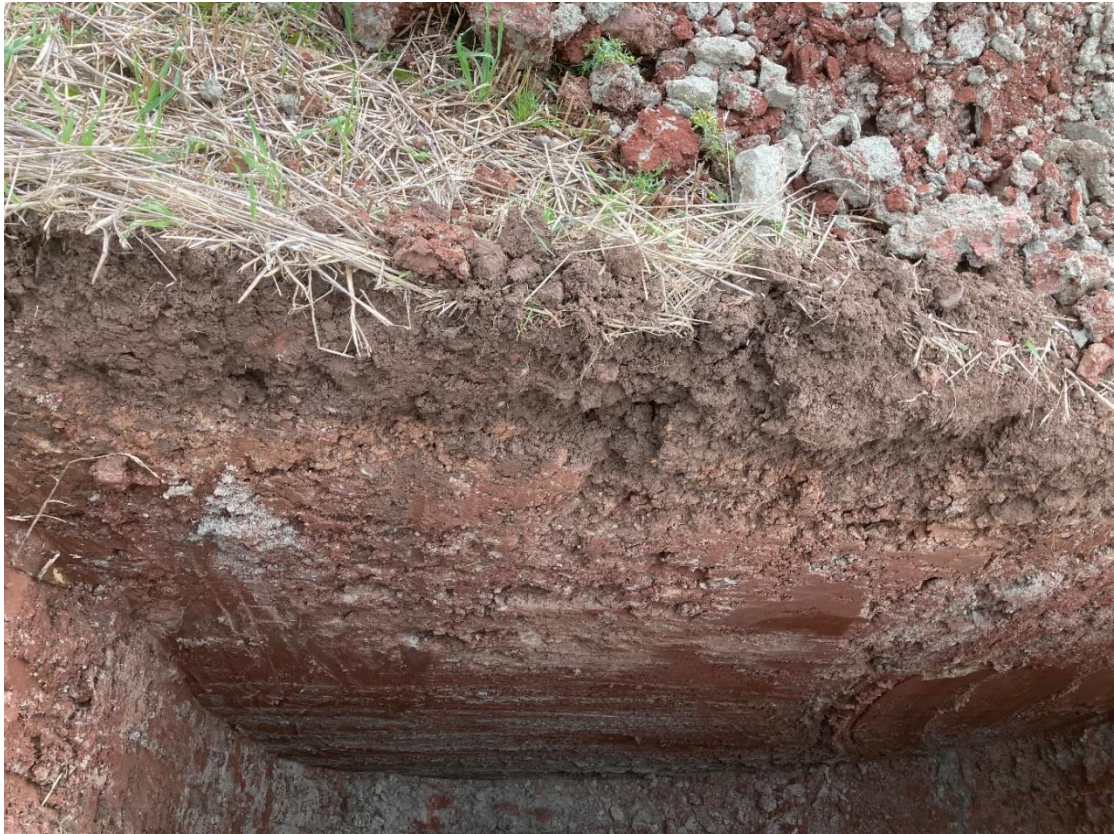
TP05 Trial Pit

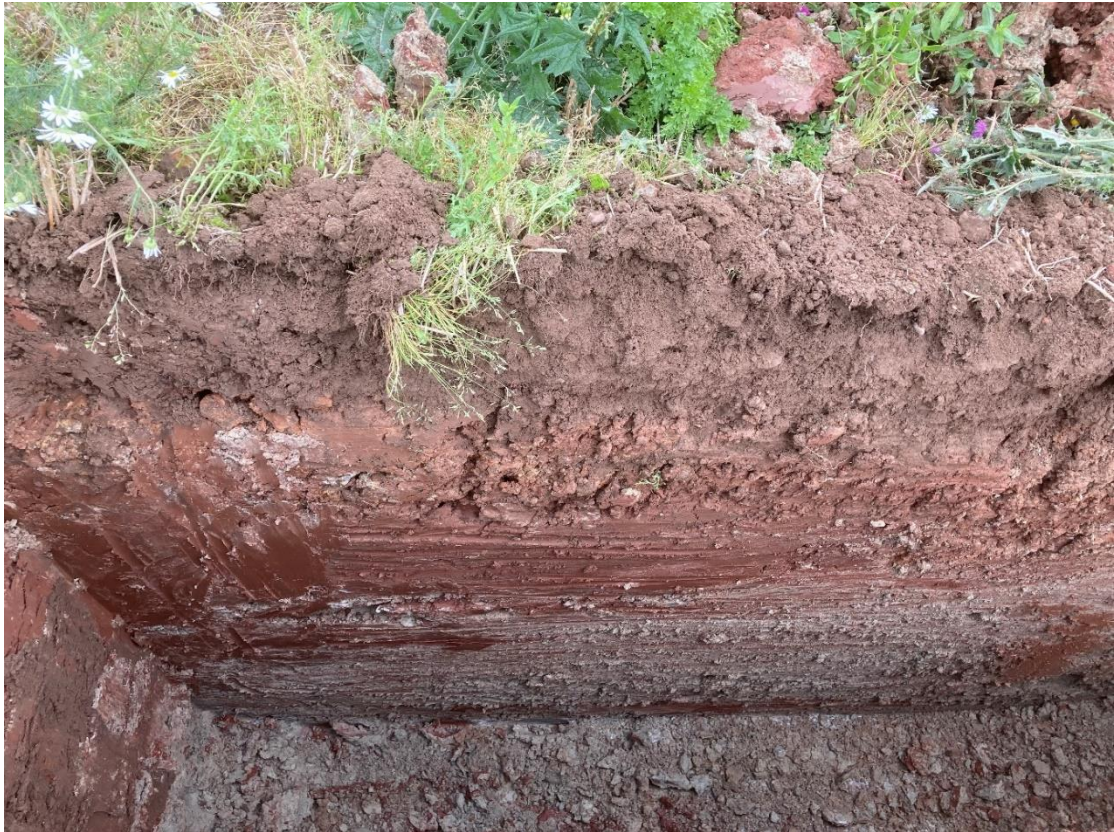
TP06 Trial Pit

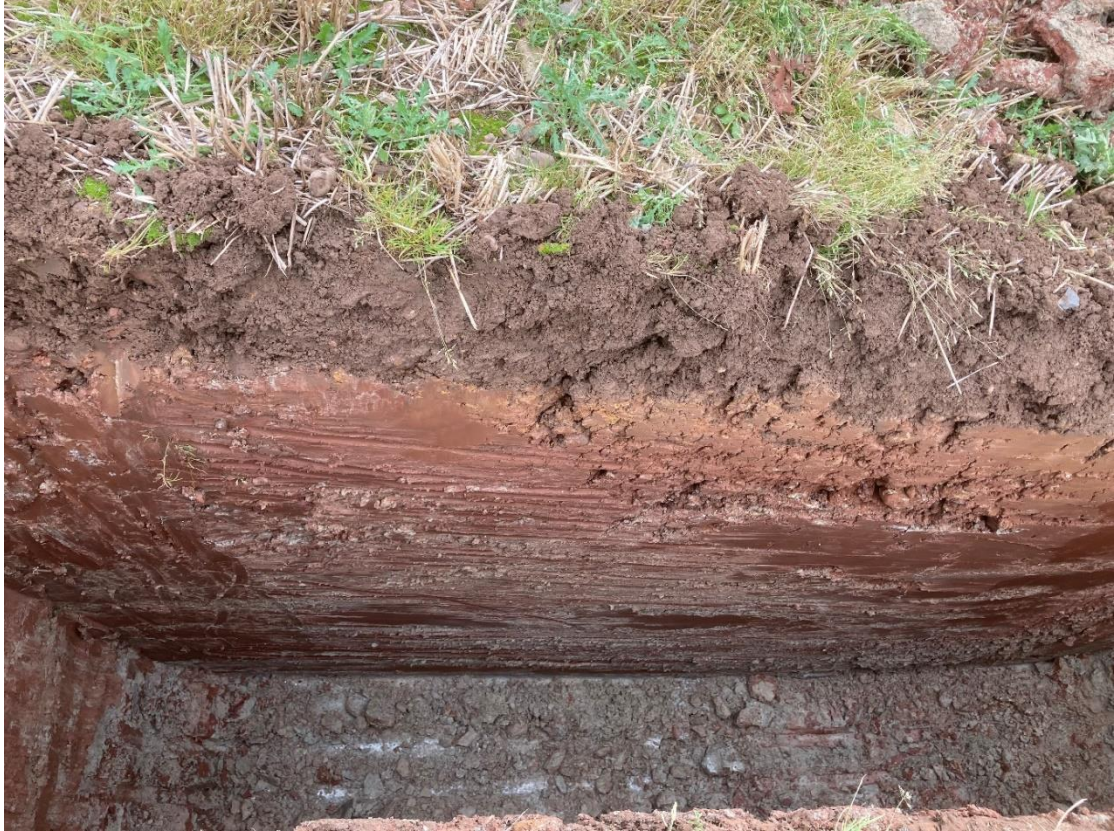
TP07 Trial Pit

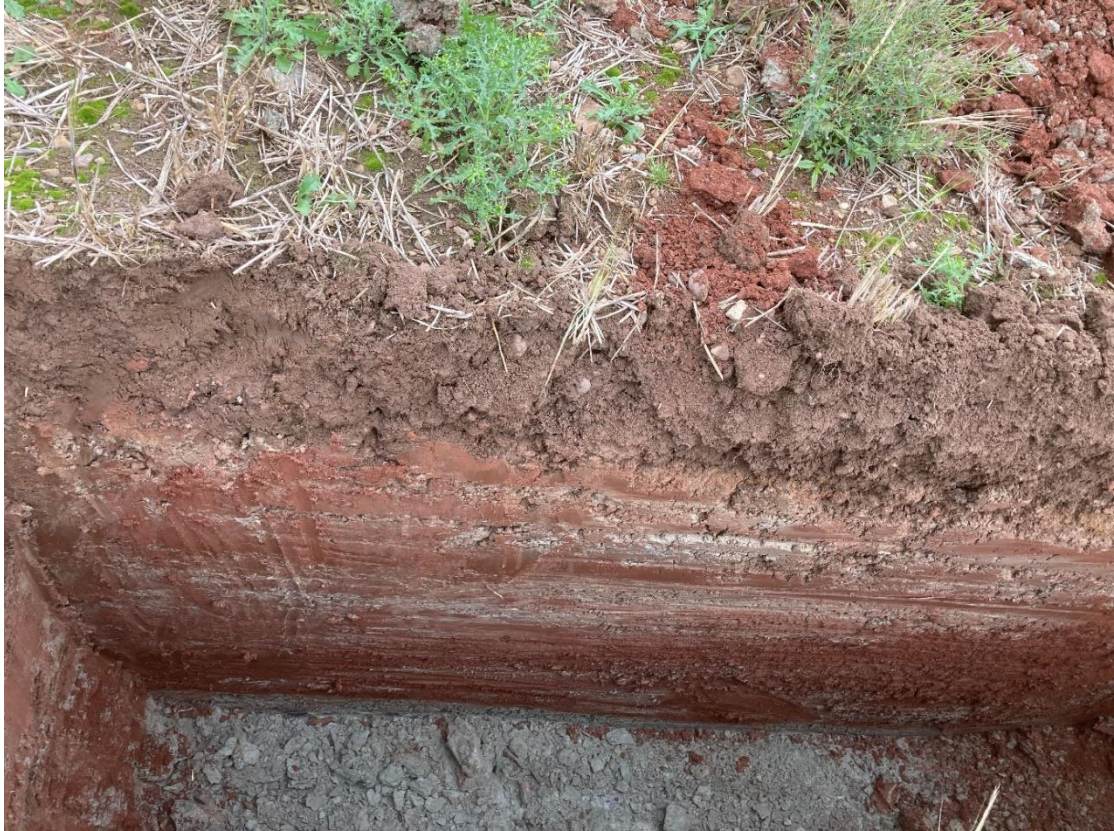
TP08 Trial Pit
